Inspection Photos
Location Name: AC 18-12V
Location ID: 308030

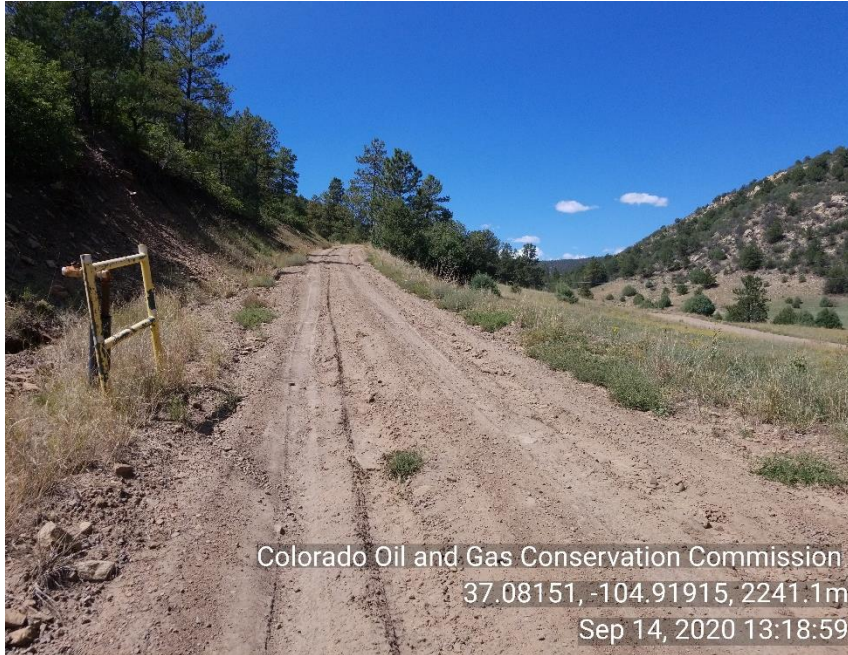
Photo 1 stormwater issues on access road from Big Bingham main road

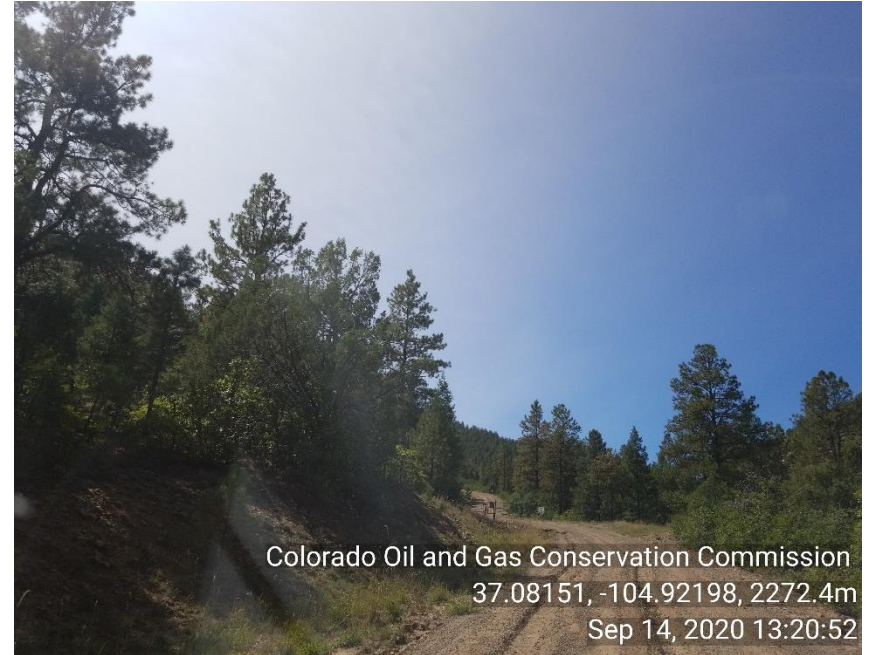
Photo 2 stormwater issues on access road from Big Bingham main road

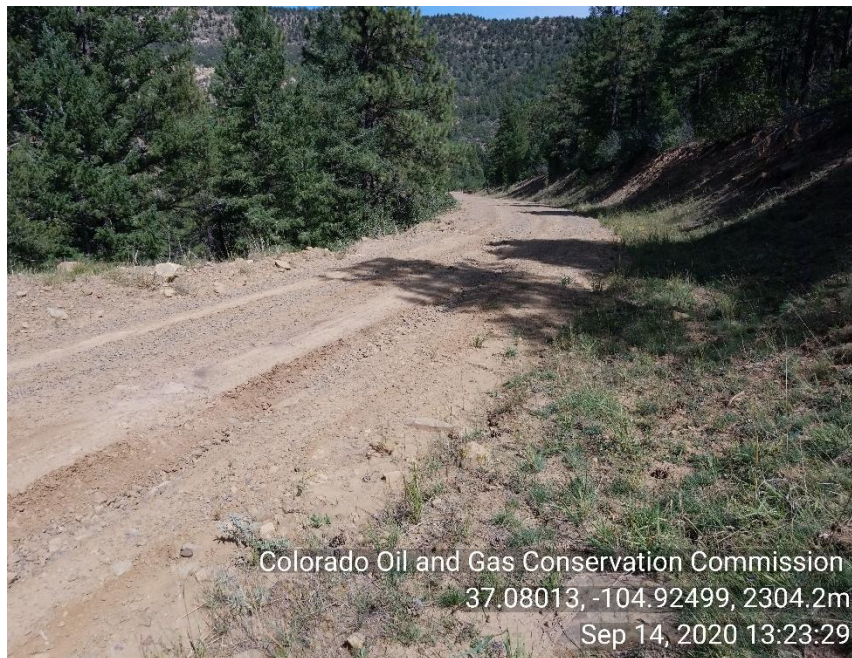
Photo 3 stormwater issues on access road from Big Bingham main road

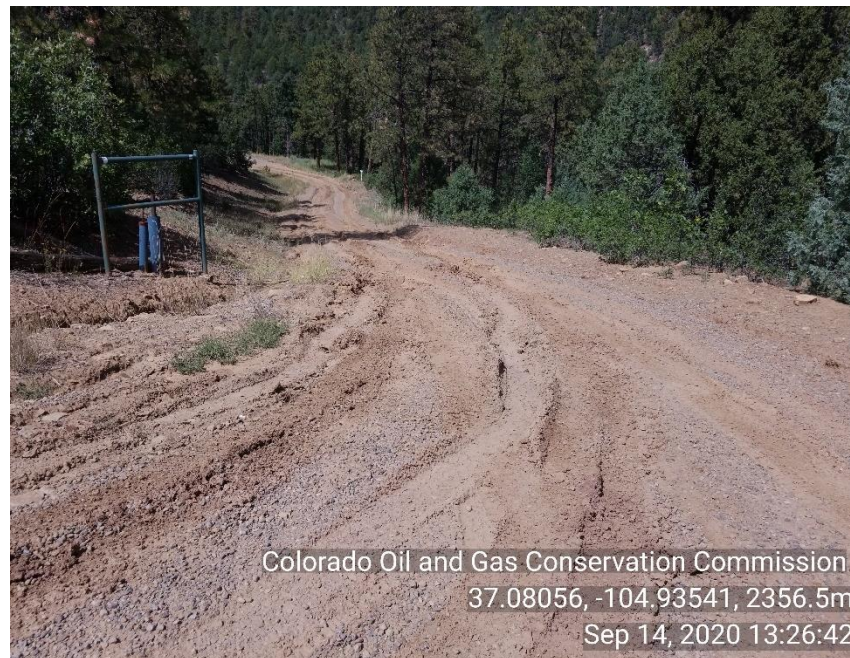
Photo 4 stormwater issues on access road from Big Bingham main road

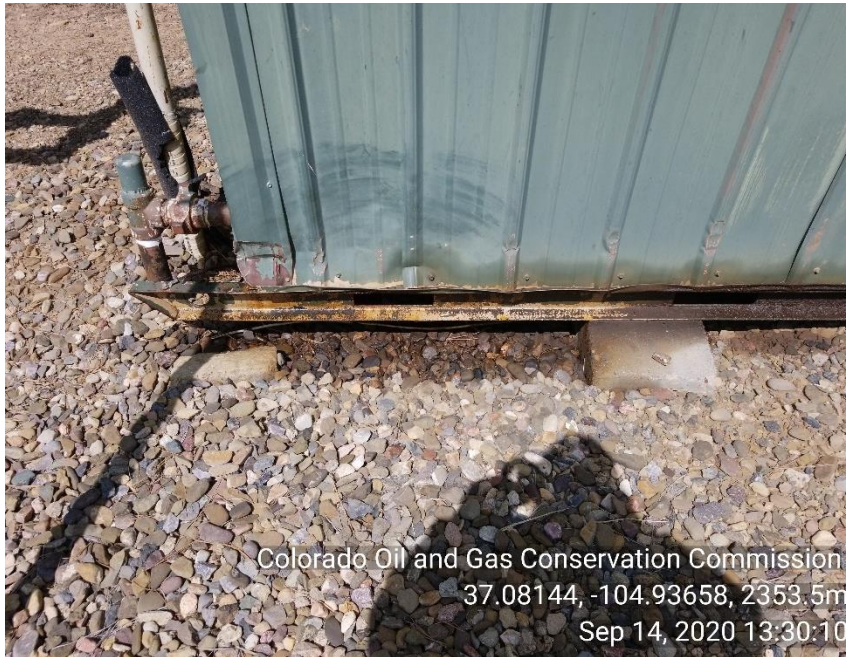
Photo 7 stained soil from active leak in separator

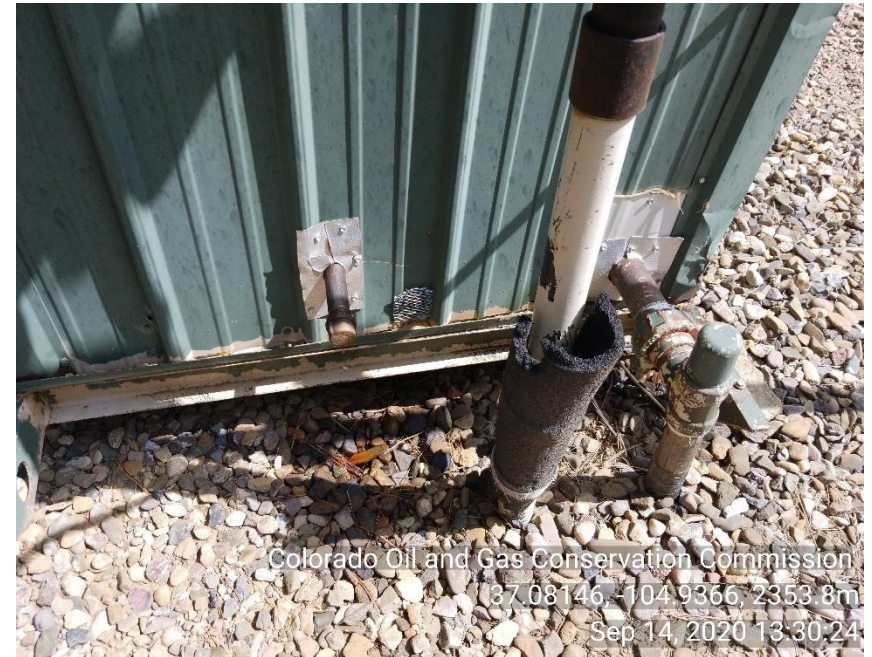
Photo 8 Stained soil from active leak in separator.

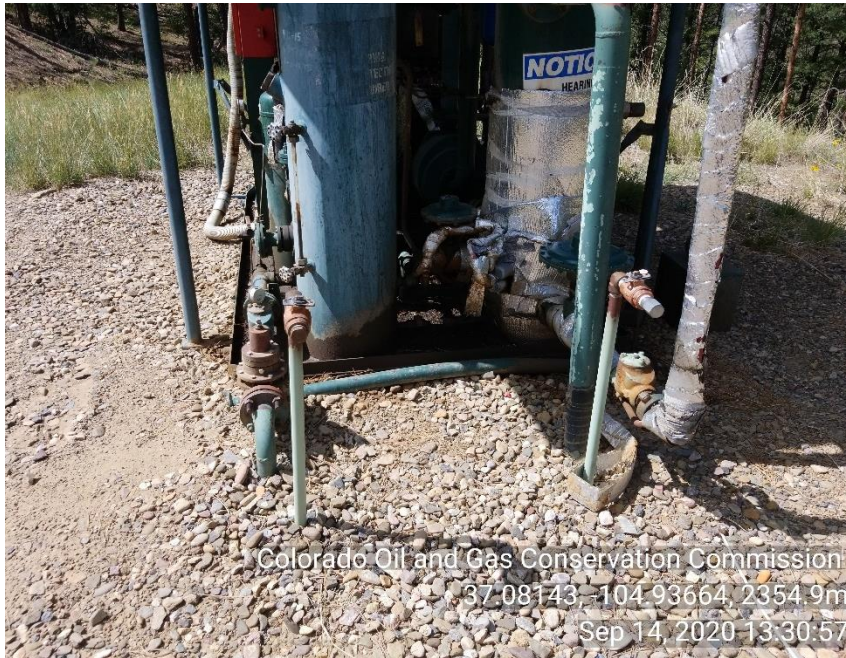
Photo 9 1" risers not LOTO

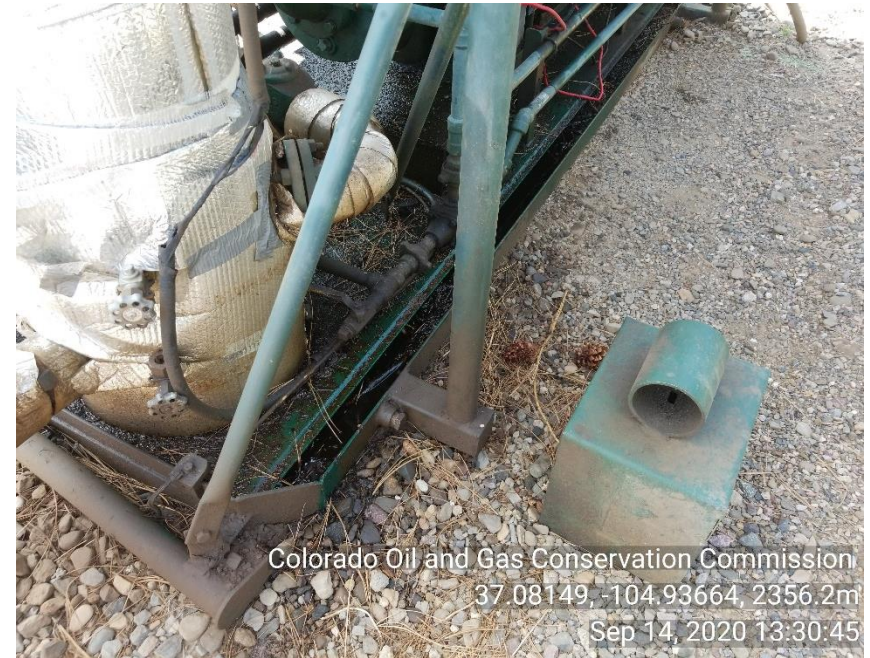
Photo 10 Stained soil around liquid ring. Mechanical issues liquid ring leaking fluid.

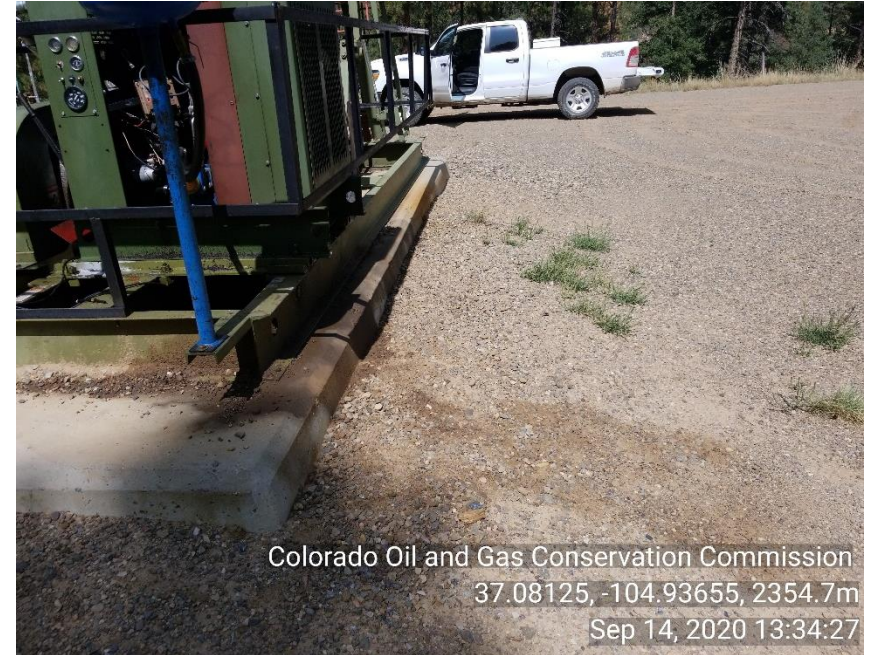
Photo 12 PU HYD leaking fluid. Stained soil and mechanical issues.

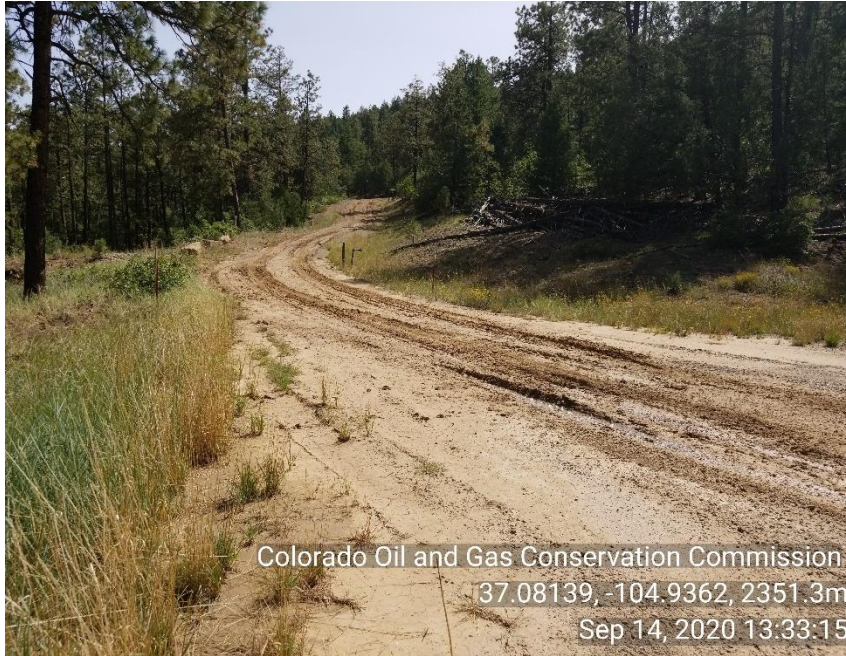
Photo 13 access road stormwater issues sediment being carried down road off location.

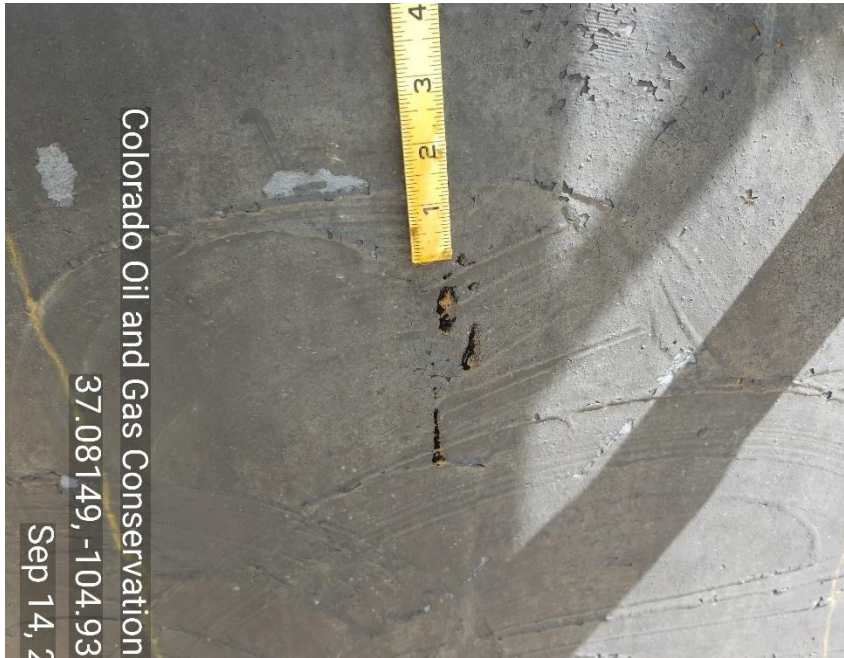
Photo 15 Approx.. 3in of what appears to be non E&P waste
in 30bbl produced water tank.
