Inspection Photos
Operator: BP America
API: 067-06482
Date: 9/11/2020

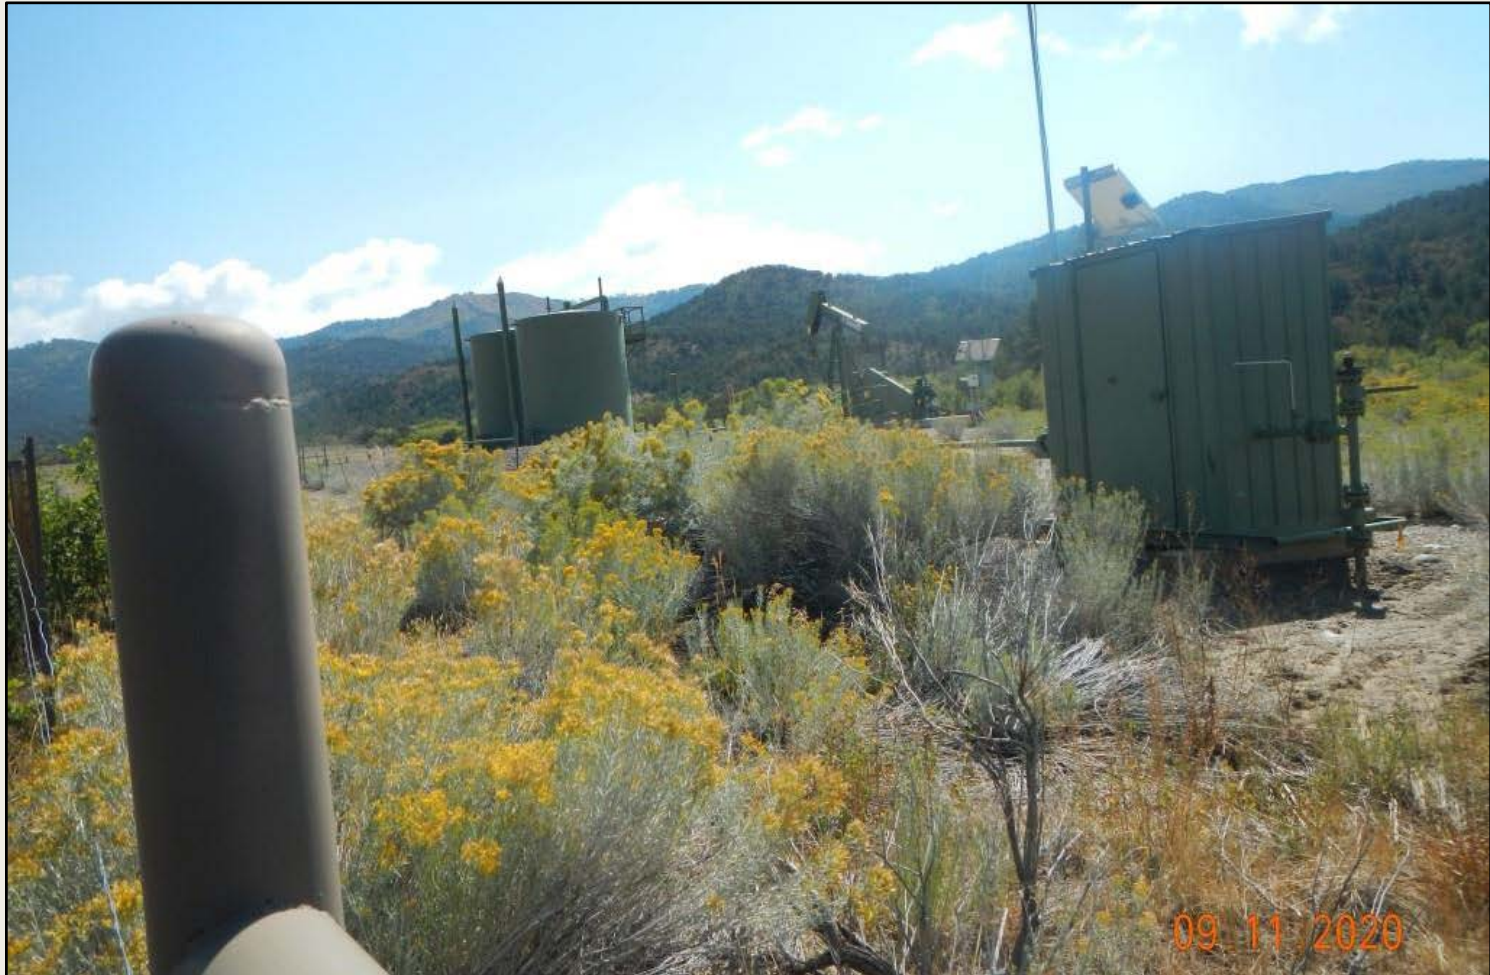
Photo 1. View of the project area from the northwestern corner facing center.

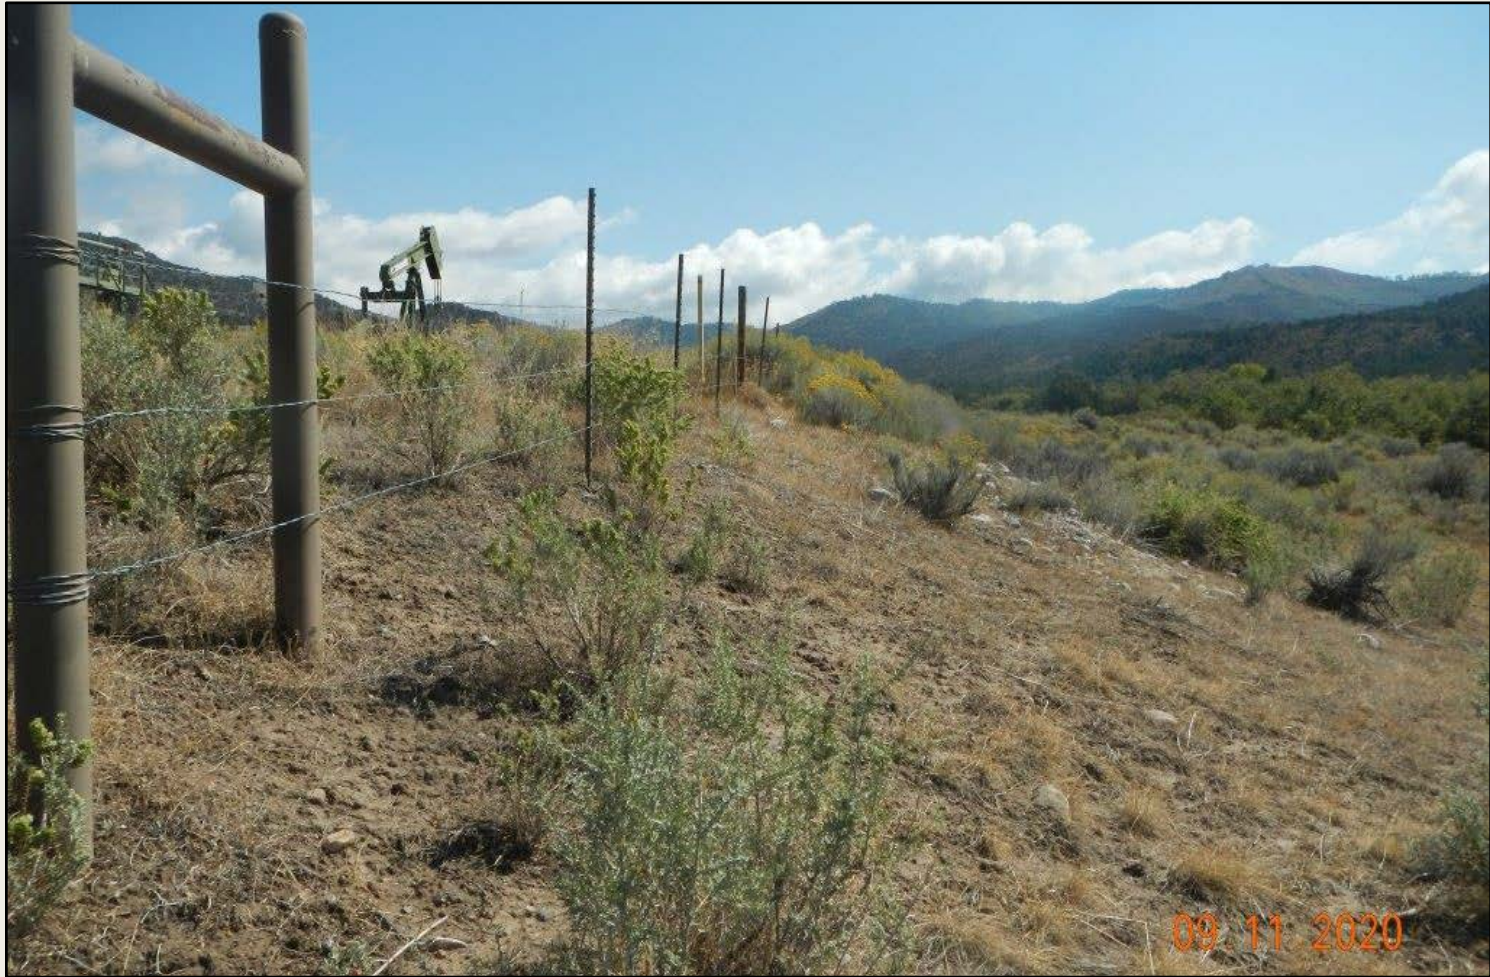
Photo 2. View of the southern fill slope from the southwestern corner facing eastward. Revegetation is progressing with grasses and shrubs such as western wheatgrass and rubber rabbitbrush.

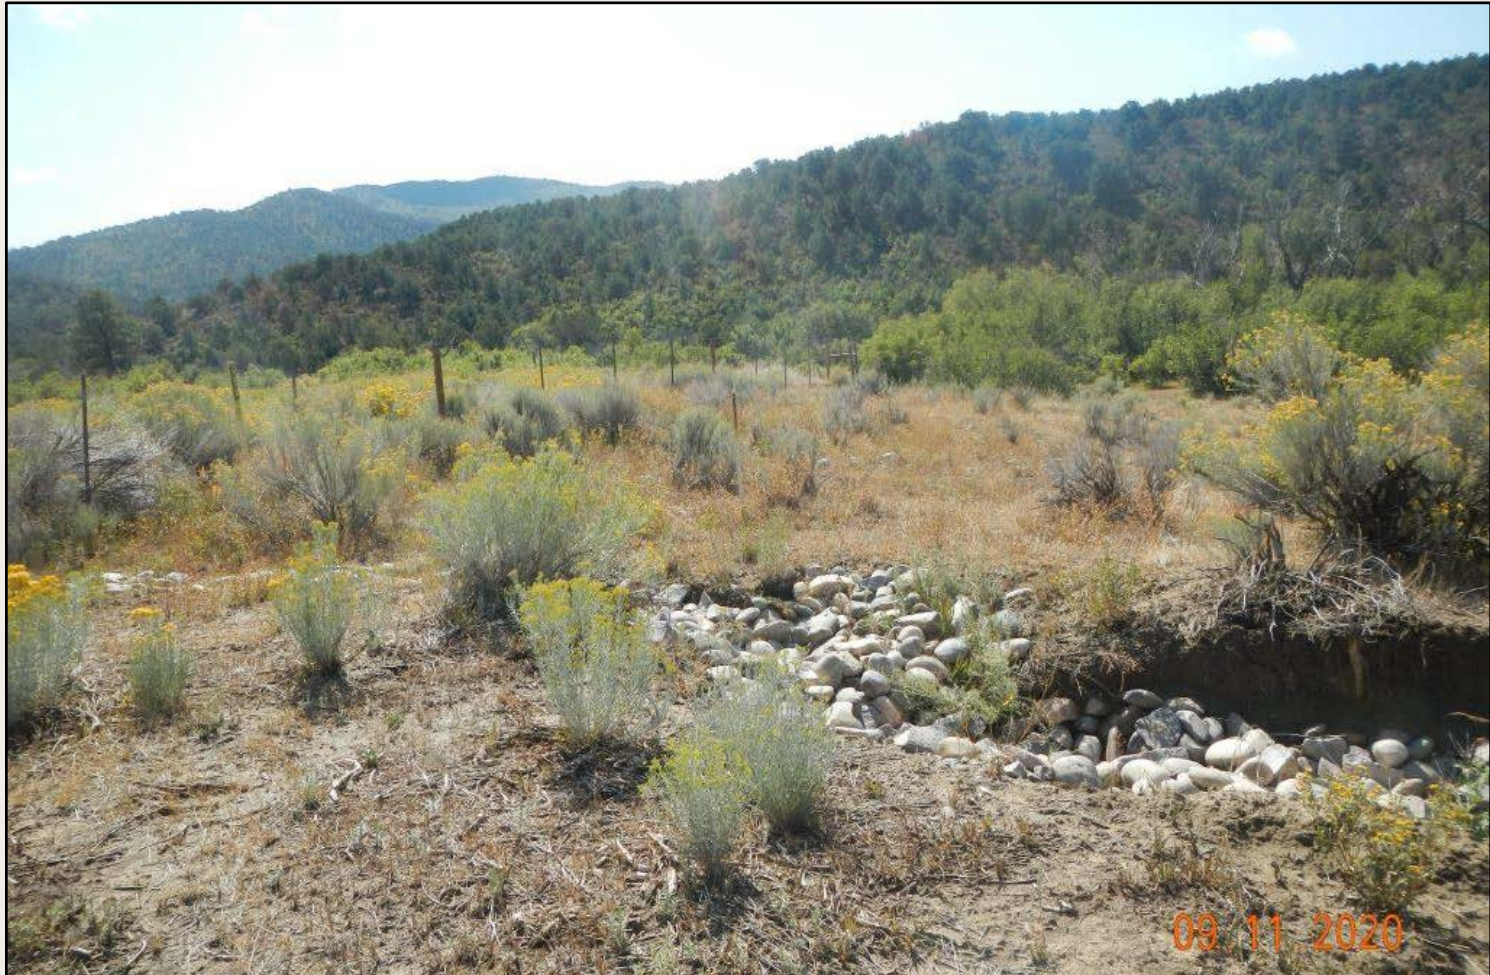
Photo 3. View of the western project area from the northwestern corner facing southward. Cobble run-down placed in erosional channel appears to be functioning. Note that smooth cobble can accelerate velocity of water flows and is not recommended as a stormwater BMP. Continue monitoring to ensure site stabilization.

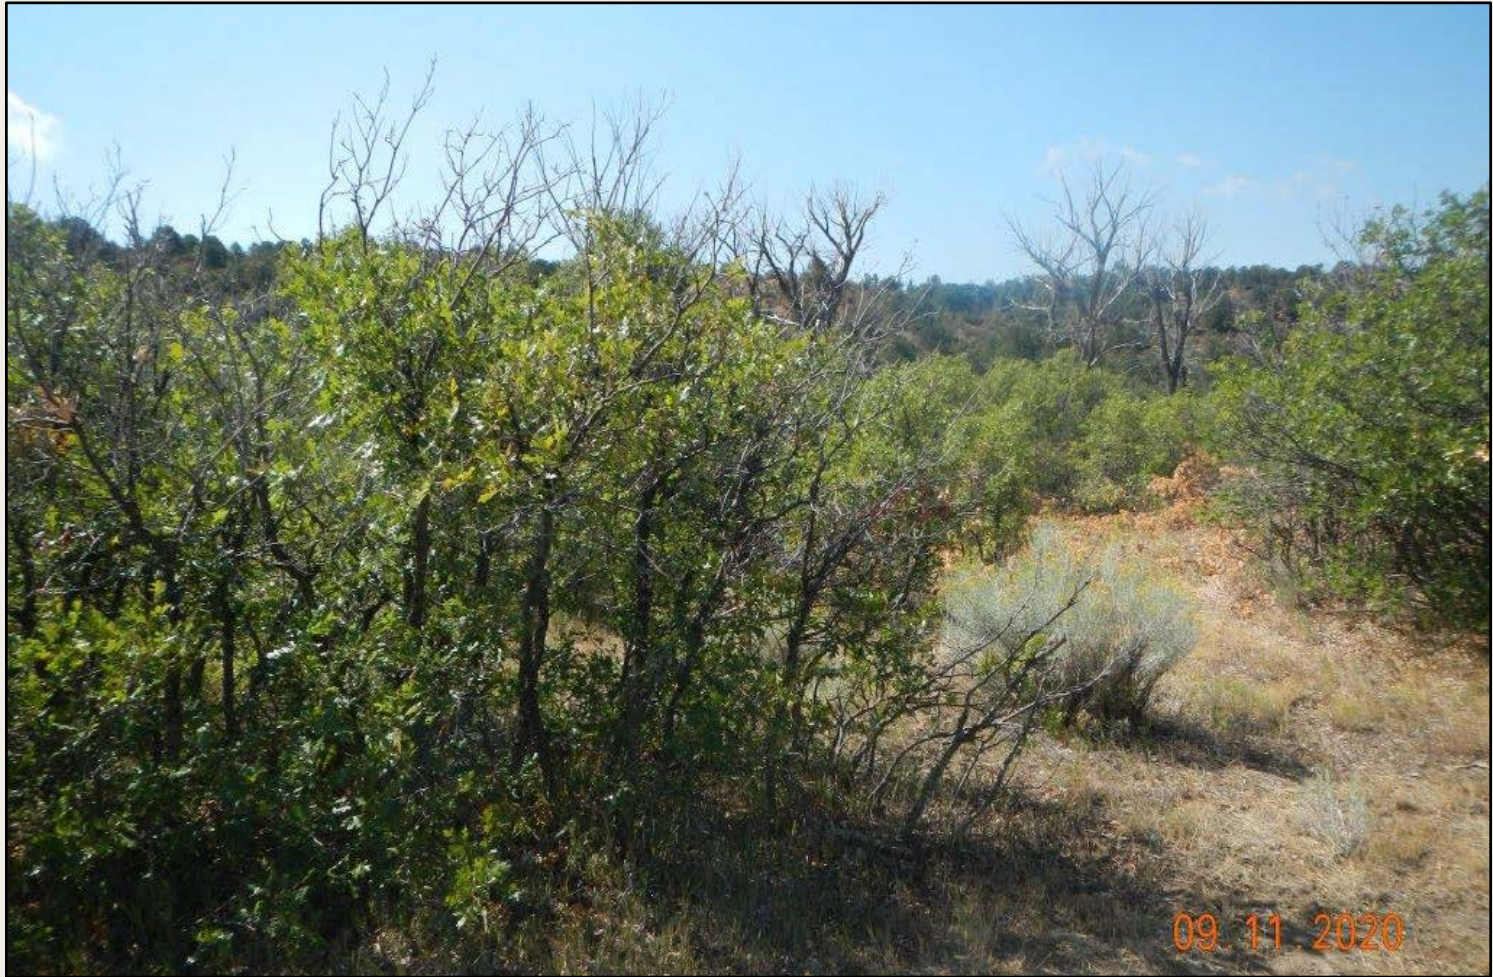
Photo 4. View of reference area vegetation comprised of gambel oak shrubland with a mix of grasses, shrubs, and forbs in the understory, such as western wheatgrass, *Heterotheca villosa*, and rubber rabbitbrush.
