Inspection Photos
Operator: Catamount Energy
API: 007-06098
Date: 9/11/2020

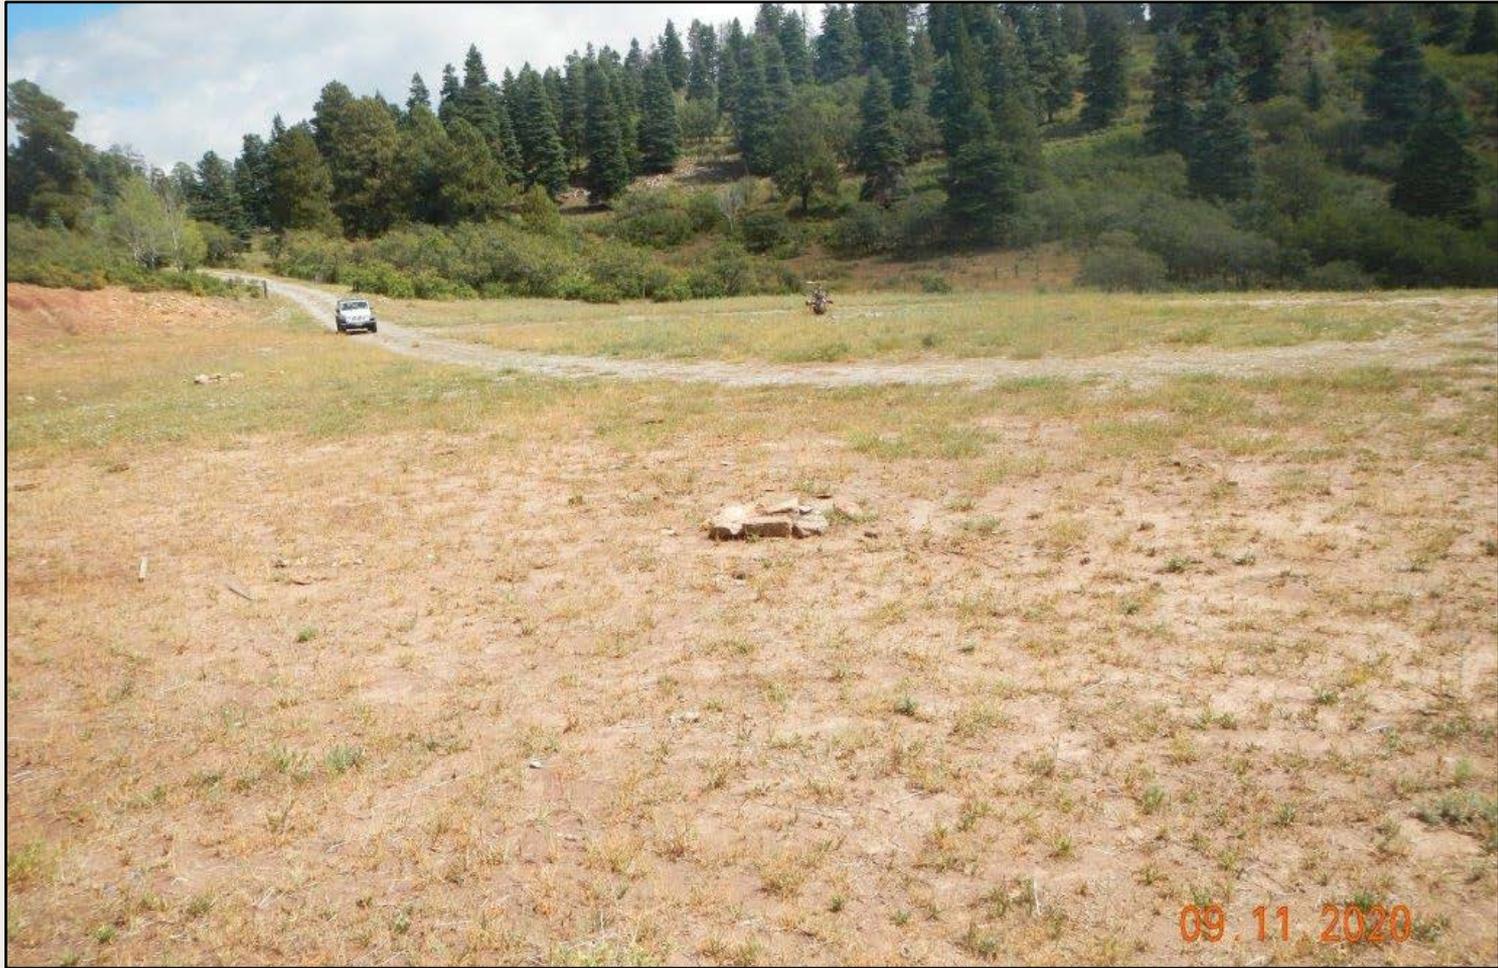
Photo 1. View of the project area from the northwestern corner facing center toward the well.

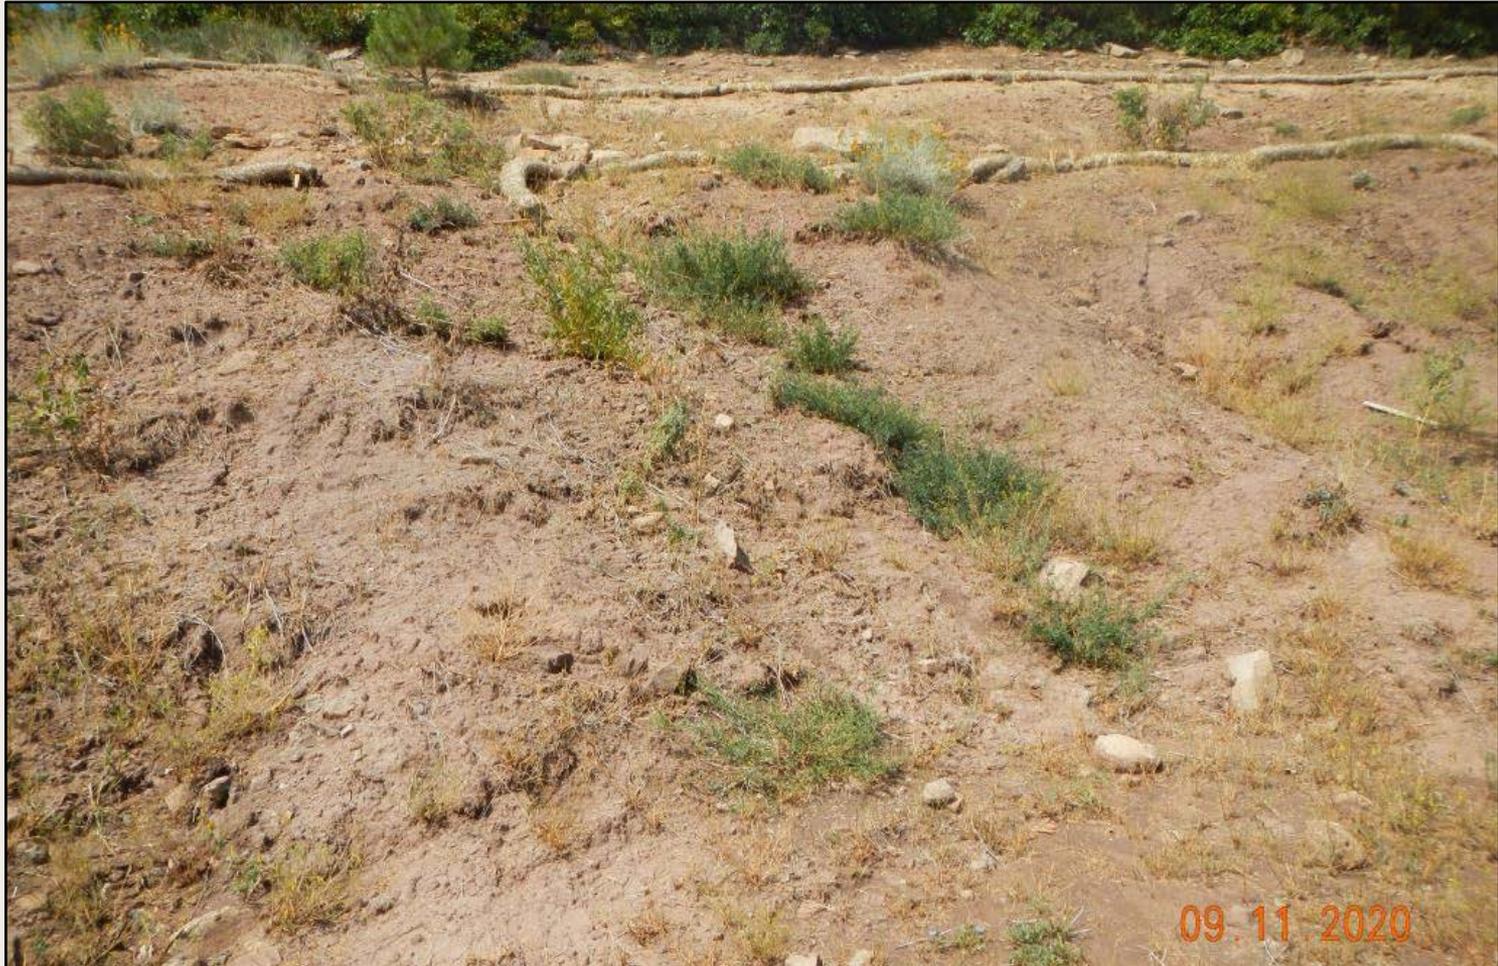
Photo 2. View of wattles placed on the northwestern cut-slope. Some wattles appear to be functioning; however, many are out of place.

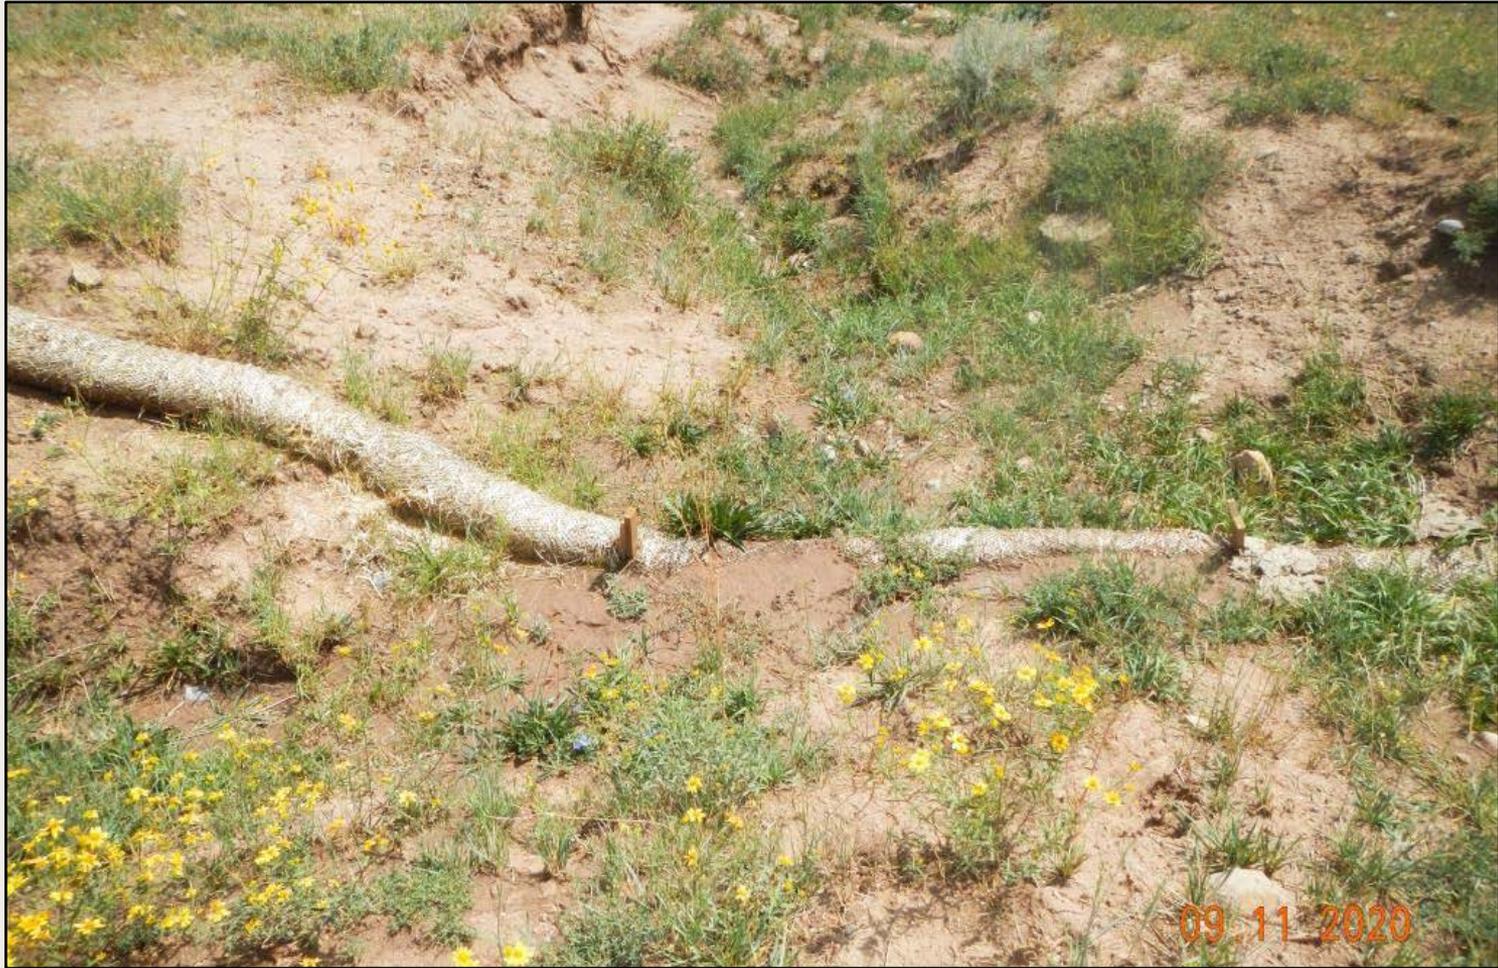
Photo 3. View of wattle in the southwestern project area that is full of sediment.

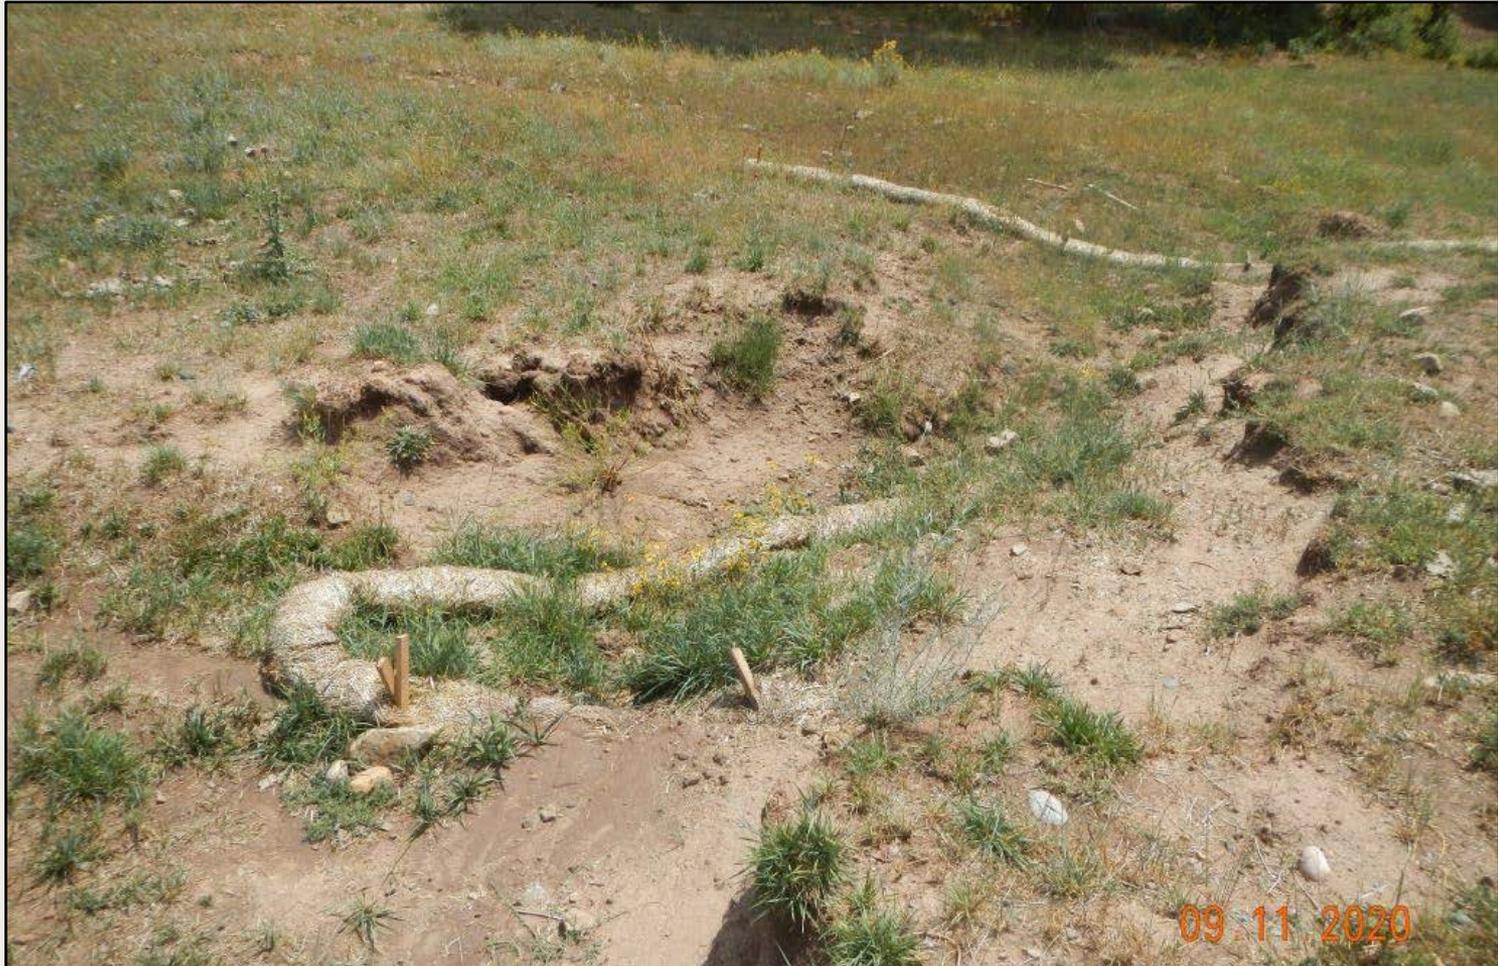
Photo 4. Downstream facing view of erosional channel identified during 2019 reclamation inspection. Wattles are installed, but out of place, full of sediment, and largely, not longer functioning. Wattles are not an adequate BMP in this area.

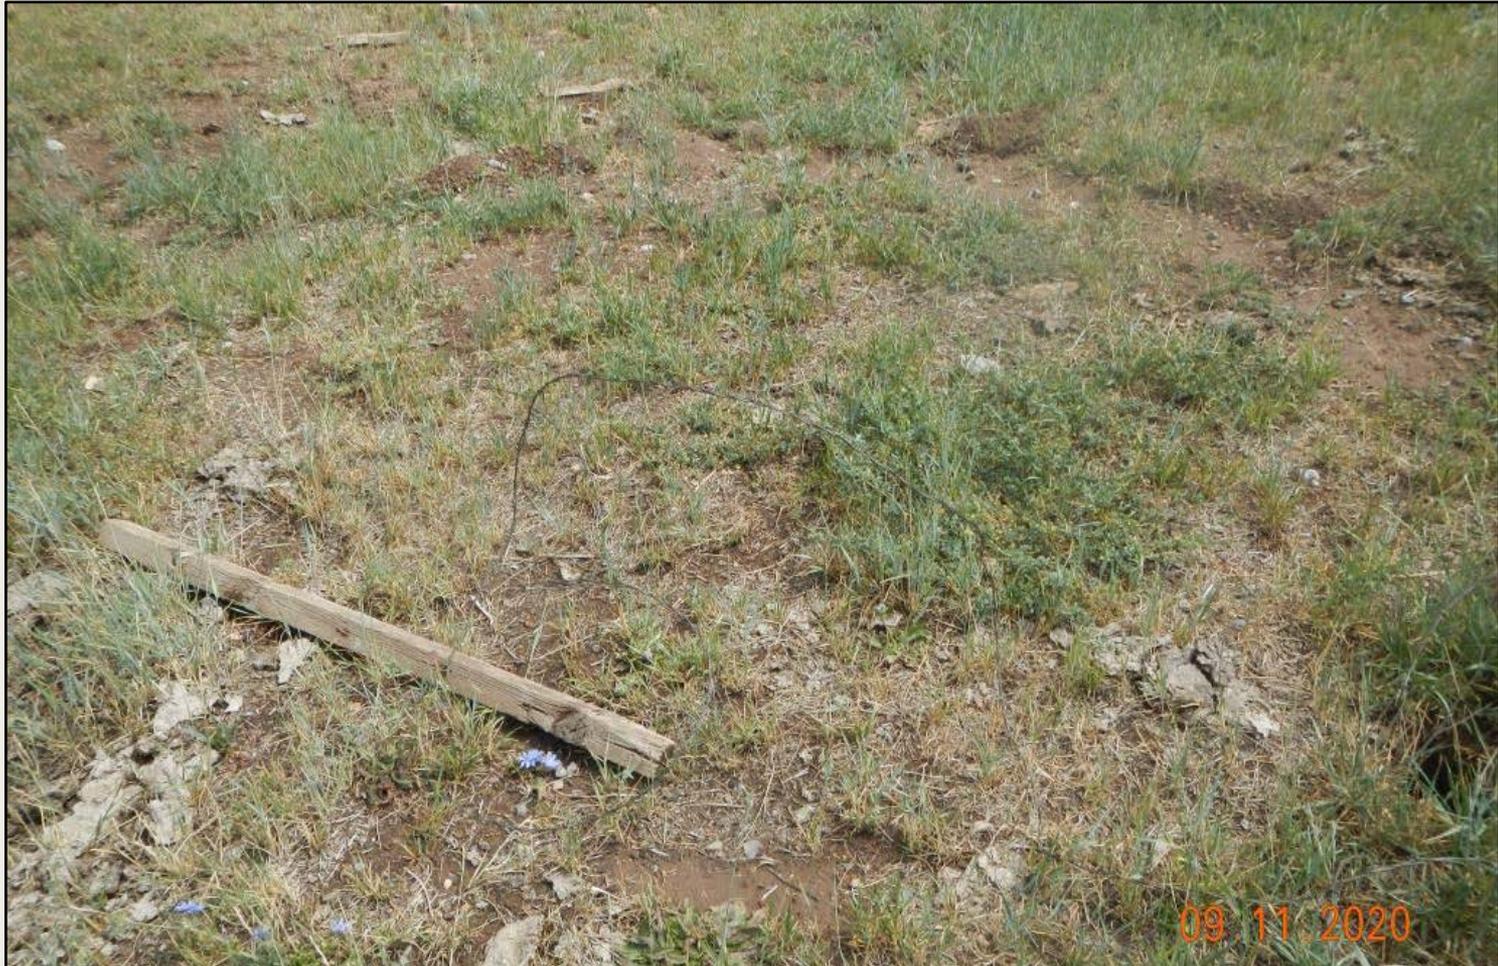
Photo 5. View of fencing and barbed wire debris.

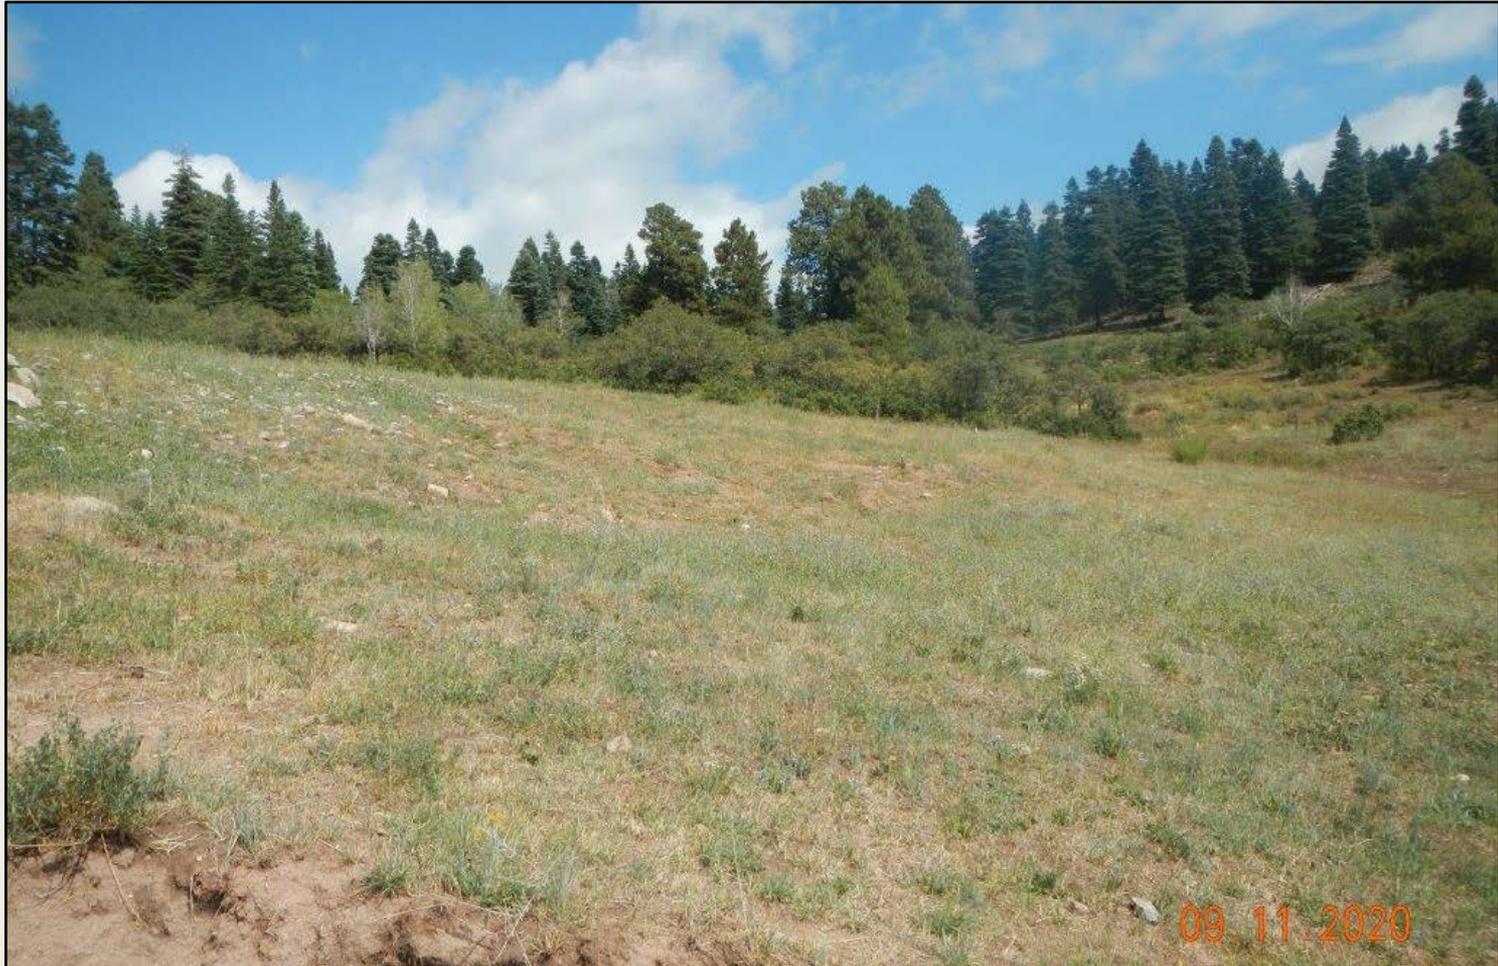
Photo 6. View of the southern project area from the southwestern corner facing eastward.

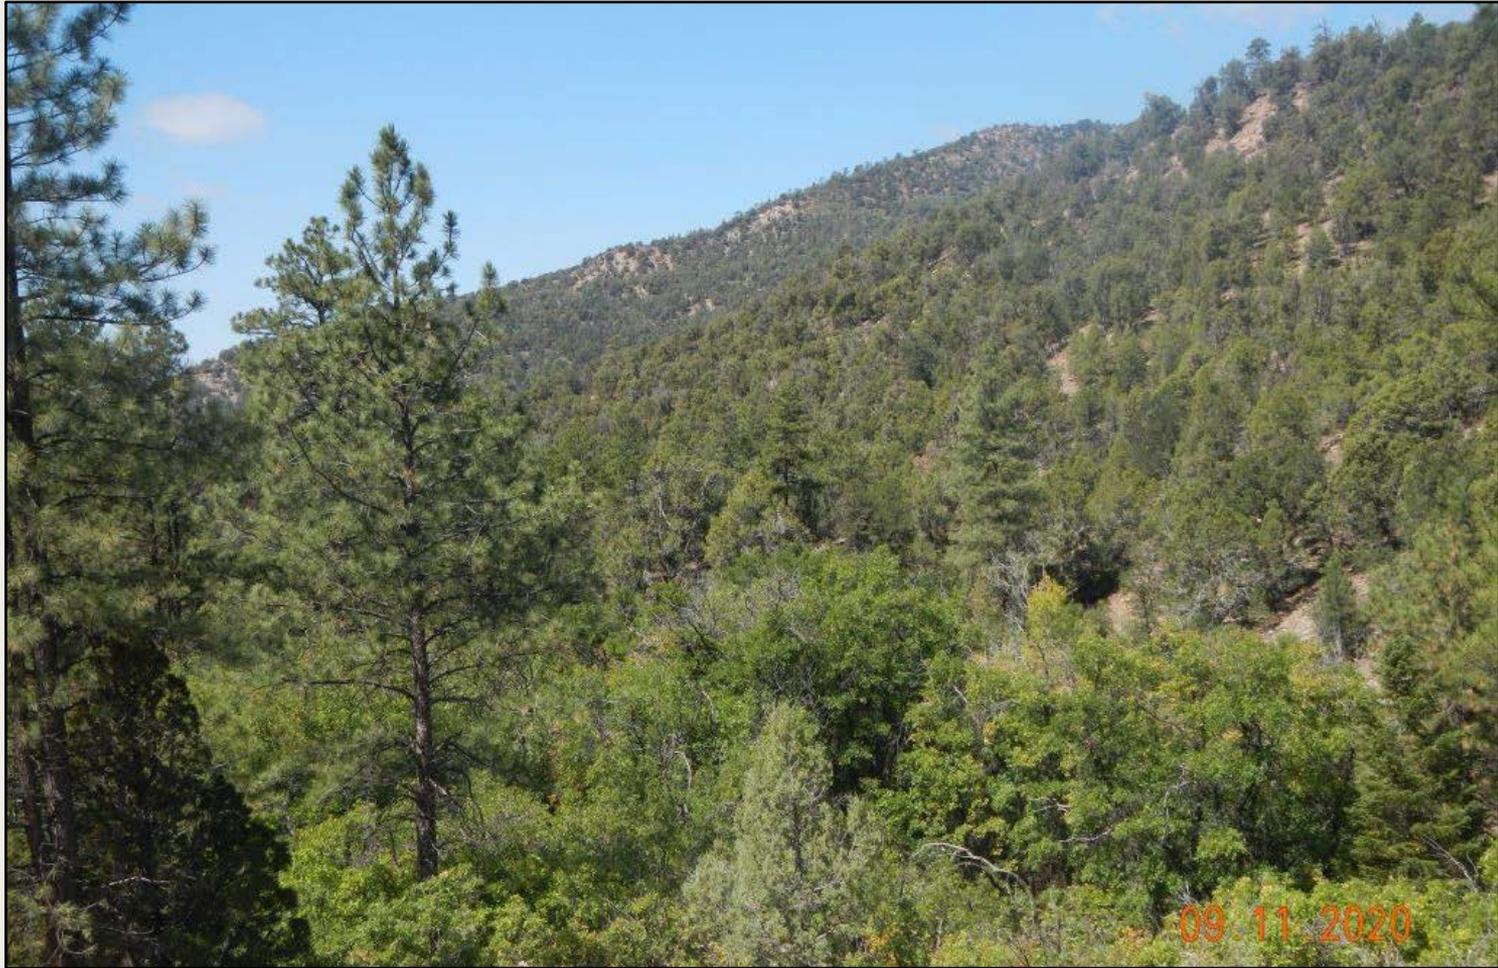
Photo 8. View of reference area vegetation comprised of ponderosa pine forest with gambel oak, snow berry, Oregon grape, and junegrass in the understory.
