Construction and Stormwater Inspection

September 15, 2020

Operator: NOBLE ENERGY INC- #100322

Location ID: 459435

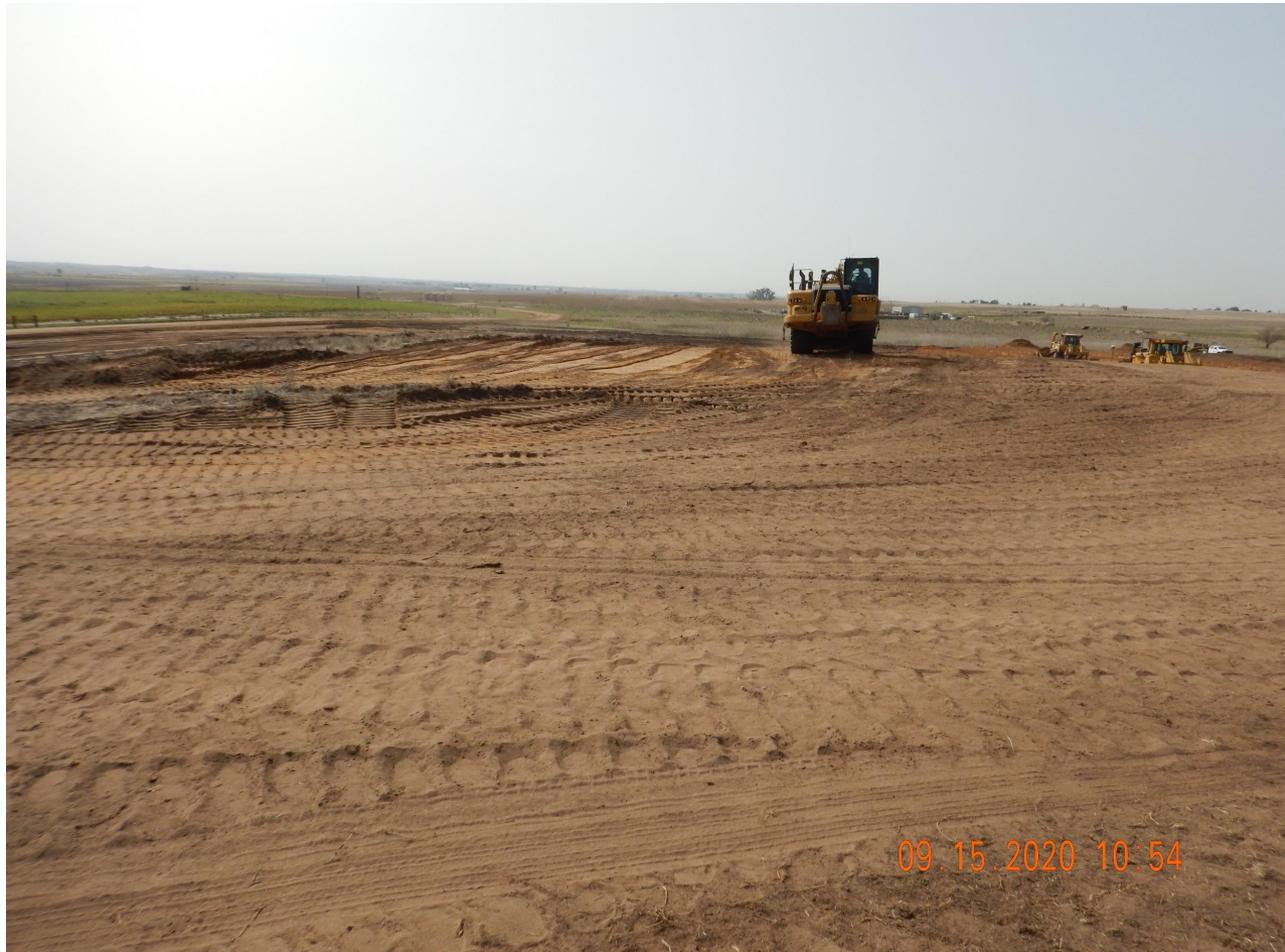
Photo 1. Photo taken from the northern location, facing South. Photo illustrates Operator is in process of performing topsoil salvage operations.

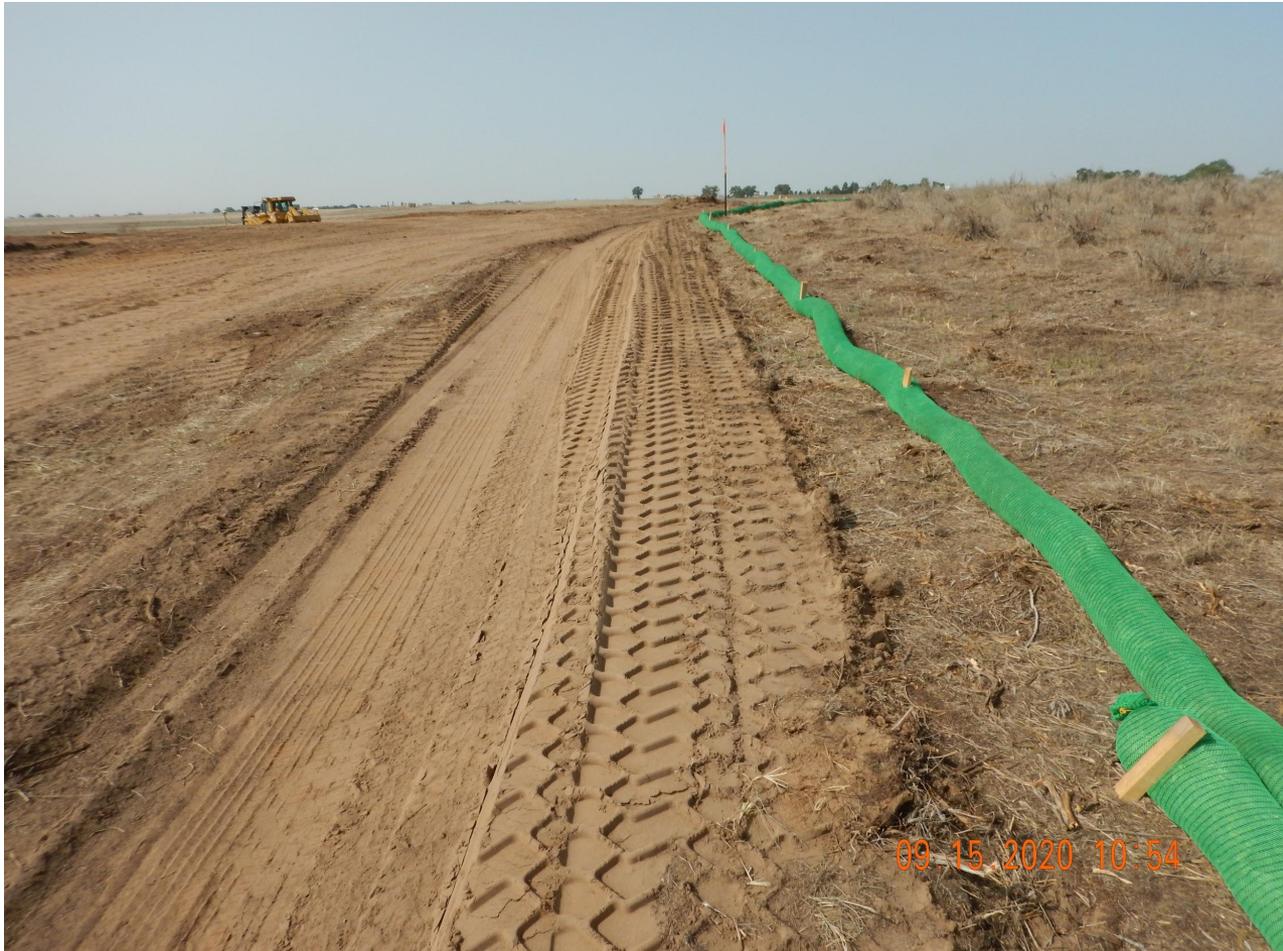
Photo 2. Photo taken from the northeastern location, facing West. Photo illustrates Operator has installed stormwater BMPs (ditch and berm, filtrex wattles) around the entire perimeter of location.

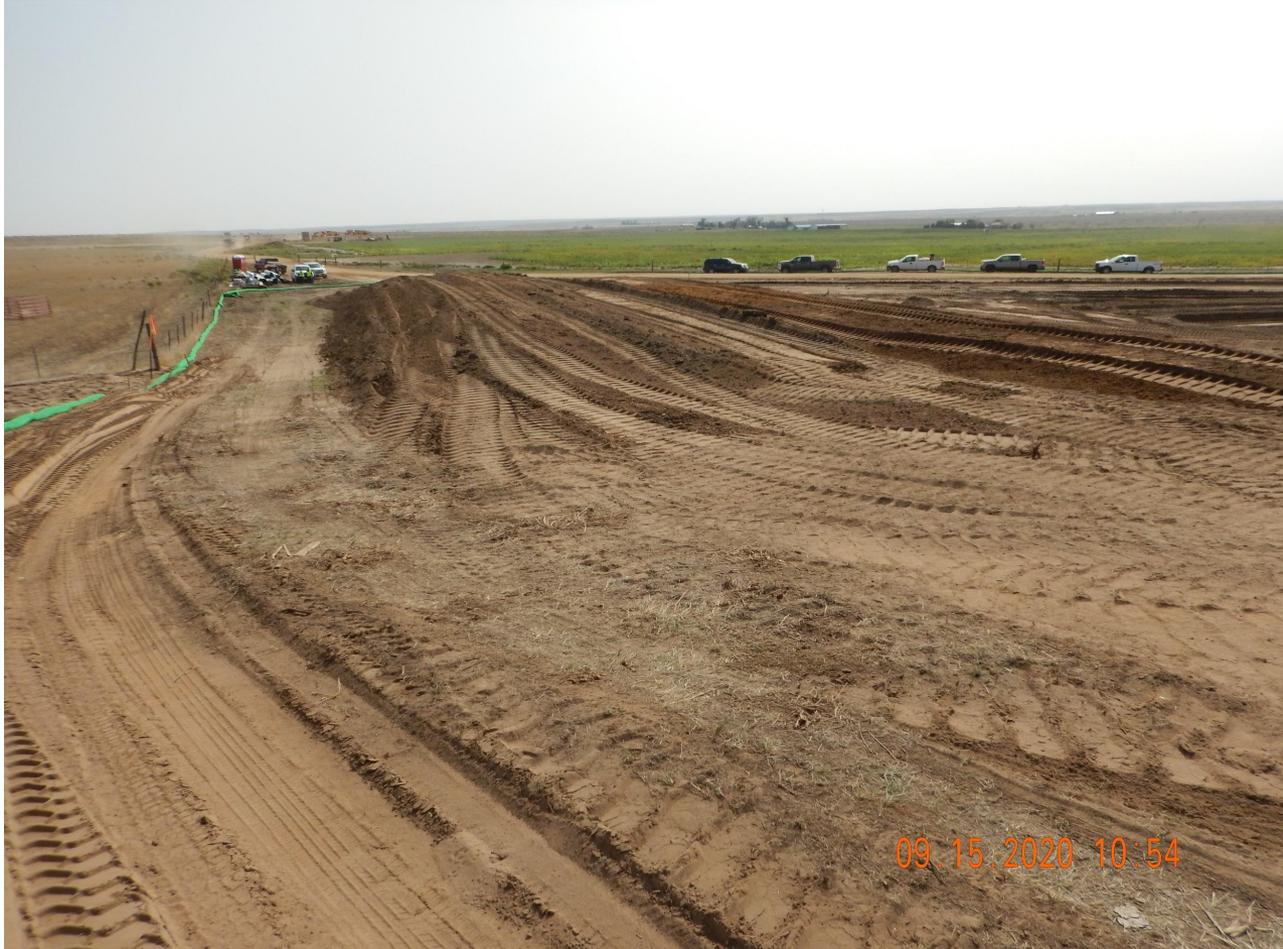
Photo 3. Photo taken from the northeastern location, facing East. Photo illustrates Operator is stockpiling topsoil along the northeastern location.

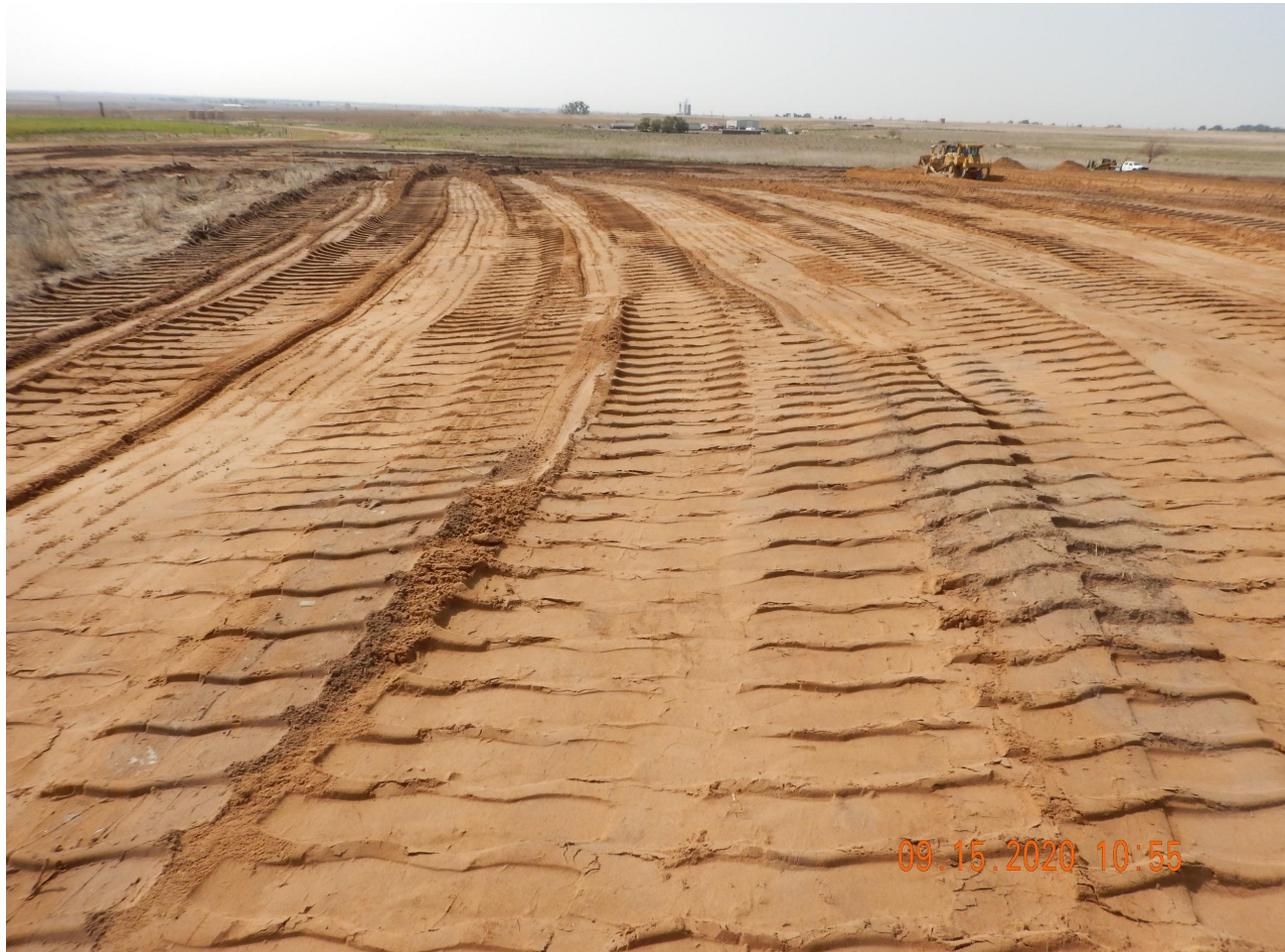
Photo 4. Photo taken from the northern section of the location, facing South. Photo illustrates Operator appears to be salvaging topsoil to an appropriate depth.

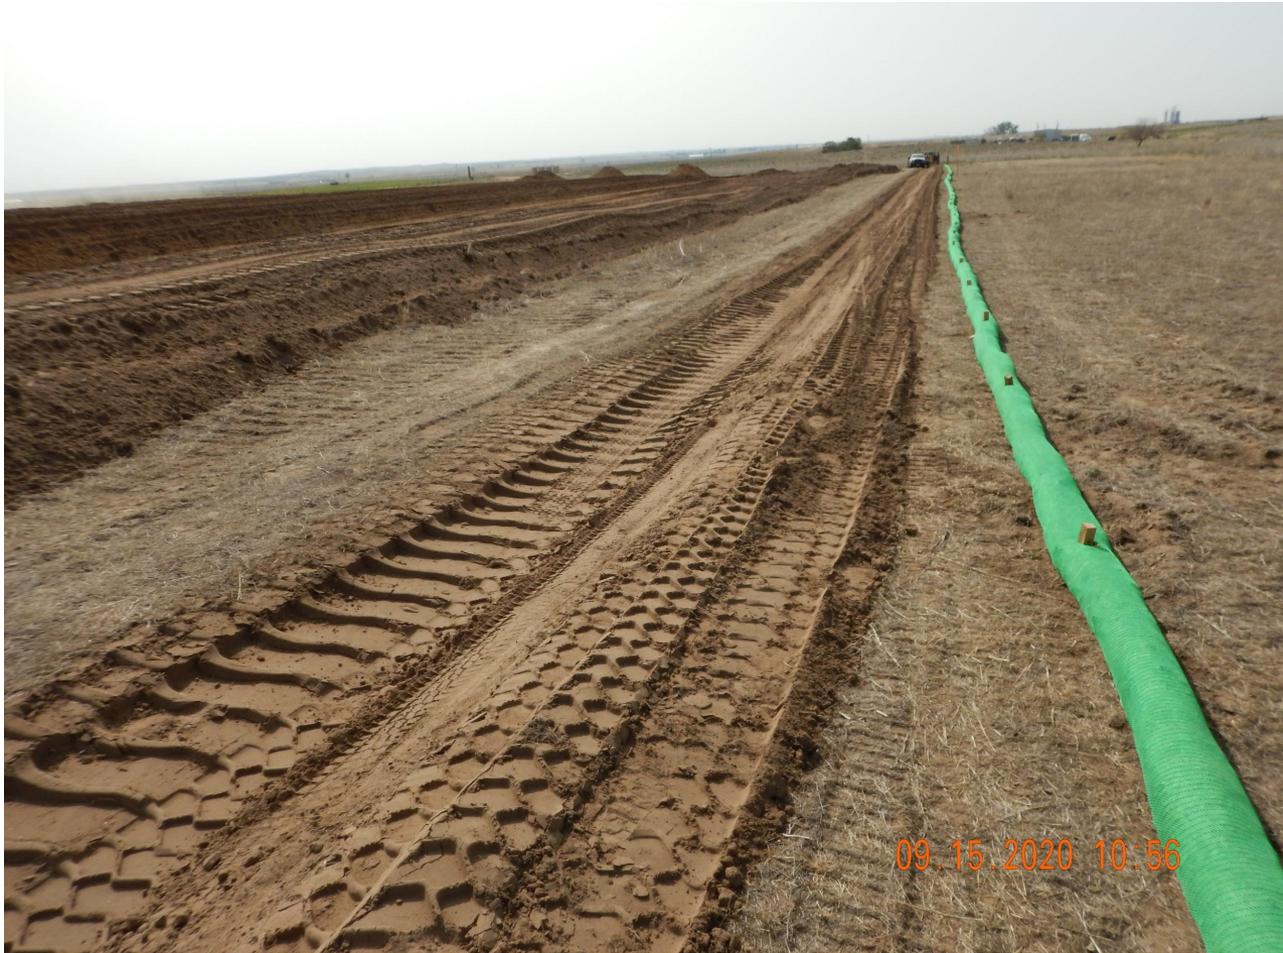
Photo 5. Photo taken from the northwestern location, facing South. See comments under Photo 2.

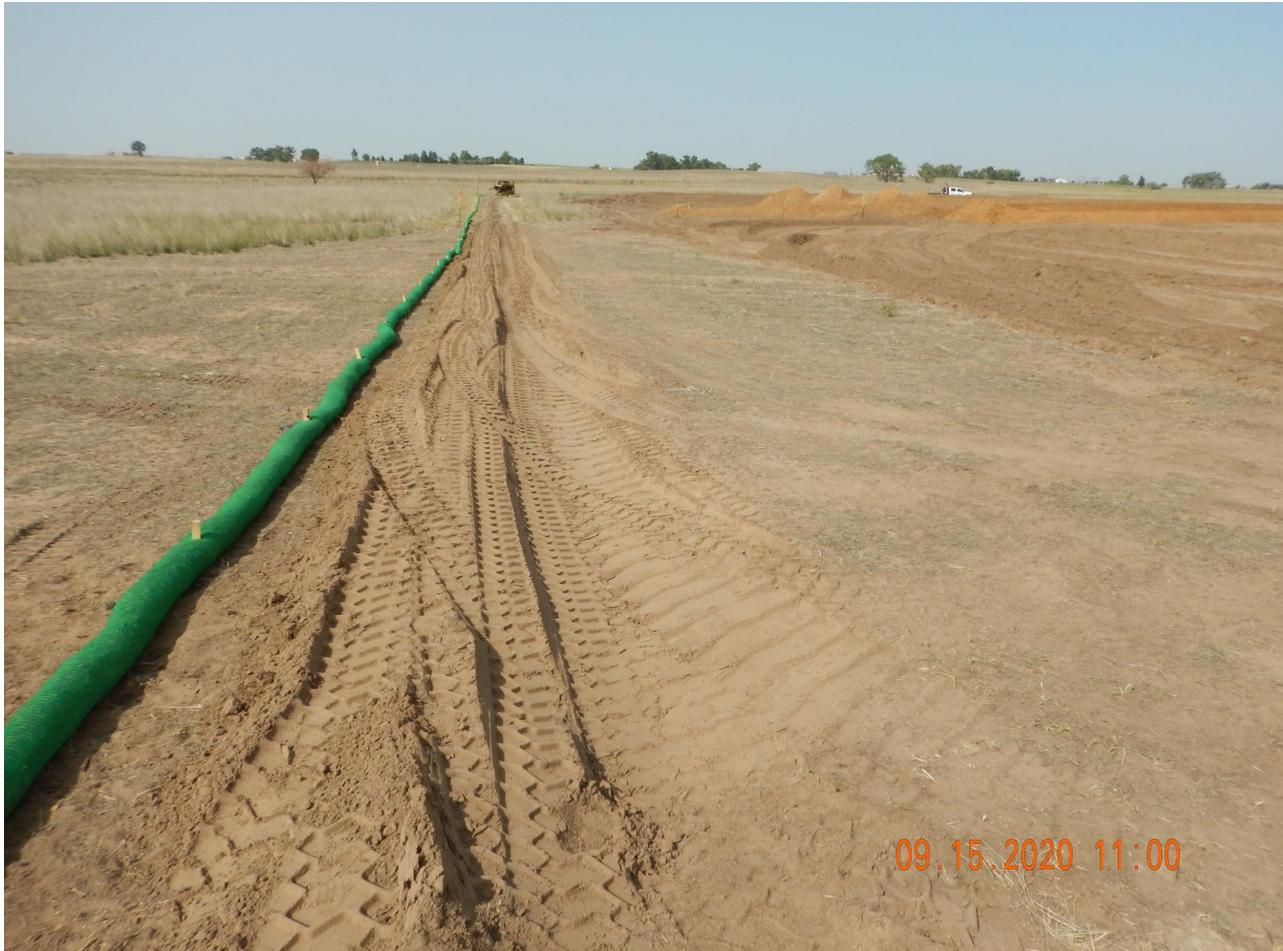
Photo 6. Photo taken from the southeastern location, facing East. See comments under Photo 2.

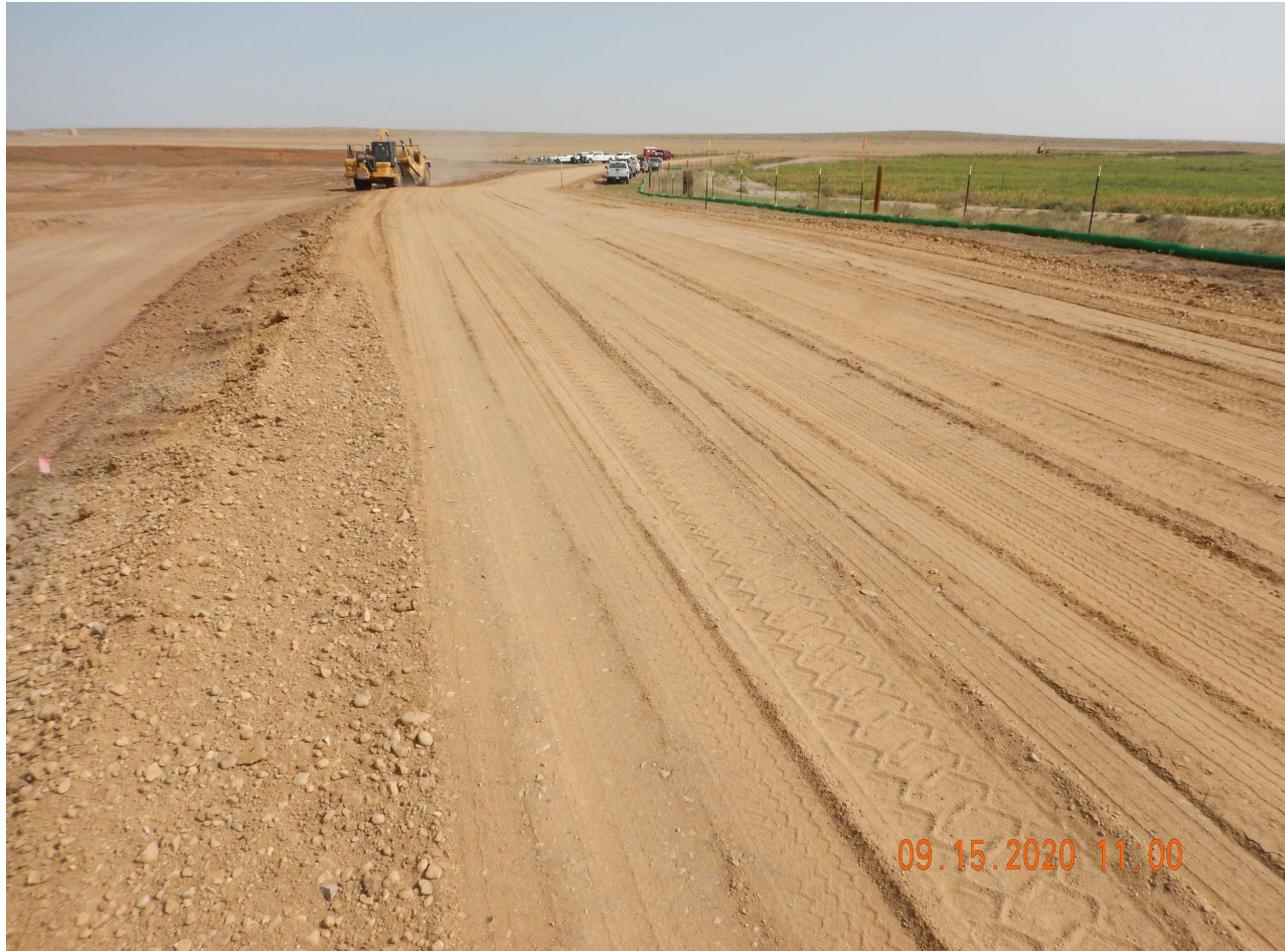
Photo 7. Photo taken from the southeastern location, facing North. See comments under Photo 2.

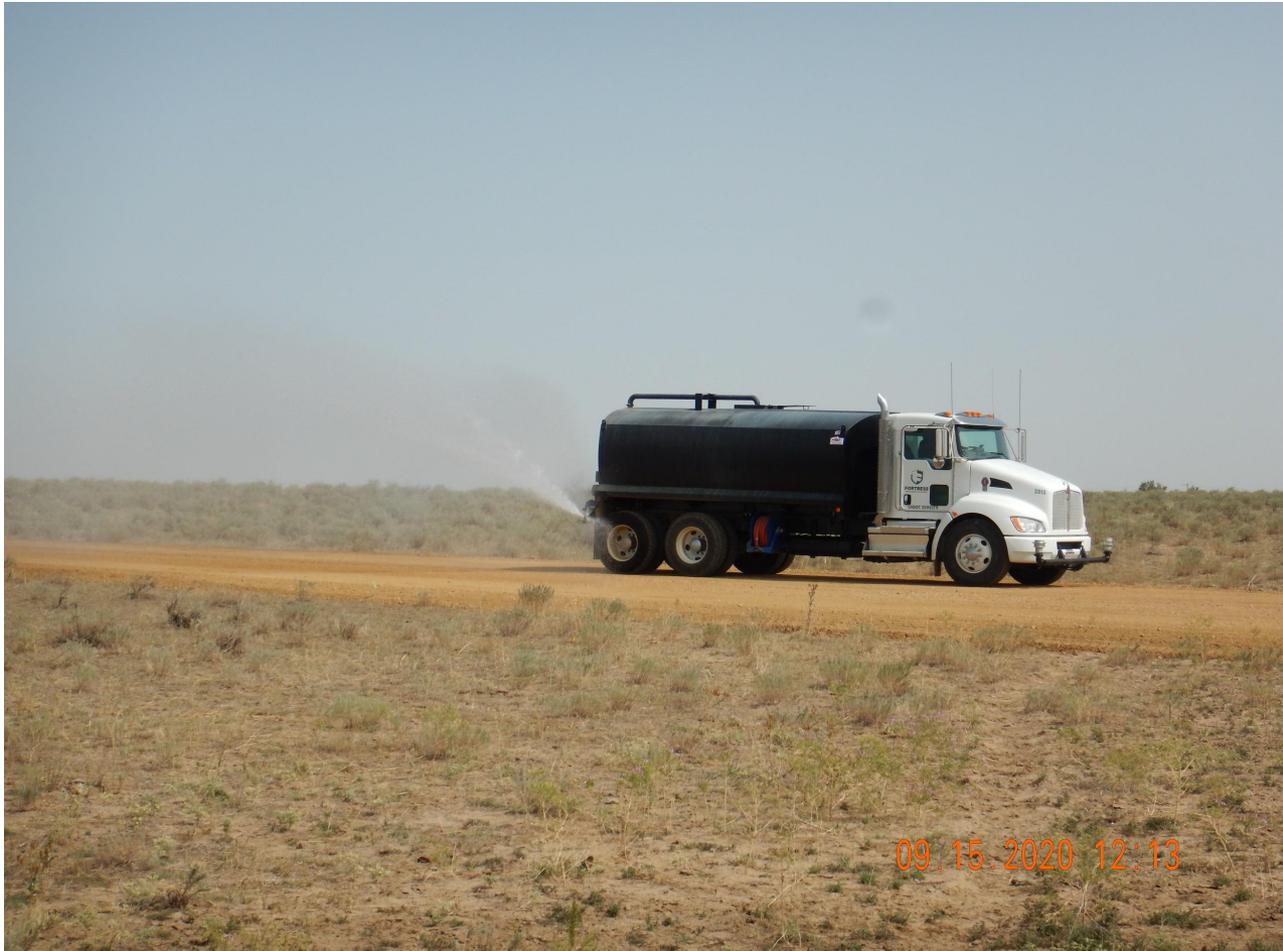
Photo 8. Photo taken from a portion of the main access road, facing North. Photo illustrates Operator had a water truck on location controlling fugitive dust.
