Construction and Stormwater Inspection

September 15, 2020

Operator: NOBLE ENERGY INC- #100322

Location ID: 459443

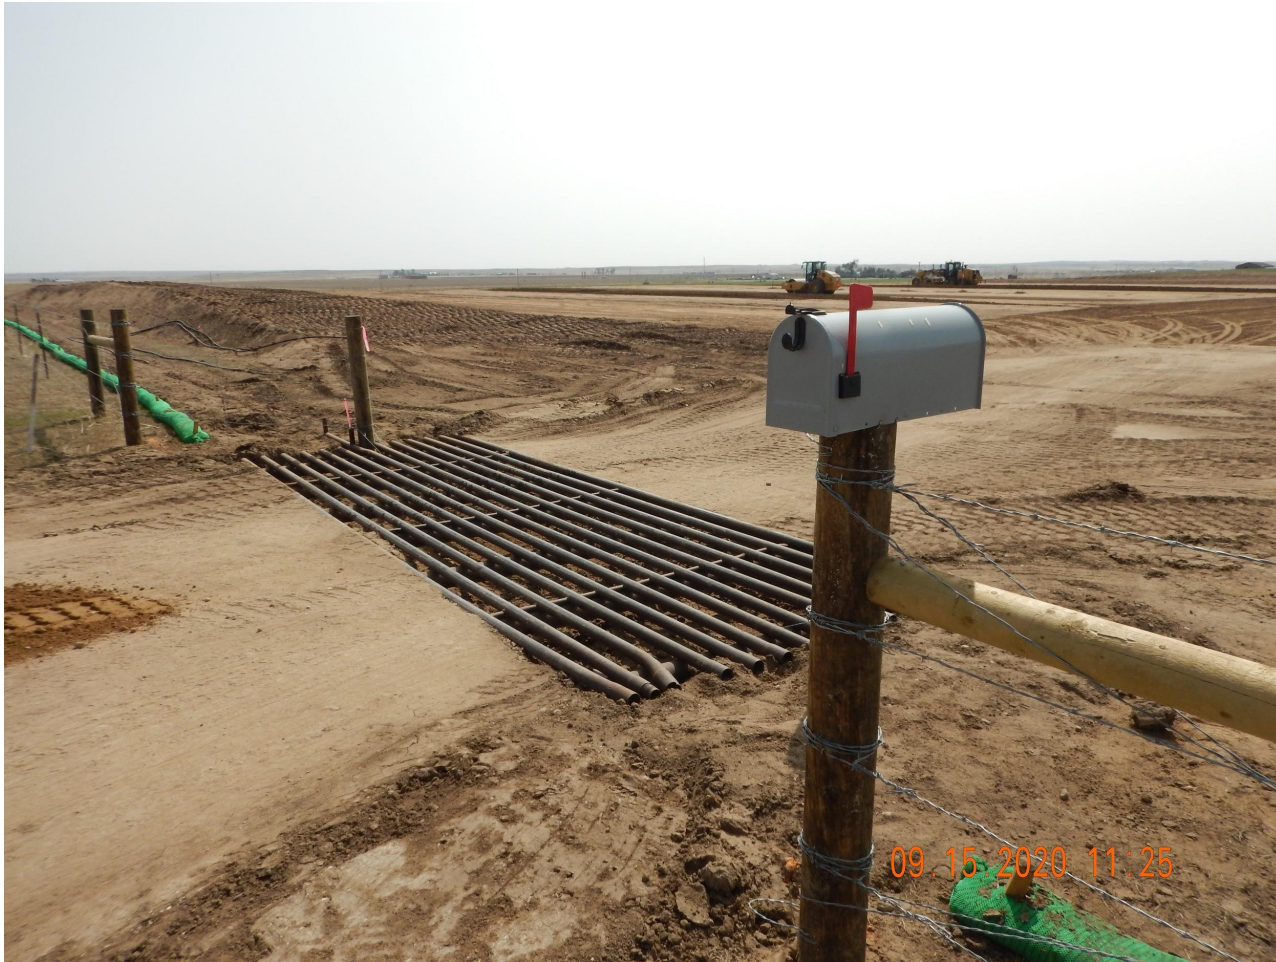
Photo 1. Photo taken from the entrance of location, facing Southeast. Photo illustrates Operator permits per the Form 2A COA.

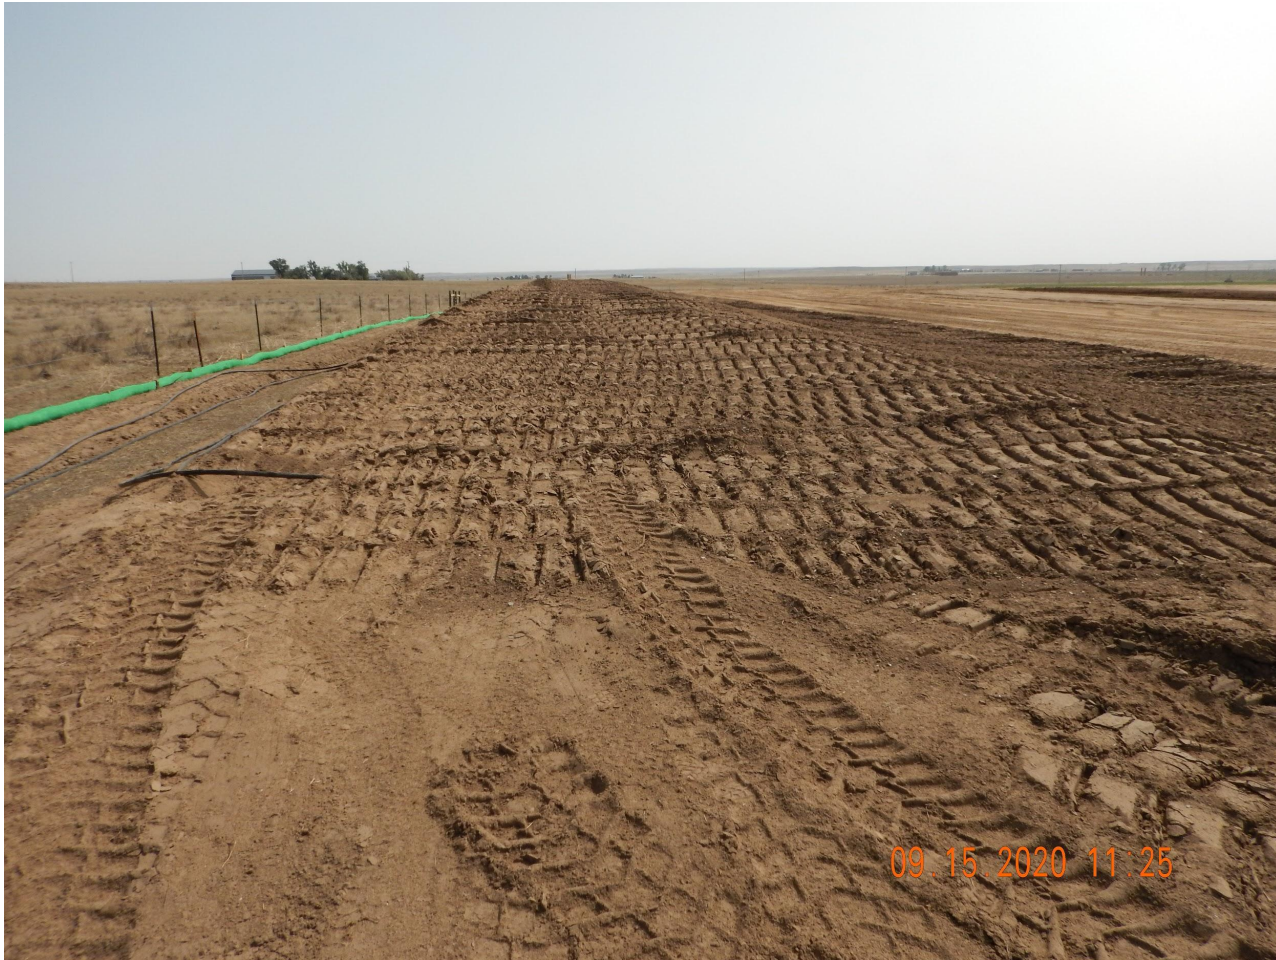
Photo 2. Photo taken from the northwestern location, facing East. Photo illustrates one of two topsoil stockpiles. Most of the stockpile has been temporarily stabilized with equipment tracking and planned operations will be performed for long-term stabilization.

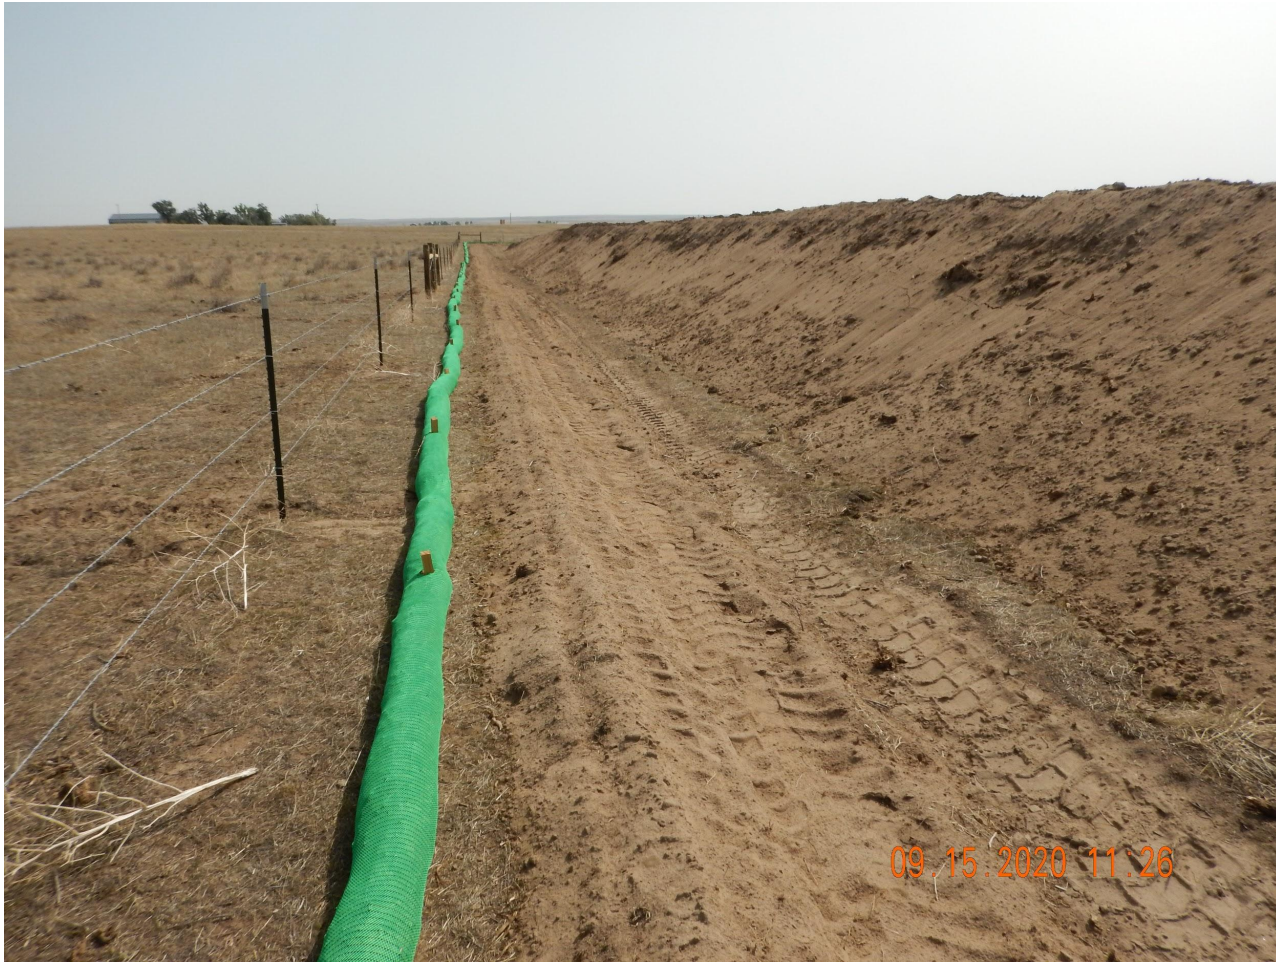
Photo 3. Photo taken from the northern location, facing East. Photo illustrates Operator has installed stormwater BMPs (ditch and berm, filtrex wattles) around the entire perimeter of location. Note: north-facing stockpile has not been stabilized. Operator indicated this would be stabilized with hydromulch and broadcast seeding.

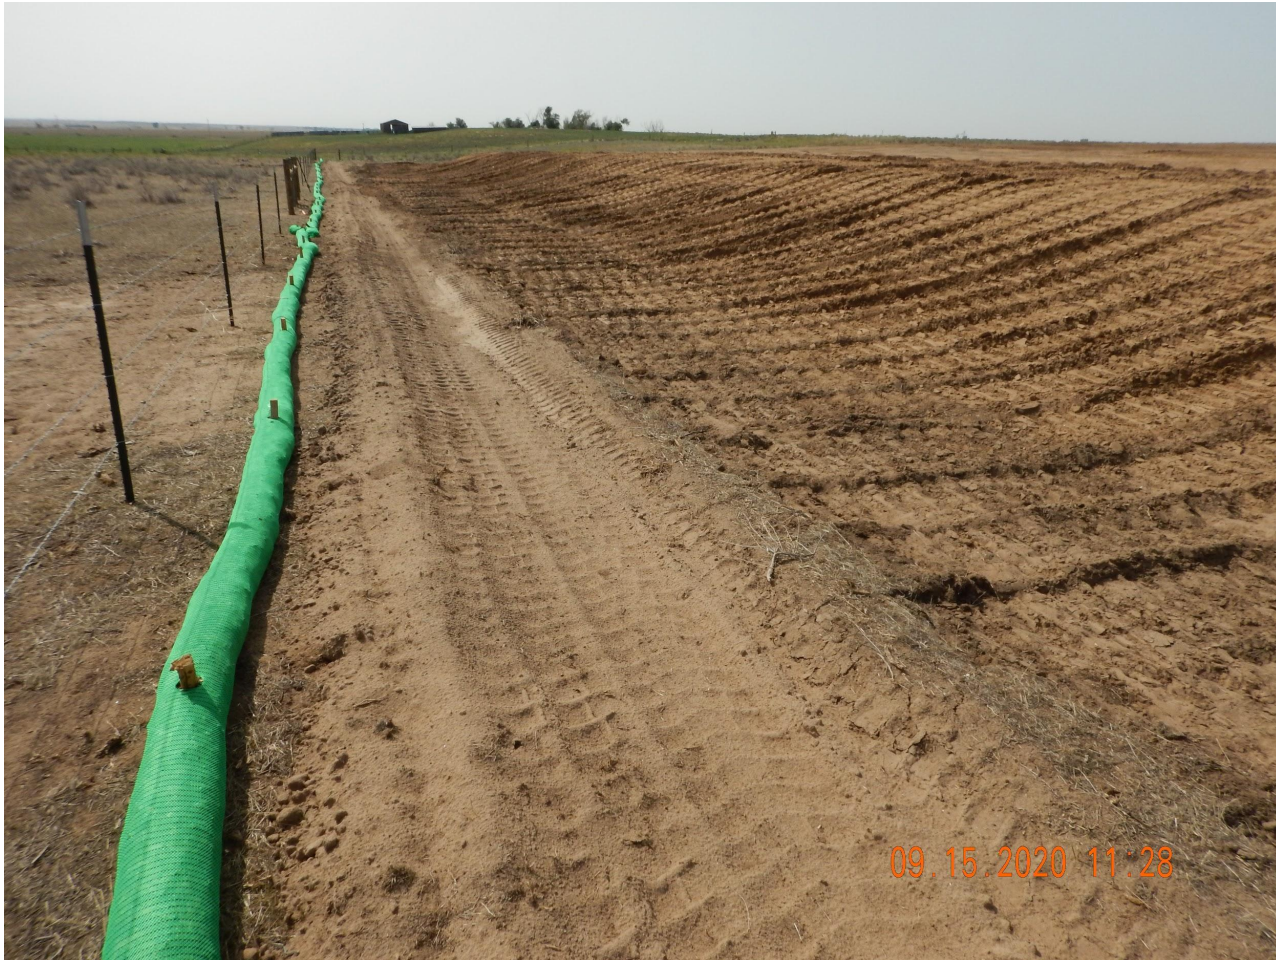
Photo 4. Photo taken from the northeastern location, facing South. See comments under Photo 3.

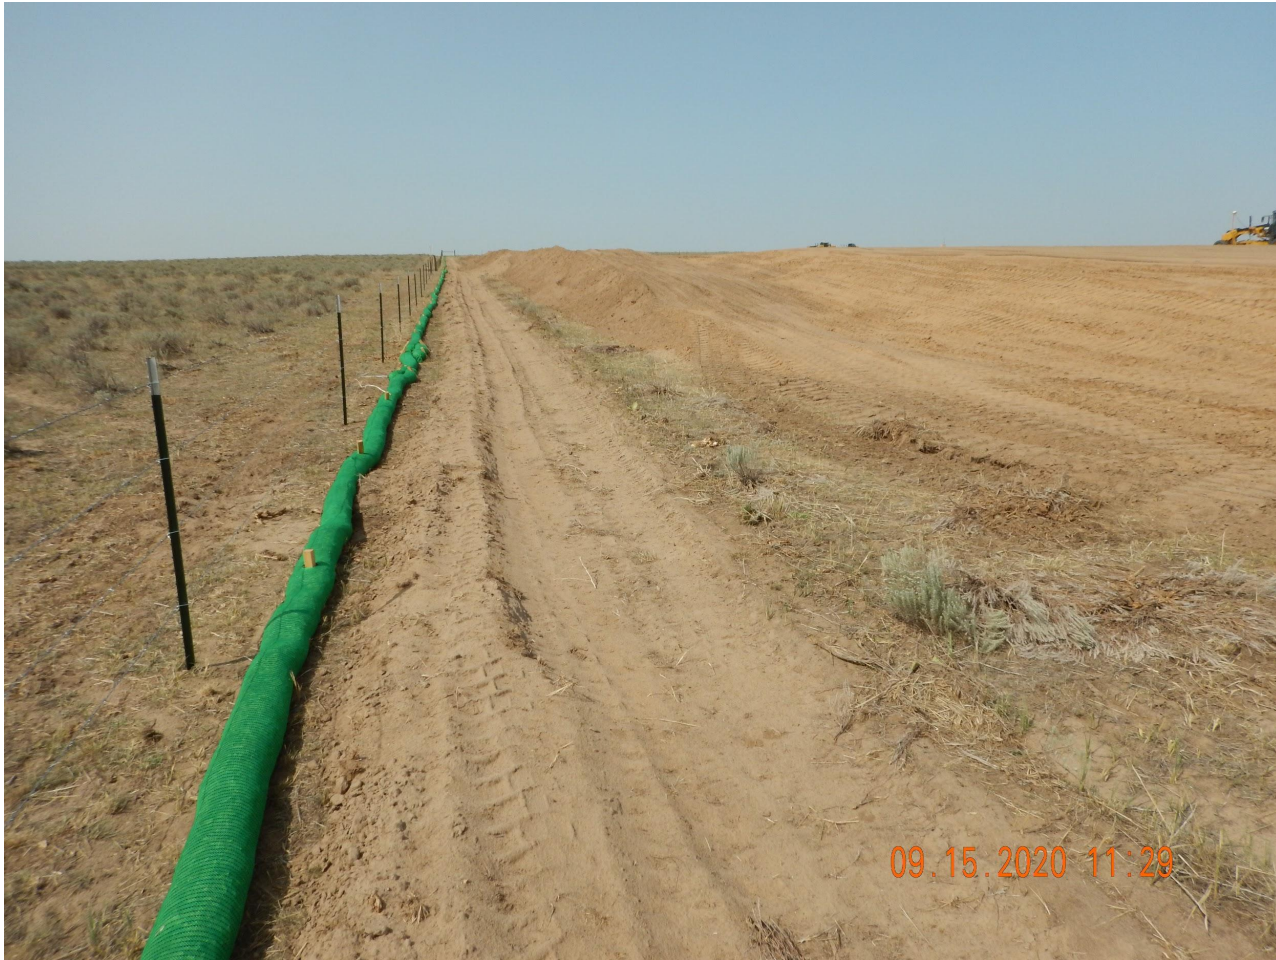
Photo 5. Photo taken from the southeastern location, facing West. See comments under Photo 3.

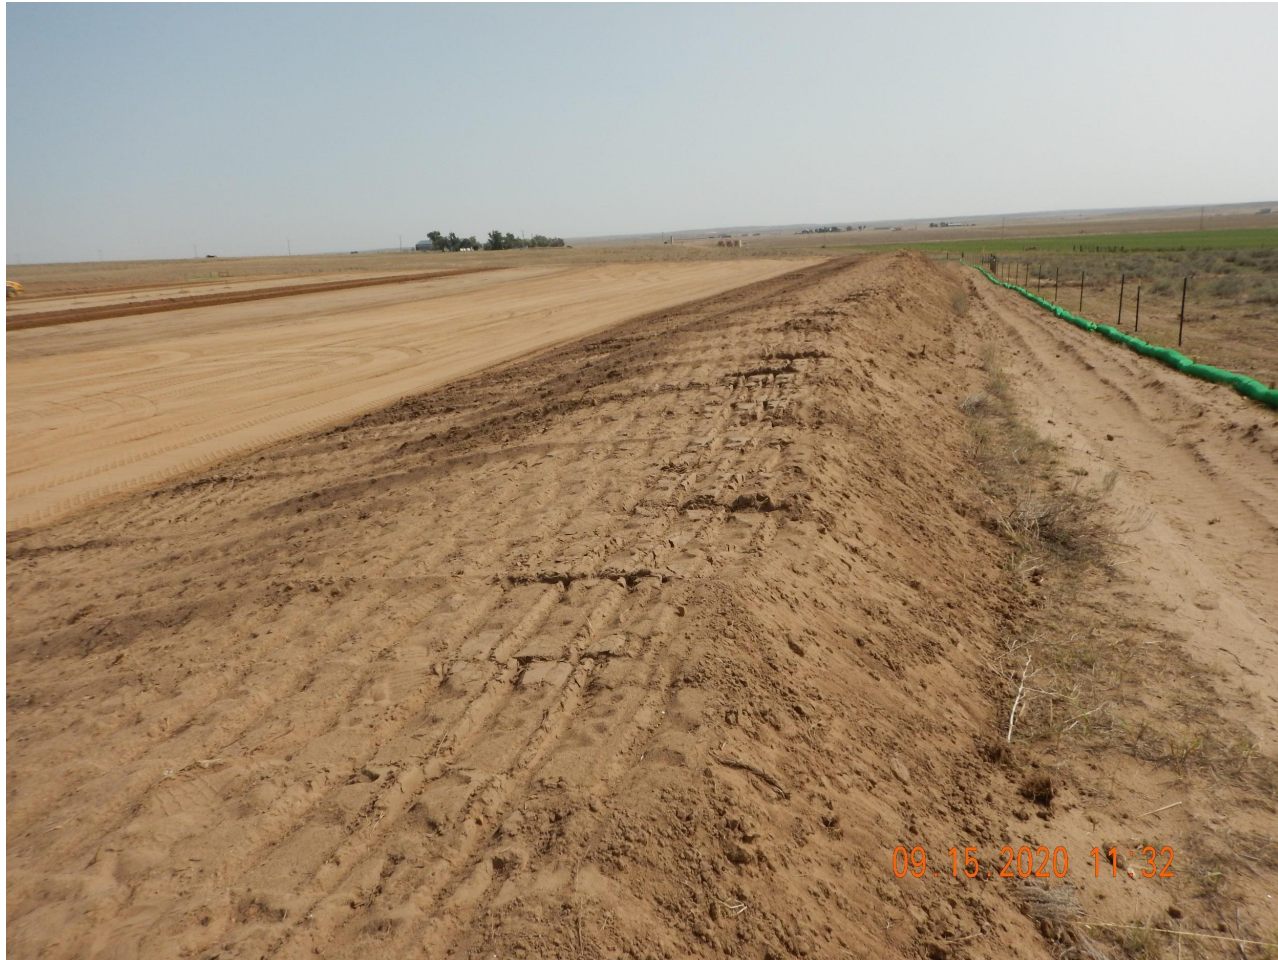
Photo 6. Photo taken from the southwestern location, facing East. Photo illustrates the second topsoil stockpile which has been temporarily stabilized with equipment tracking.

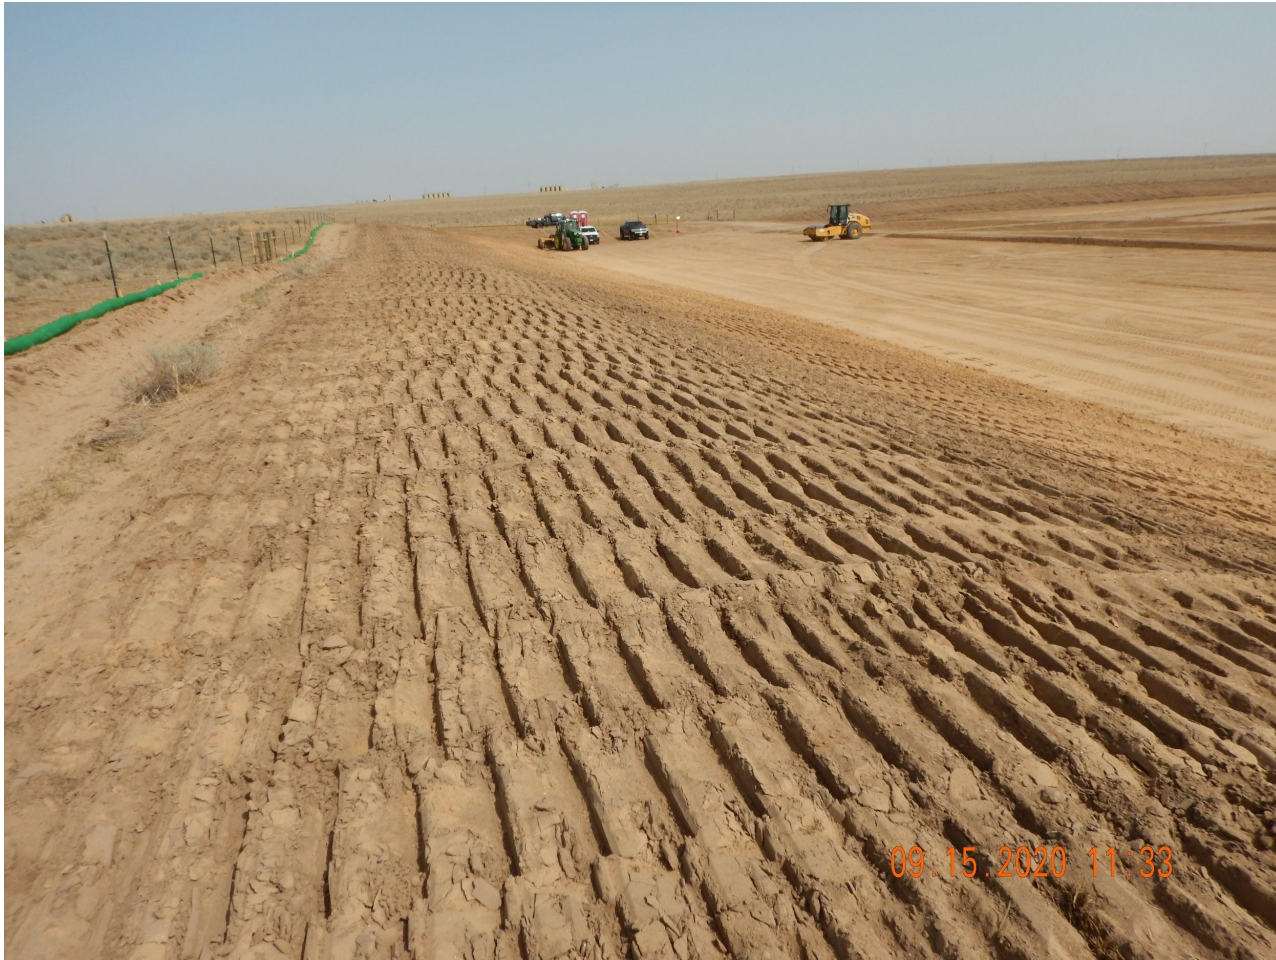
Photo 6. Photo taken from the southwestern location, facing North. Photo illustrates the cut slope has been temporarily stabilized with equipment tracking.

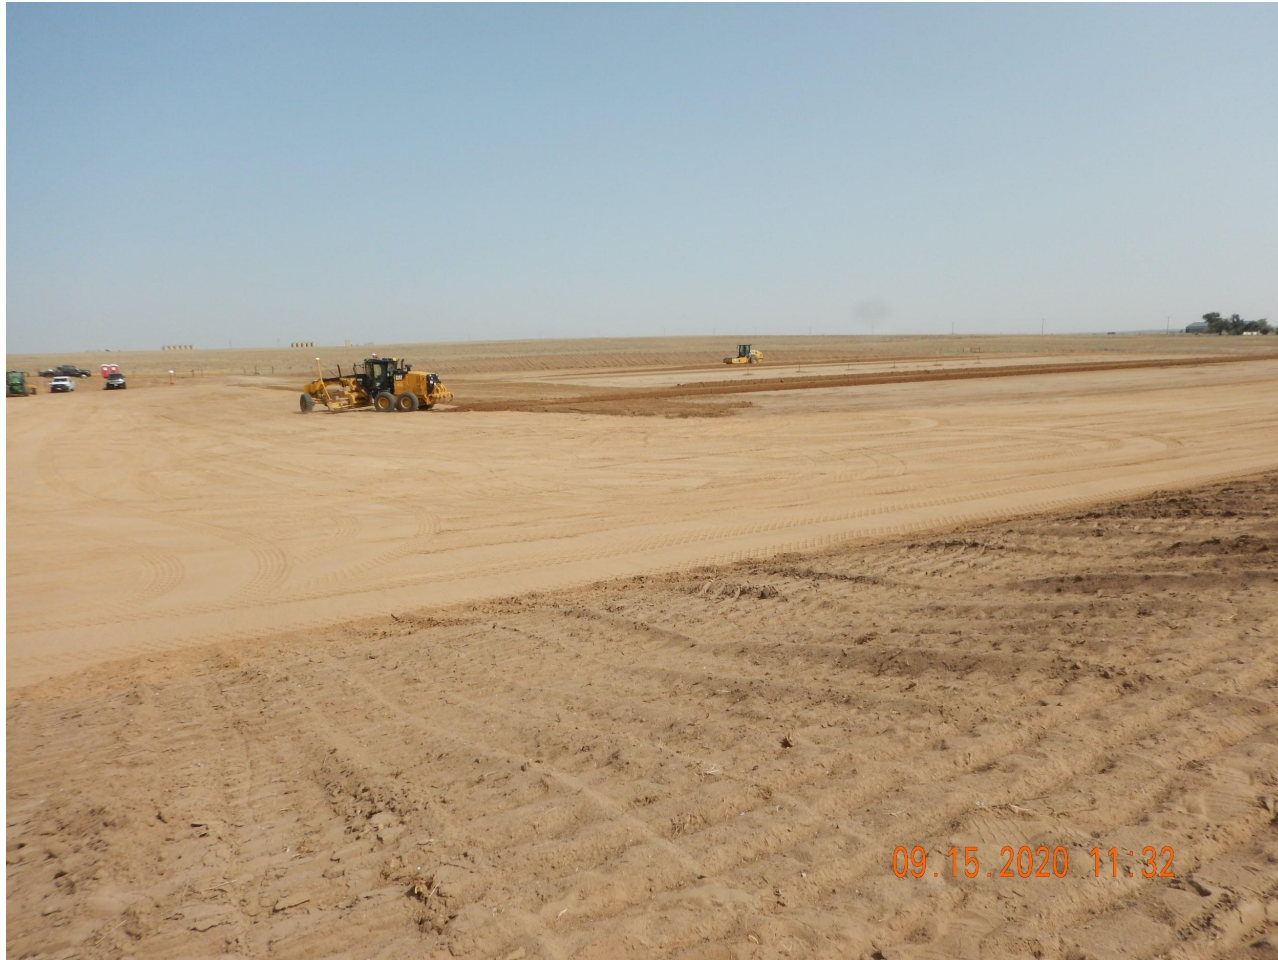
Photo 7. Photo taken from the southwestern location, facing Northeast. Photo illustrates Operator is in process of added roadbase to the location.

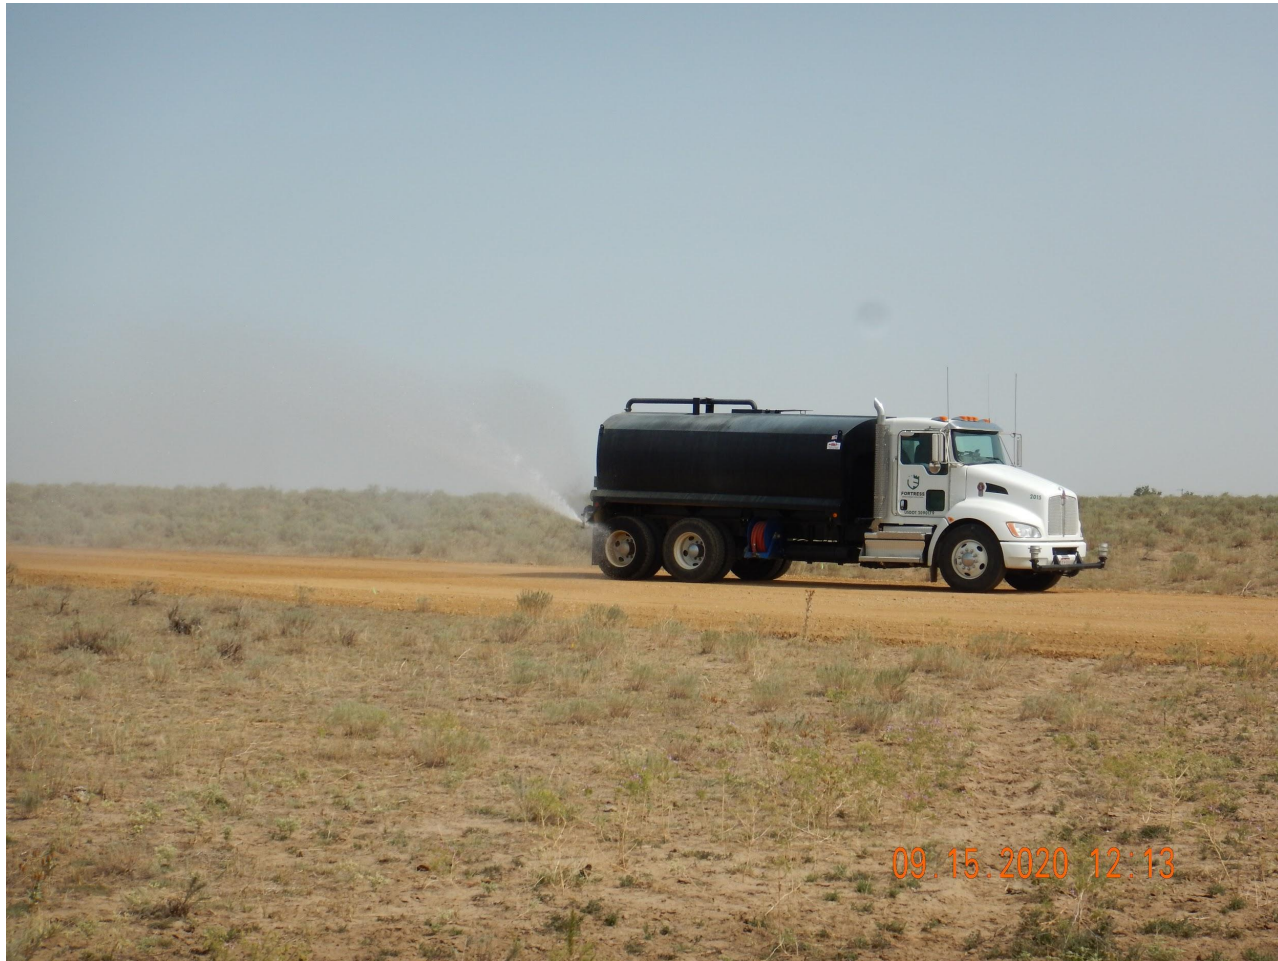
Photo 8. Photo taken from a portion of the main access road, facing North. Photo illustrates Operator had a water truck on location controlling fugitive dust.
