Inspection Photos
Operator: BP America
API: 067-09066
Date: 9/15/2020

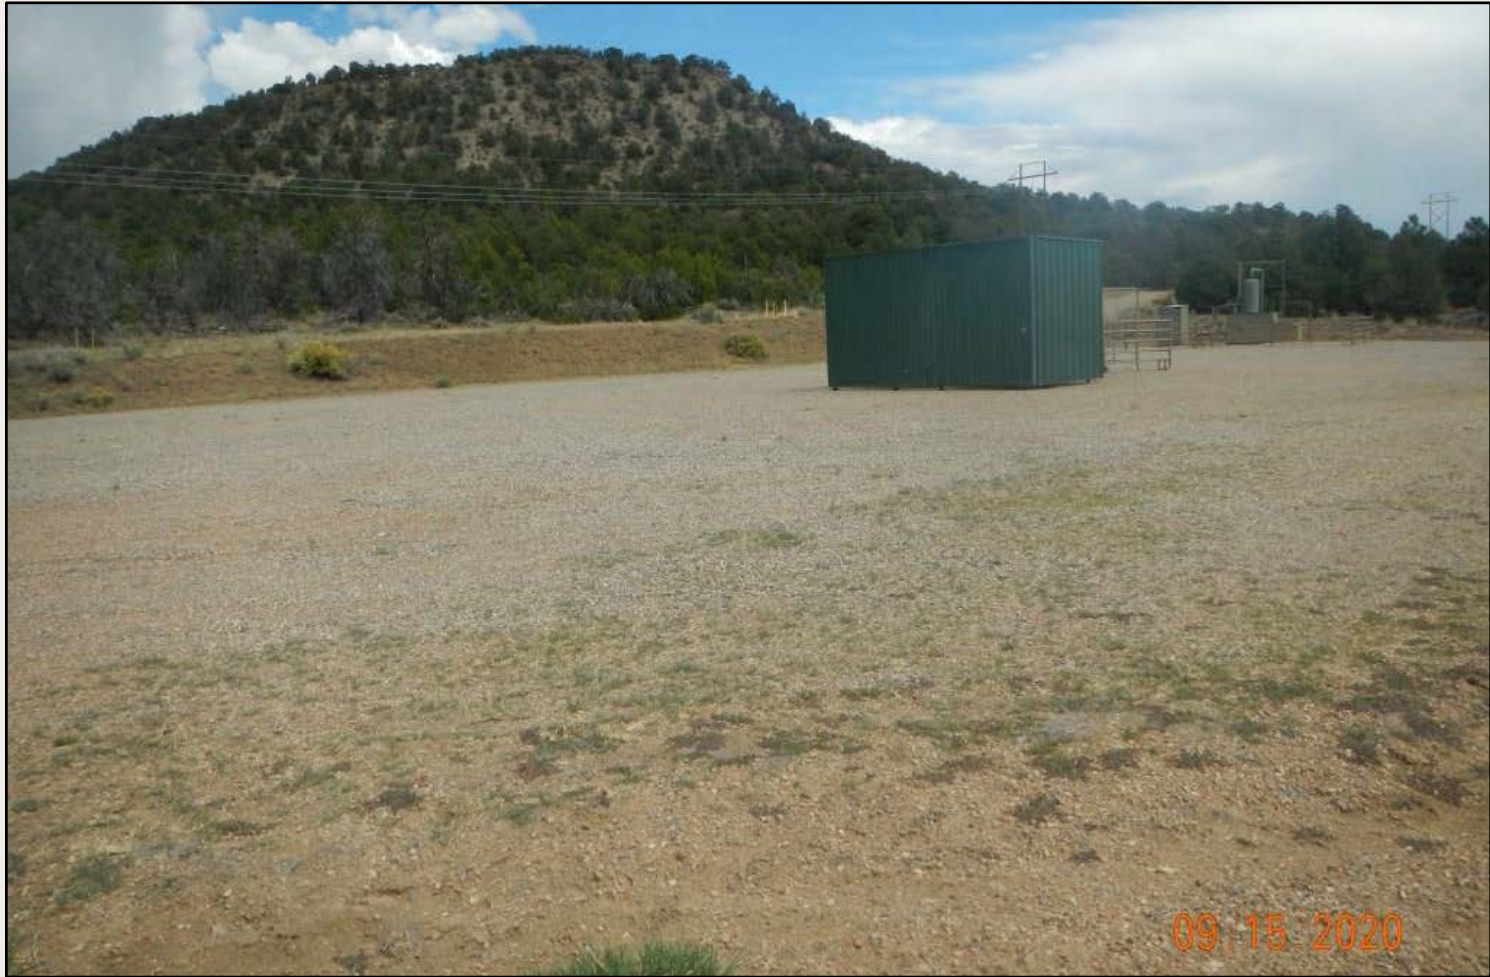
Photo 1. View of the project area from the southwestern corner facing center.

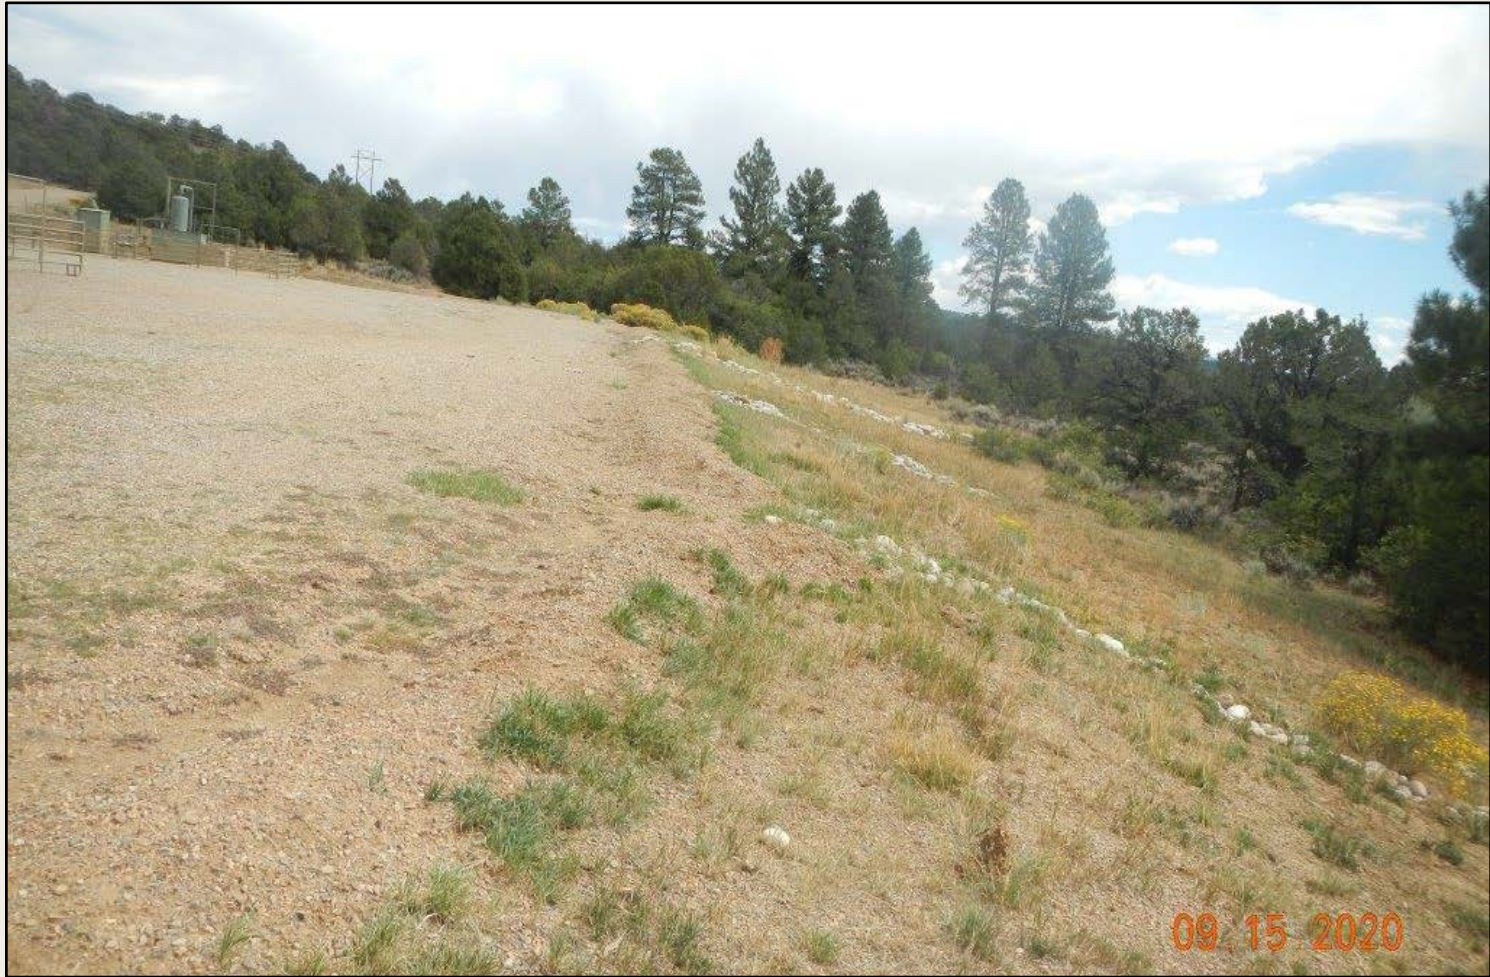
Photo 2. View of the southern fill slope from the southwestern corner facing eastward. Revegetation is progressing within the interim reclamation area, largely with grasses such as western wheatgrass and sand dropseed.

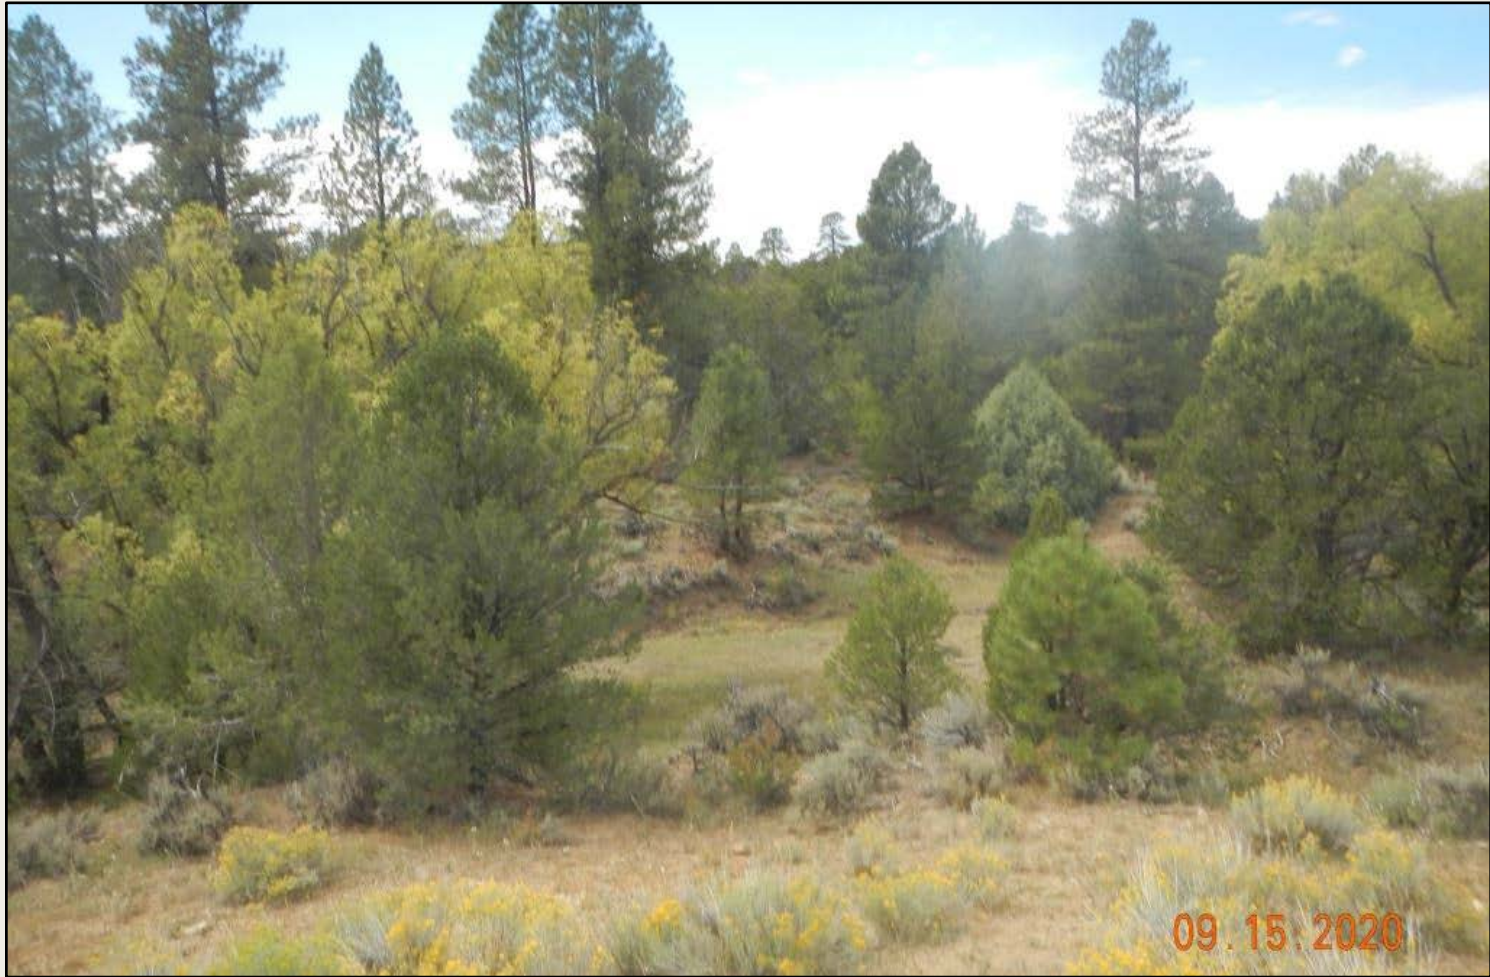
Photo 3. View of reference area vegetation comprised of ponderosa pine woodland with understory of gambel oak, snowberry, black sage, and western wheatgrass.
