Inspection Photos
Operator: BP America
API: 067-07059
Date: 9/15/2020

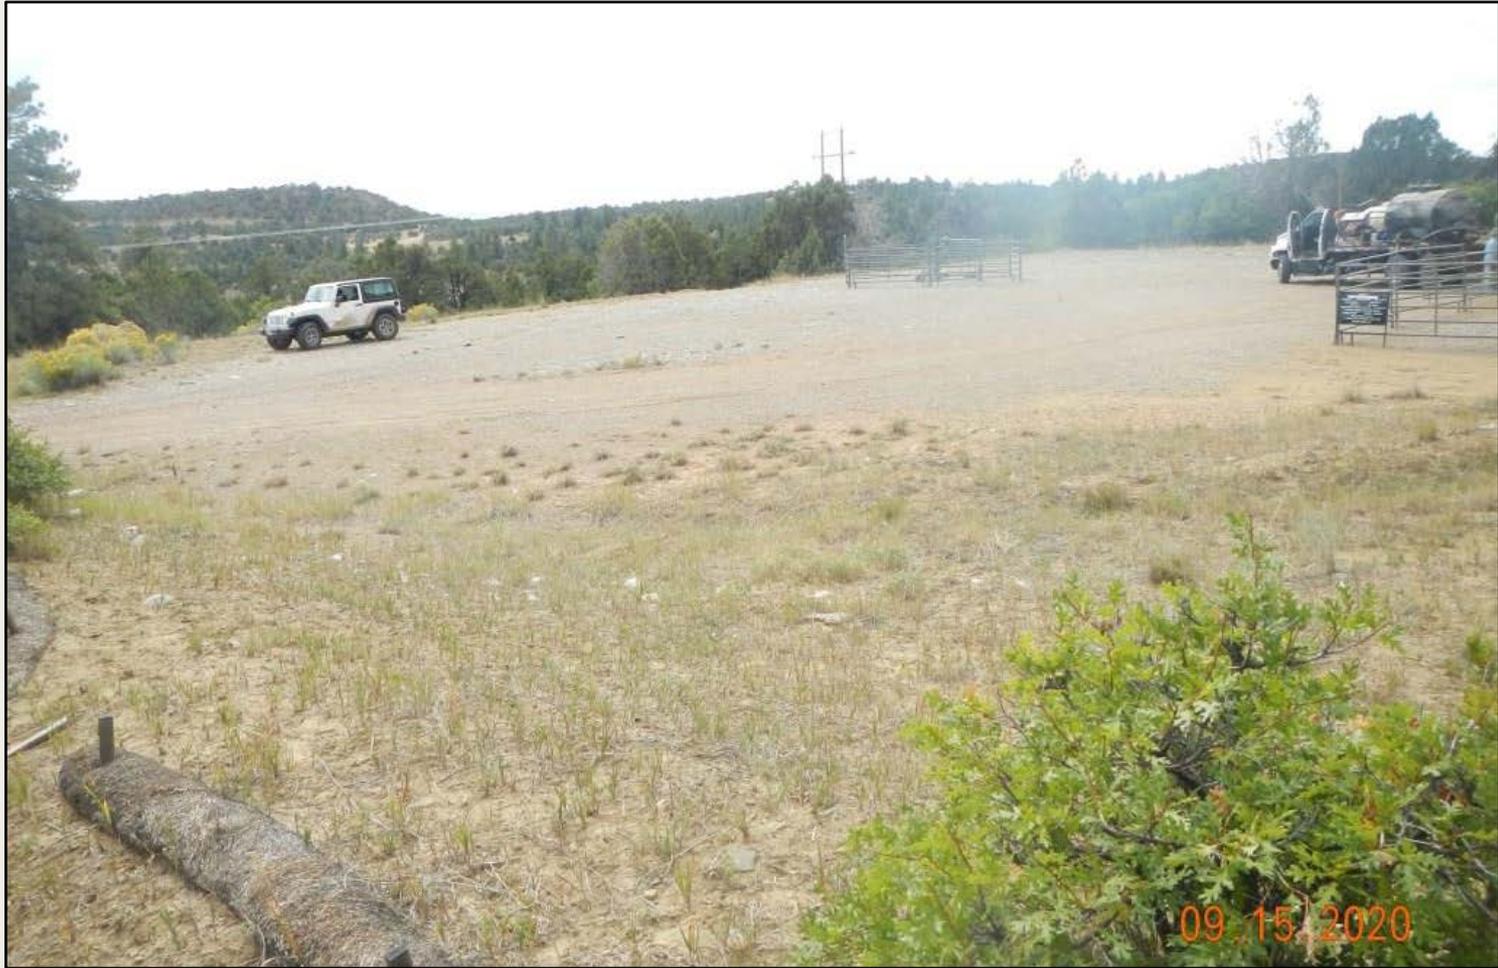
Photo 1. View of the project area from the northeastern corner facing center.

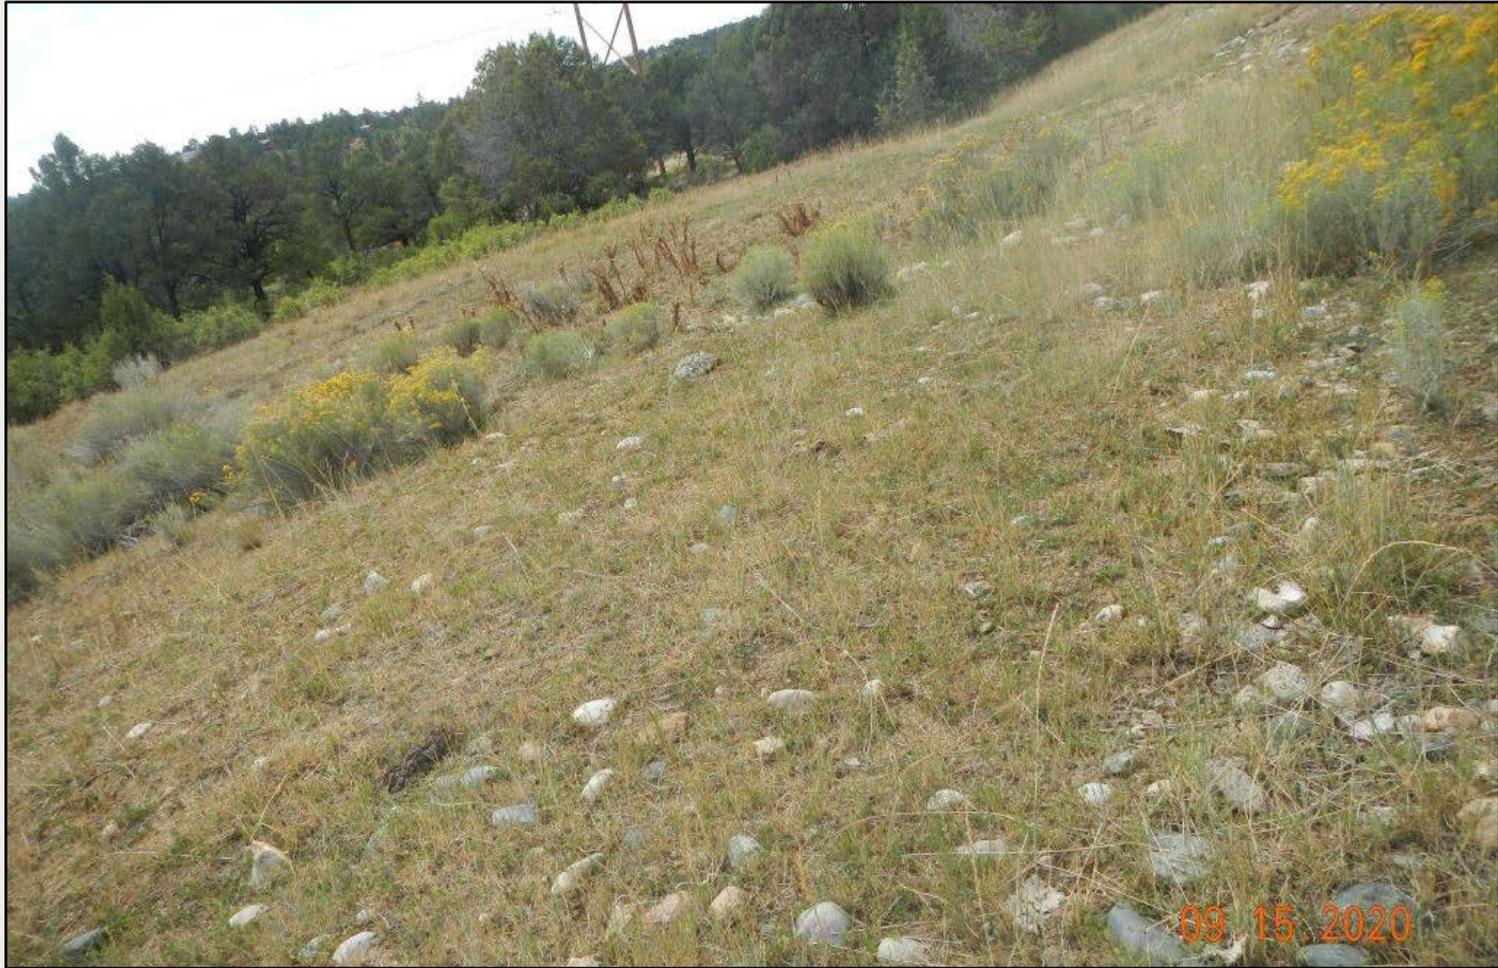
Photo 2. View of the southern fill slope from the southeastern corner facing westward. Revegetation is progressing within the interim reclamation area, largely with grasses such as western wheatgrass, smooth brome, and sand dropseed.

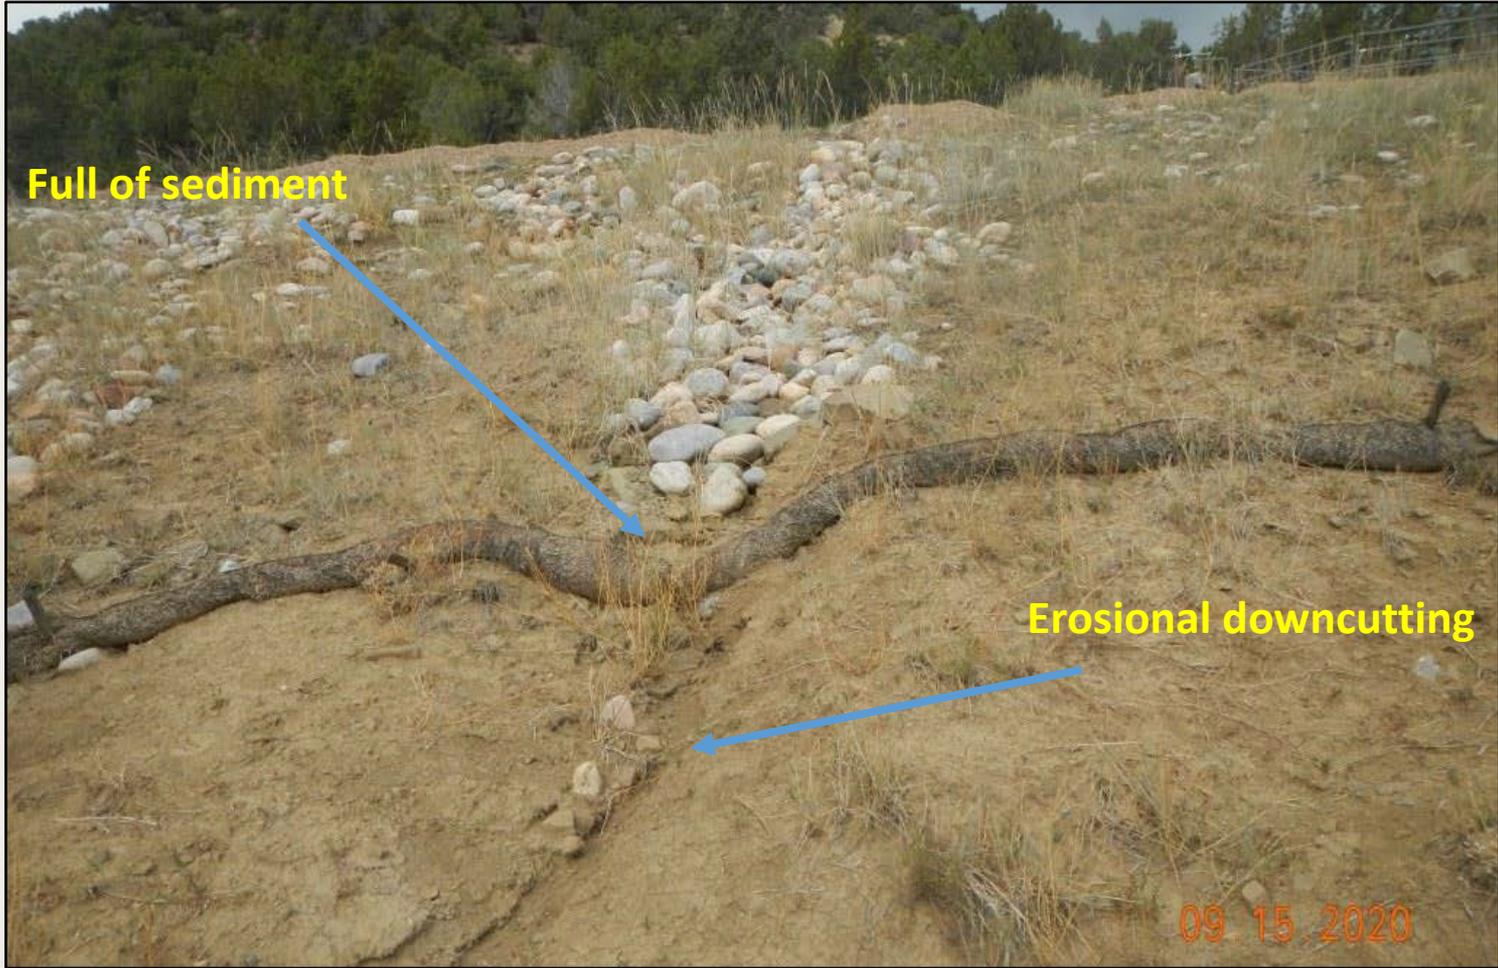
Photo 3. View of BMPs within the southern fill slope. Wattles are full of sediment. Erosional downcutting is continuing downstream from the wattles.

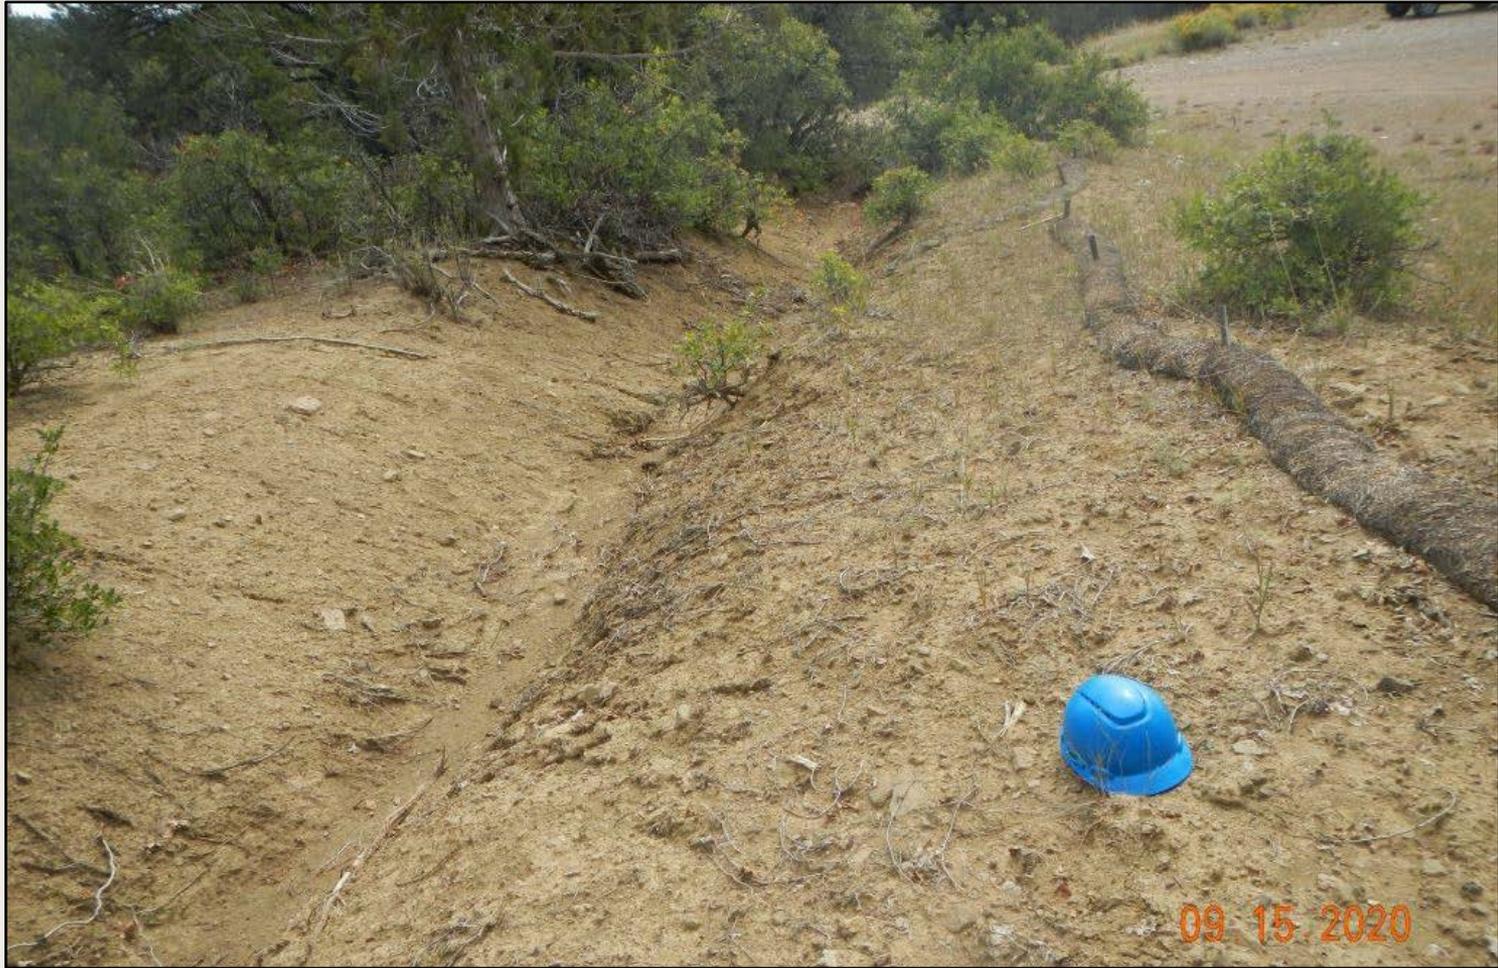
Photo 4. View of eastern stormwater diversion. Stormwater controls need to be installed to de-energize stormwater flowing through the channel and over the banks. Channel is eroding in width and depth (approx. 5-6 ft wide and 4-5 feet deep).

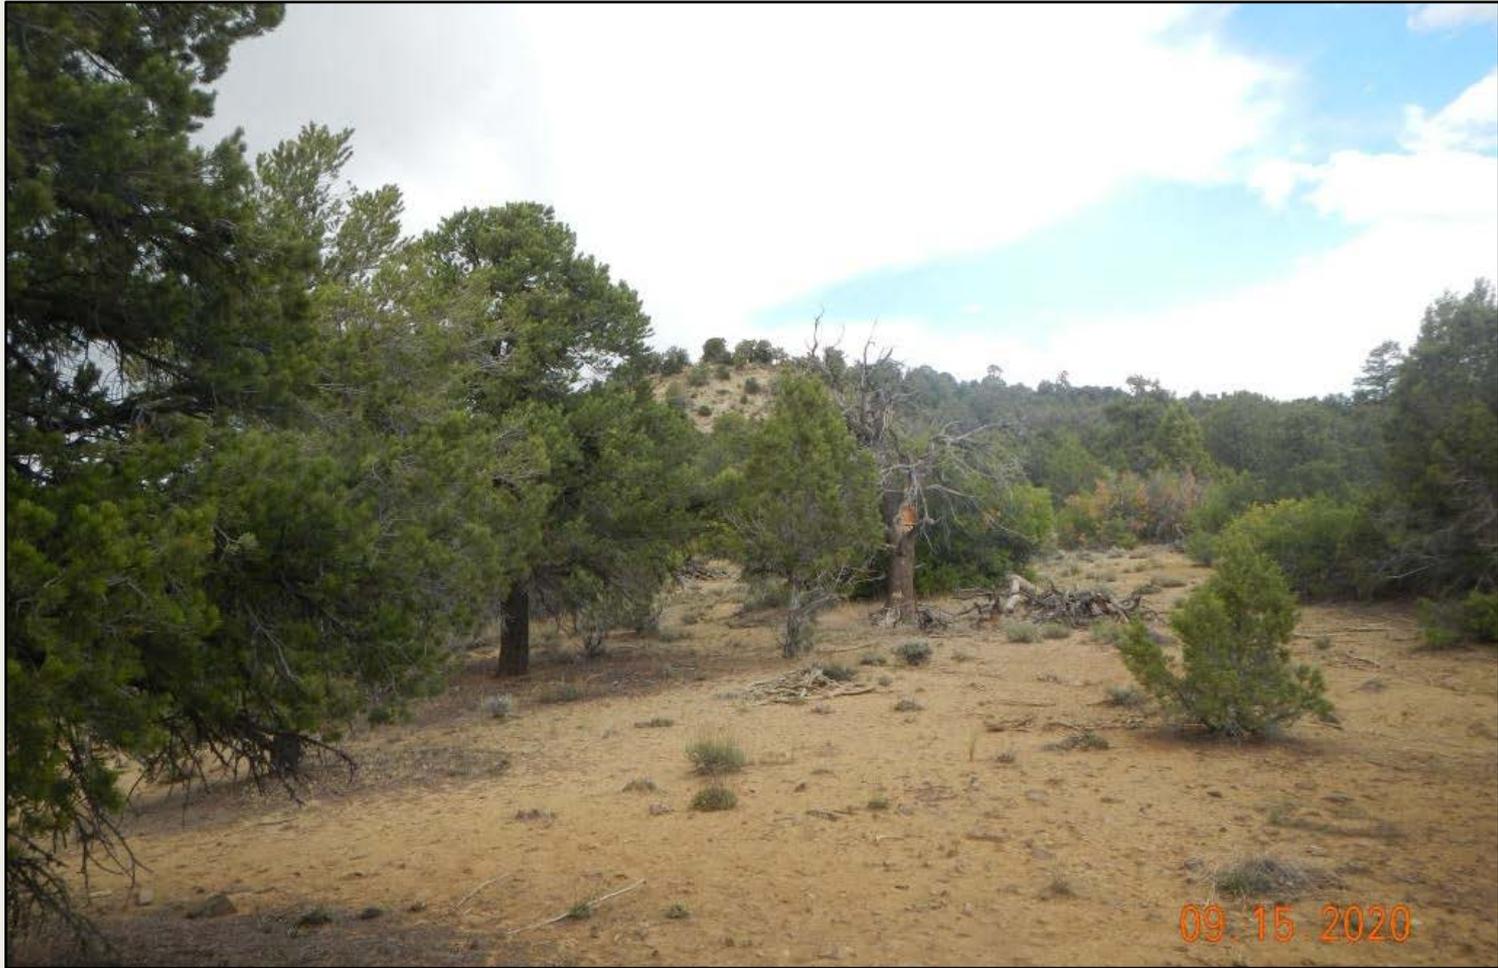
Photo 5. View of reference area vegetation comprised of pinyon and juniper woodland with shrubs and forbs in the understory such as big sagebrush, gambel oak, buckwheat, and Indian ricegrass.
