Inspection Photos
Operator: BP America
API: 067-07752
Date: 9/15/2020

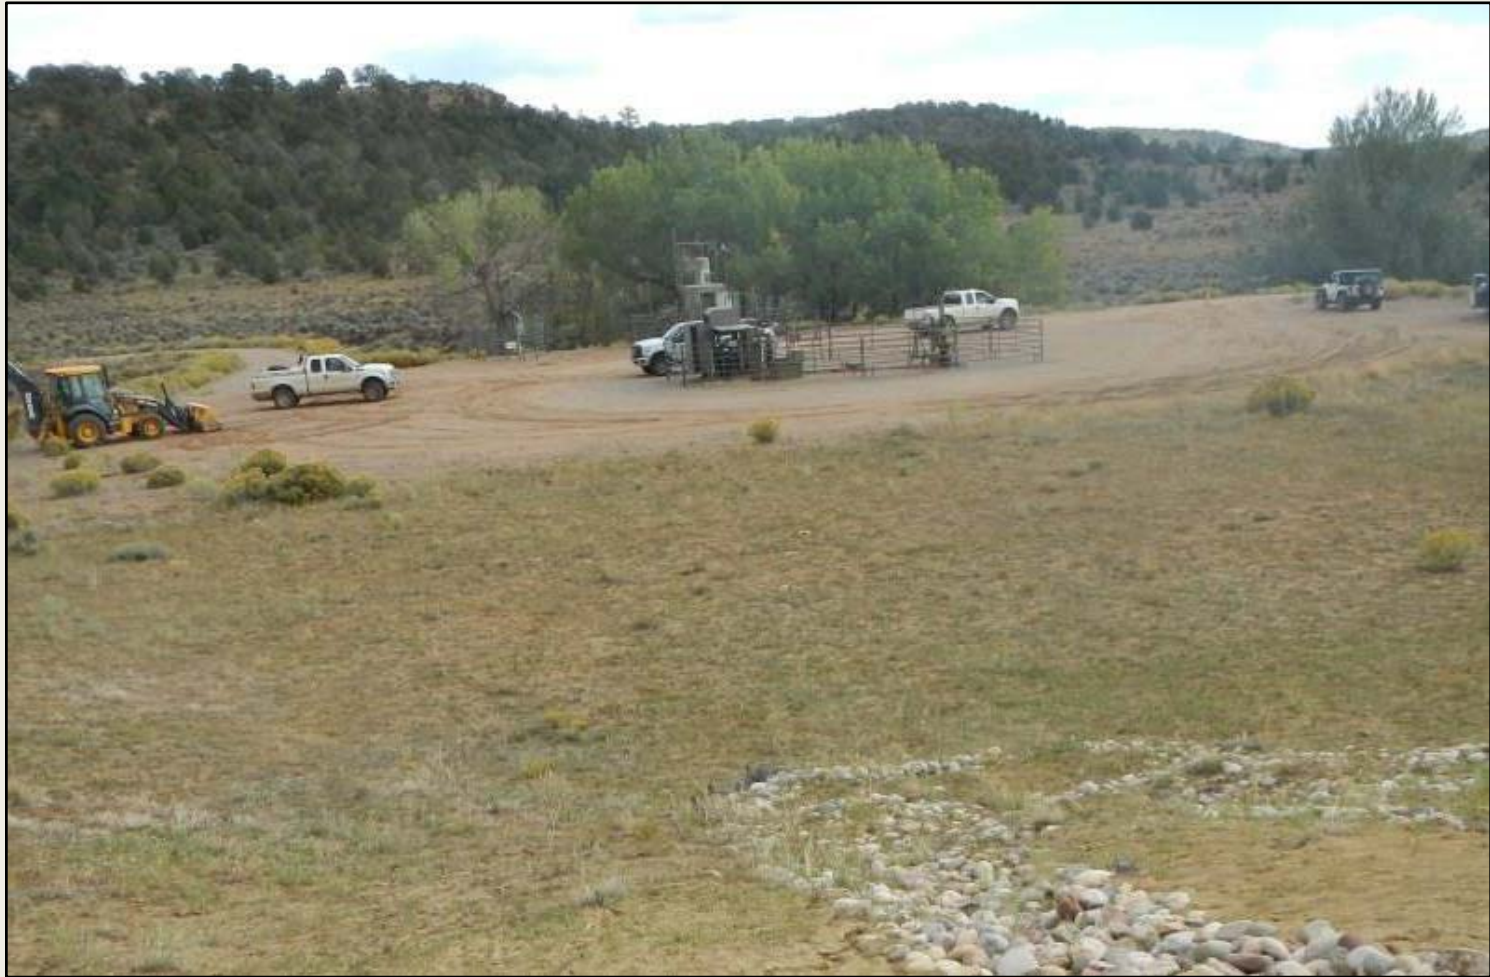
Photo 1. View of the project area from the northwestern corner facing center.

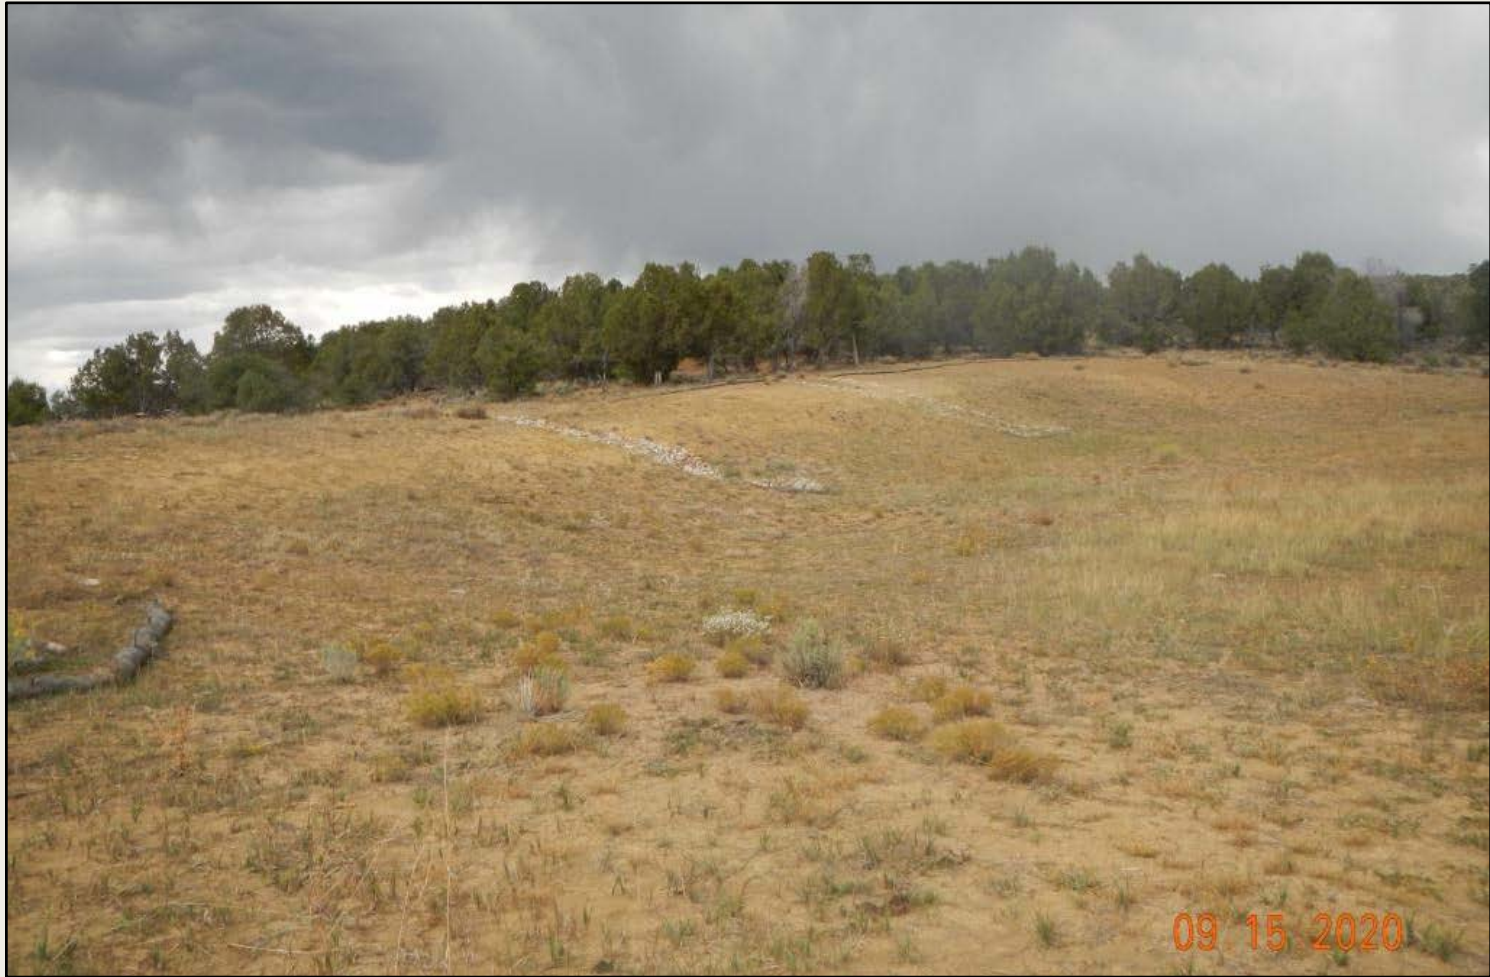
Photo 2. View of the western cut-slope from the southern corner facing northwestward. Revegetation is progressing within the interim reclamation area, largely with grasses such as western wheatgrass, smooth brome, and sand dropseed. Stormwater BMPs are largely functioning, but maintenance is needed. Portions of revegetation on the northeastern cut-slope remain sparse and need to be monitored and re-seeded if not increasing.

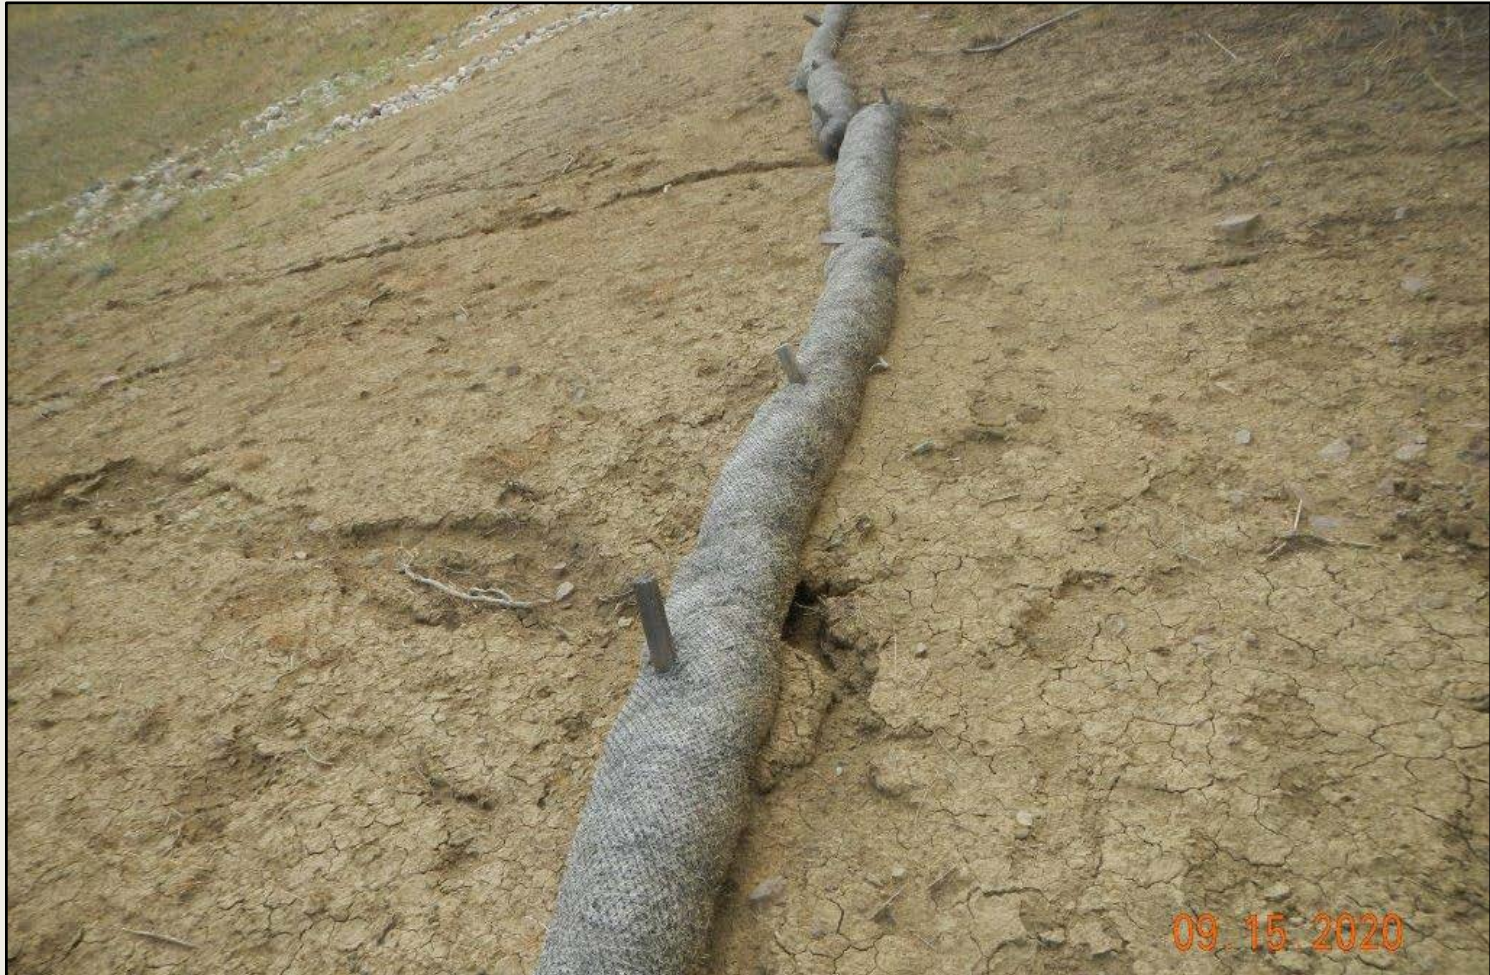
Photo 3. View of BMPs on the northwestern edge of the project area, needing maintenance.

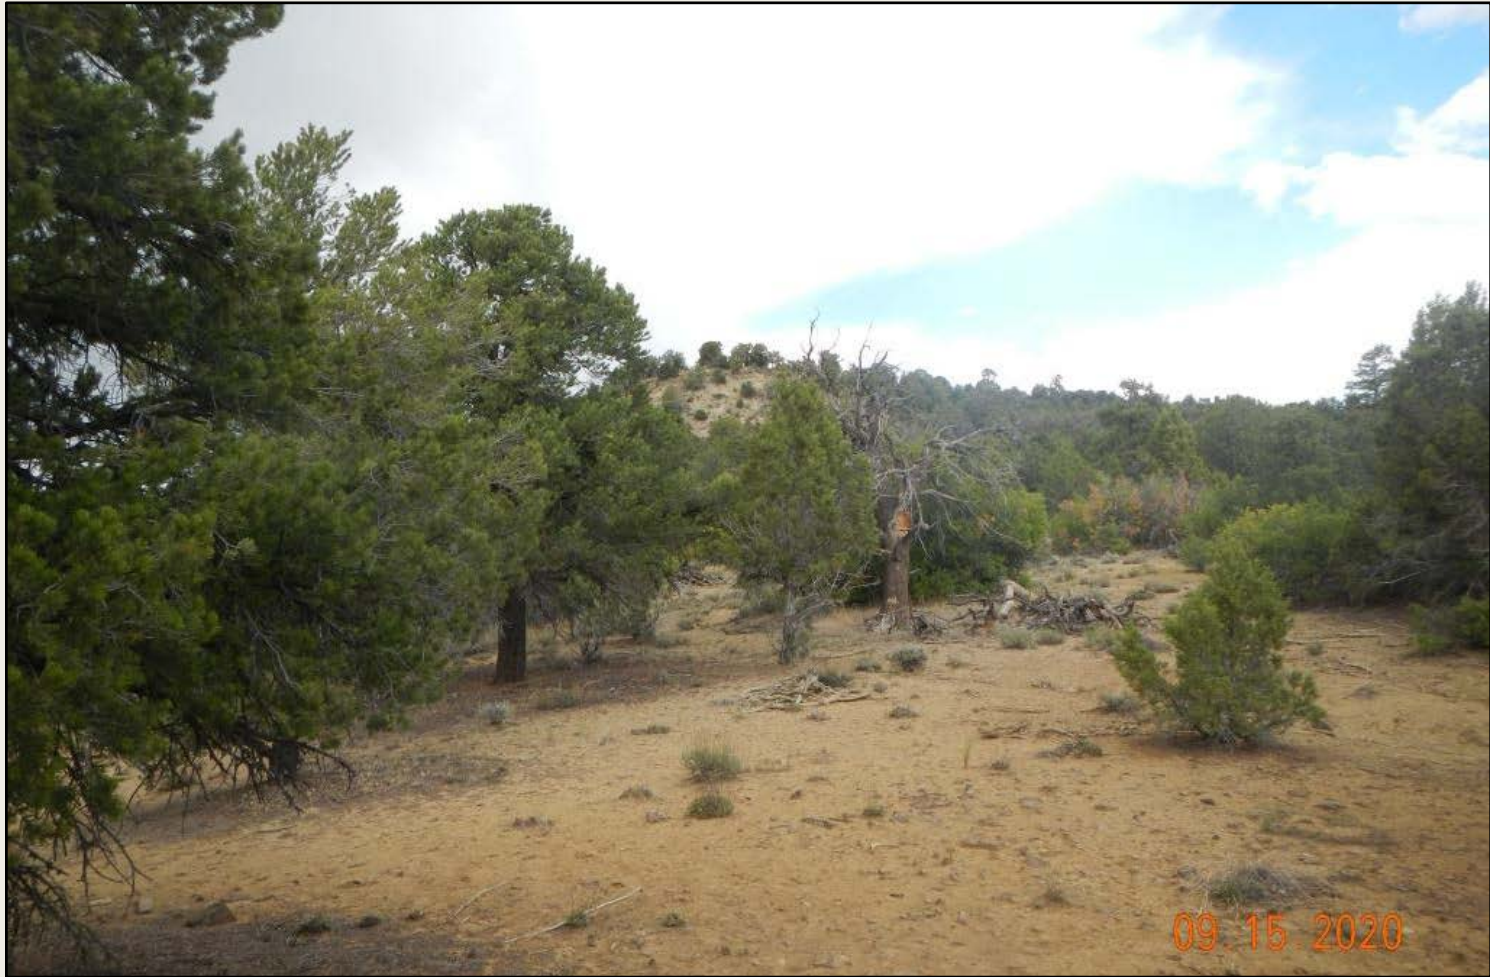
Photo 4. View of reference area vegetation comprised of pinyon and juniper woodland with shrubs and forbs in the understory such as big sagebrush, gambel oak, buckwheat, and Indian ricegrass.

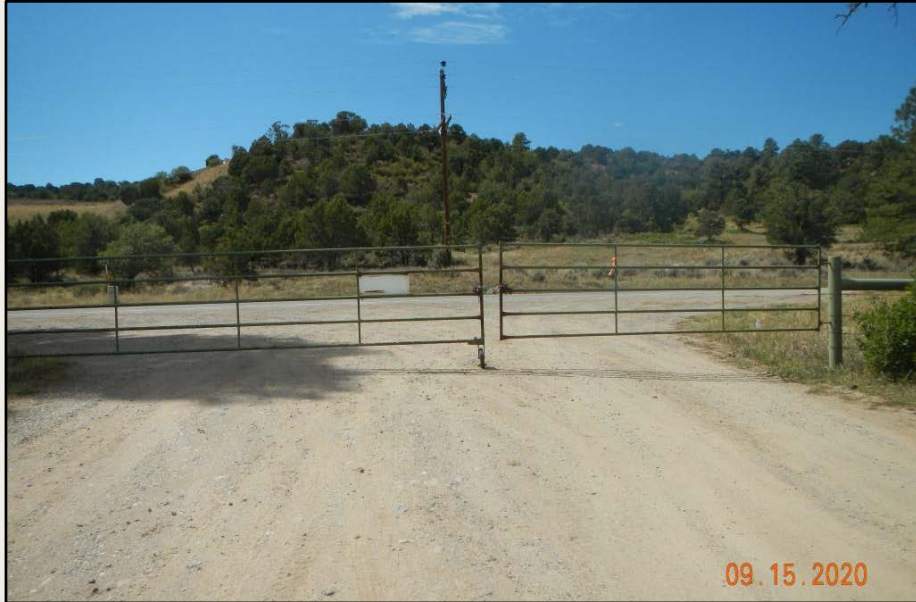
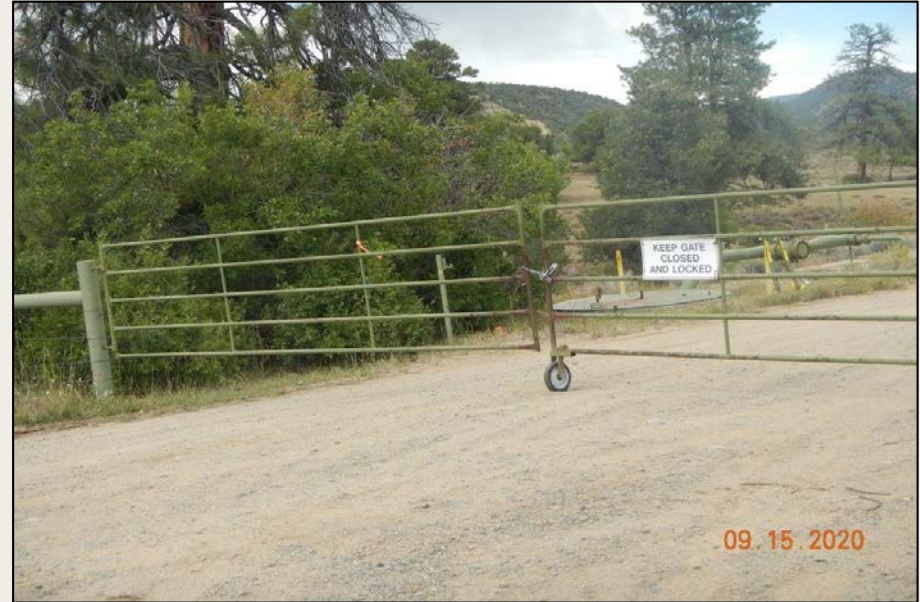
Photos 6/75. Locked gate coming in (left) and leaving (right).
