**Inspection Photos**  
**Operator: BP America**  
**API: 067-09062**  
**Date: 9/15/2020**

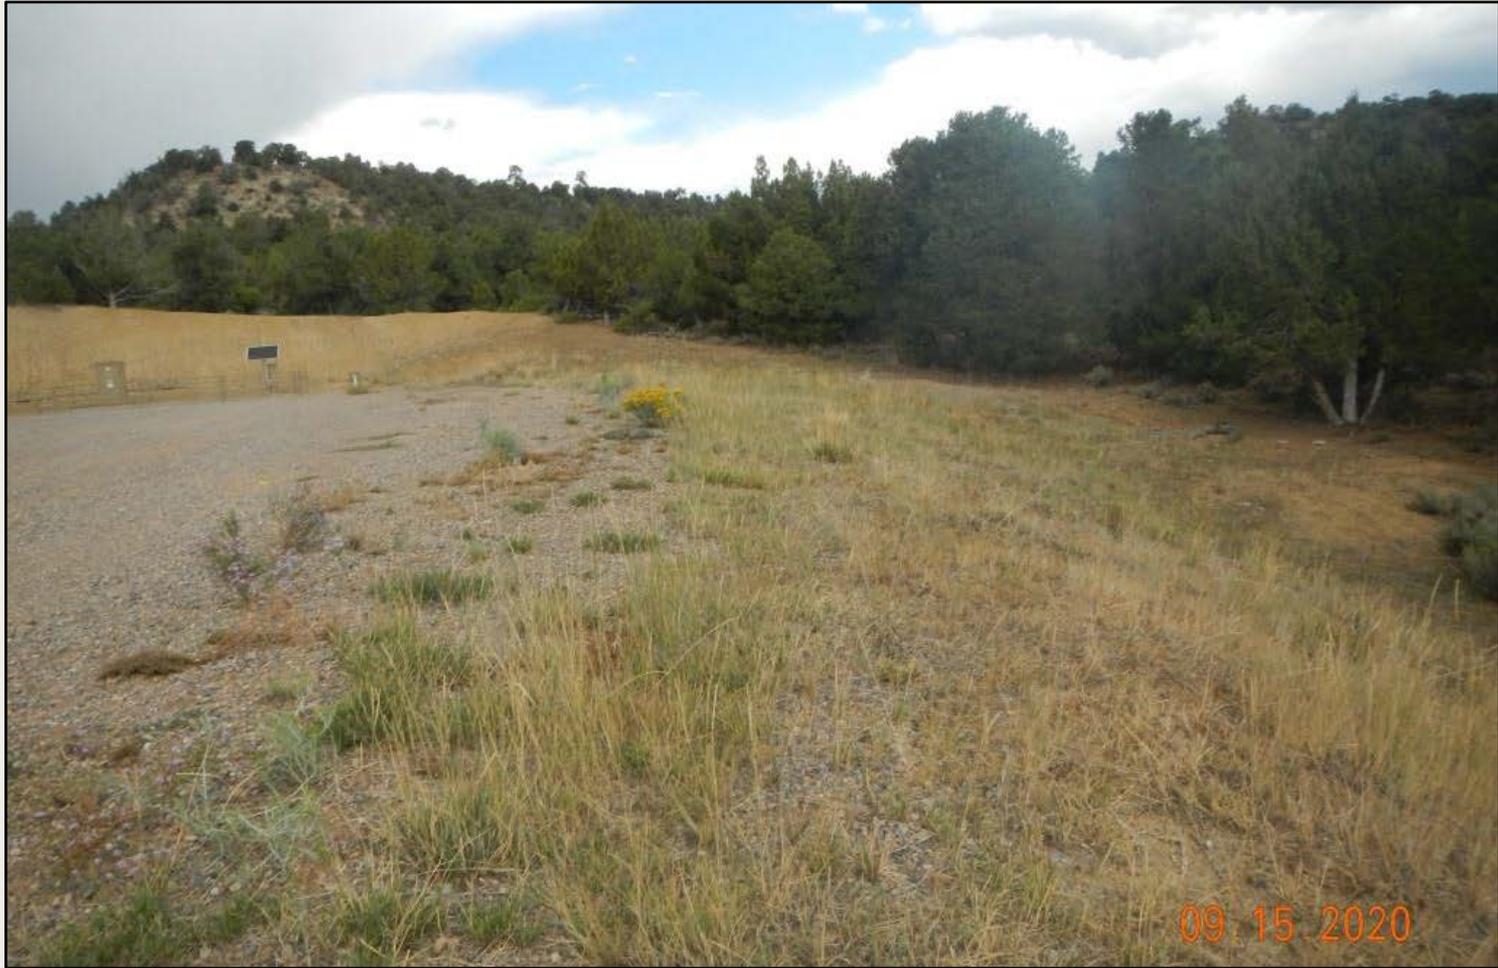
Photo 1. View of the eastern project area from the southeastern corner facing northward. Revegetation is progressing with western wheatgrass.

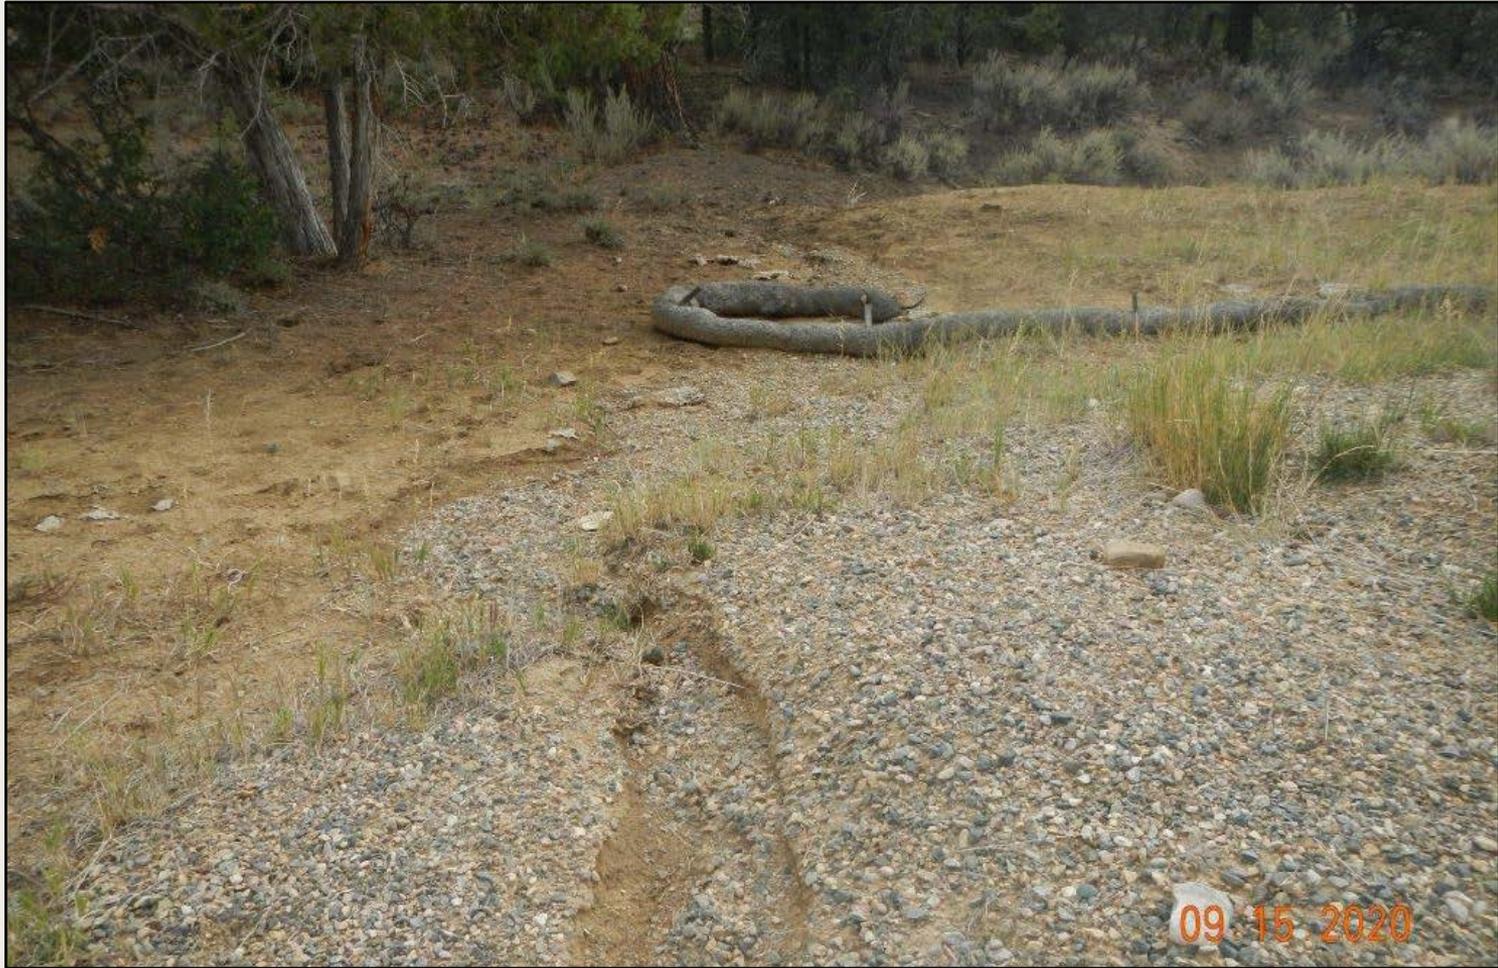
Photo 2. View of erosional channel (approx. 1 ft wide and 6-8 in deep) in the southeastern project area and wattle needing repair /maintenance.

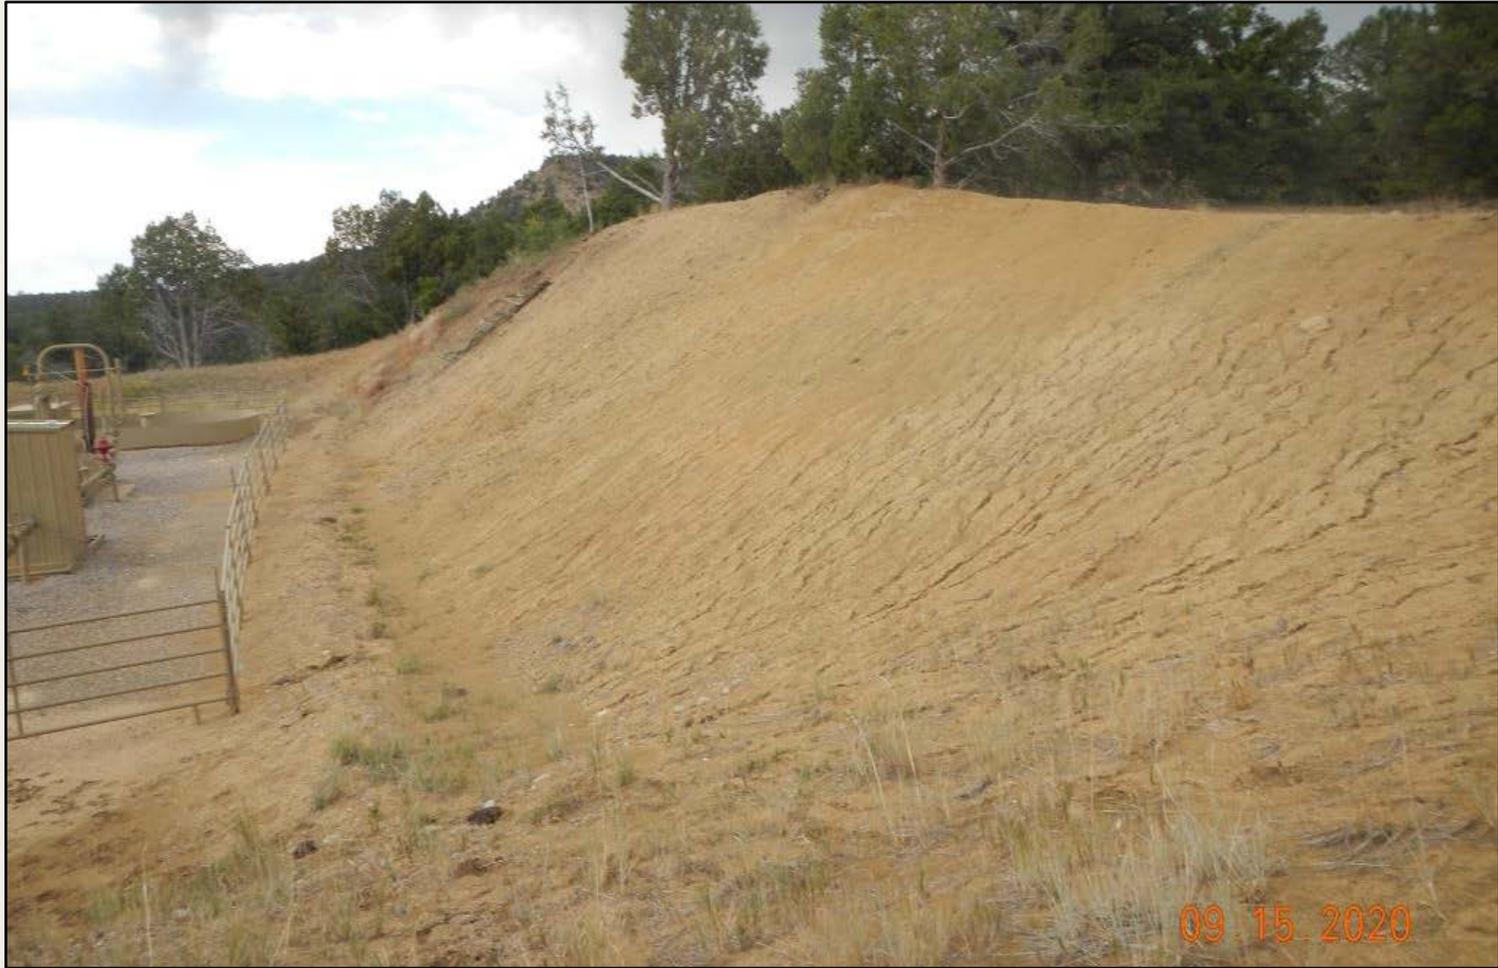
Photo 3. View of bare soils on the northern cut-slope. Erosion controls are needed here.

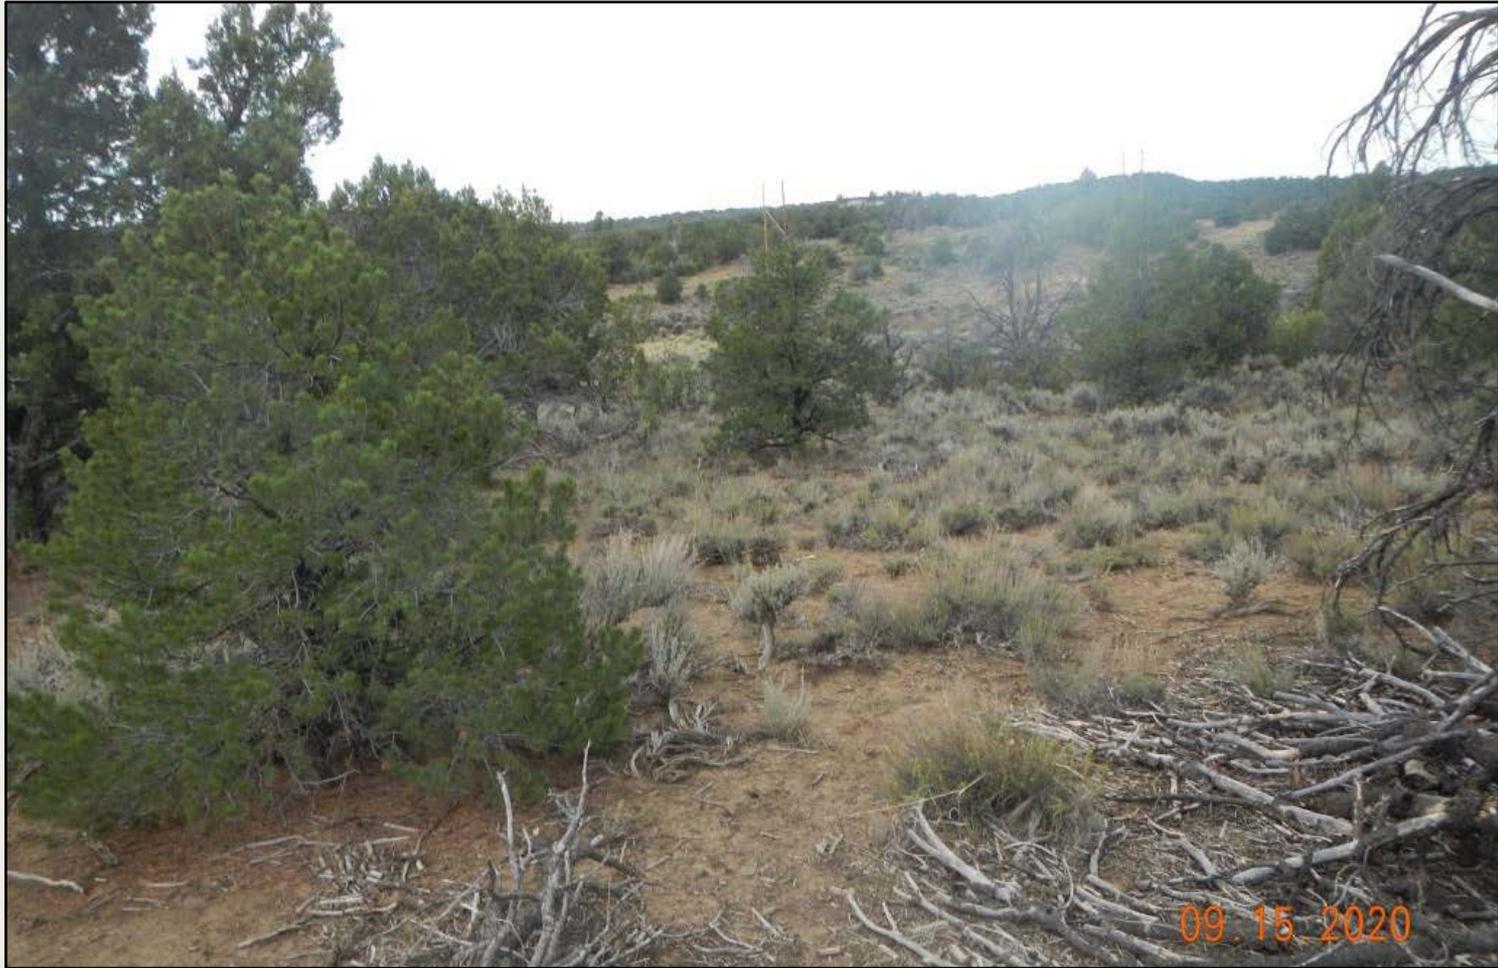
Photo 4. View of reference area vegetation comprised of pinyon and juniper woodland with shrubs and forbs in the understory such as big sagebrush, gambel oak, buckwheat, and Indian ricegrass.

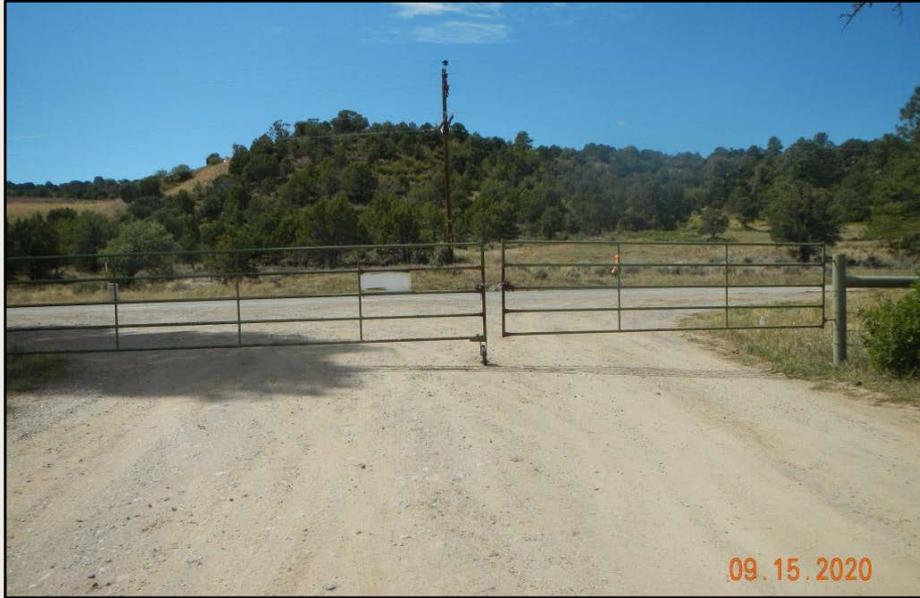
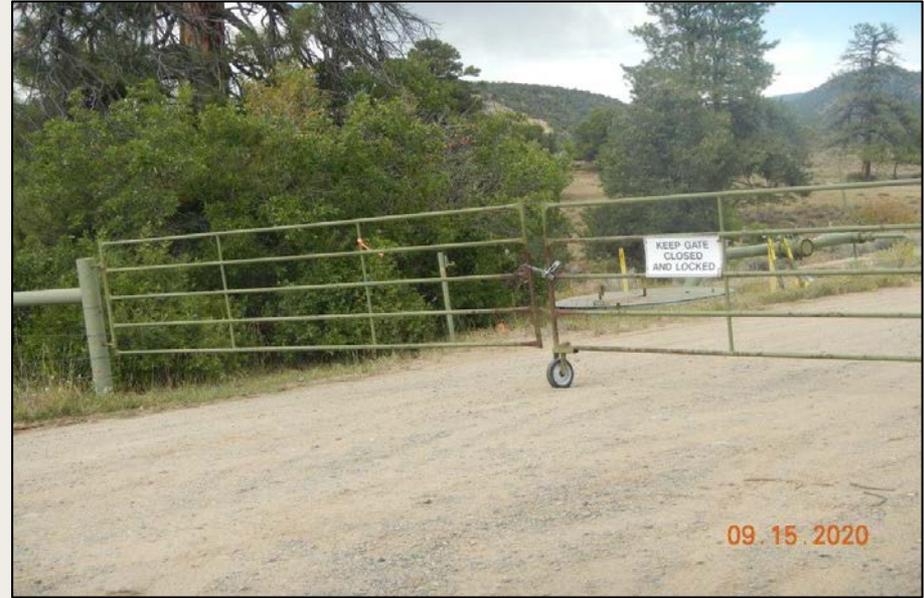
Photos 5/6. Locked gate coming in (left) and leaving (right).
