Inspection Photos
Operator: BP America
API: 067-09064
Date: 9/15/2020

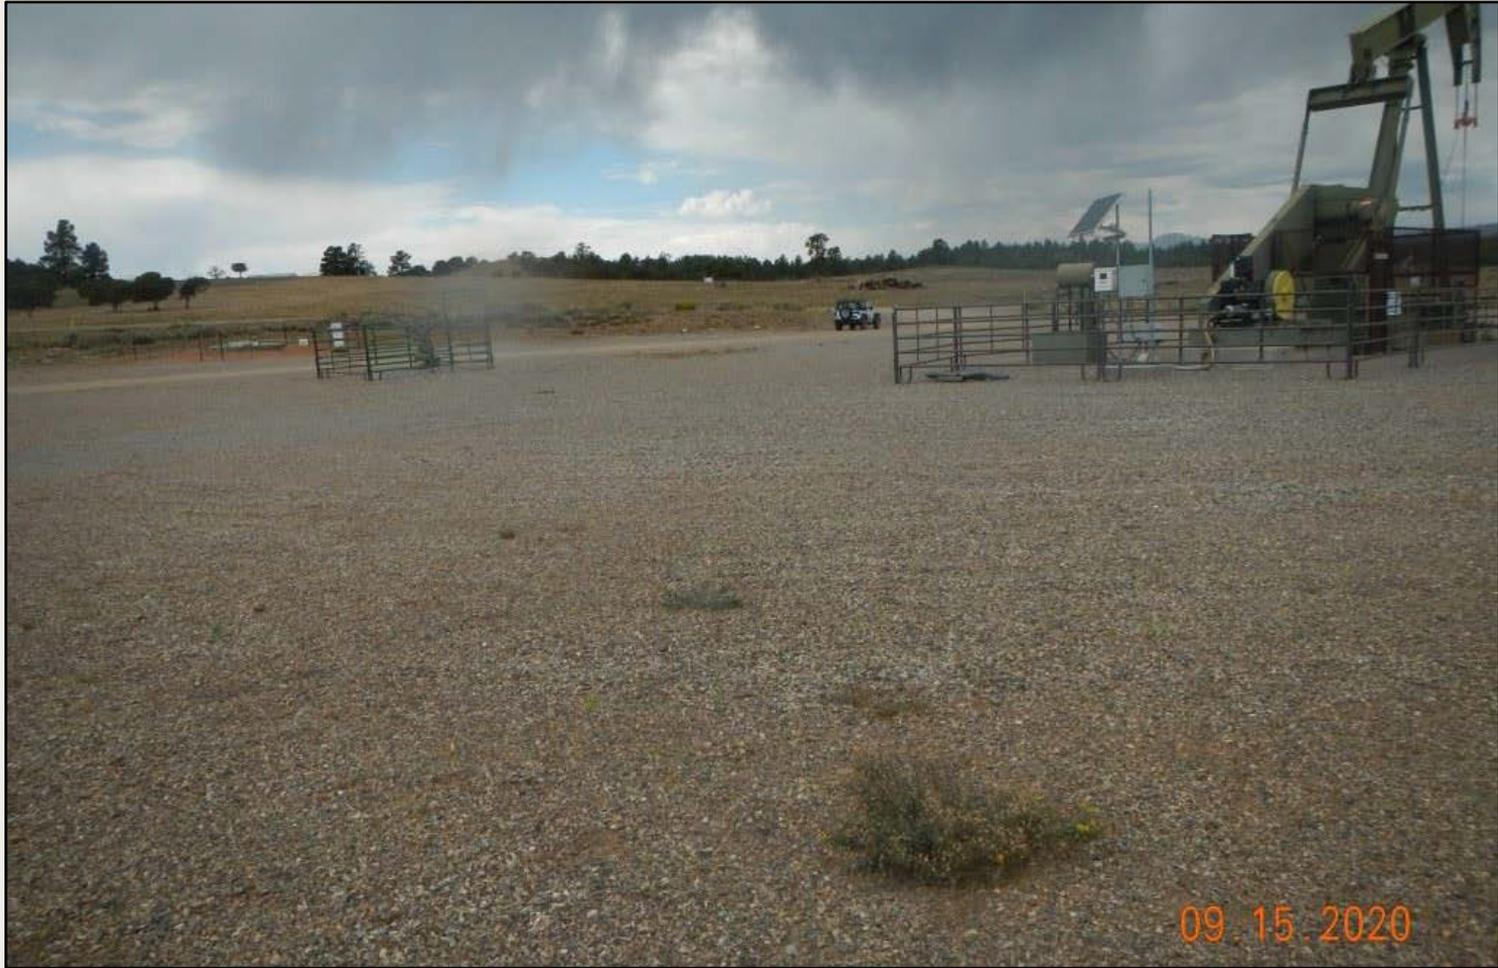
Photo 1. View of the project area from the northeastern corner facing center.

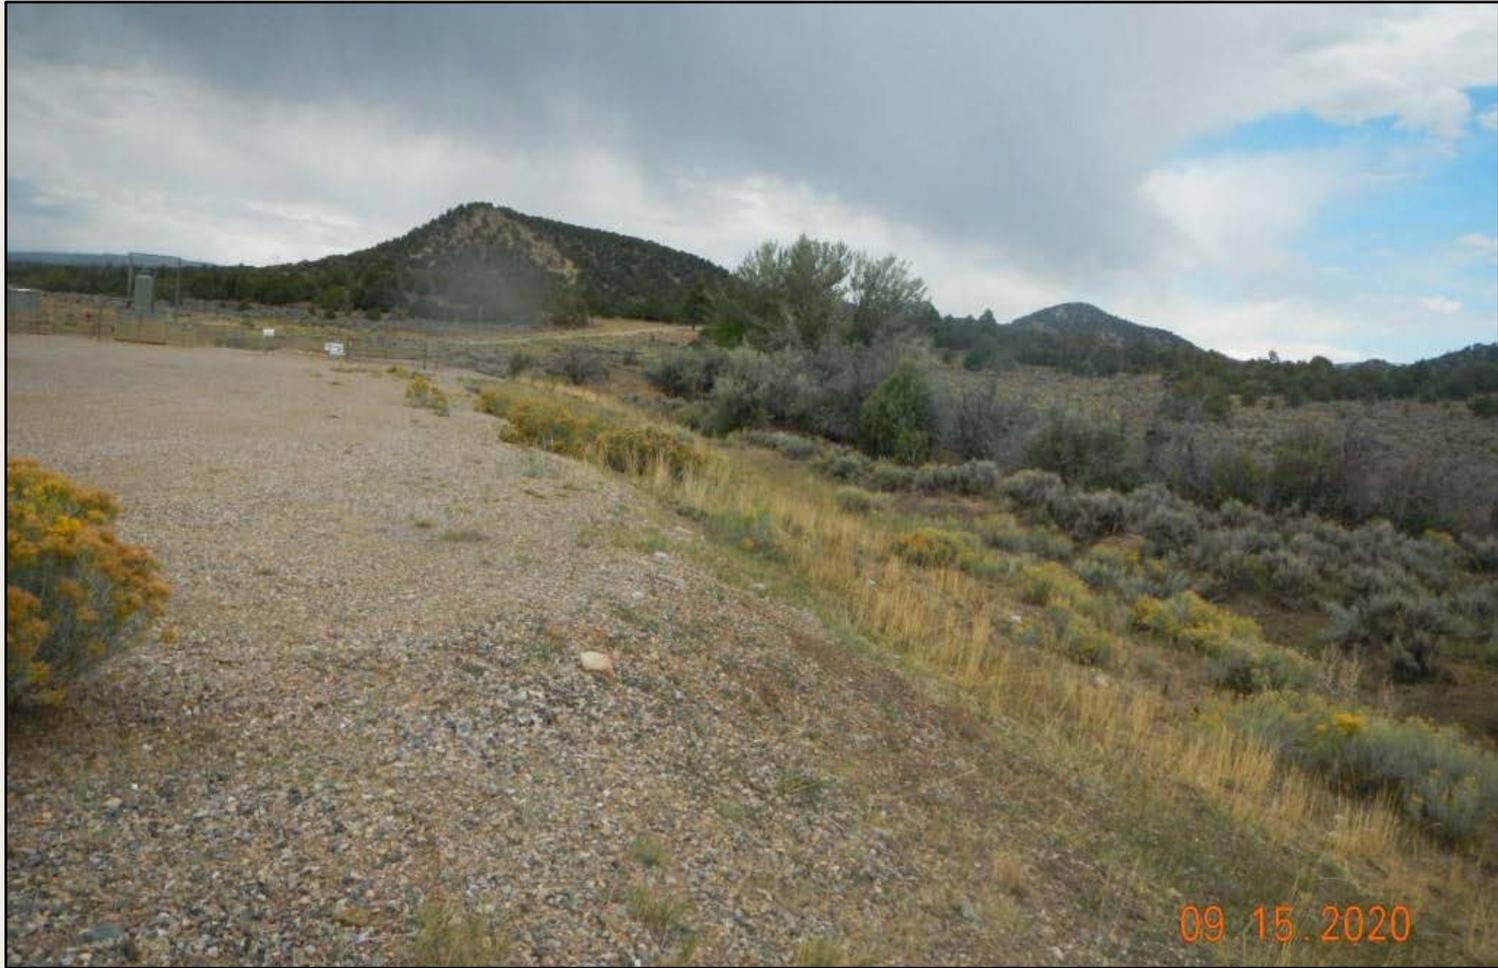
Photo 2. View of the northern project area from the northeastern corner facing westward. Revegetation is progressing with grasses and shrubs such as western wheatgrass and rubber rabbitbrush.

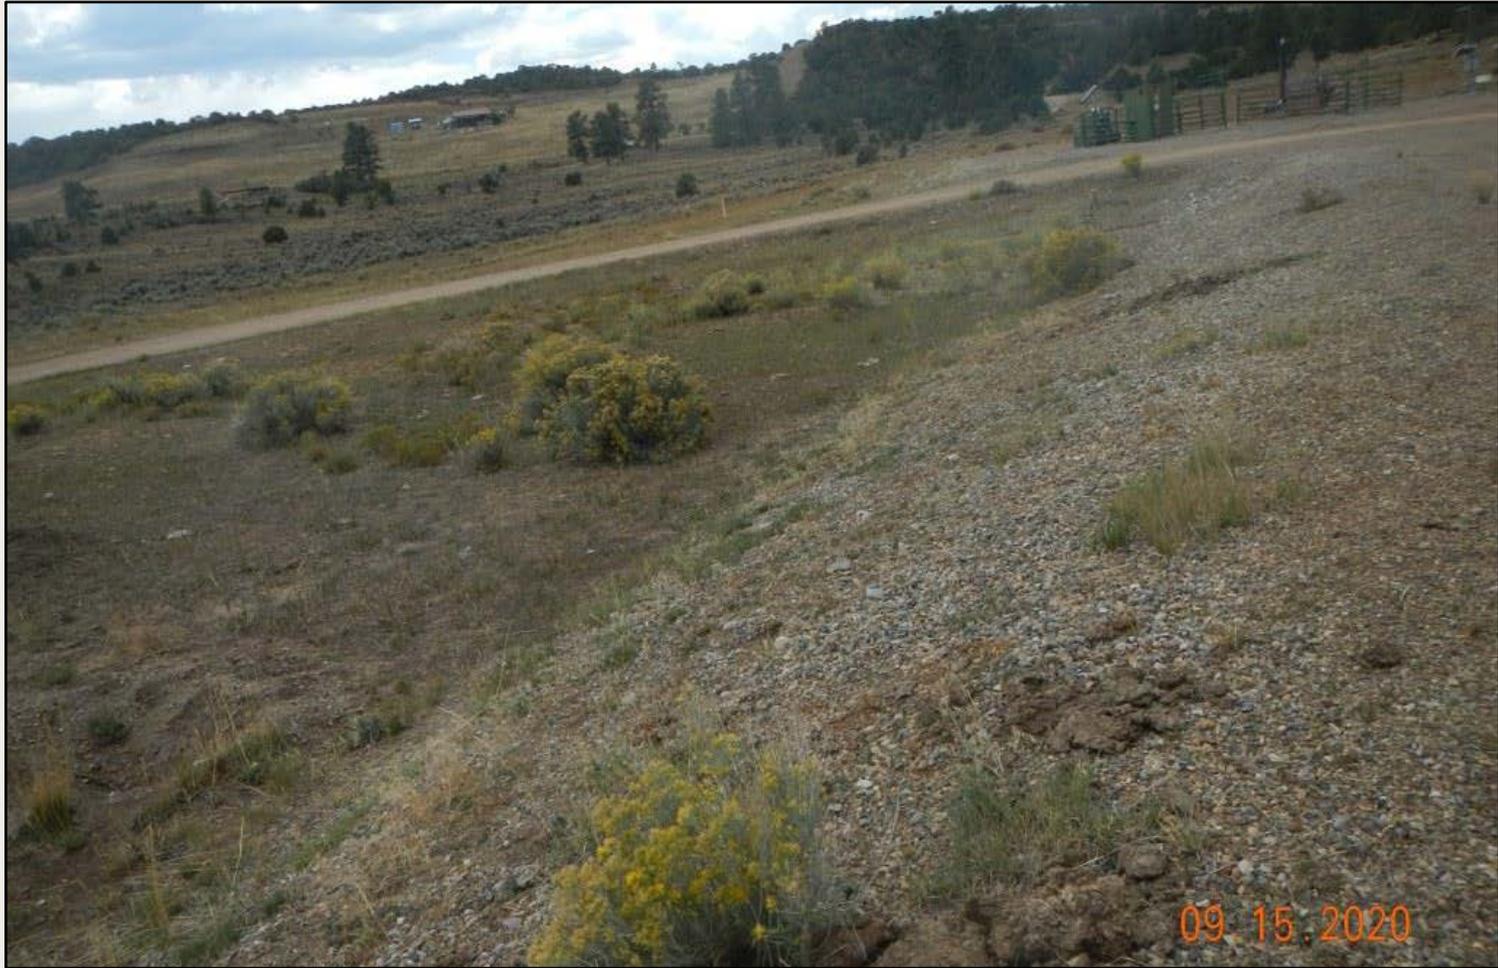
Photo 3. View of the eastern project area from the northeastern corner facing southward.
