Inspection Photos

API: 071-08063

Operator: TIMBER CREEK OPERATING LLC

Inspection Date: 9/11/2020

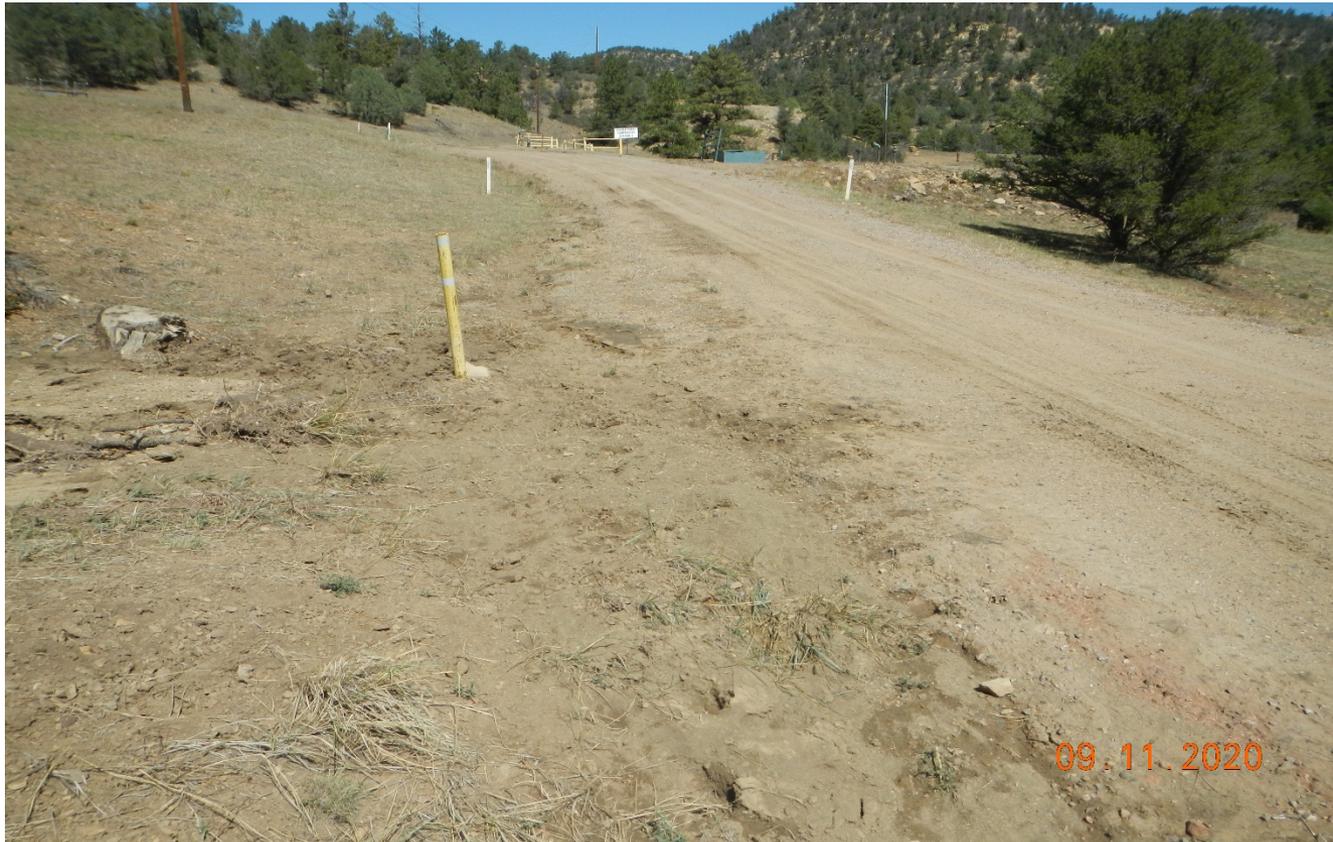
Photo 1. Facing north along the main access road. The culvert is filled in with sediment. Lat/Long:37.15037,-104.88728.

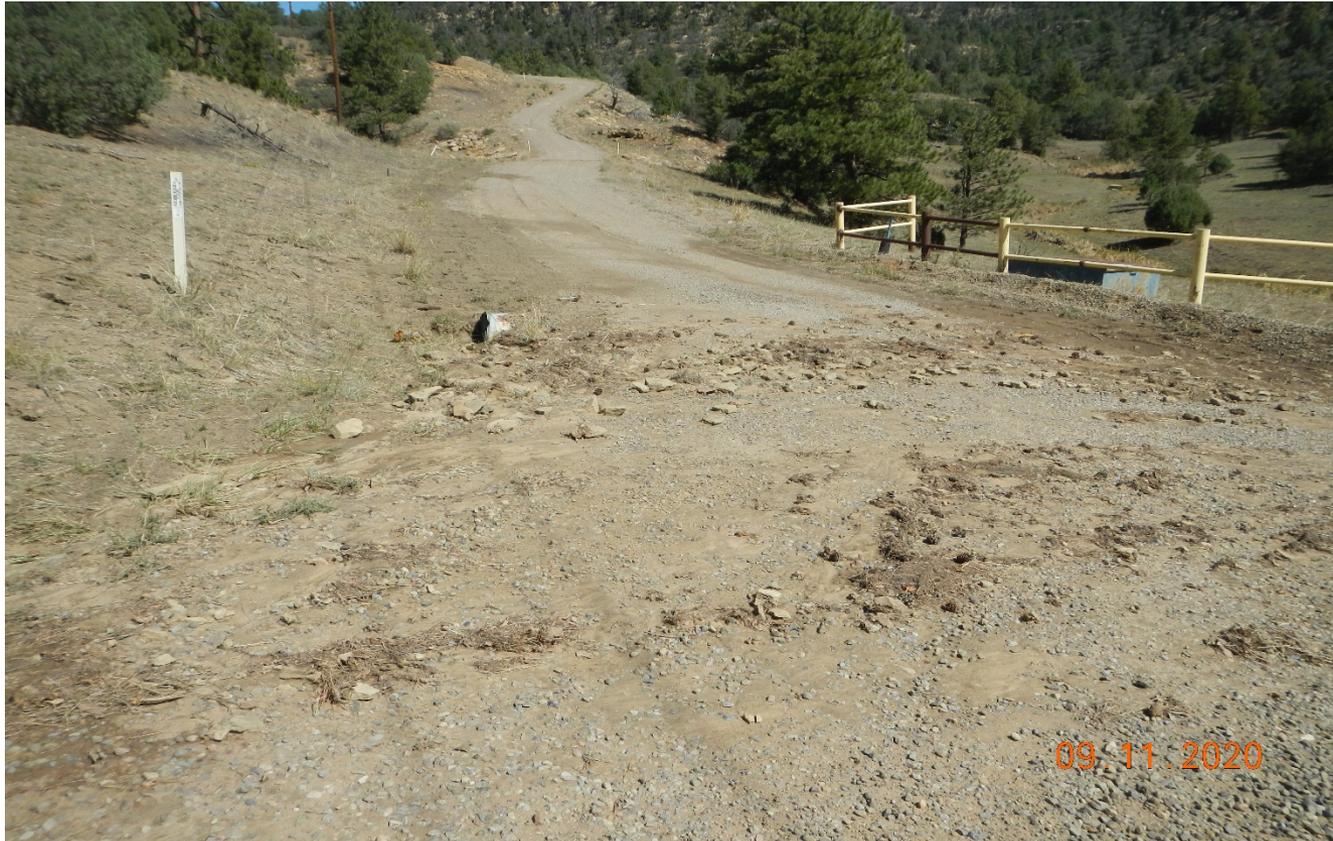
Photo 2. Stormwater is not properly diverted toward the culvert.

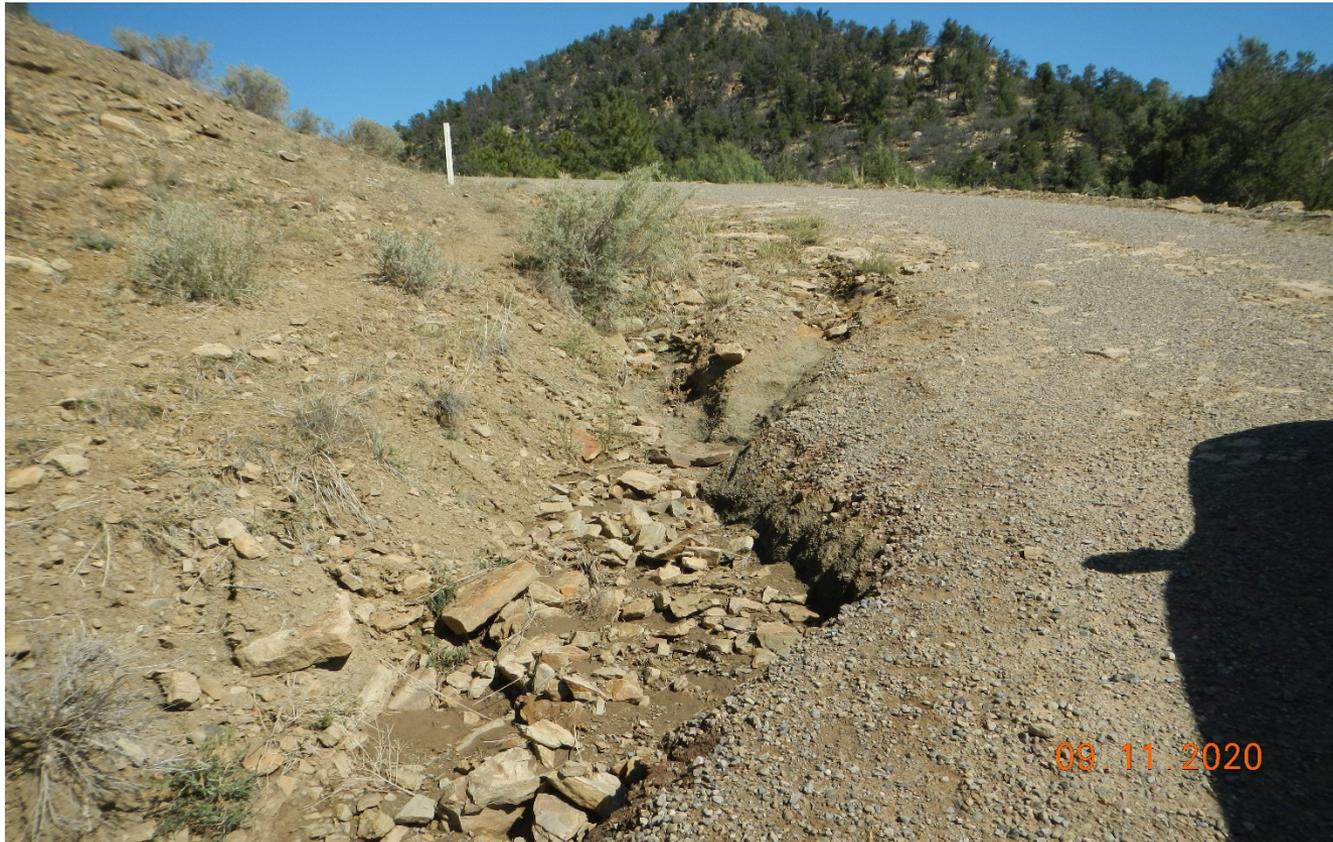
Photo 3. There is erosion along the side of the road that needs to be repaired and stabilized.

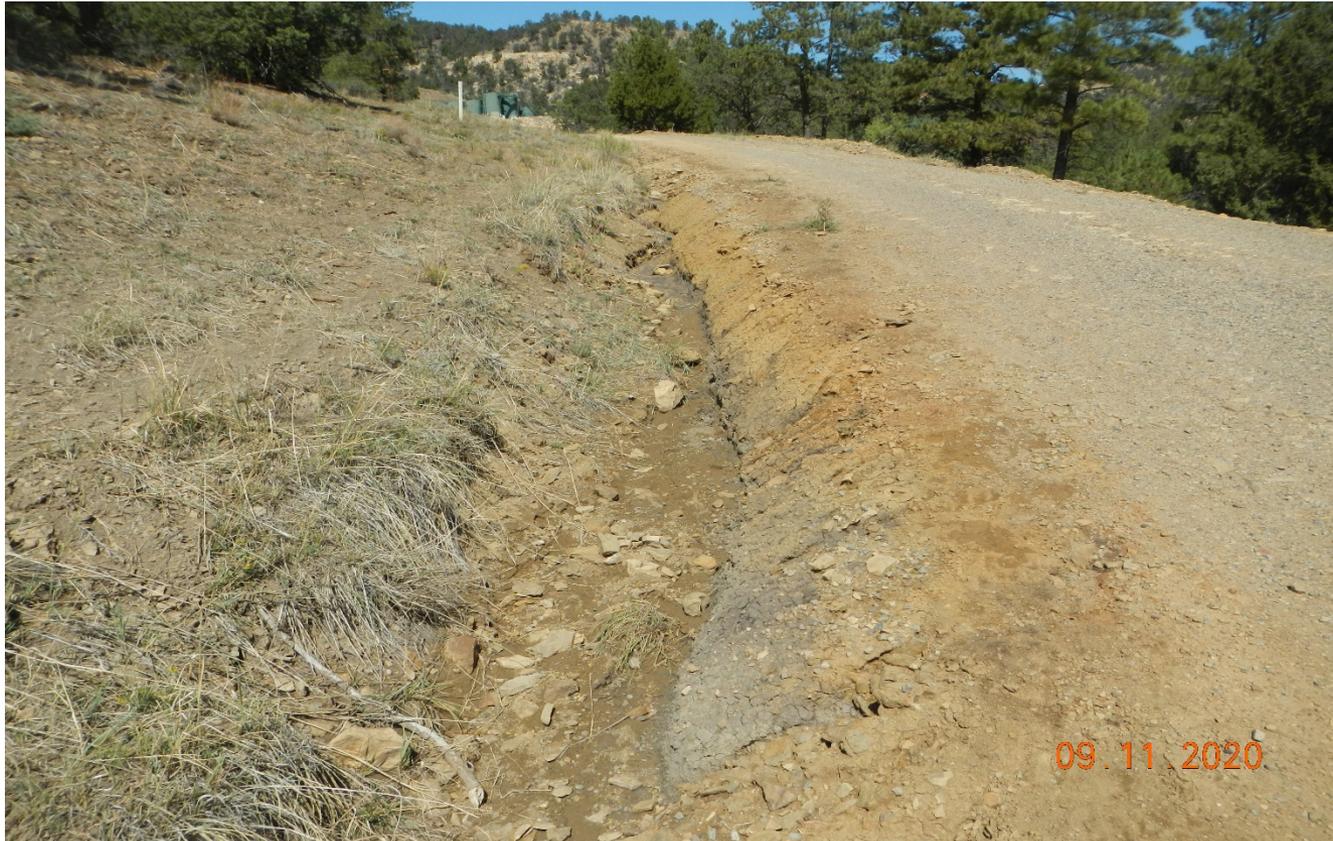
Photo 4. There is erosion along the side of the road that needs to be repaired and stabilized.
