Inspection Photos

9/17/2020

Operator: LARAMIE ENERGY LLC - 10433

Location ID: 335921

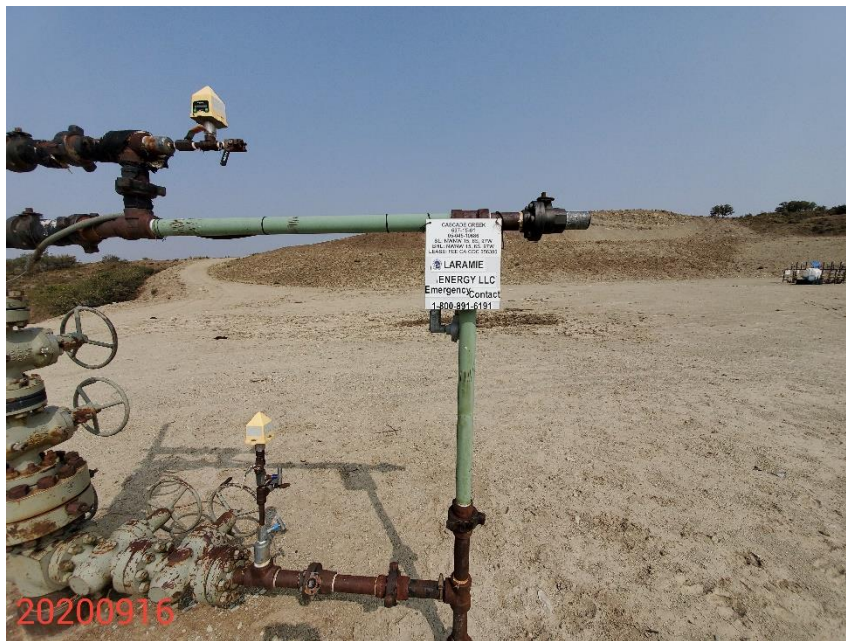
Photo 1: Photo shows signage has been installed/updated at well.

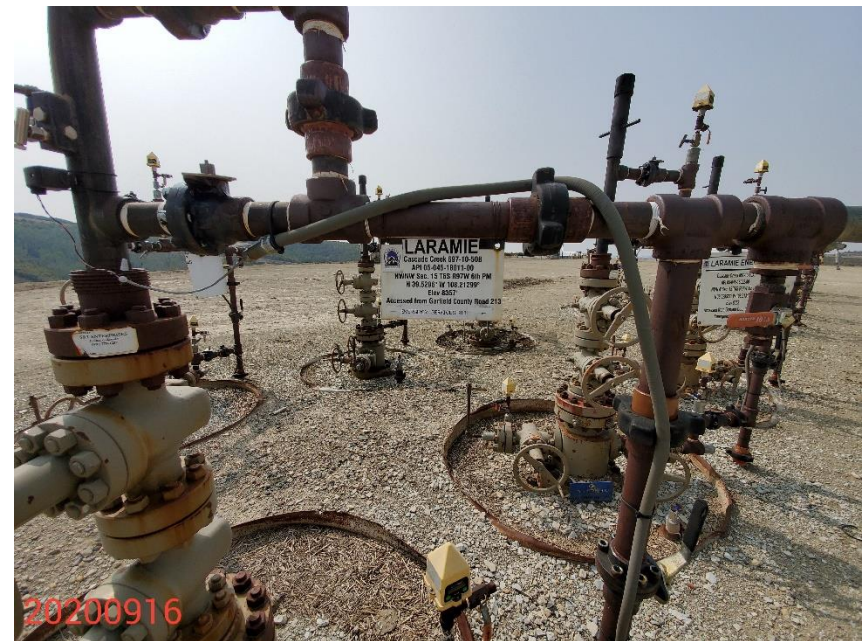
Photo 2: Photo shows signage has been installed/updated at well.

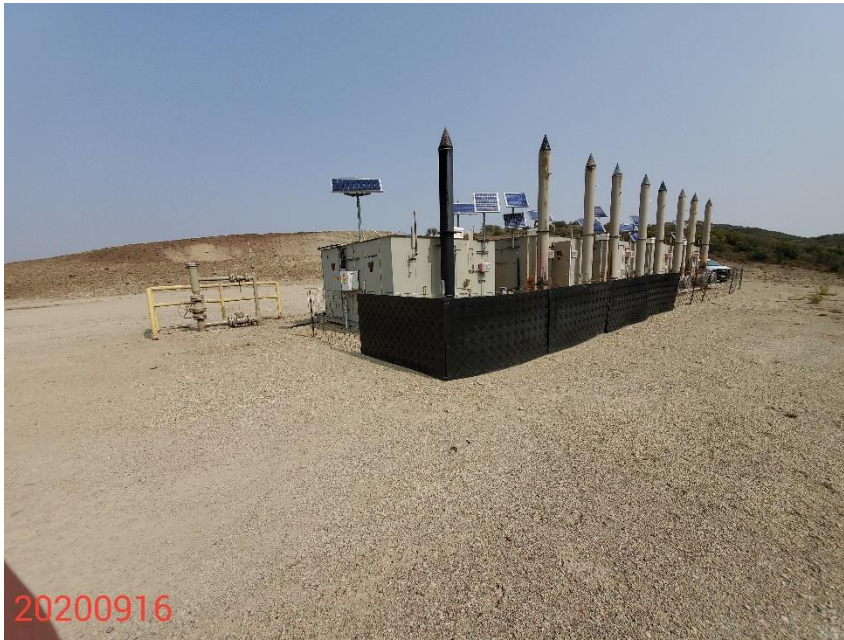
Photo 3: Photo shows unused ladder equipment has been removed, and panels/fence has been maintained.

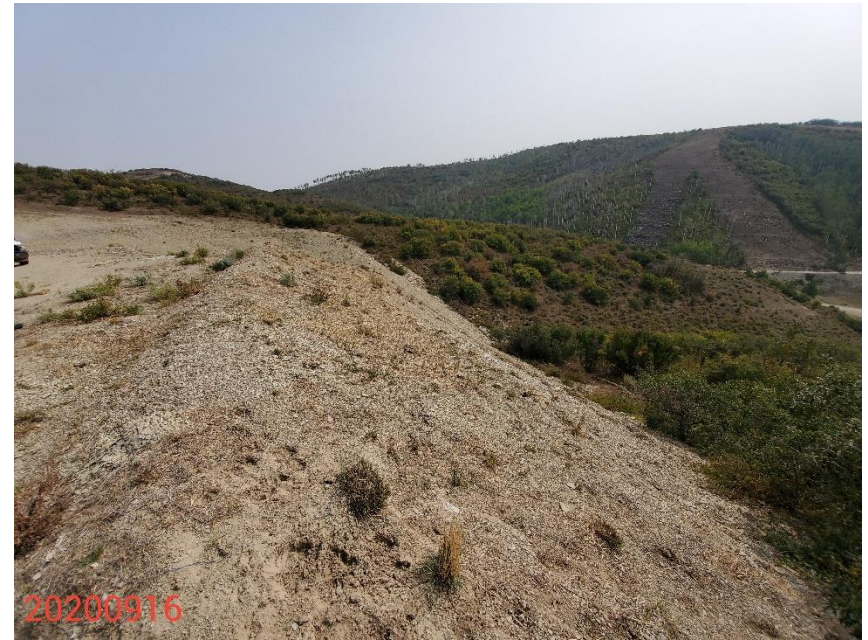
Photo 4: Photo taken from the southeast end of the Location, facing east. Photo shows areas of the Location, including fill slopes, that have not been recontoured/regraded or reclaimed to their original condition in accordance w/ 1003 rules. BMPs appear insufficient or missing to stabilize slopes.

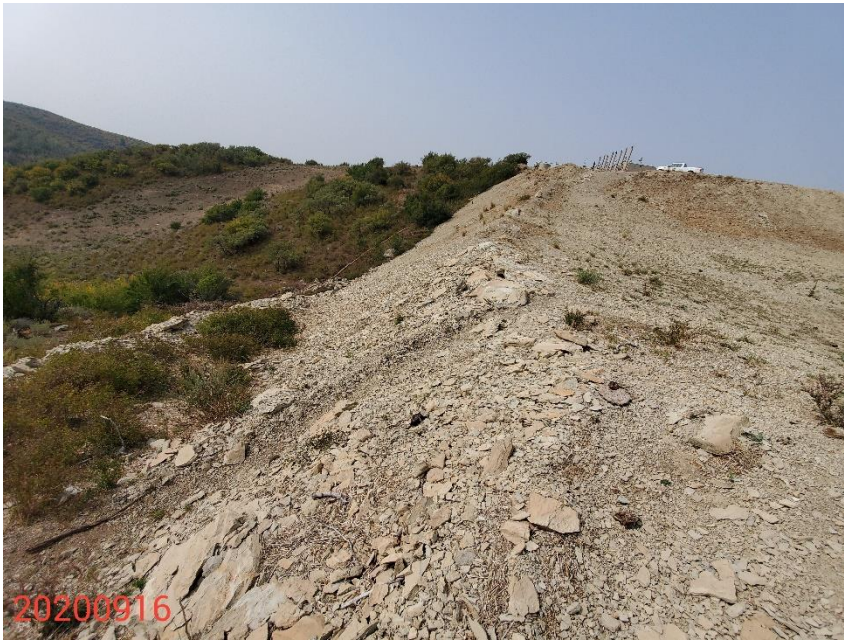
Photo 5: Photo taken from the southeast end of the Location, facing west. Photo shows areas of the Location, including fill slopes, that have not been recontoured/regraded or reclaimed to their original condition in accordance w/ 1003 rules. BMPs appear insufficient or missing to stabilize slopes. .

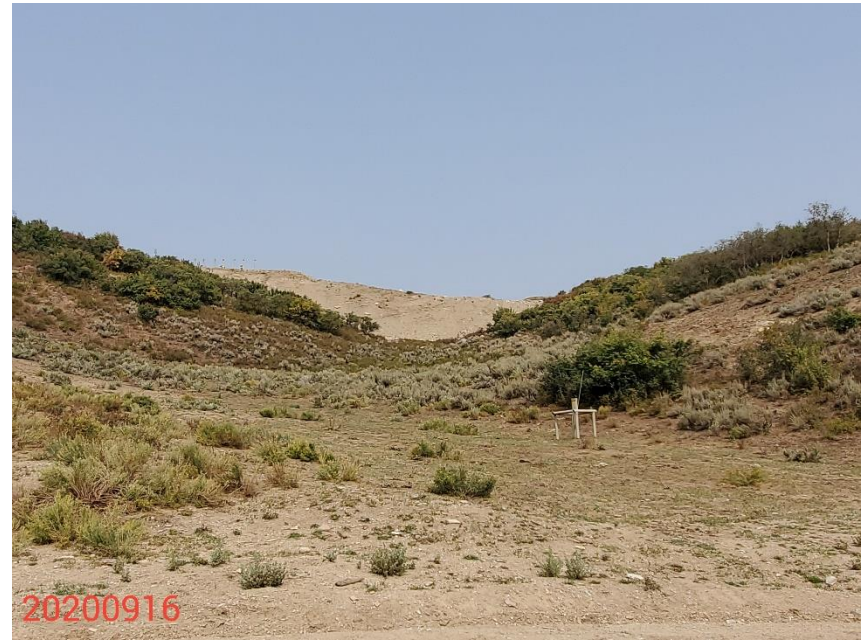
Photo 6: Photo taken from the south of the Location, facing north. Photo shows fill slopes that have not been recontoured/regraded or reclaimed to their original condition in accordance w/ 1003 rules.

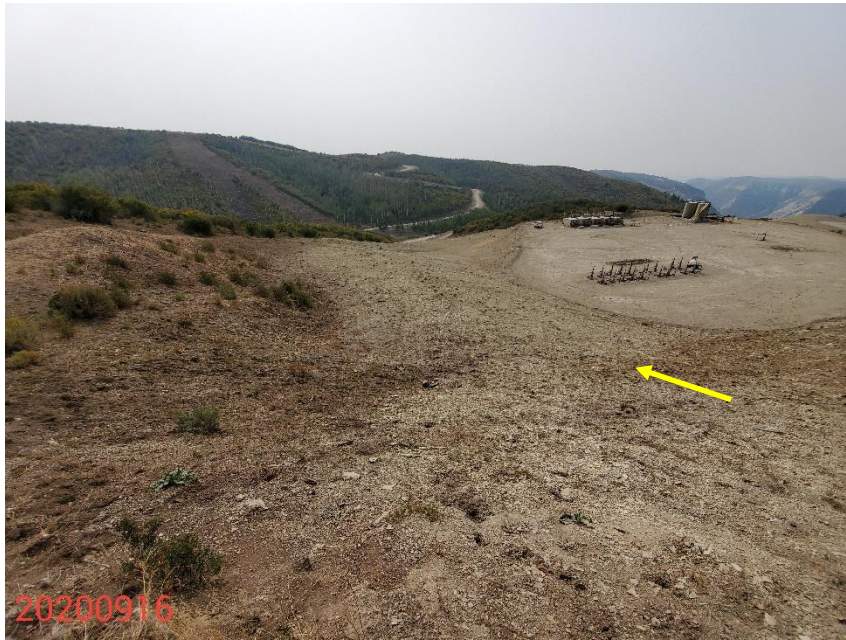
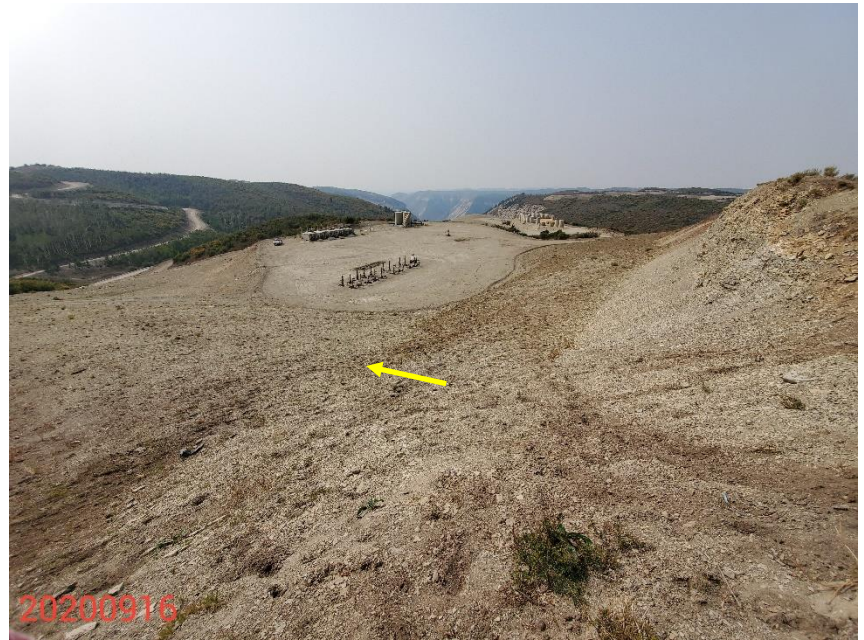
Photo 7: Photo taken from the east end of the Location, facing south. Photos 7-8 provide an overview of the Location from south to southwest. Photo also shows areas (left of arrow) that appear to be subsoils; it does not appear that topsoil horizons were placed back to their relative original position.

Photo 8: See comments under photo 7

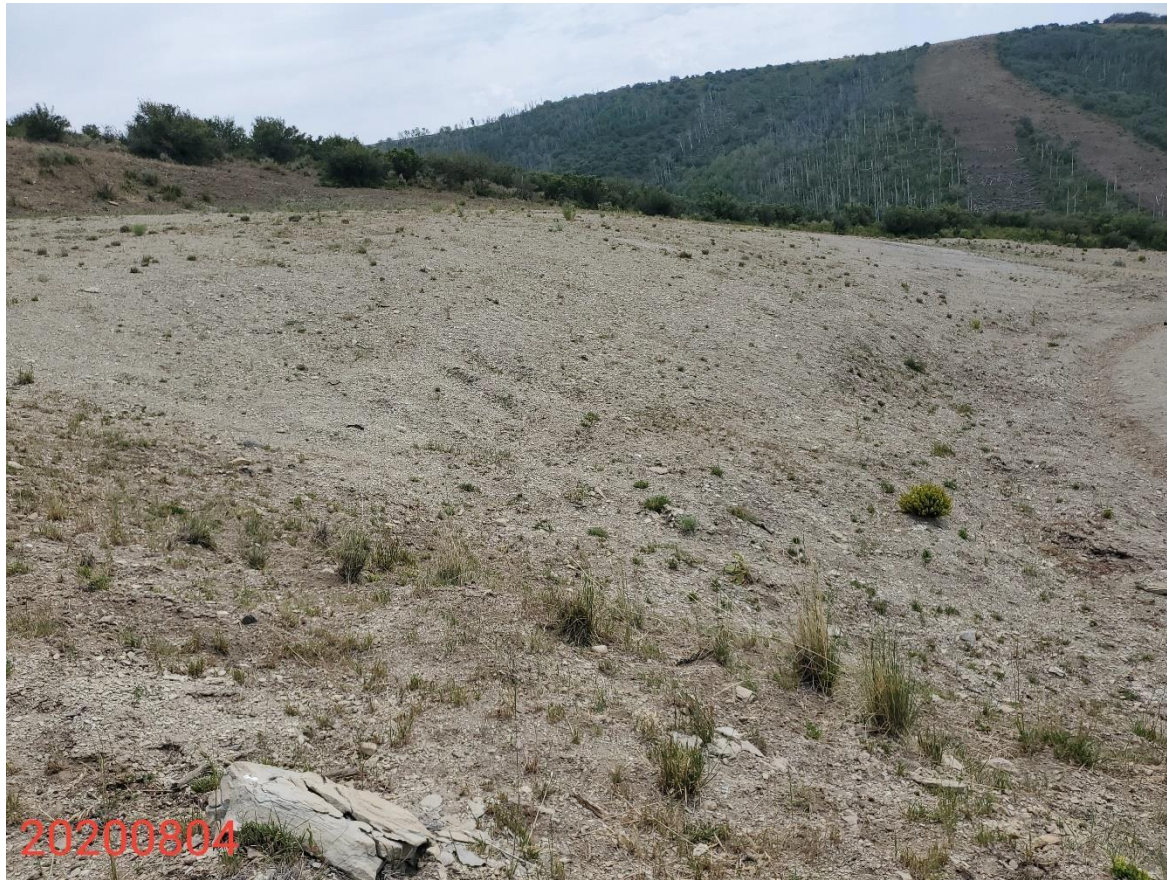
Photo 8.1 Photo copied from the 8/4/2020 inspection, taken from the northeast end of the Location, facing south. Photo shows interim areas. Soils at the surface appear to be subsoils; it does not appear that topsoil horizons were placed back to their relative original position.

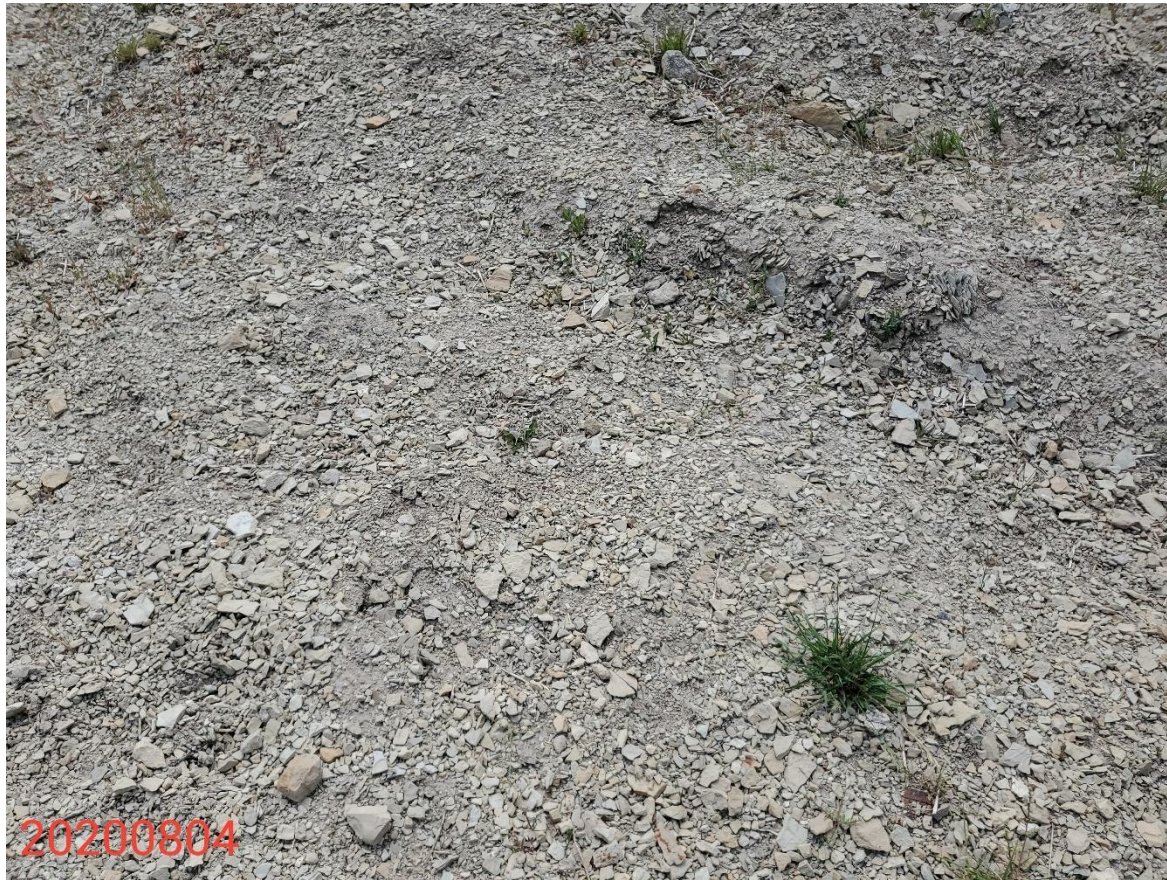
Photo 8.2 : Continued from photo 8.1 Photo show soil surface of interim area. it does not appear that topsoil horizons were placed back to their relative original position.

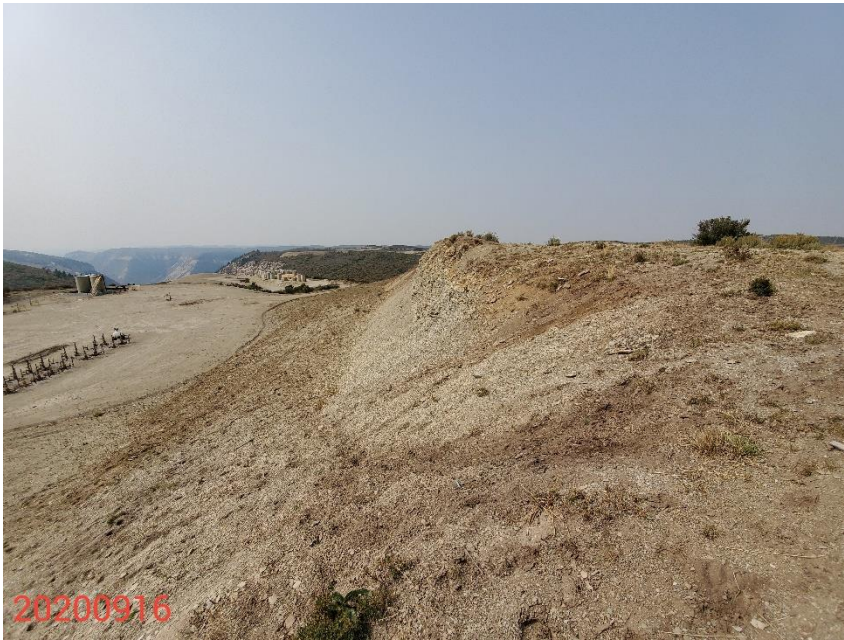
Photo 9: Photo taken from the east end of the Location, facing southwest. Photo shows cut slopes; interim areas have not been contoured/regraded and reclaimed to their original condition.

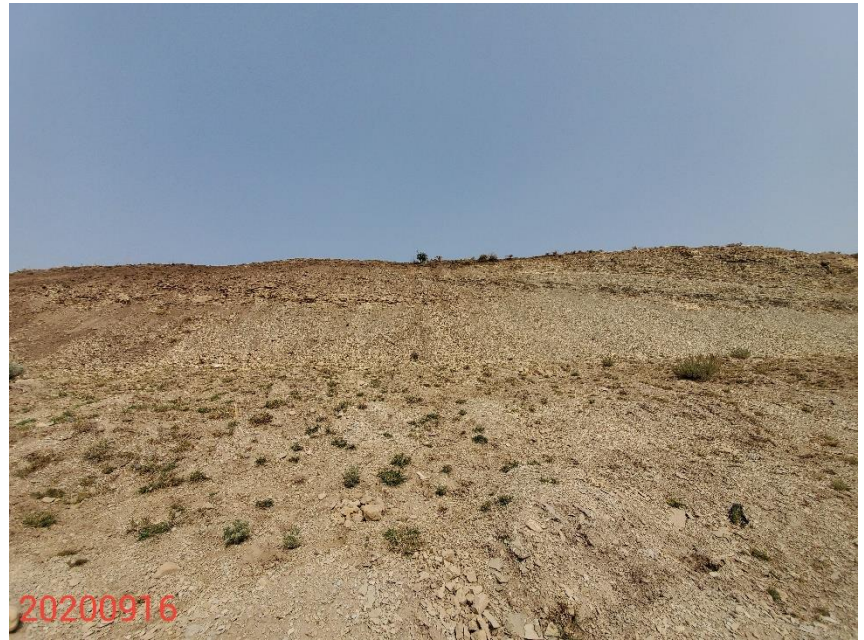
Photo 10: Photo of cut slopes on the north end of the location, facing north. Photo shows BMPs remain missing or insufficient to stabilize slopes.

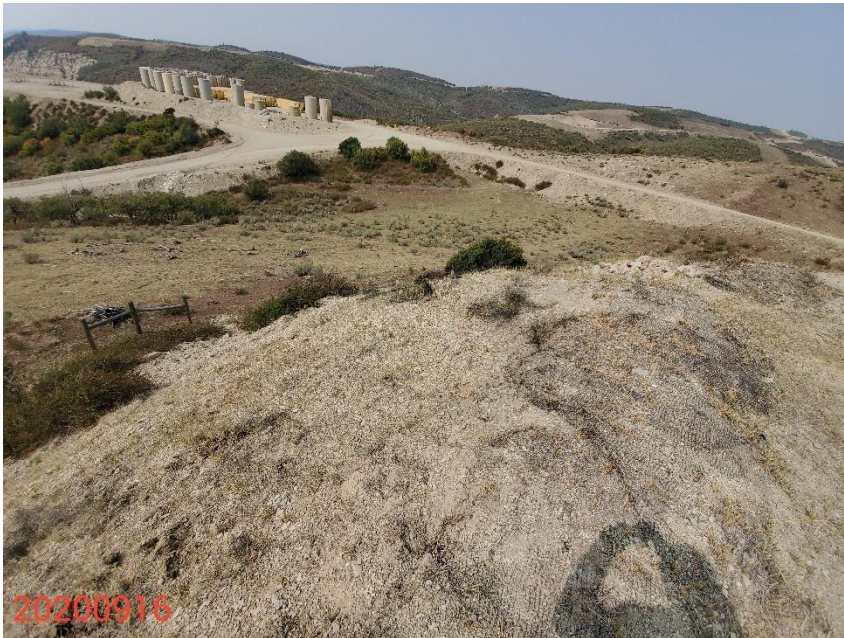
Photo 11: Photo taken from the southwest end of the Location, facing west. Photo shows erosion net BMP remains in disrepair, and is considered Debris.

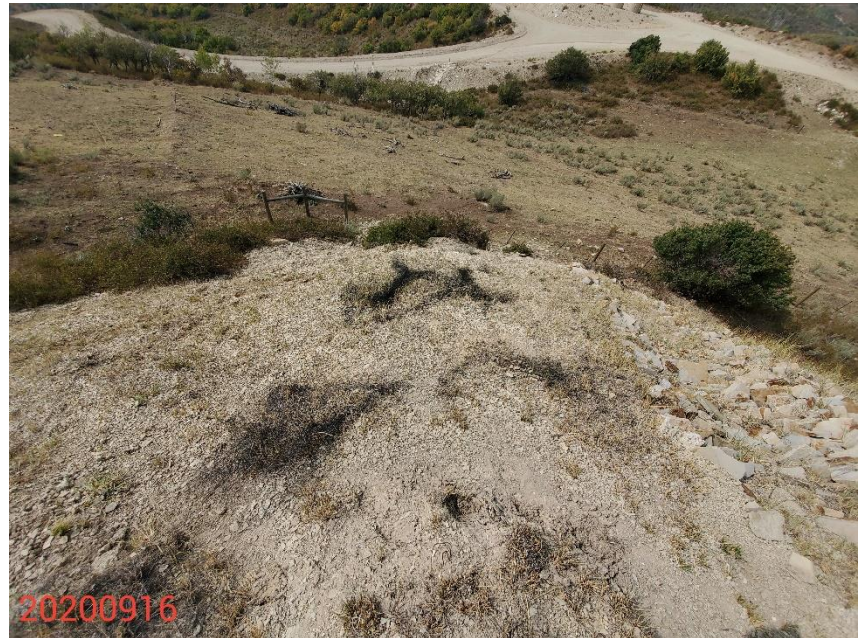
Photo 12: Continued from photo 11. Photo shows erosion net BMP remains in disrepair, and is considered Debris.
