Inspection Photos

API: 071-06721

Operator: EVERGREEN NATURAL RESOURCES

Inspection Date: 9/16/2020

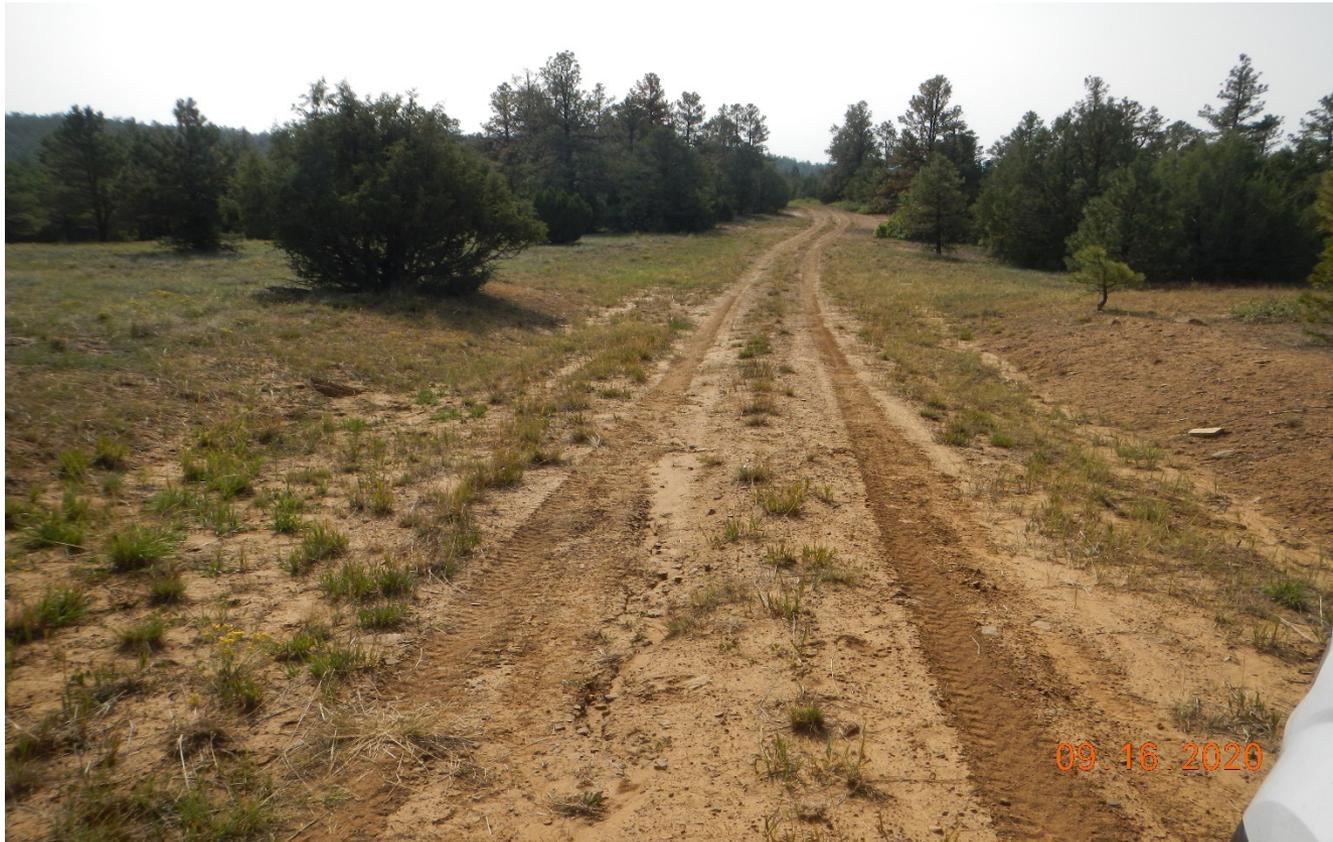
Photo 1. Facing southeast toward the access road which has not been reclaimed.

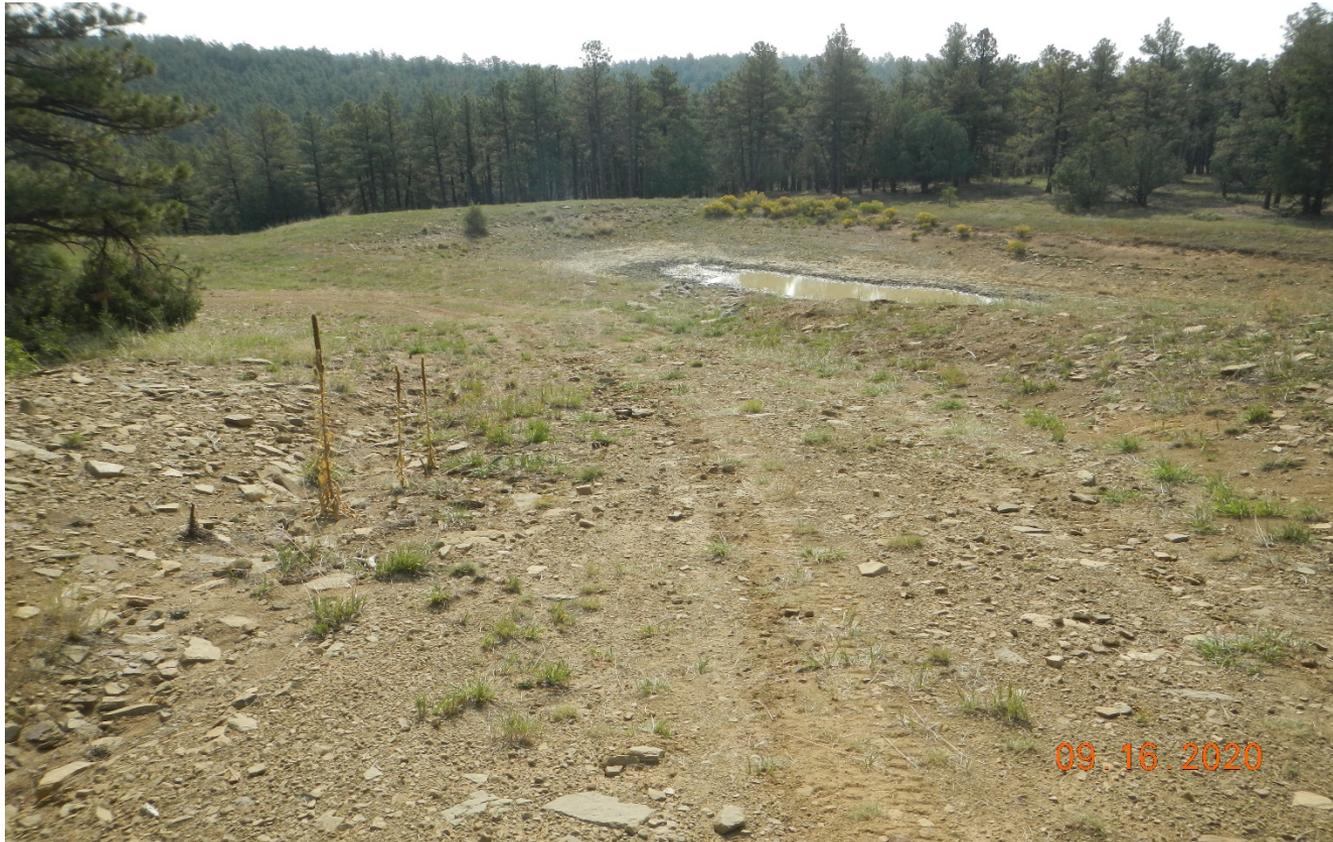
Photo 2. Facing southeast toward the location.

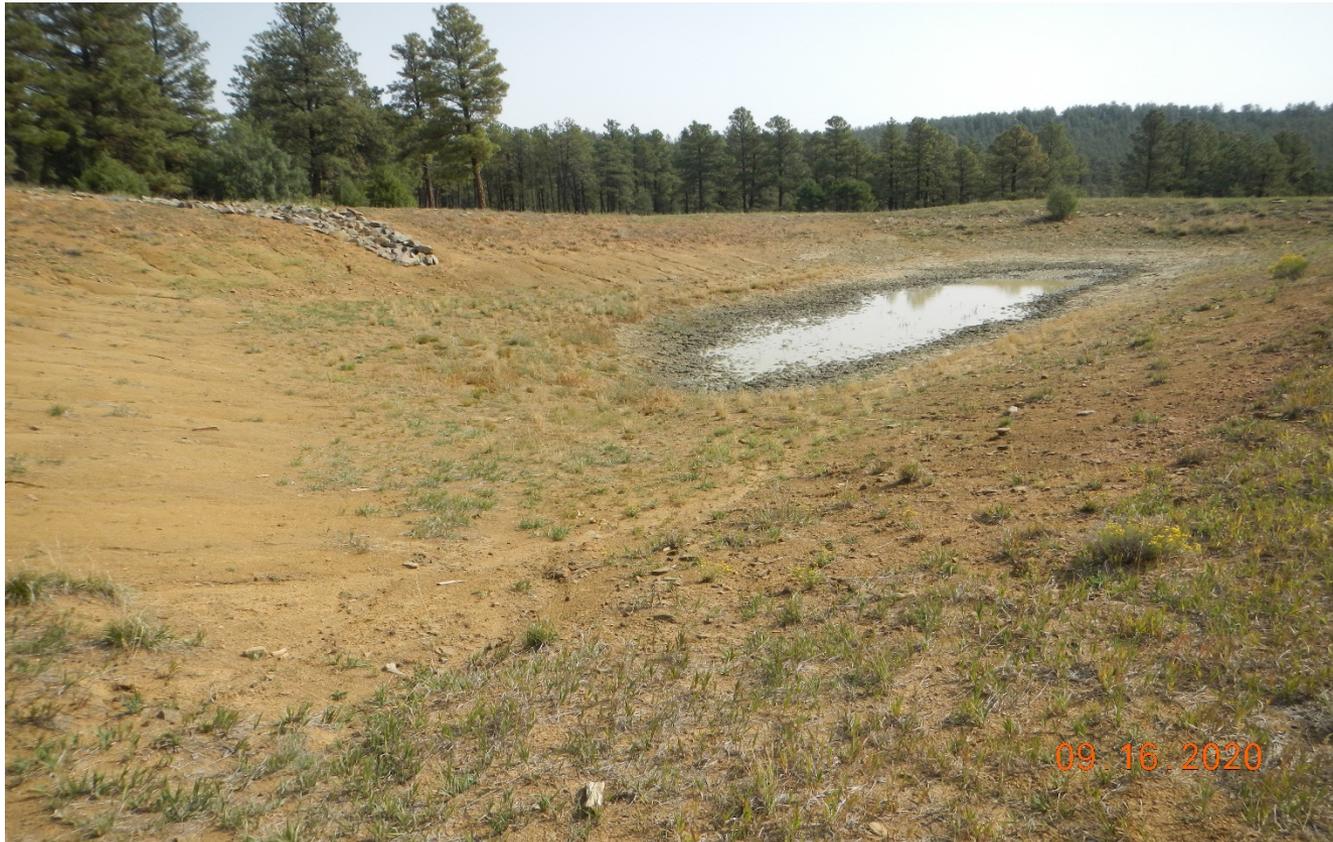
Photo 3. The pit remains at the location and has not been backfilled and reclaimed.

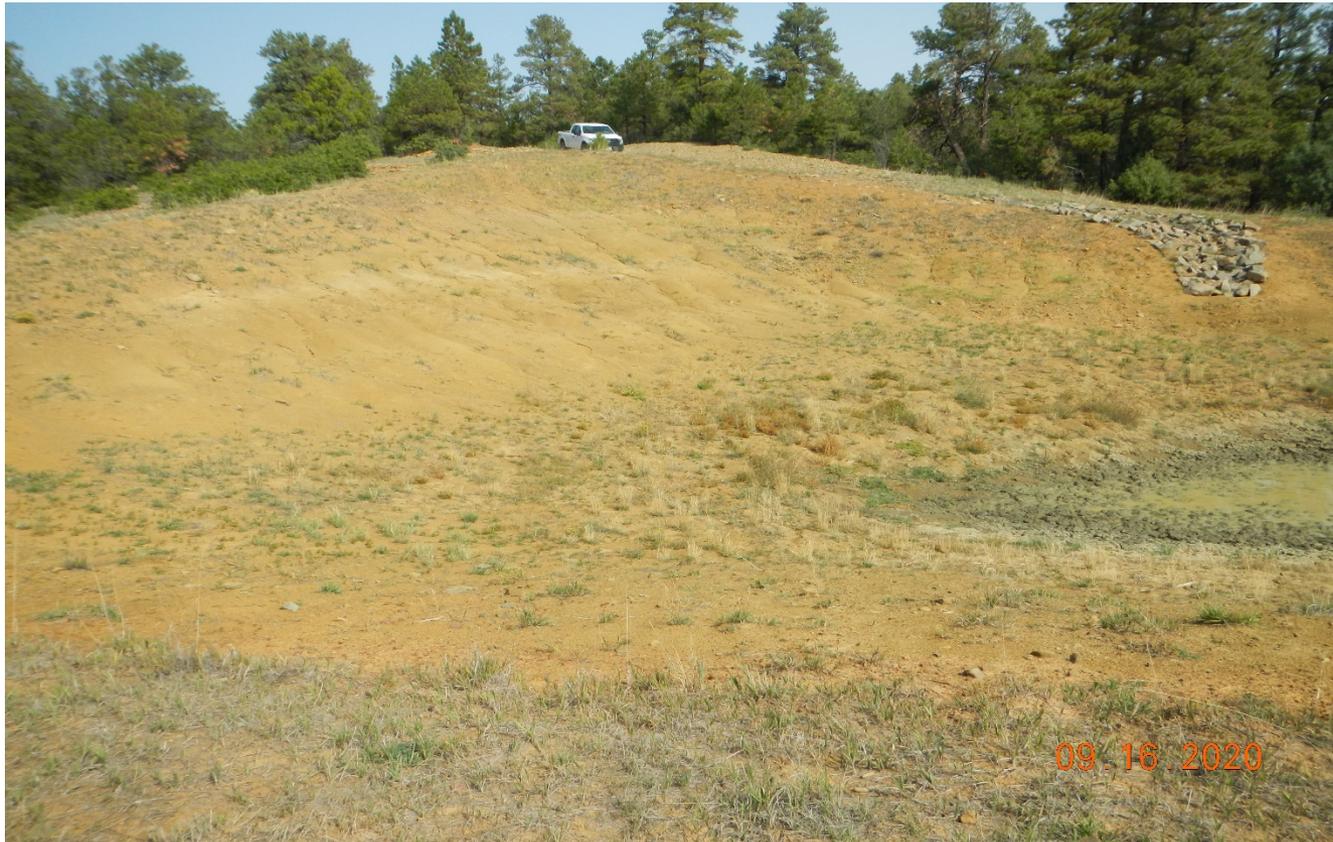
Photo 4. There is erosion along the cut slope of the pit which is not stabilized.

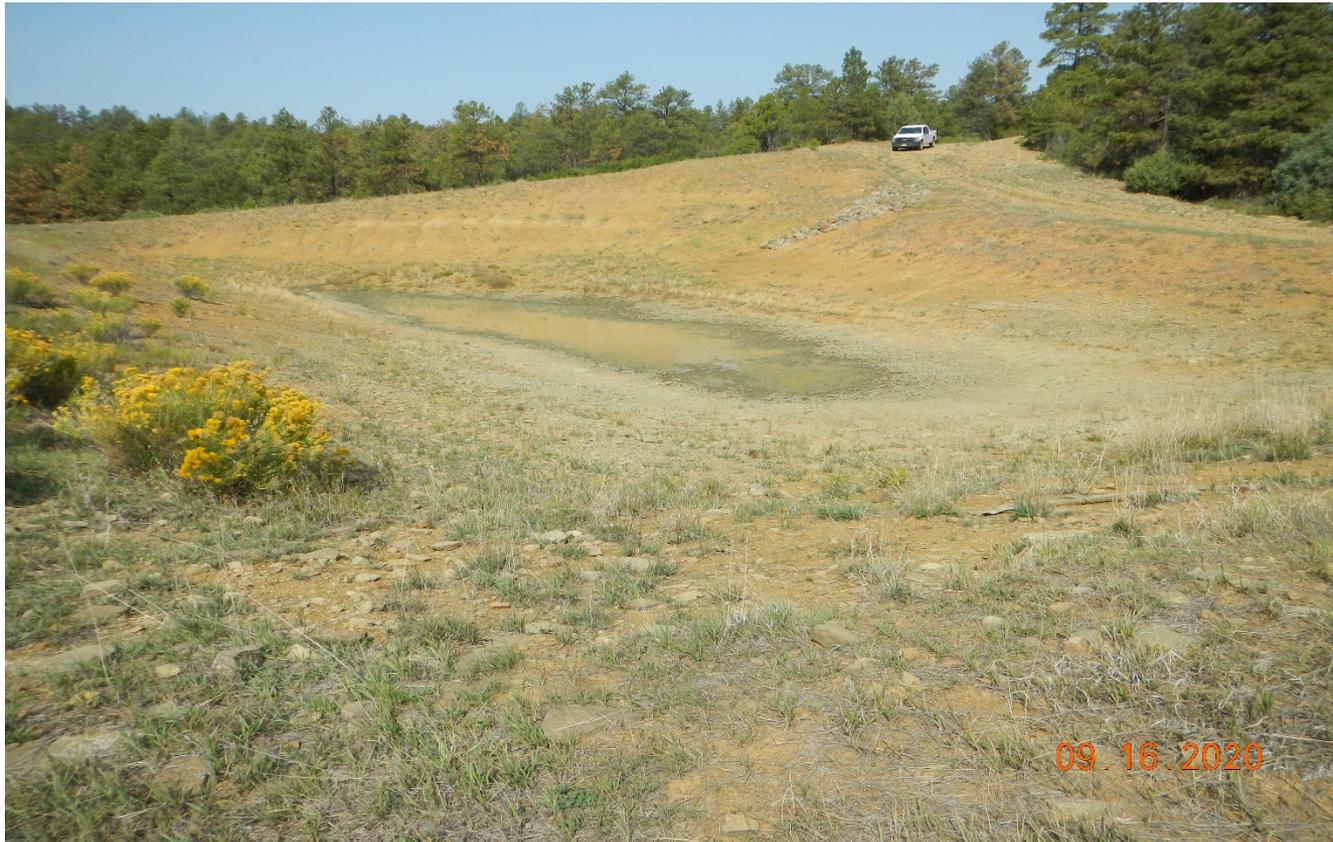
Photo 5. Facing northwest toward the pit location.

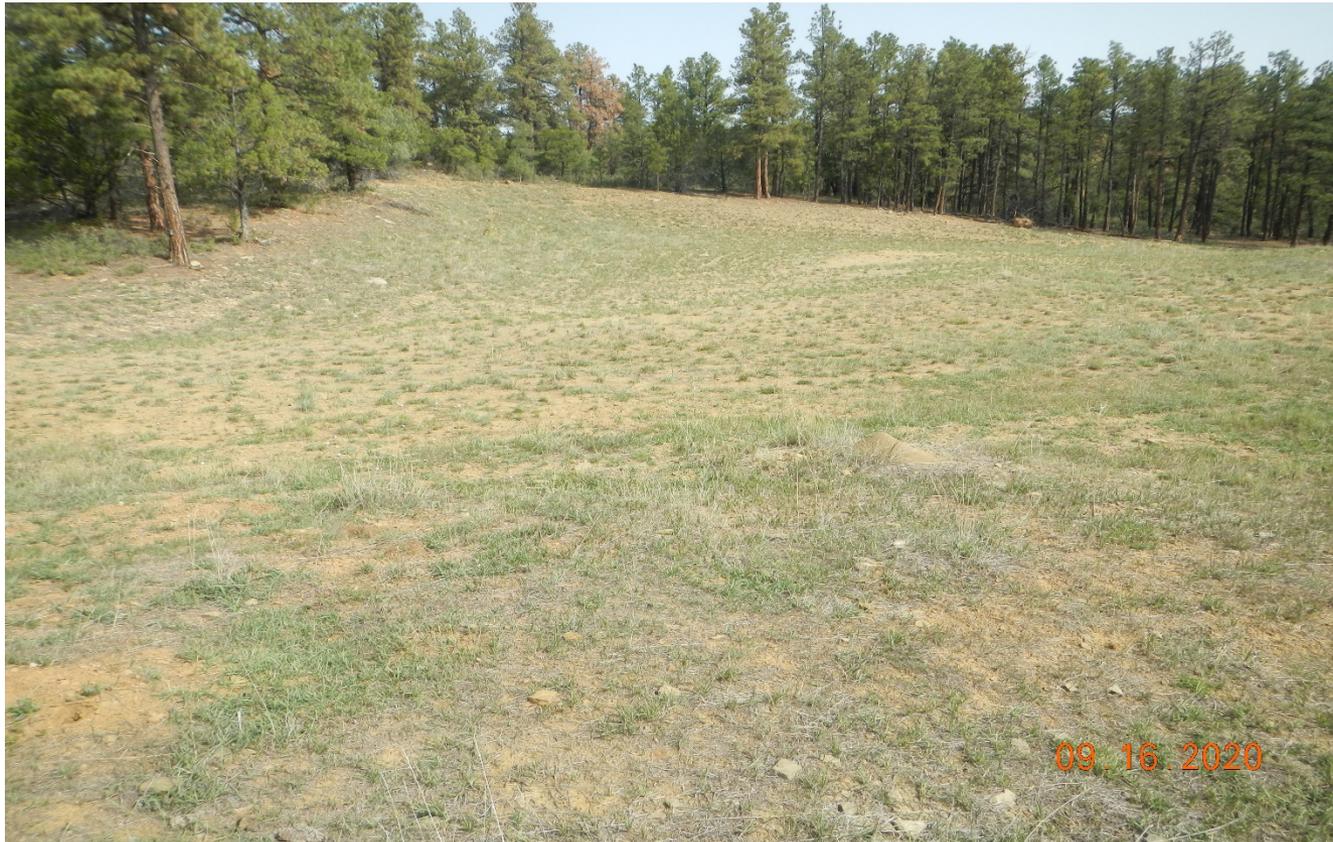
Photo 6. Facing north towards the location.
