Inspection Photos
Operator: BP America
API: 067-08898
Date: 9/18/2020

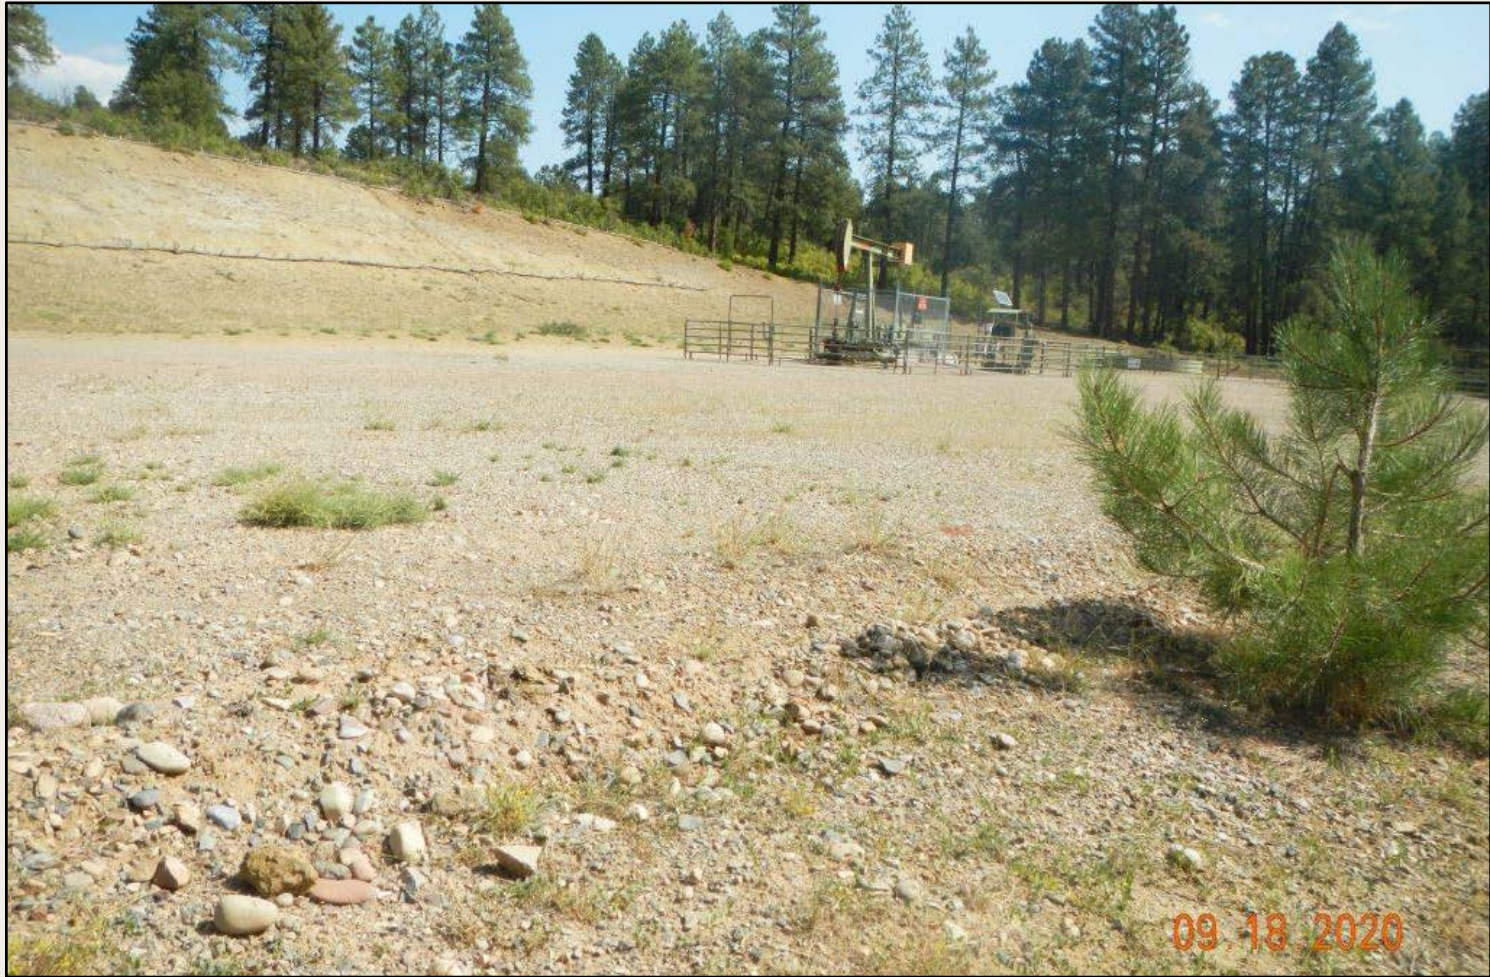
Photo 1. View of the project area from the southwestern corner facing center.

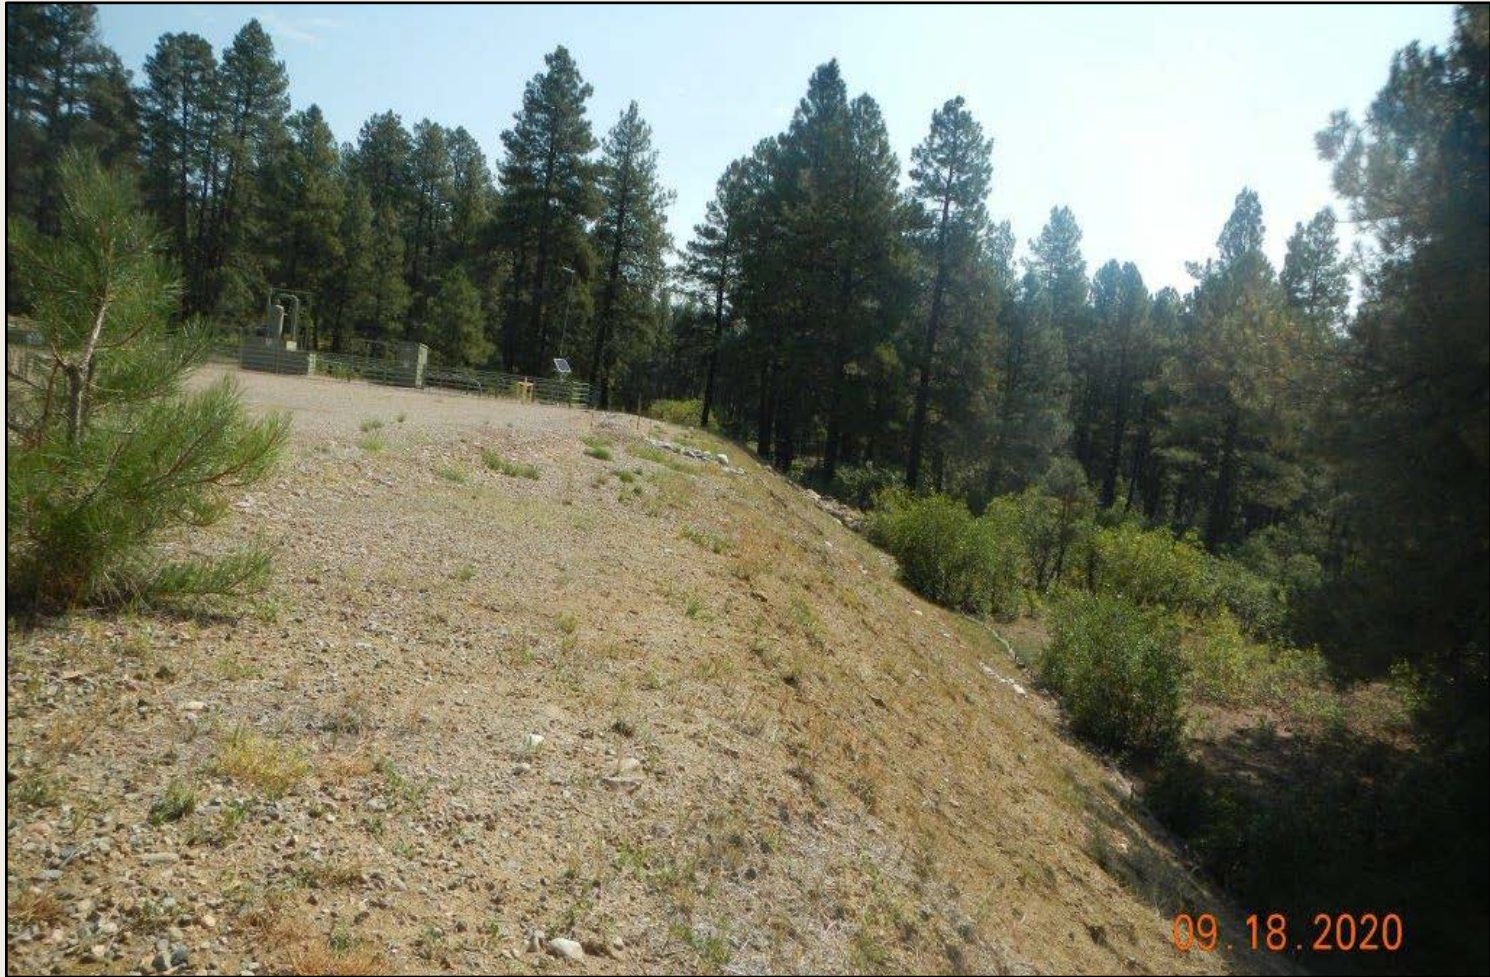
Photo 2. View of the southern project area from the southwestern corner facing eastward. Revegetation is progressing with grasses such as western wheatgrass and smooth brome.

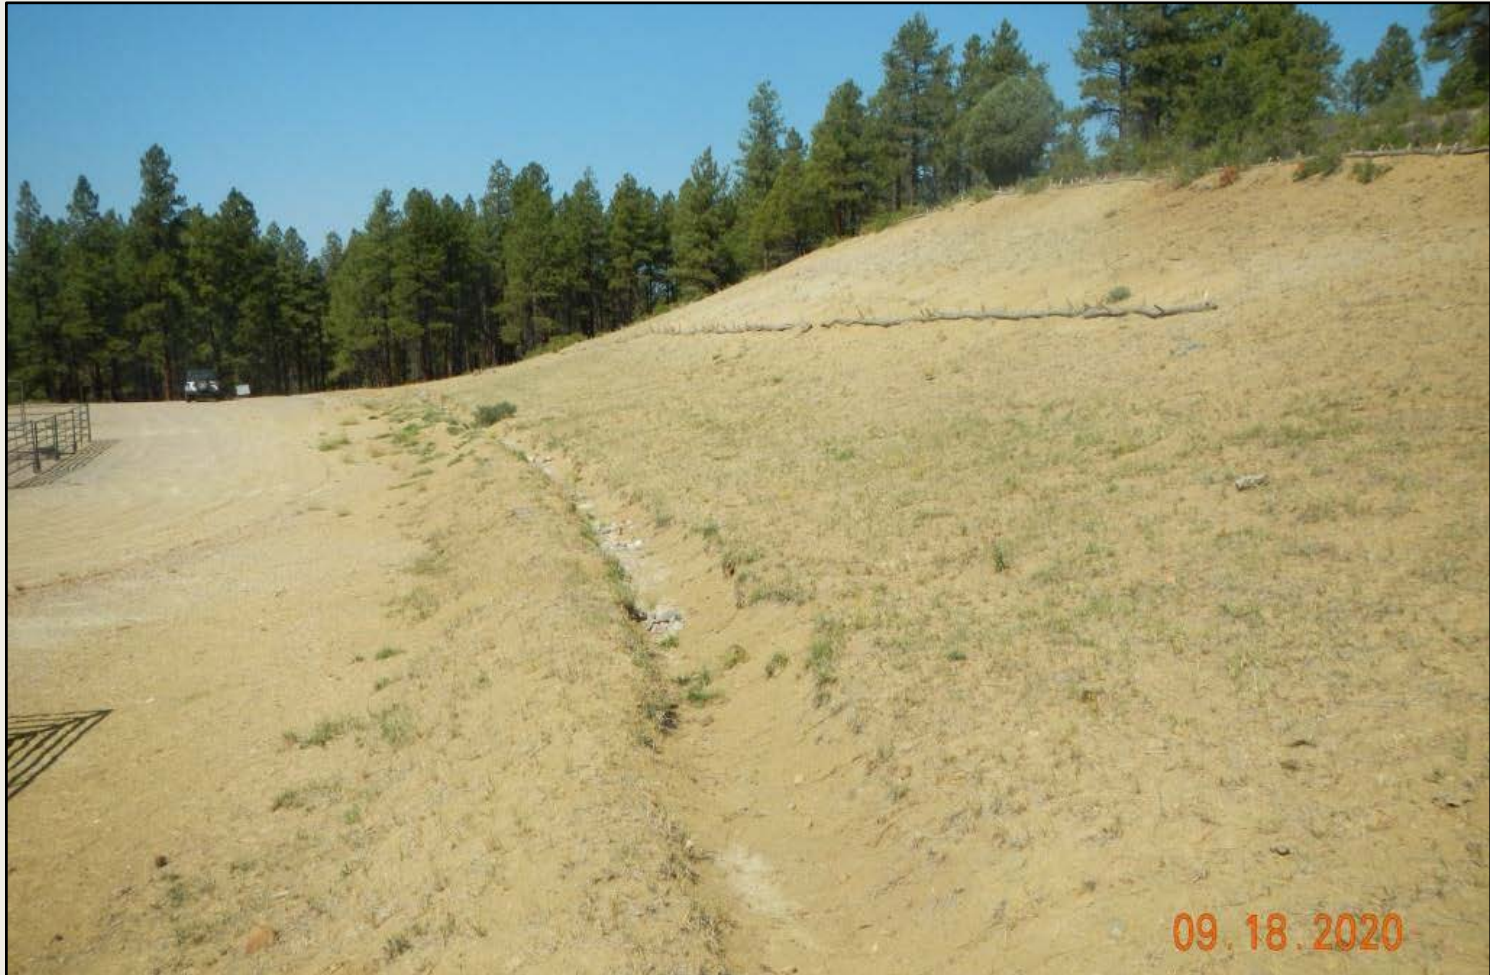
Photo 3. View of the northern project area from the northeastern corner facing westward.

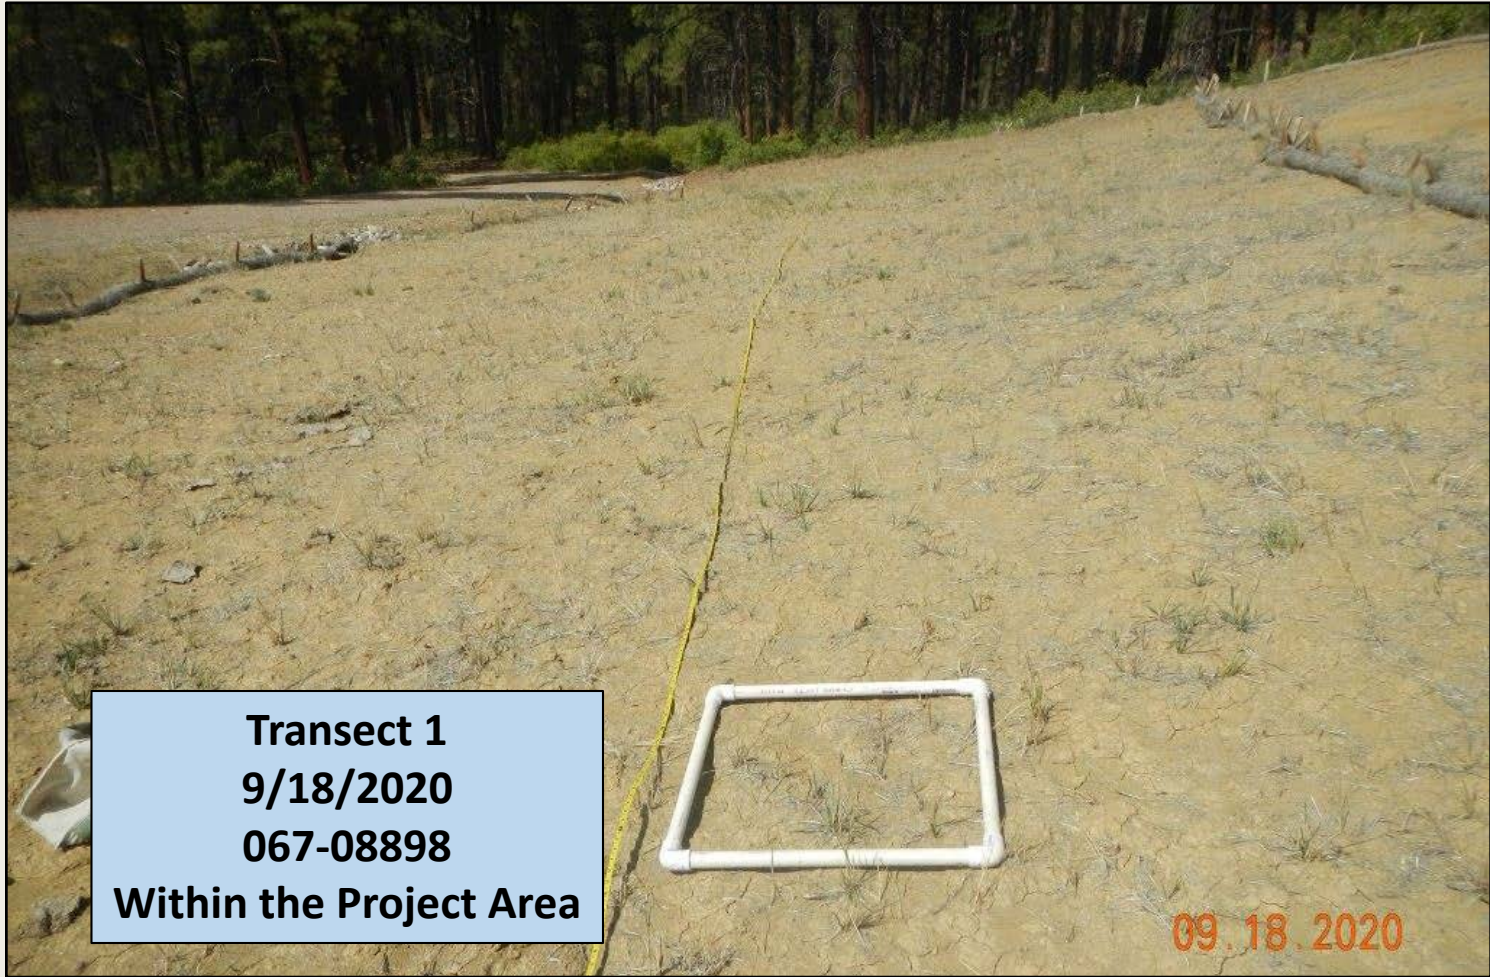
Photo 4. View of the beginning of “Germination Transect 1”, facing westward.

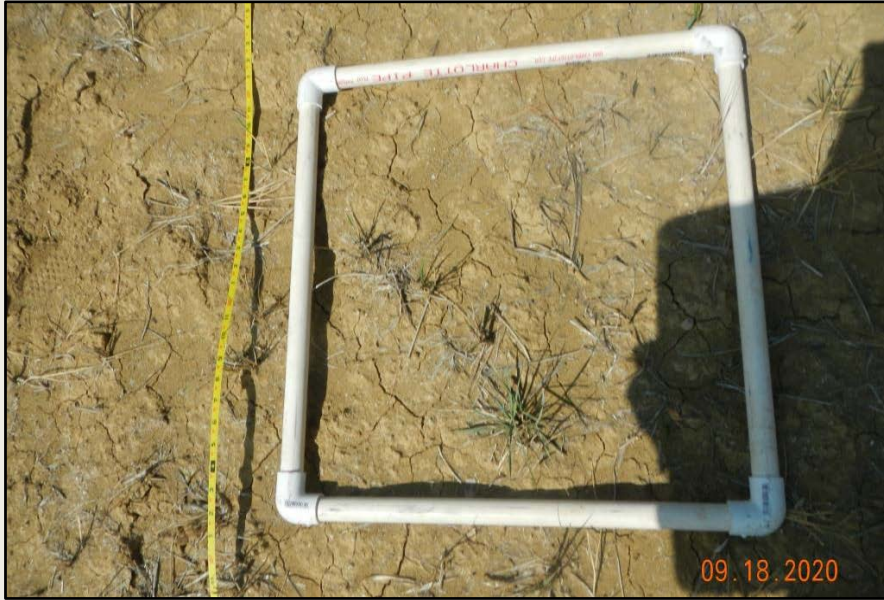
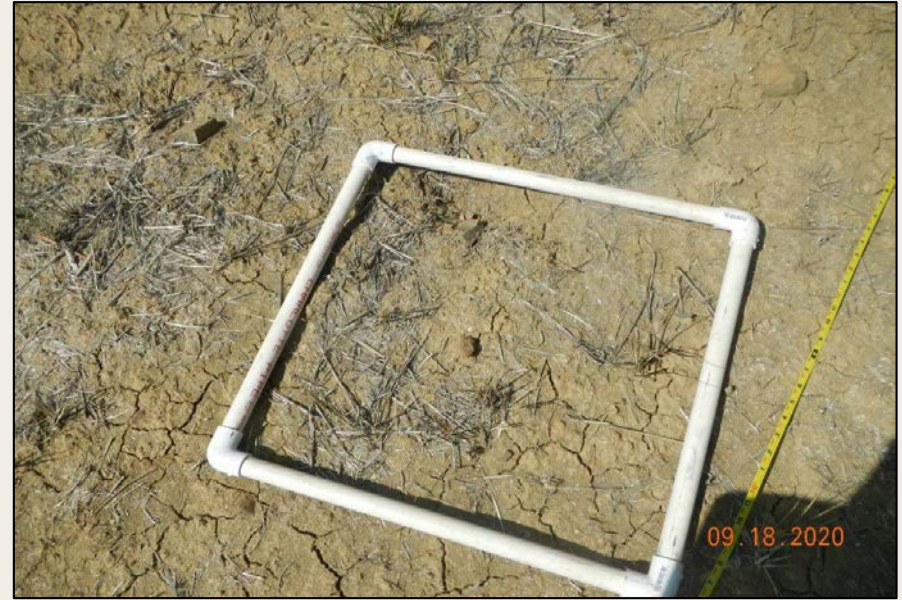
Photos 5/6. Birdseye view of typical germination quadrats along the transect. Young grasses such as western wheatgrass are becoming established here.
