**Inspection Photos**  
**Operator: BP America**  
**API: 067-08897**  
**Date: 9/18/2020**

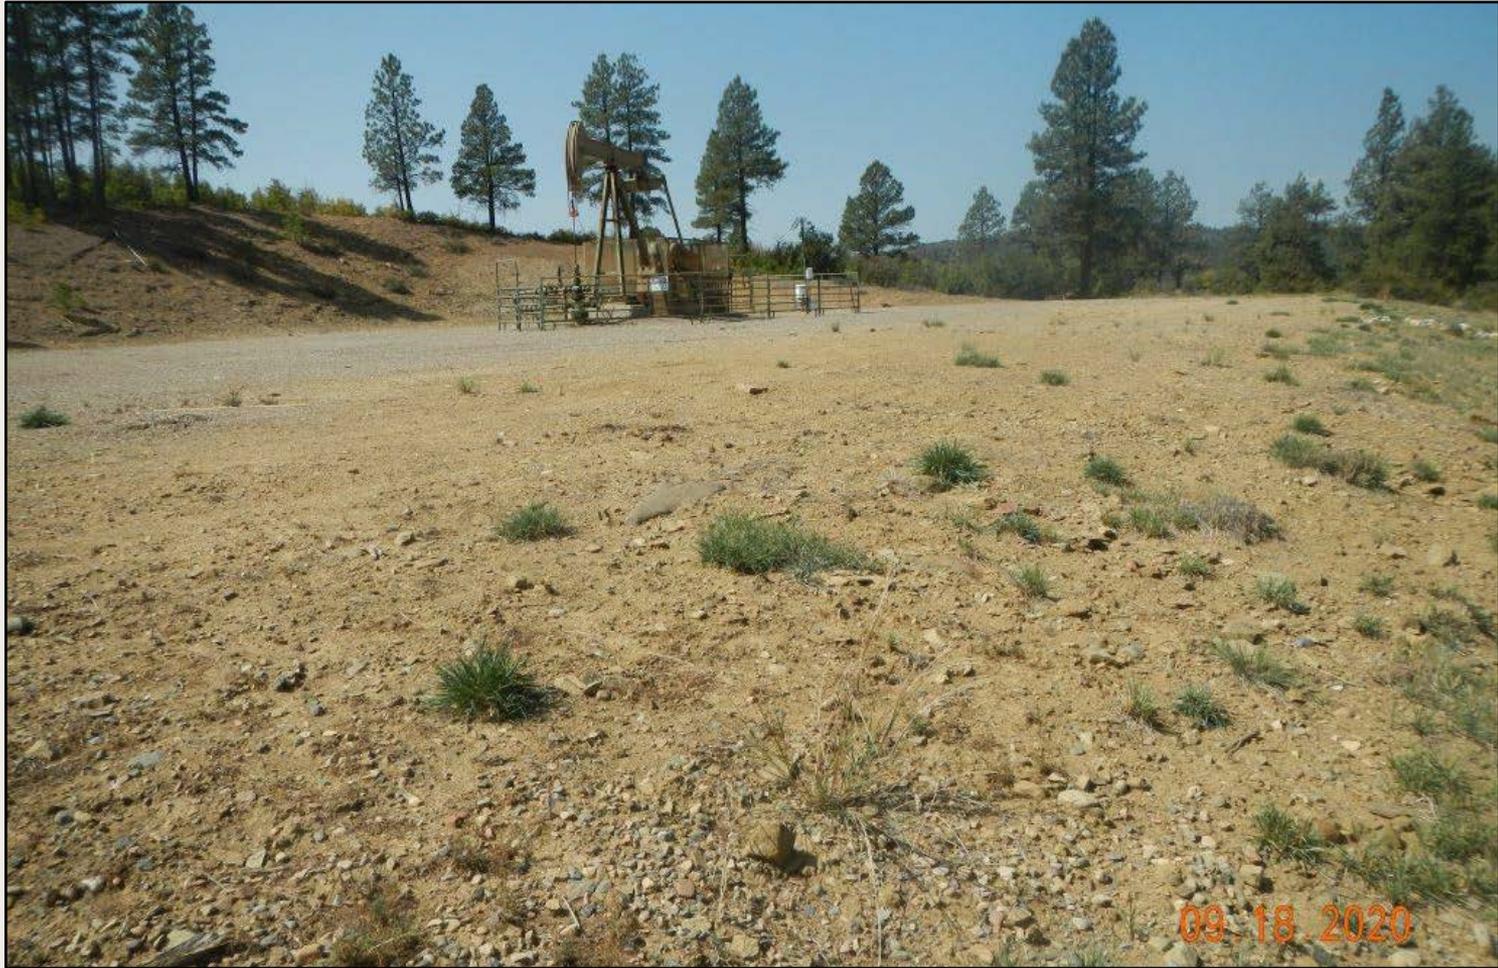
Photo 1. View of the project area from the northeastern corner facing center.

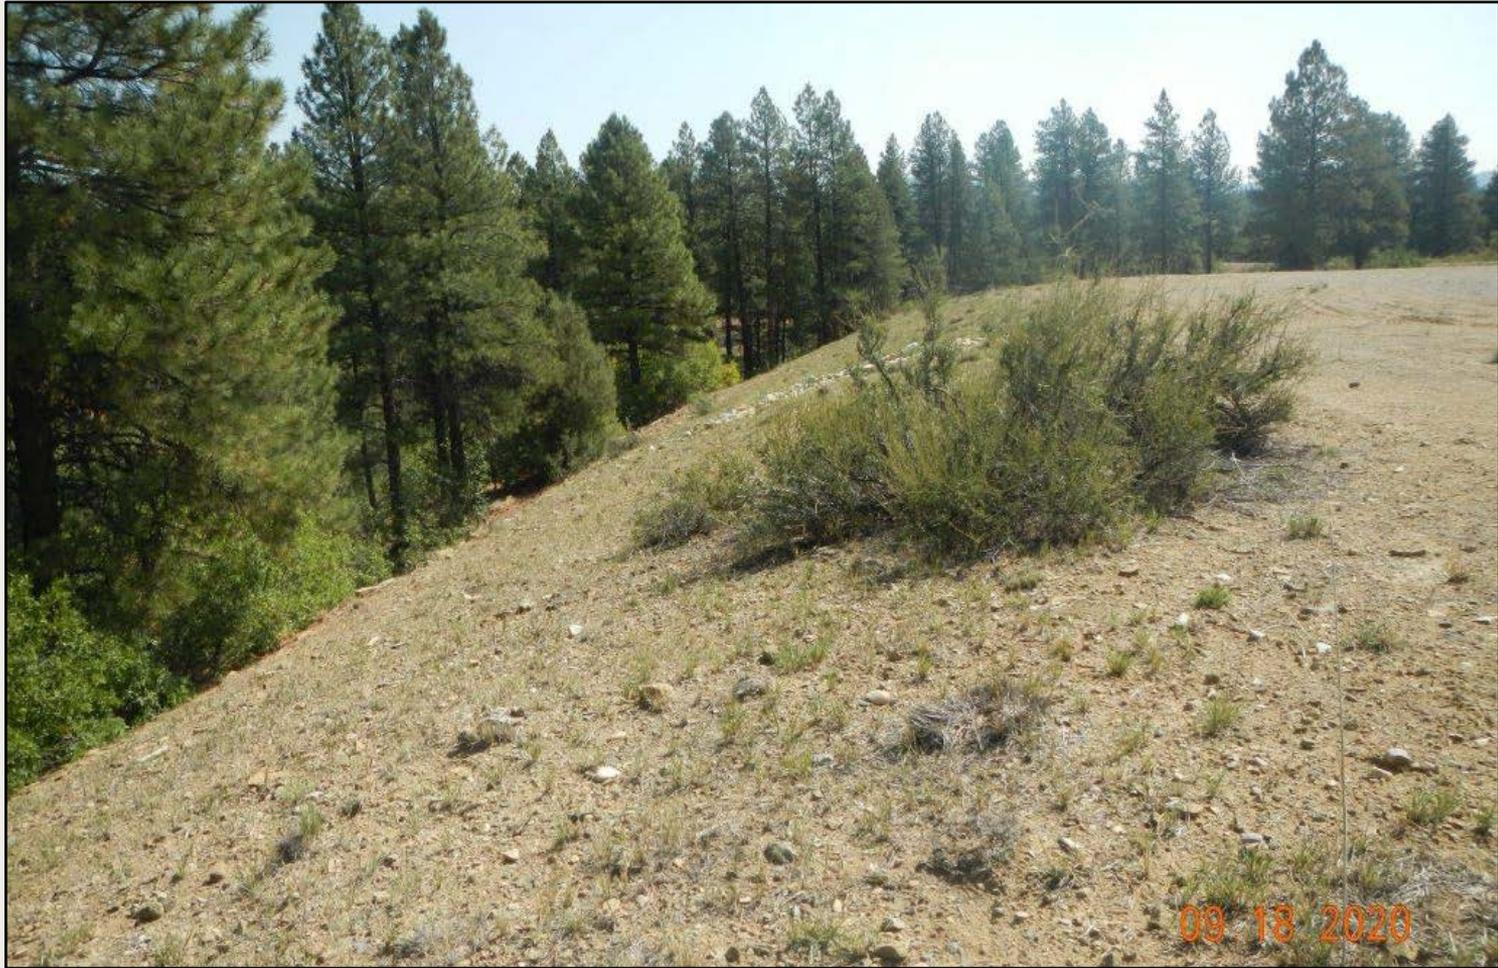
Photo 2. View of the northern project area from the northwestern corner facing eastward. Revegetation is progressing with grasses such as western wheatgrass and smooth brome.

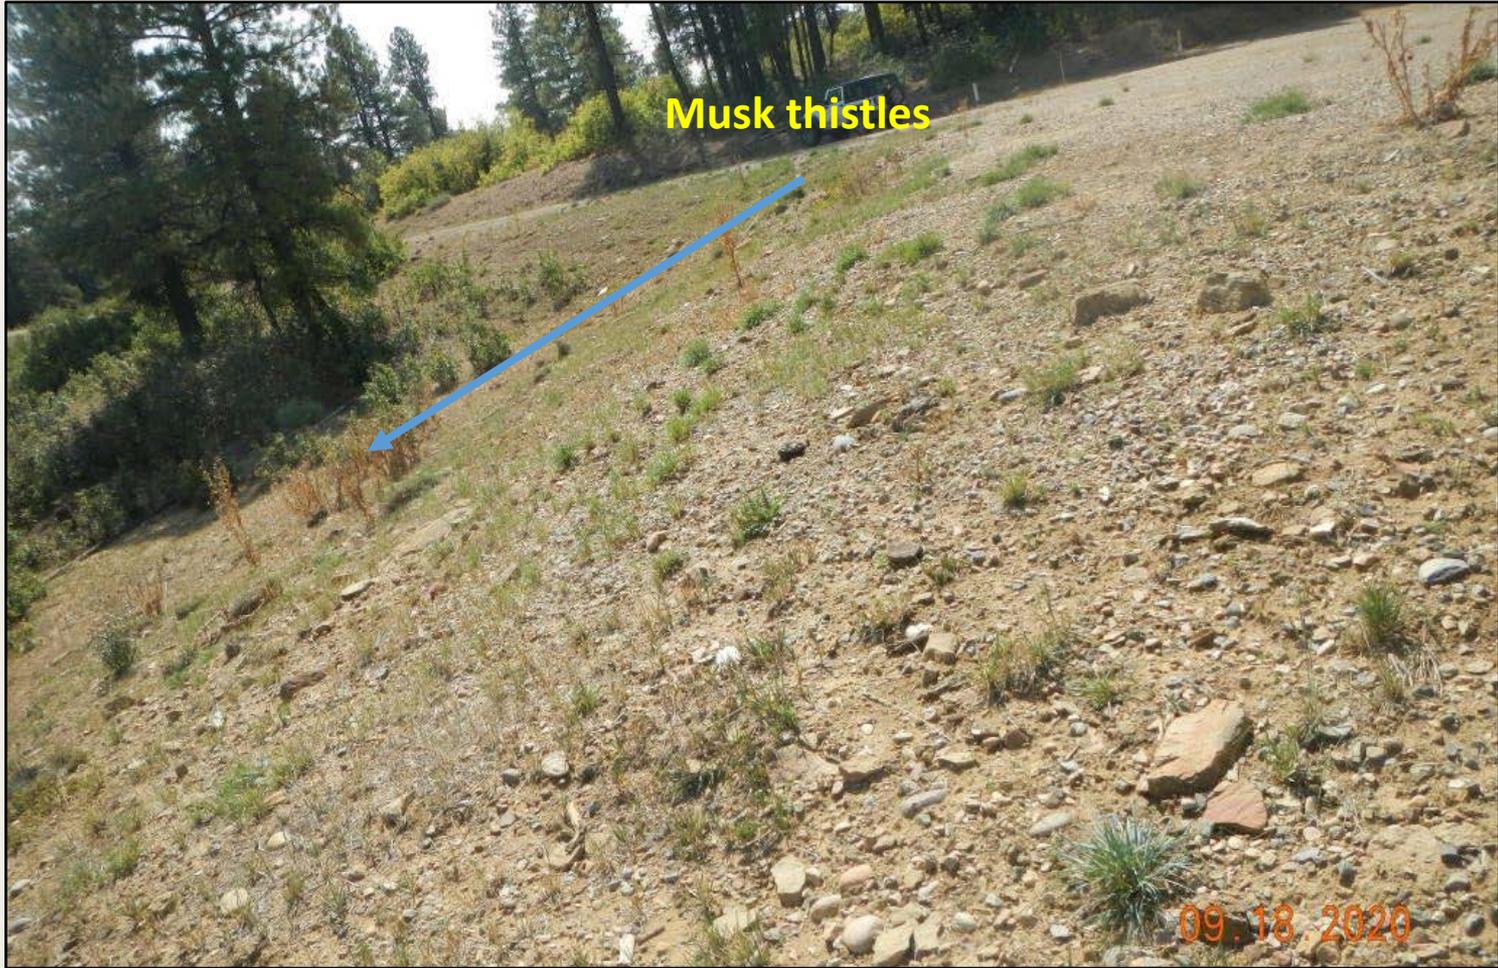
Photo 3. View of the eastern project area from the northeastern corner facing southward. Musk thistles appear herbicide-treated. Monitoring and treatment needs to continue as seedheads appear to support viable seed material.

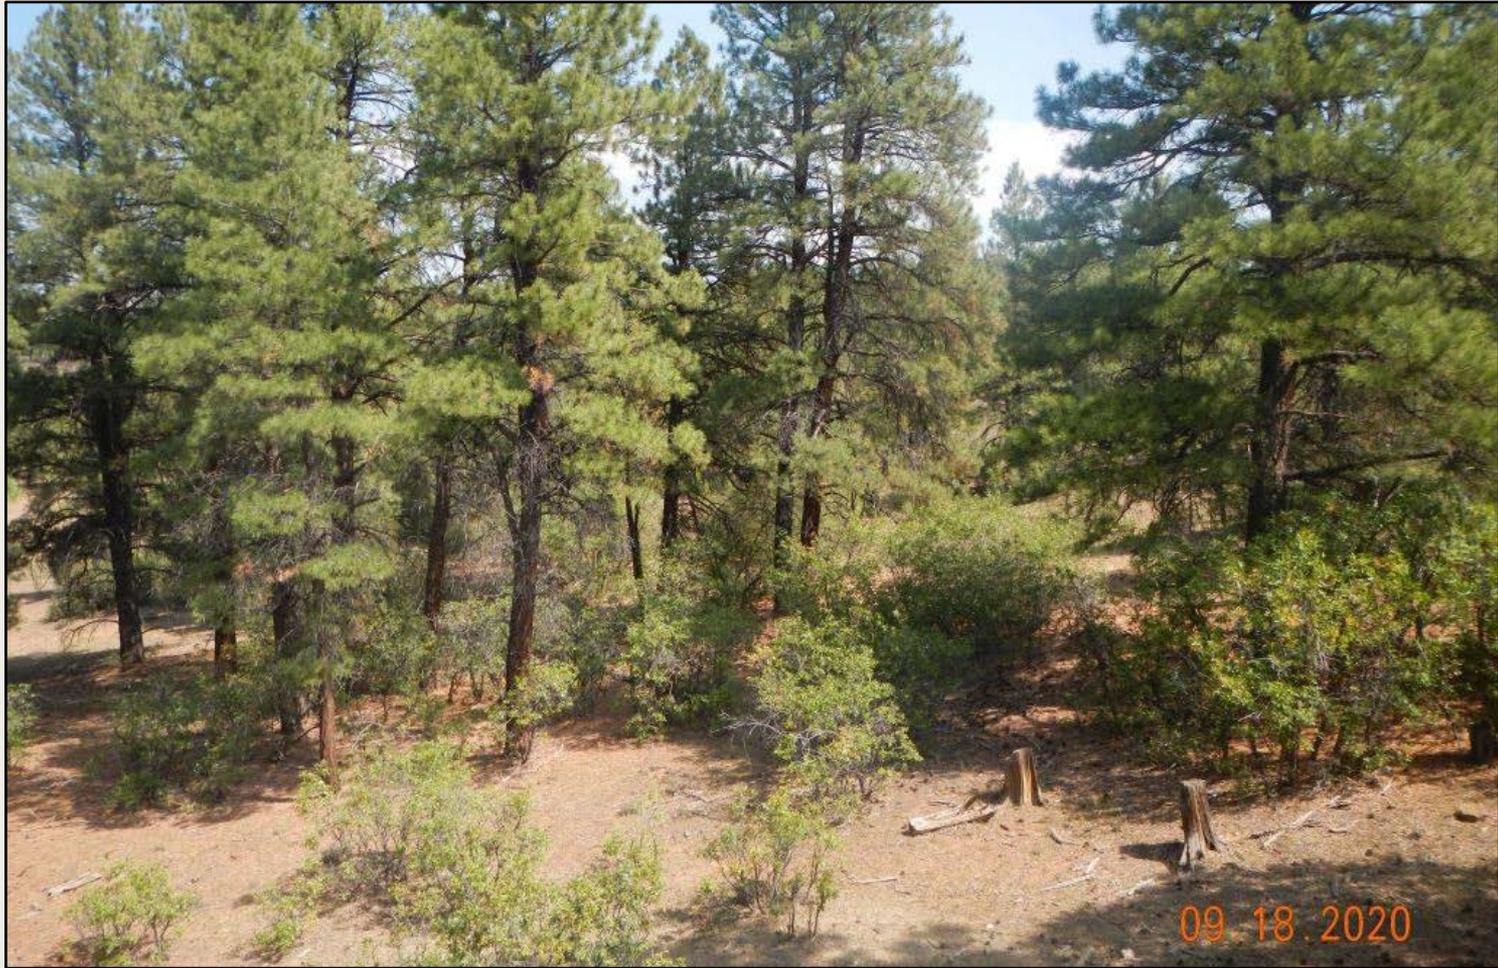
Photo 4. View of reference area vegetation comprised of ponderosa pine woodland with understory of gambel oak, western wheatgrass, and antelope bitterbrush.

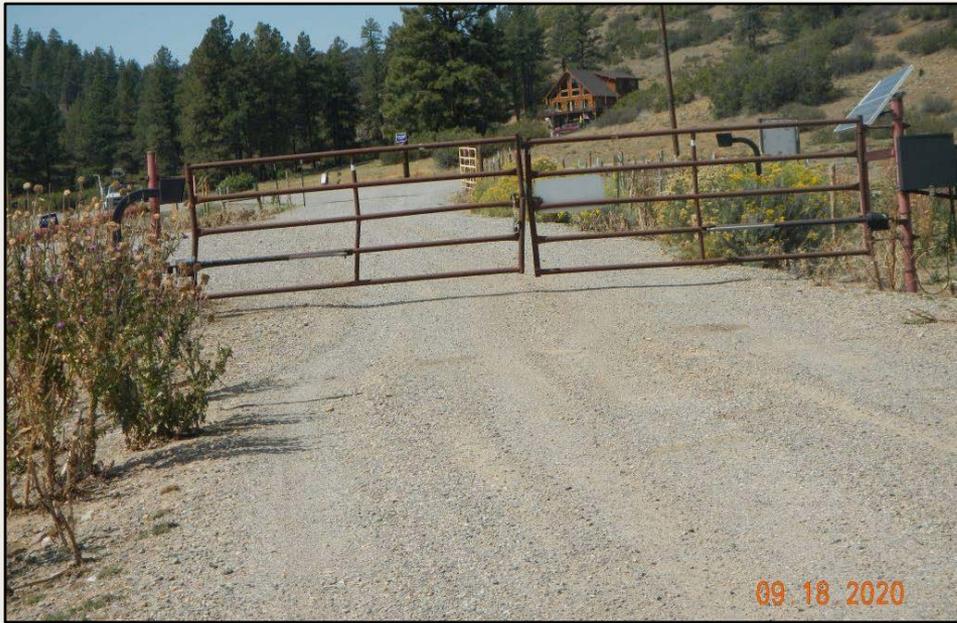
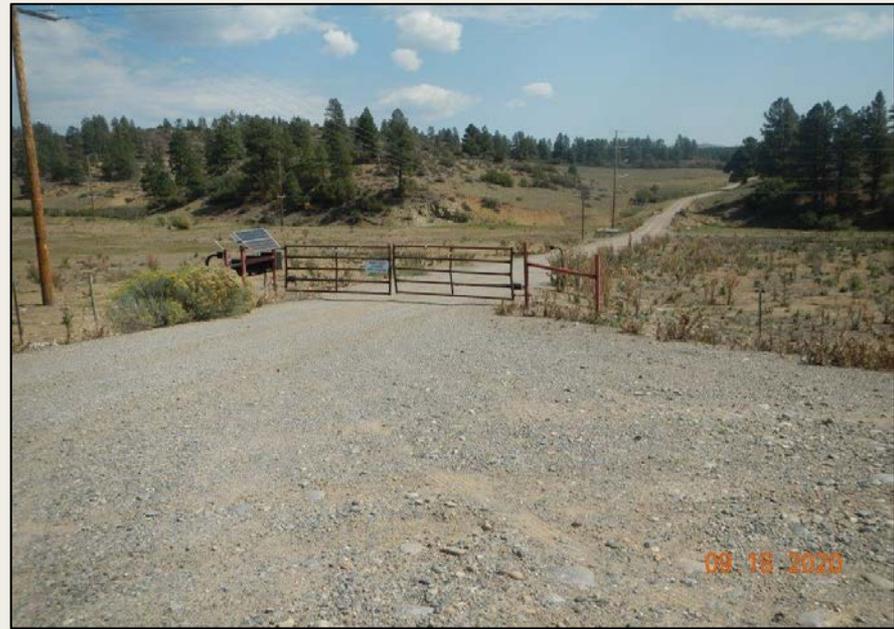
Photos 5/6. Locked gate coming in (left) and leaving (right).
