Inspection Photos
Operator: BP America
API: 067-08882
Date: 9/18/2020

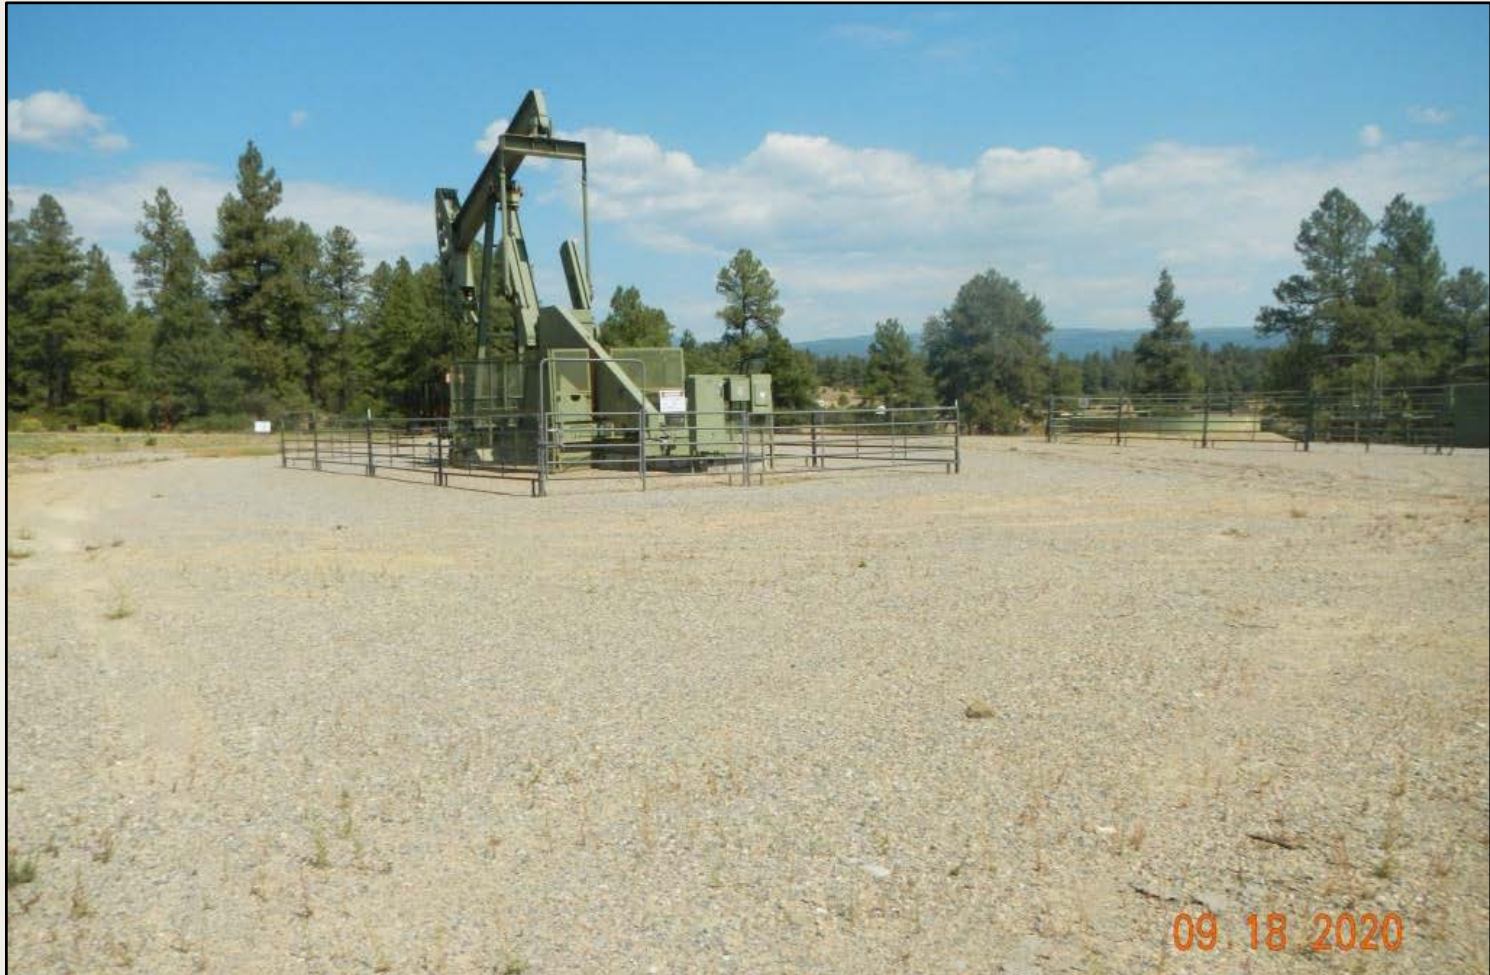
Photo 1. View of the project area from the southwestern corner facing center.

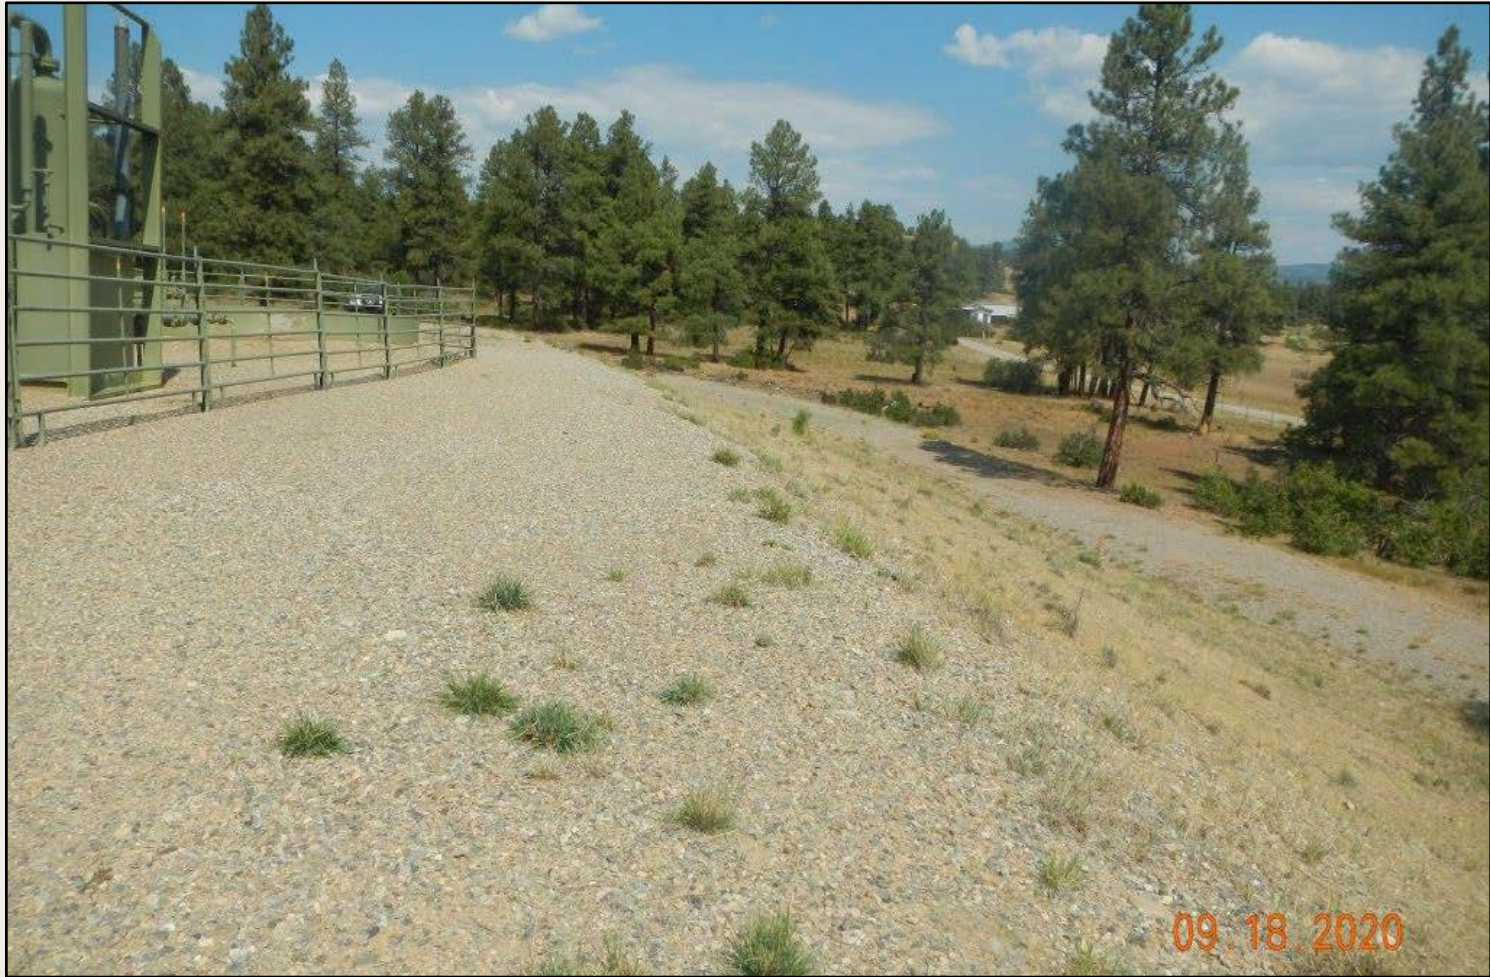
Photo 2. View of the eastern fill slope from the southeastern corner facing northward. Revegetation is progressing with grasses such as western wheatgrass and sand dropseed, largely in a grazed condition.

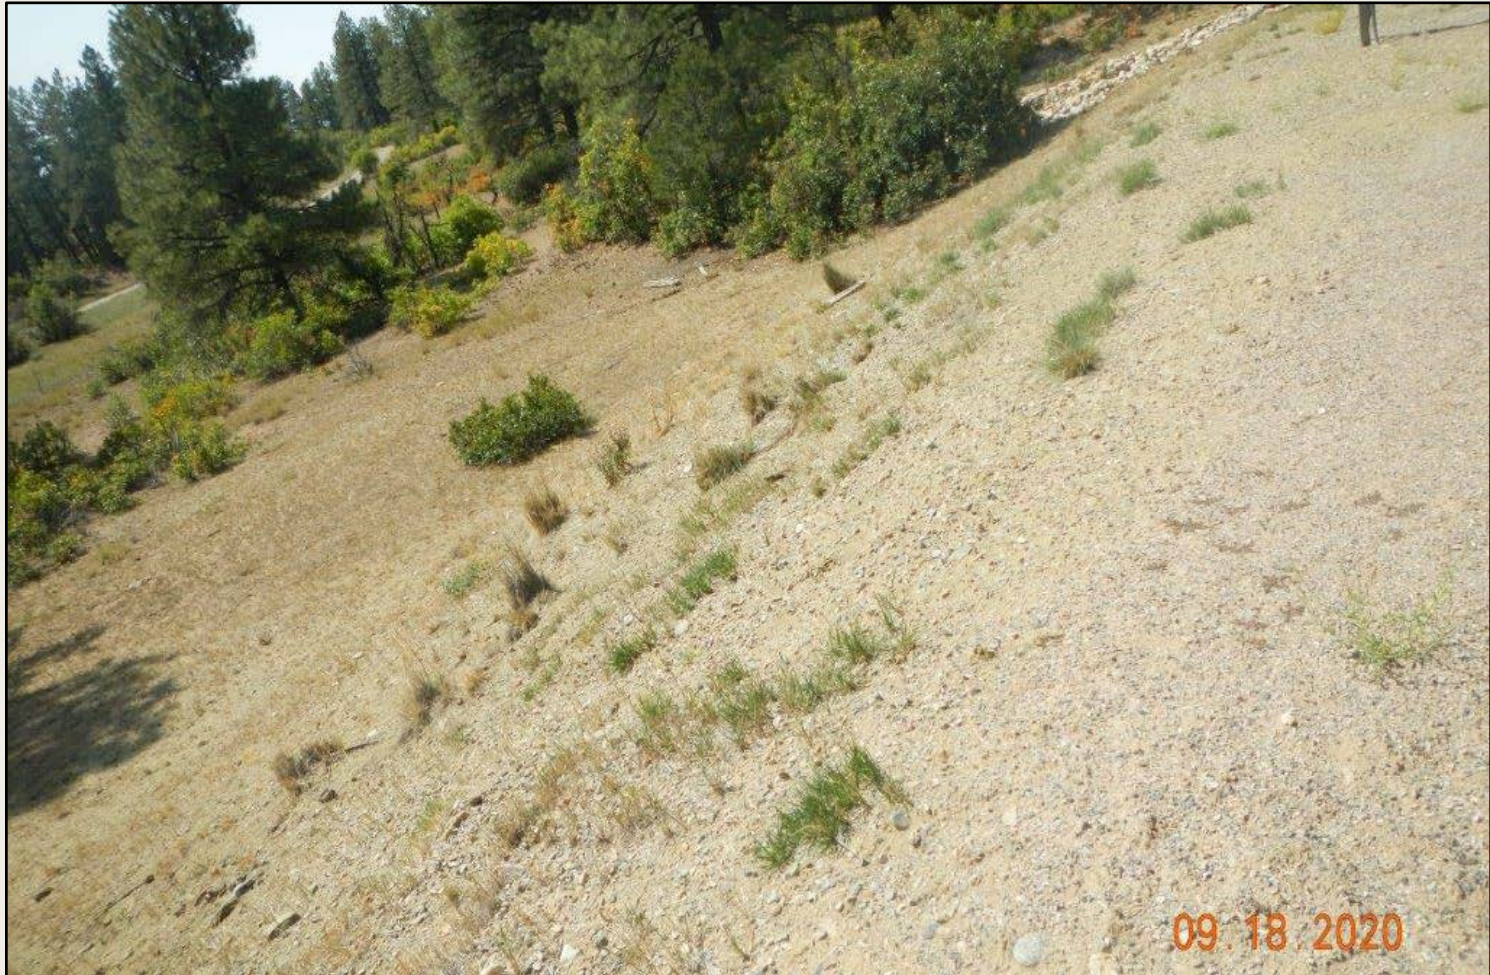
Photo 3. View of the southern fill slope from the southeastern corner facing eastward.
