Inspection Photos  
Operator: BP America  
API: 067-08881  
Date: 9/18/2020

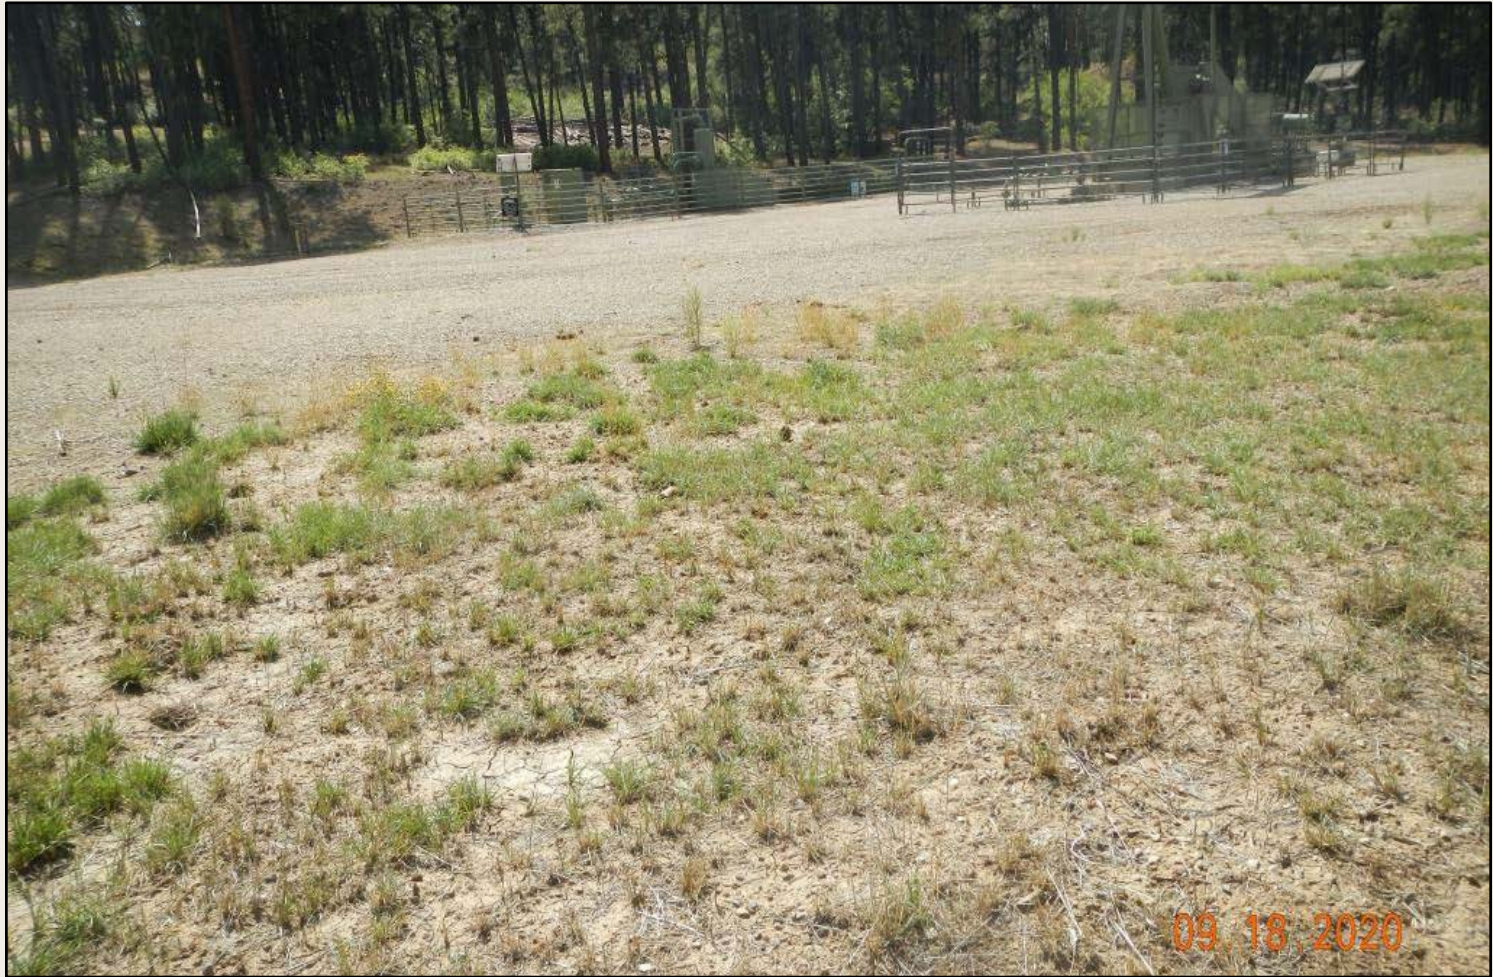
Photo 1. View of the project area from the northeastern corner facing center.

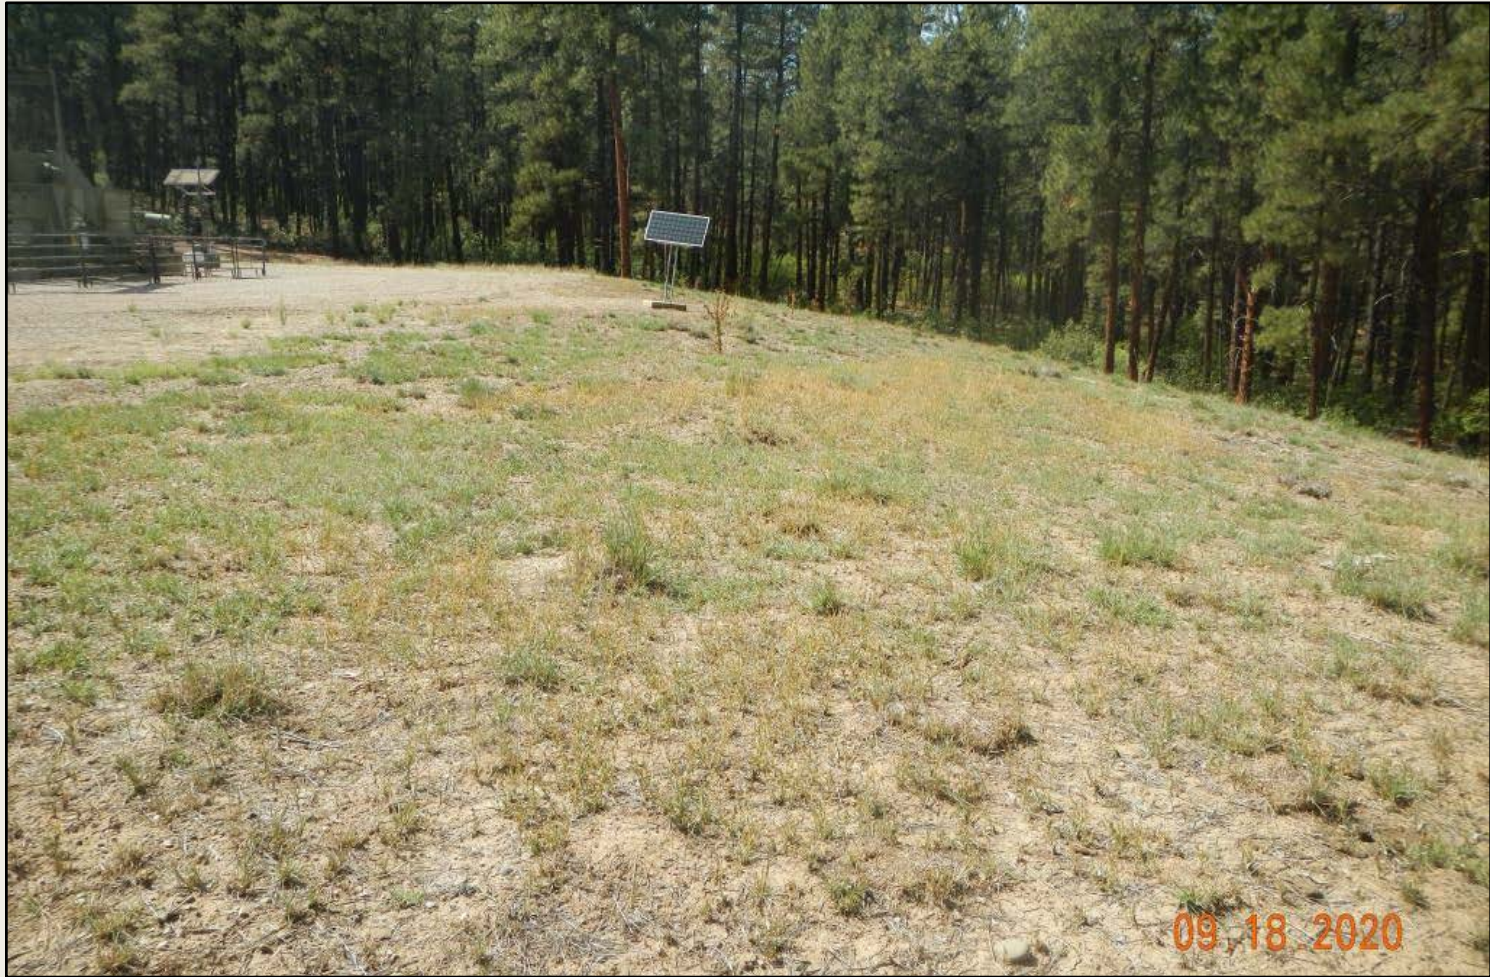
Photo 2. View of the northern fill slope from the northeastern corner facing westward. Revegetation is progressing with grasses such as western wheatgrass and sand dropseed, largely in a grazed condition.

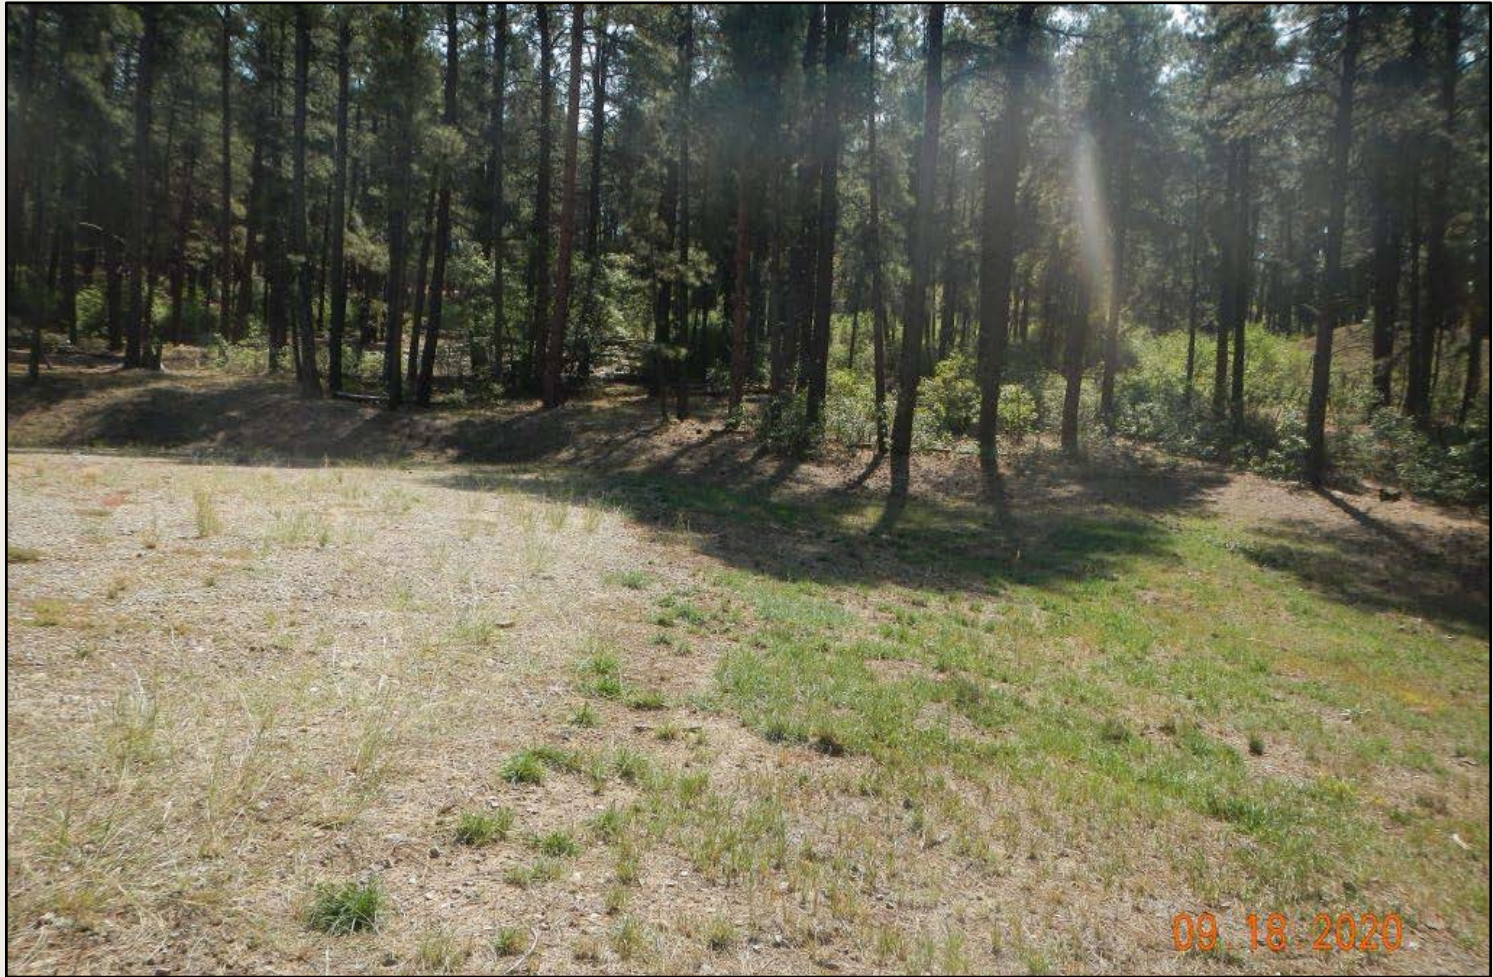
Photo 3. View of the western fill slope from the northwestern corner facing southward.

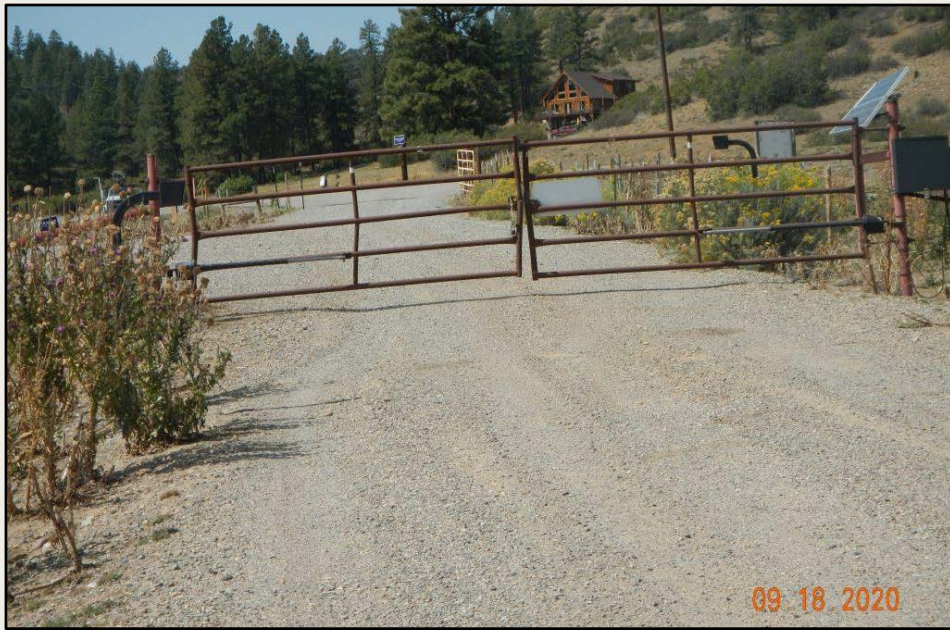
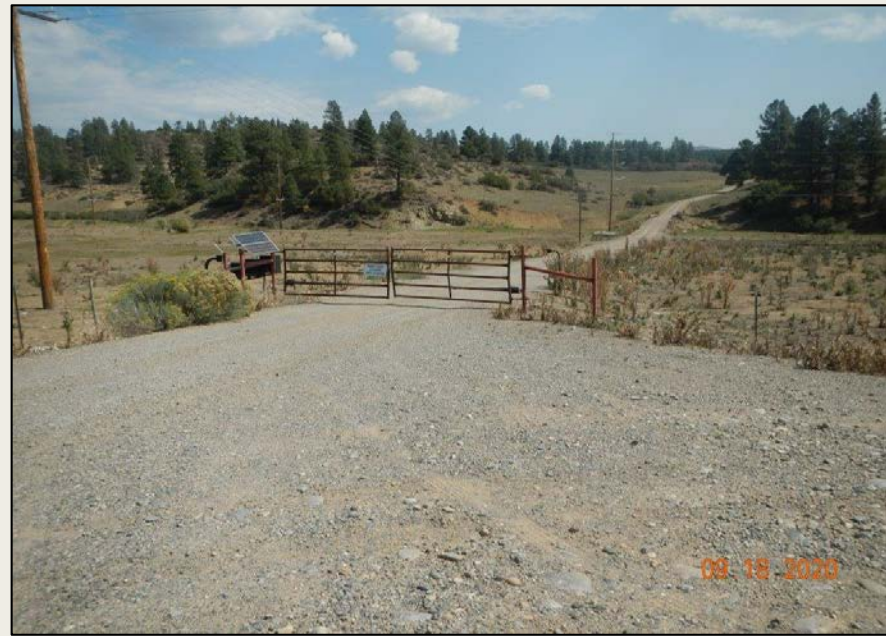
Photos 5/6. Locked gate coming in (left) and leaving (right).
