**Inspection Photos**  
**Operator: BP America**  
**API: 067-06948**  
**Date: 9/18/2020**

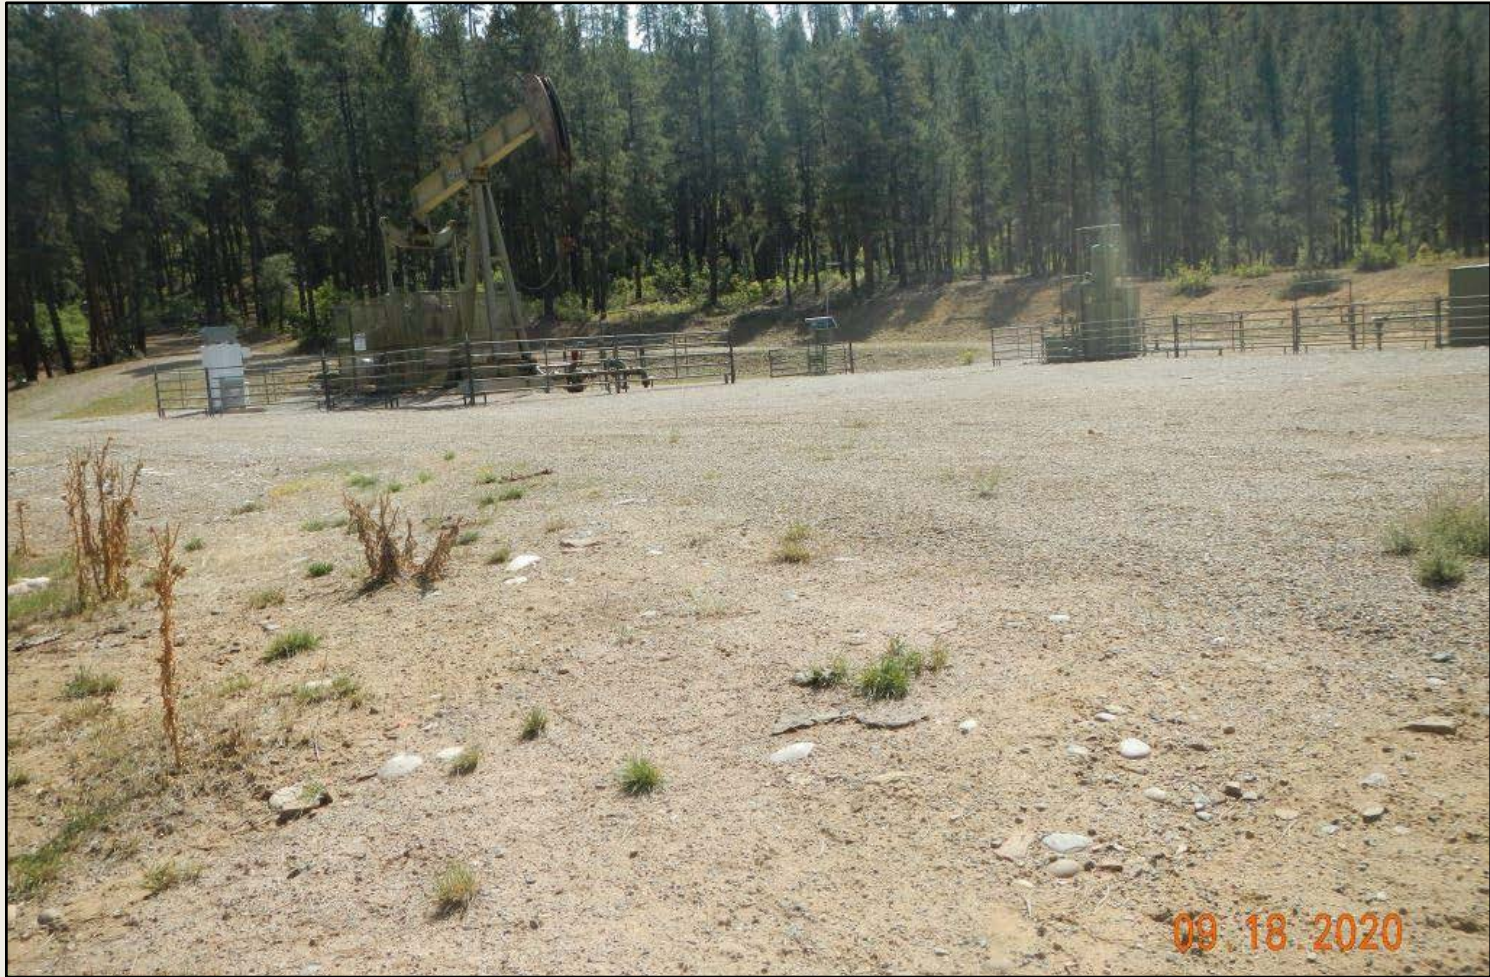
Photo 1. View of the project area from the northwestern corner facing center.

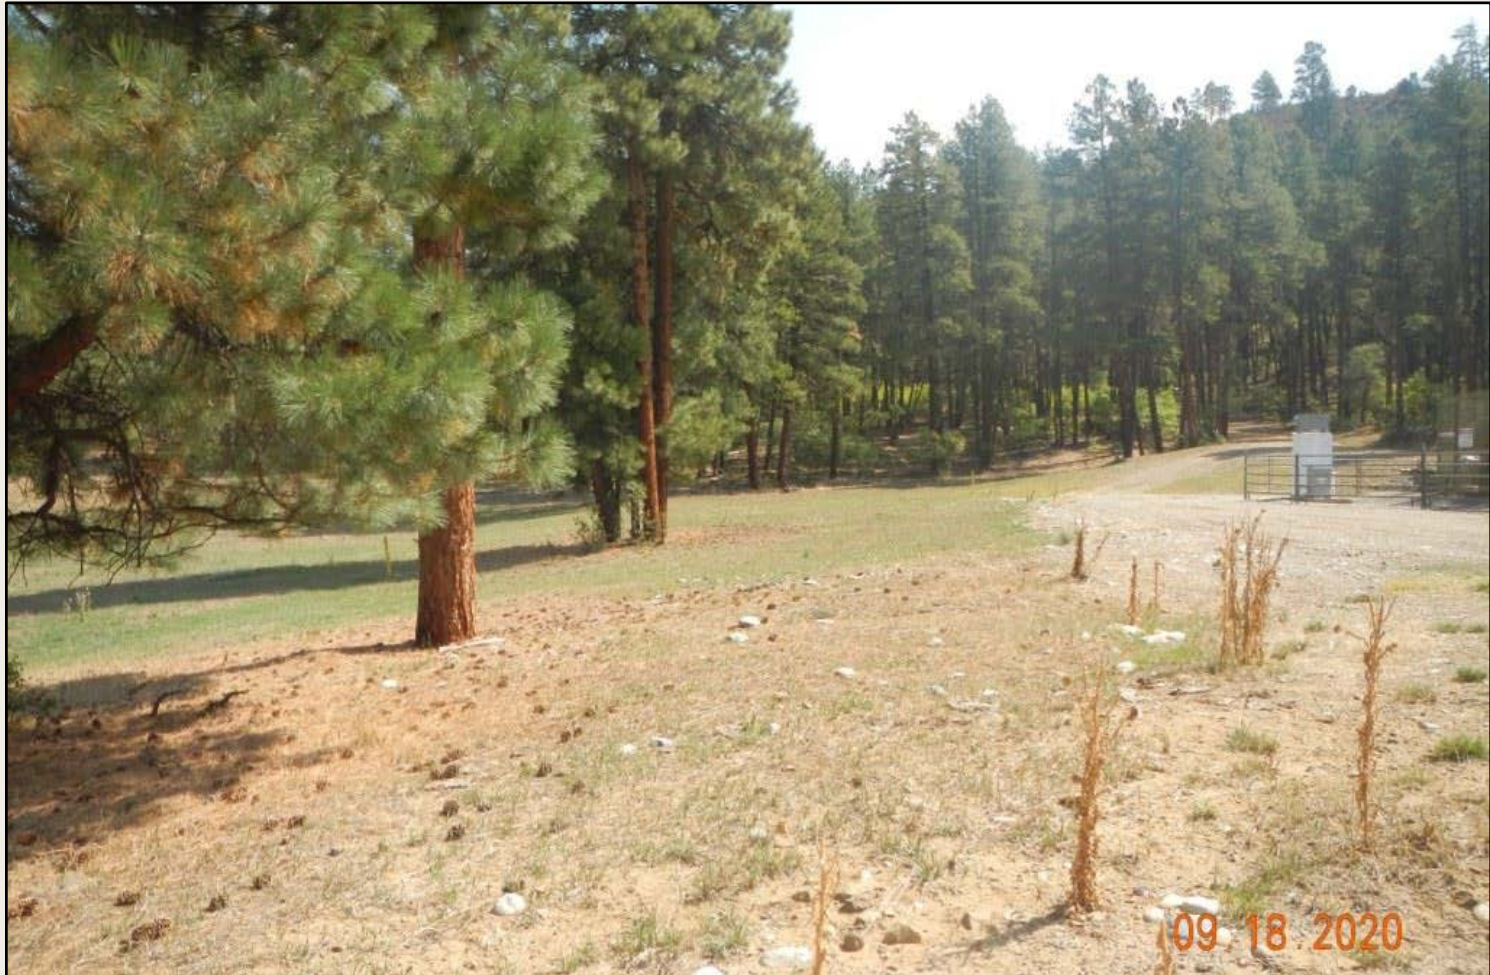
Photo 2. View of the northern fill slope from the northwestern corner facing eastward. Revegetation is progressing with grasses such as western wheatgrass and sand dropseed, largely in a grazed condition. Musk thistles appear to be herbicide treated in a post-flowering condition.

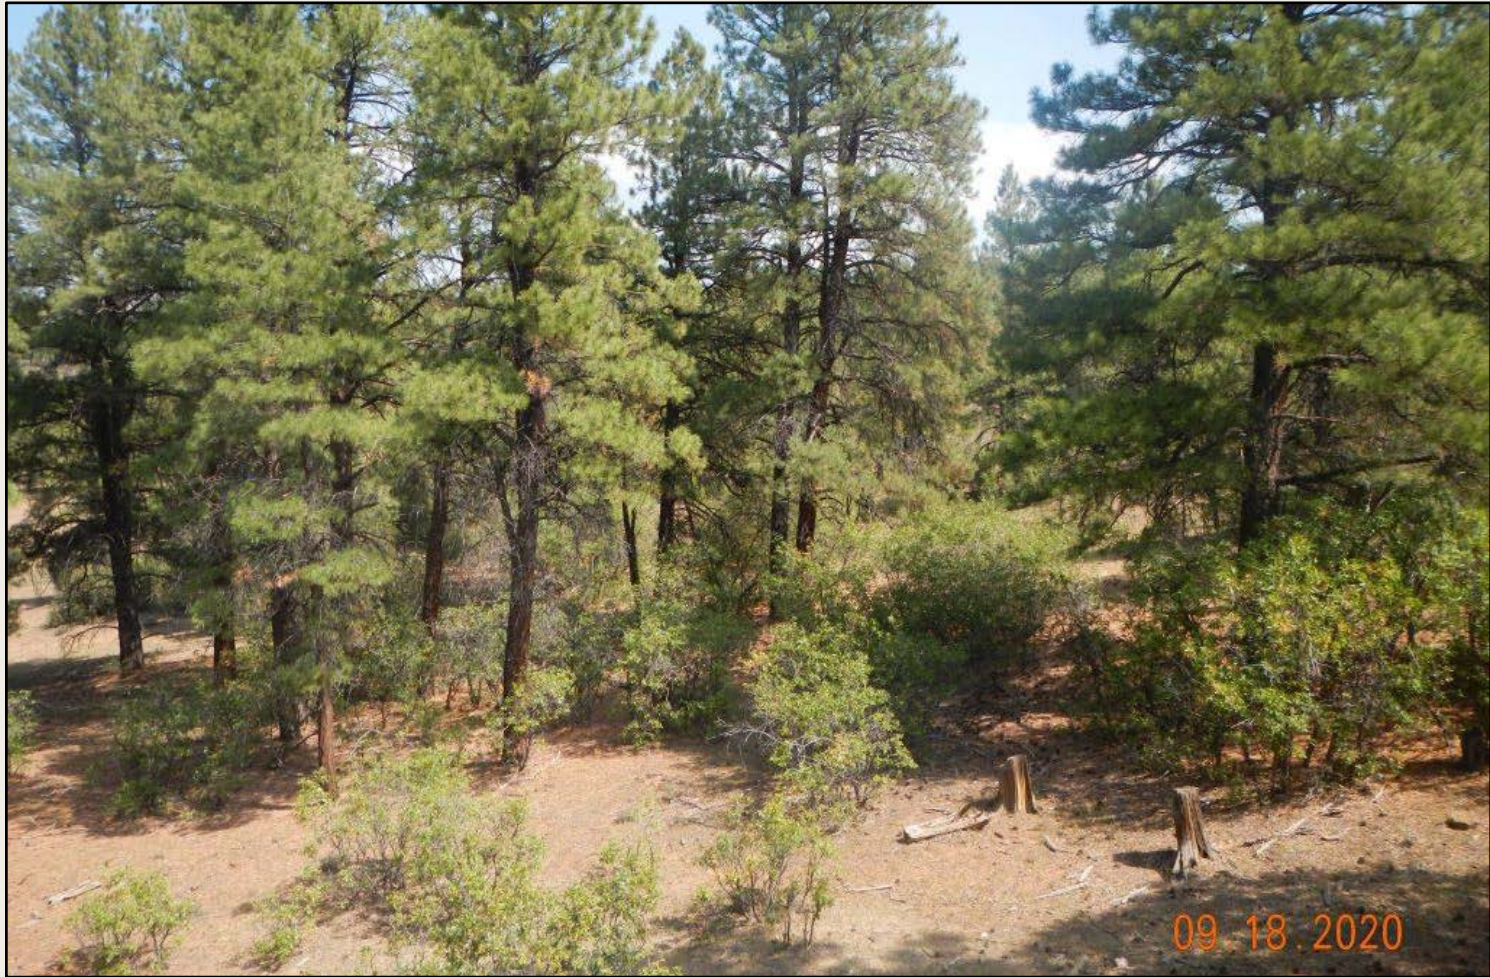
Photo 3. View of reference area vegetation comprised of ponderosa pine woodland with understory of gambel oak, western wheatgrass, squirreltail, and antelope bitterbrush.

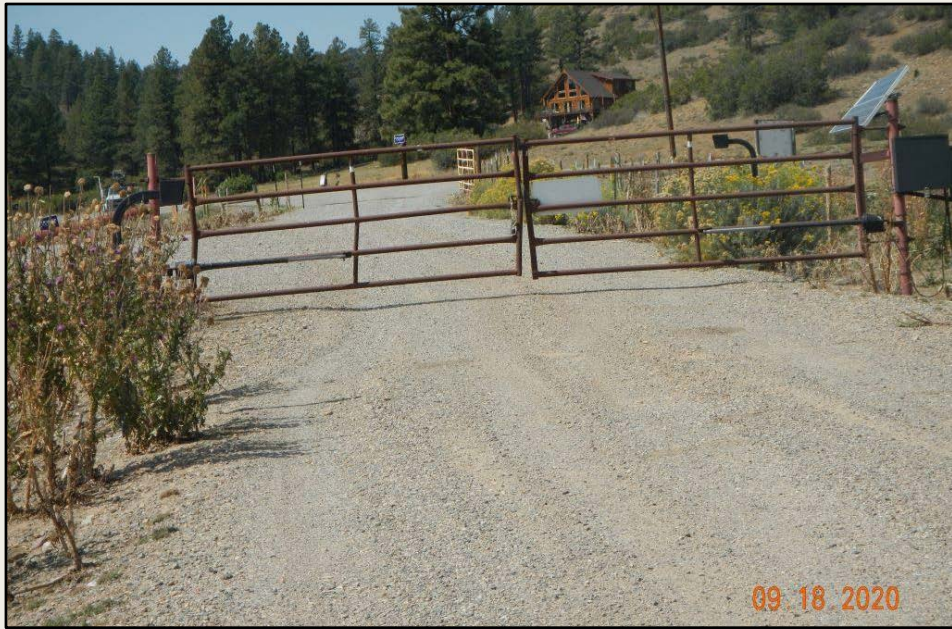
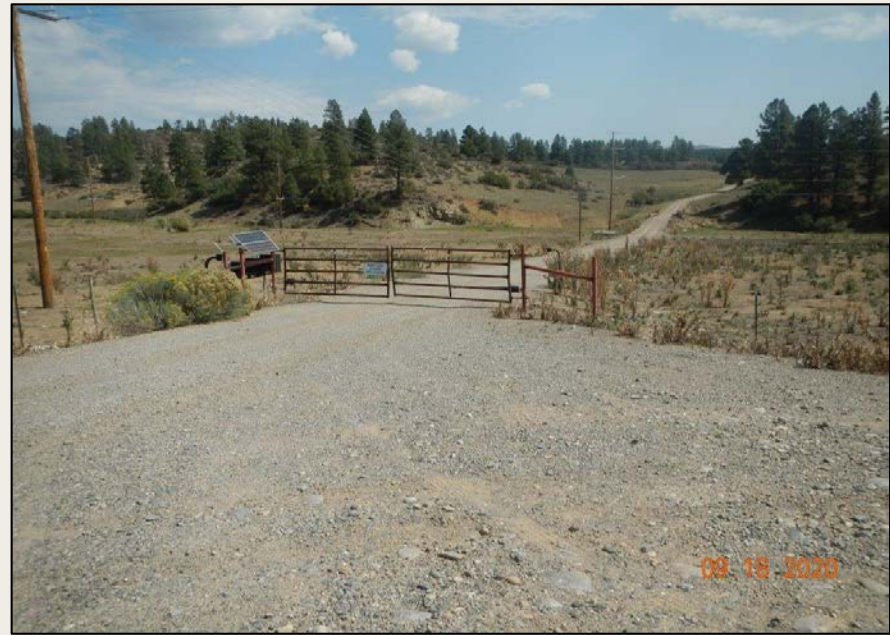
Photos 4/5. Locked gate coming in (left) and leaving (right).
