Inspection Photos
Operator: BP America
API: 067-06778
Date: 9/18/2020

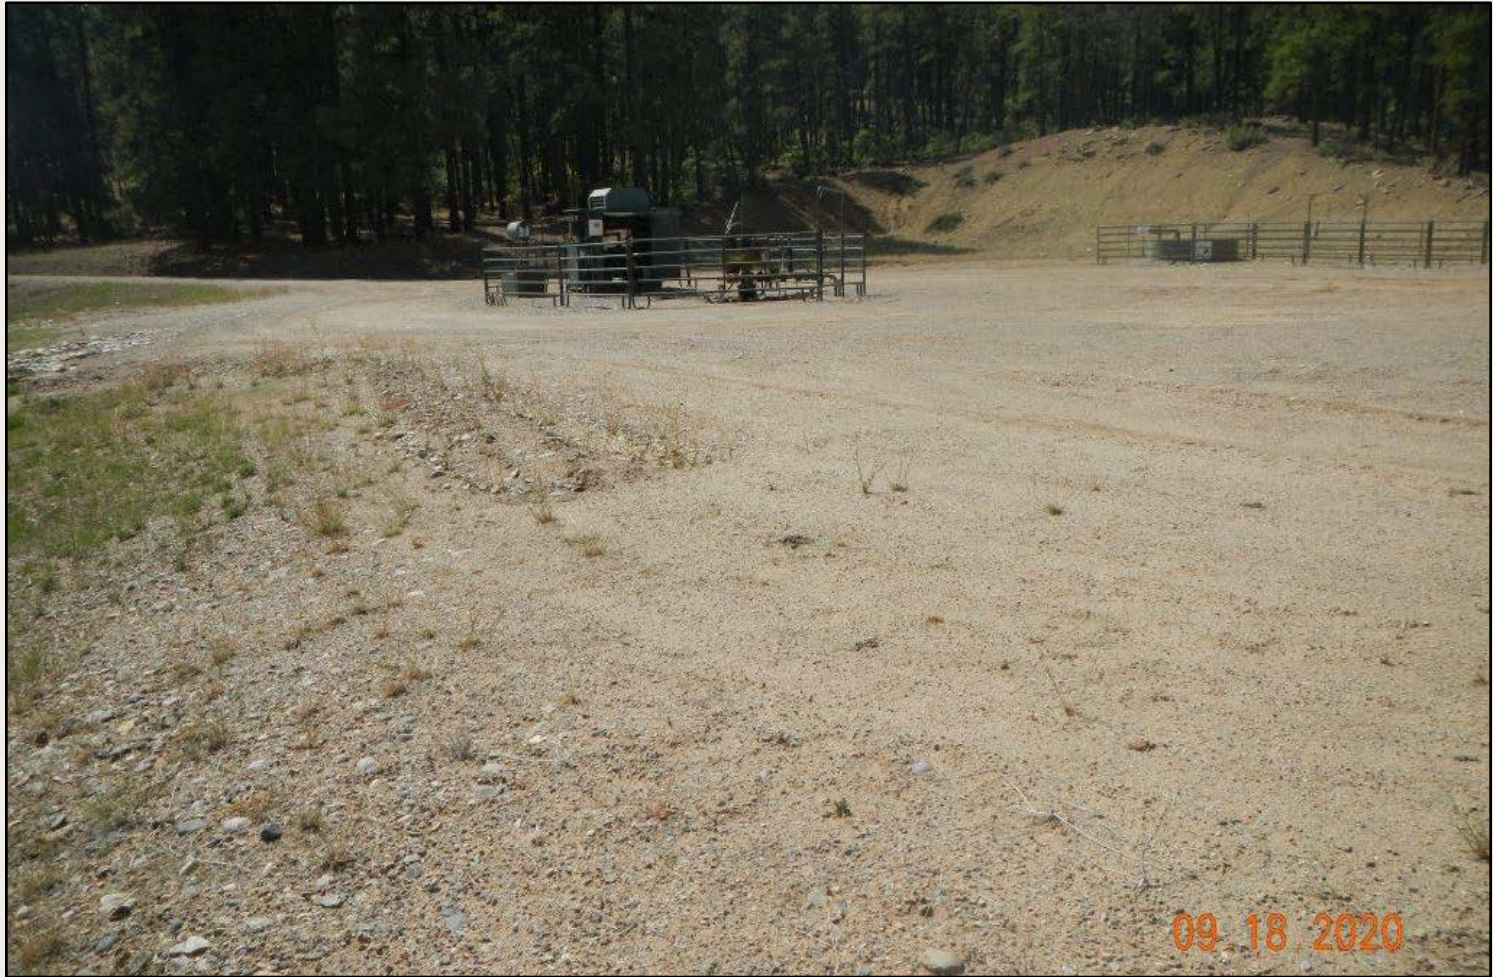
Photo 1. View of the project area from the northeastern corner facing center.

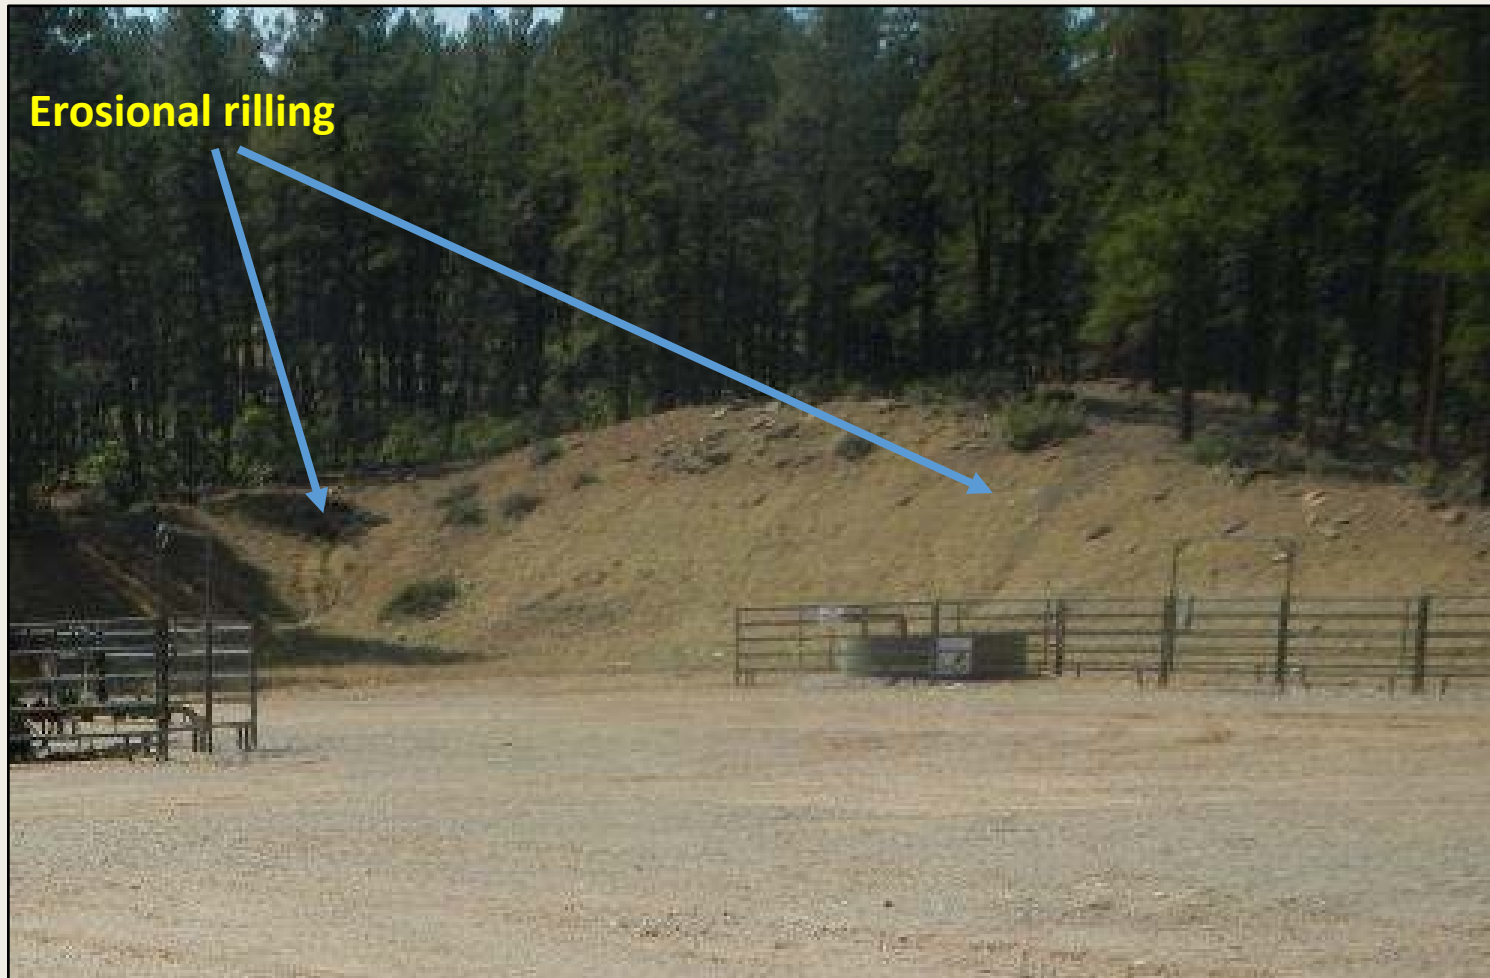
Photo 2. View of bare soils on the southwestern cut-slope where stabilization is needed.

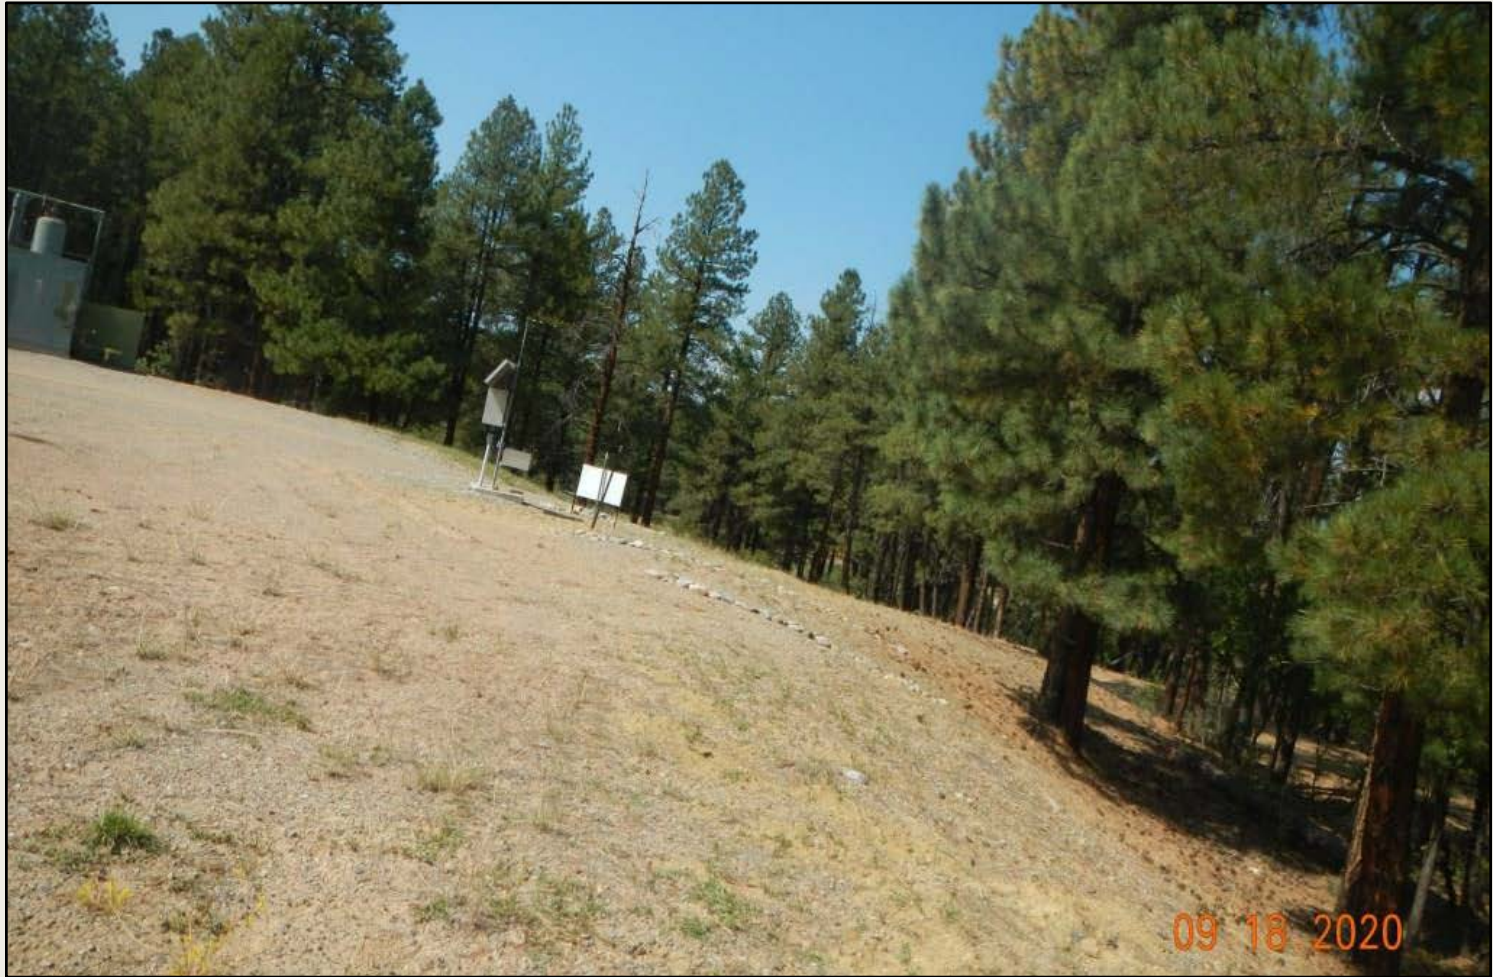
Photo 3. View of the northern fill slope from the northeastern corner facing westward. Revegetation is progressing with grasses such as western wheatgrass, largely in a grazed condition.

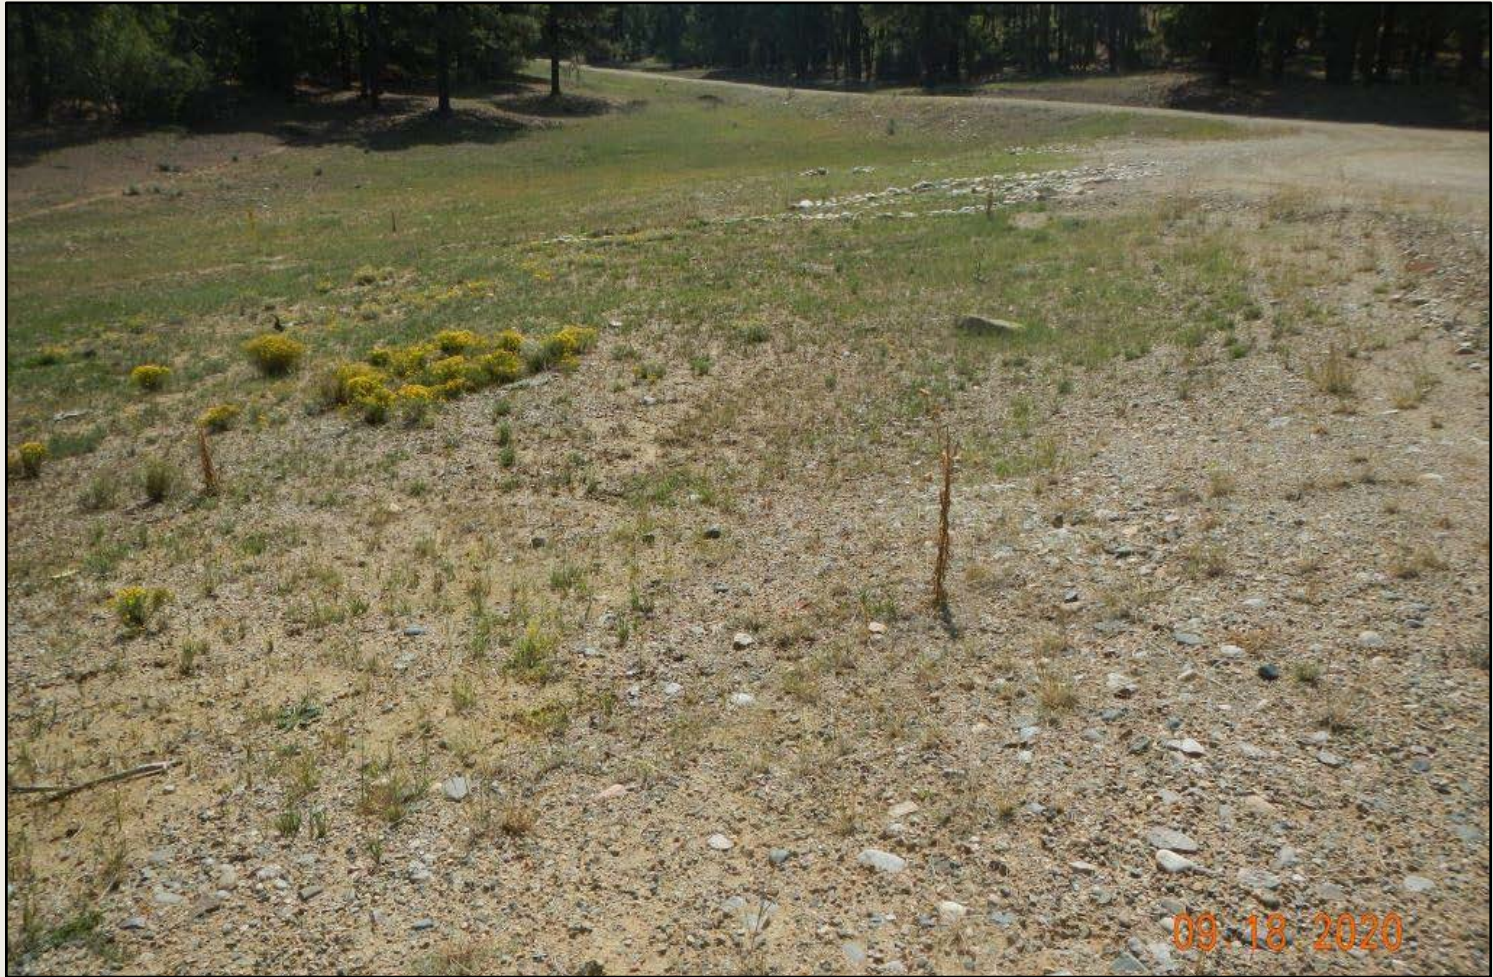
Photo 4. View of the eastern fill slope facing southward. Shallow berm and cobble BMPs are placed and appear to be functioning at this time.

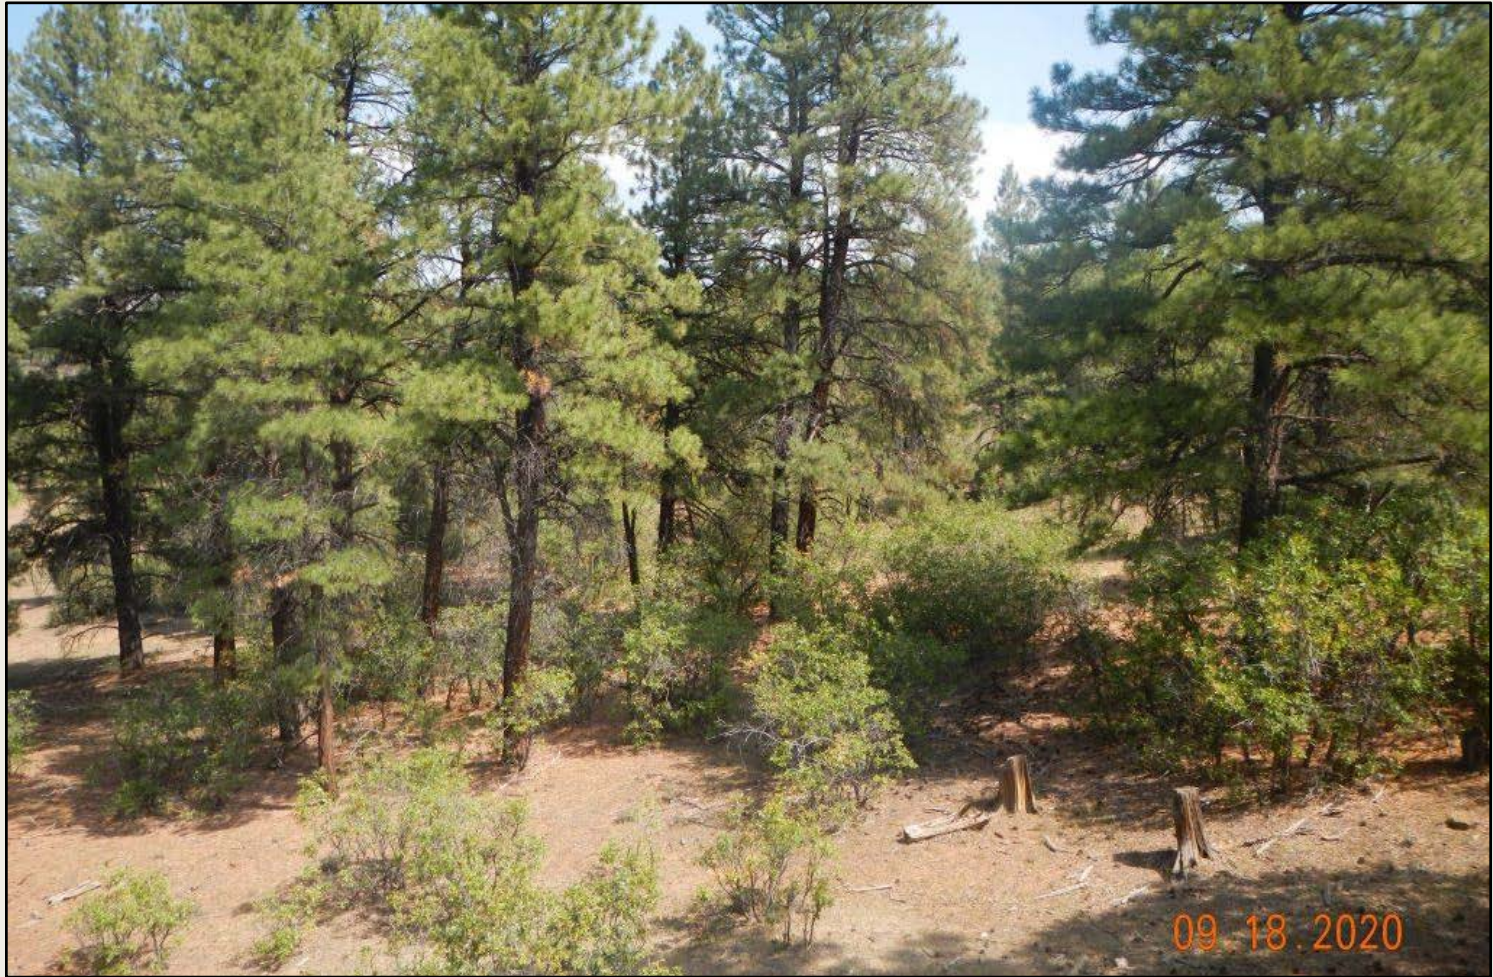
Photo 5. View of reference area vegetation comprised of ponderosa pine woodland with understory of gambel oak, western wheatgrass, squirreltail, and antelope bitterbrush.

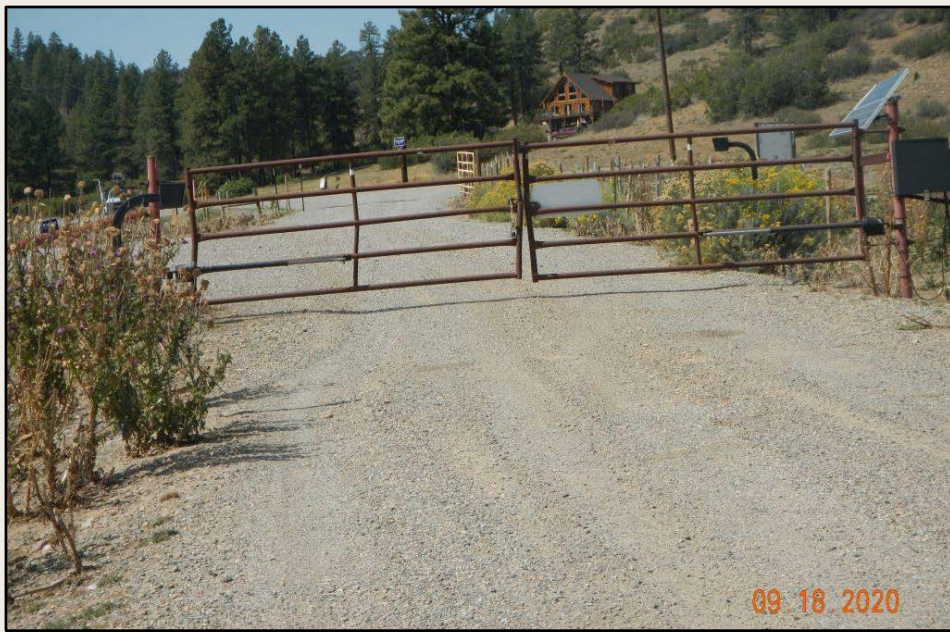
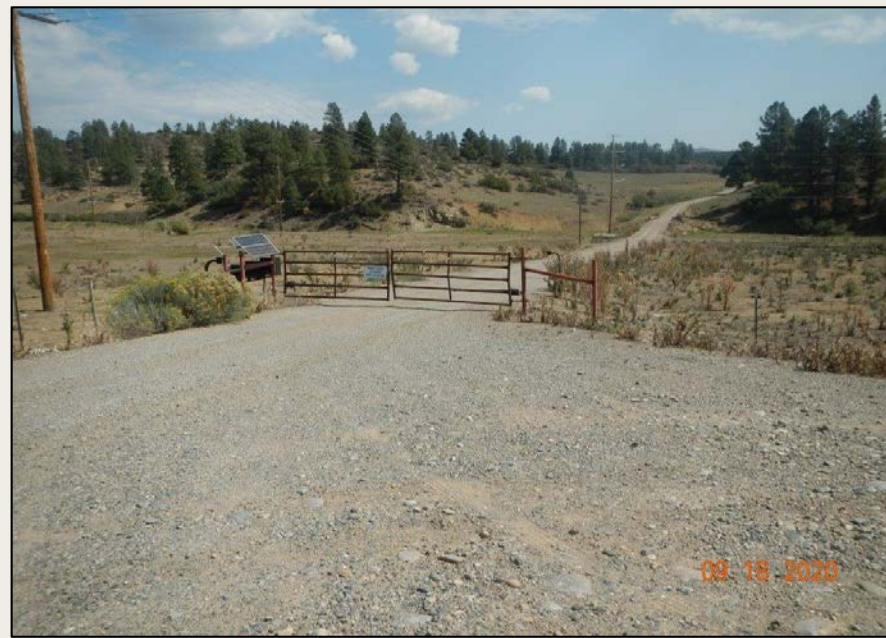
Photos 6/7. Locked gate coming in (left) and leaving (right).
