Well Name : Coggins 1 -10

API # : 039-06383

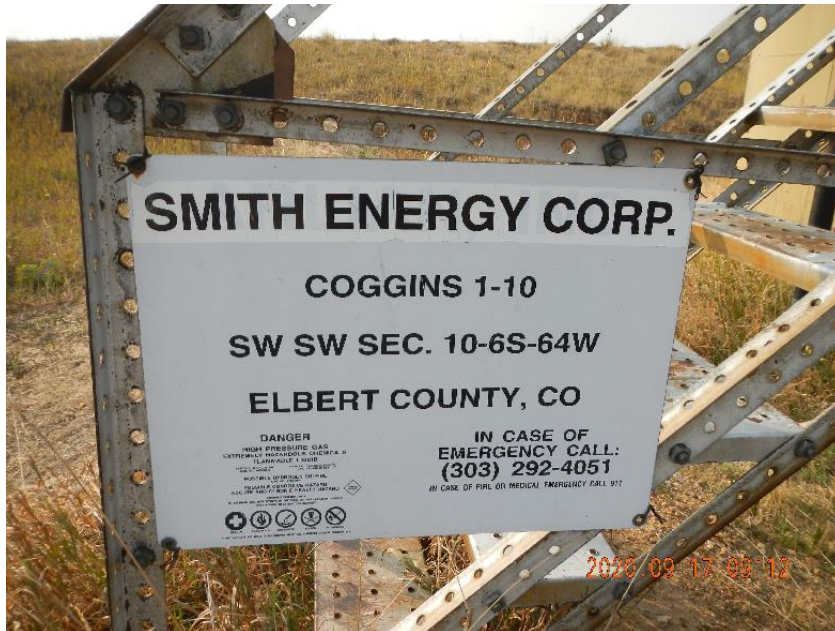
Photo 1: Location sign at tank battery.

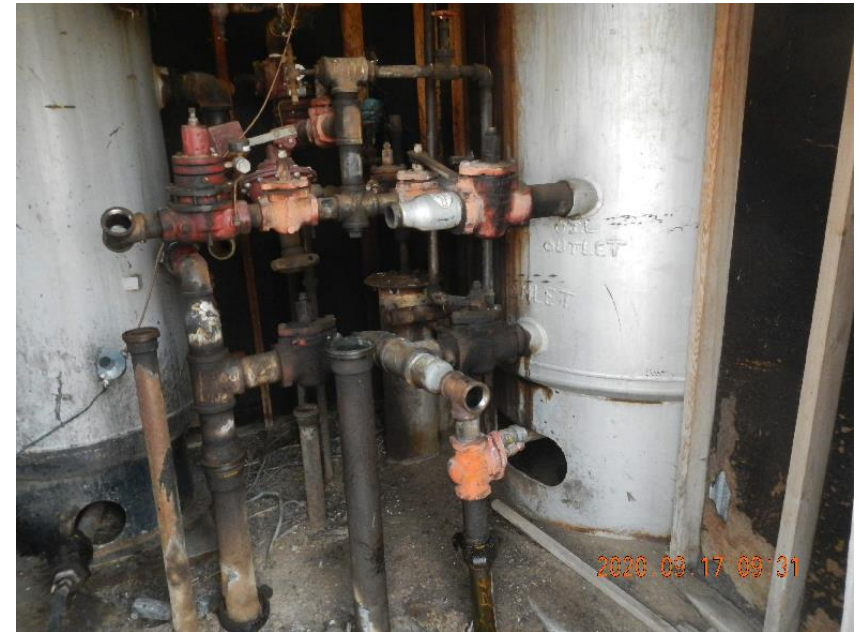
Photo 2: Disconnected lines for treaters inside heater treater shed.

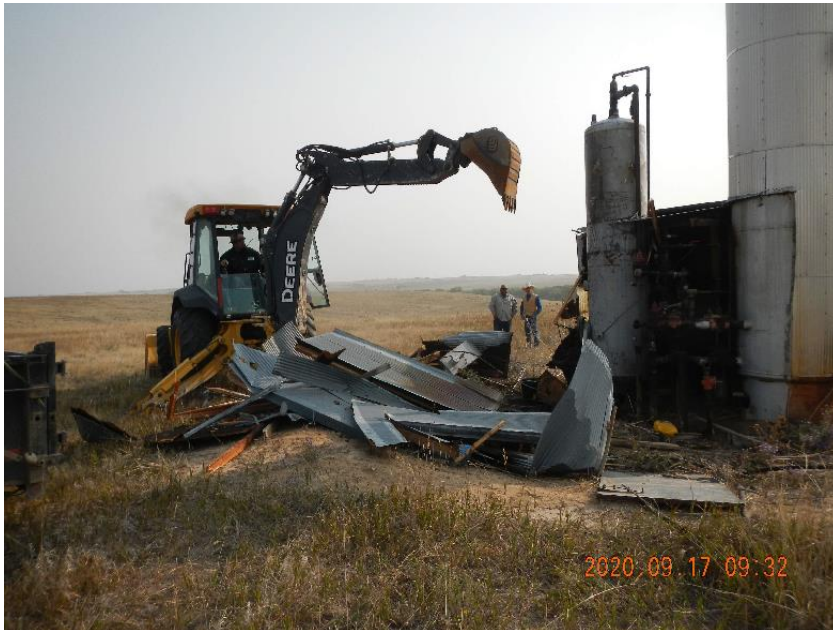
Photo 3: Tearing down heater treater shed.

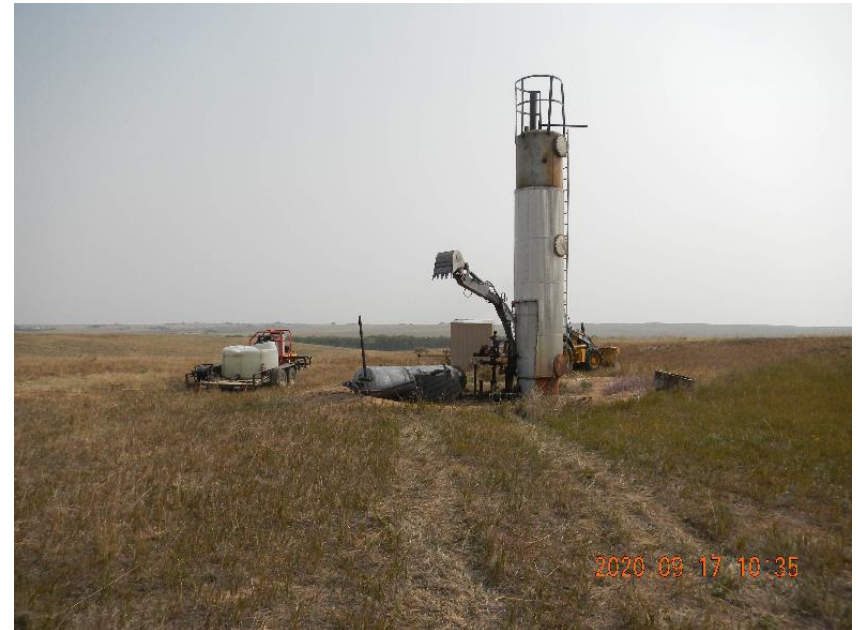
Photo 4: Laying down disconnected treaters for haul off and removal.

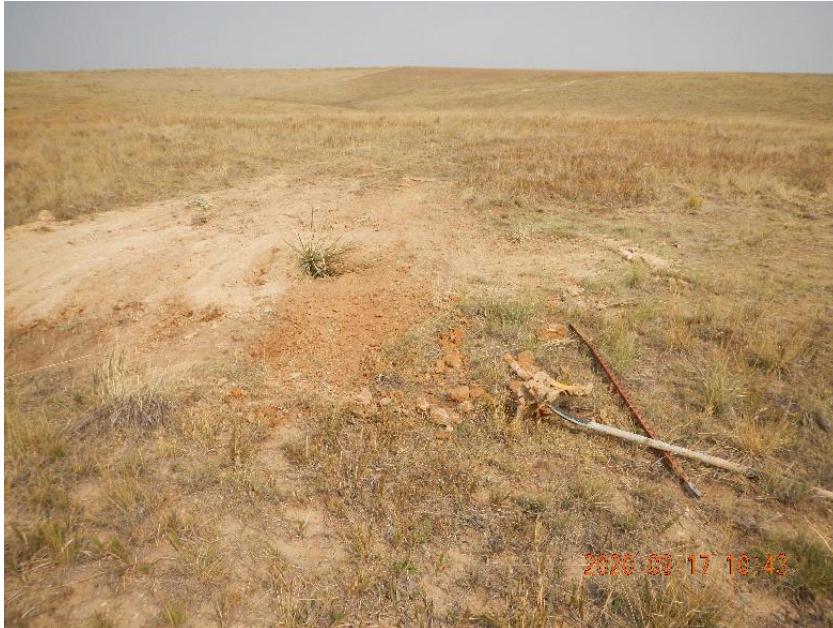
Photo 5: One of three anchors located and removed.

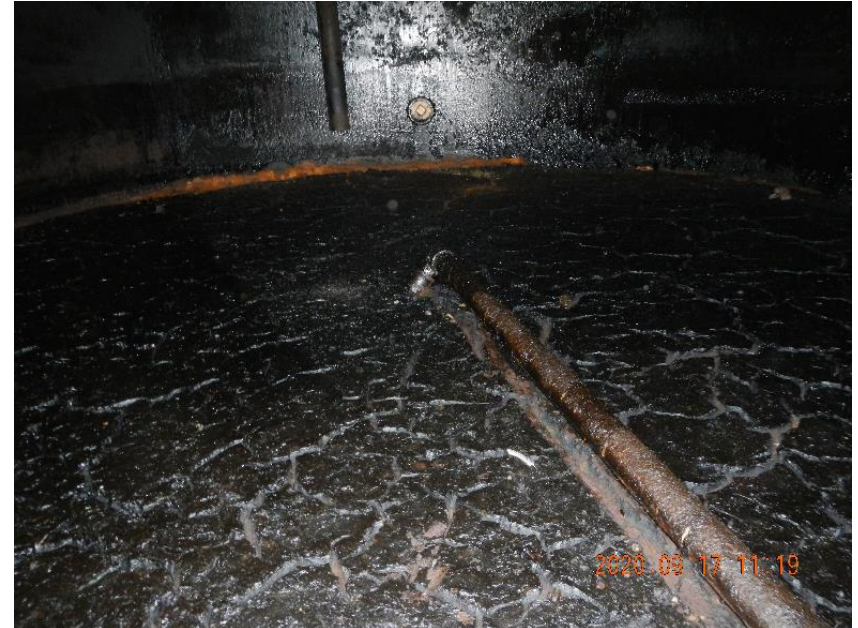
Photo 6: View inside unused tank after hatch removed.

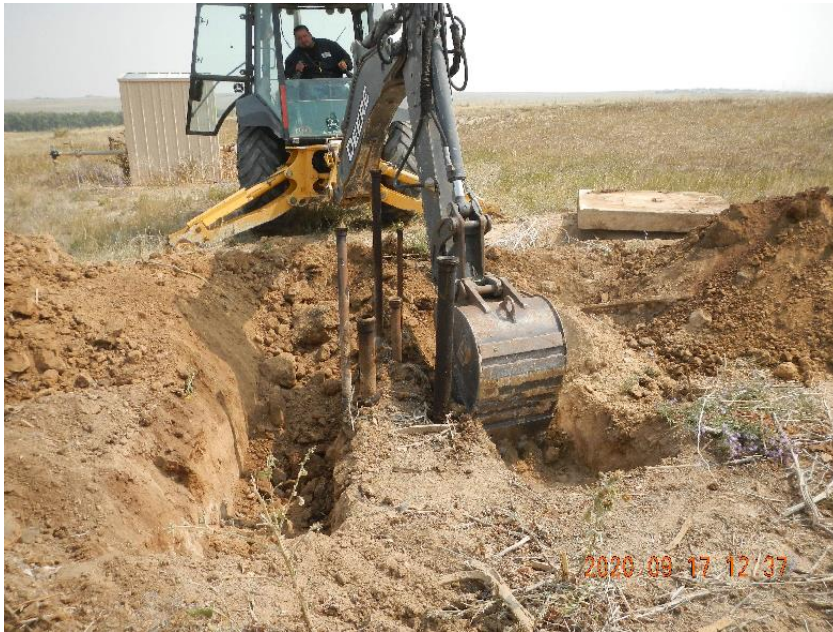
Photo 7: Excavating flow line risers at heater treater site.

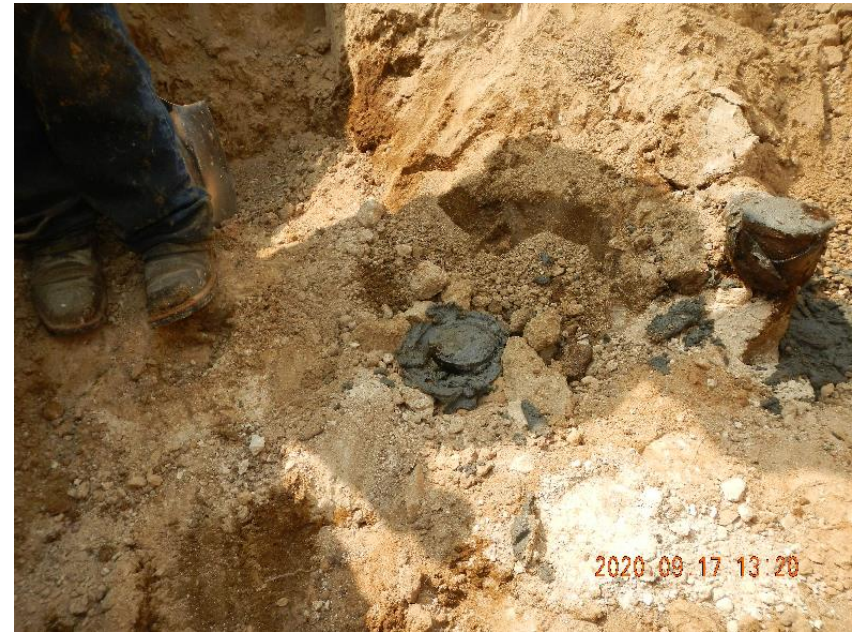
Photo 8: Cement plugging flow lines for abandonment.

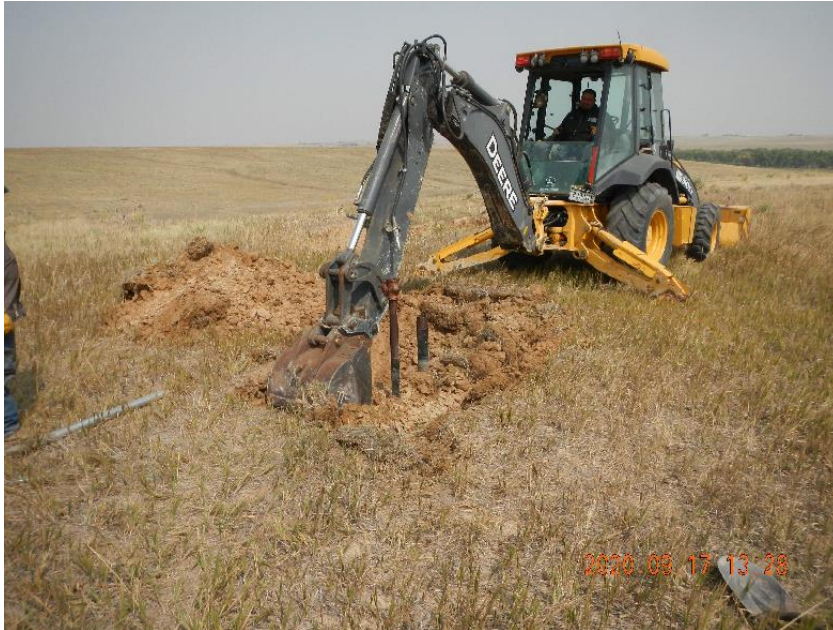
Photo 9: Excavating flow lines on E side of meter run shed.

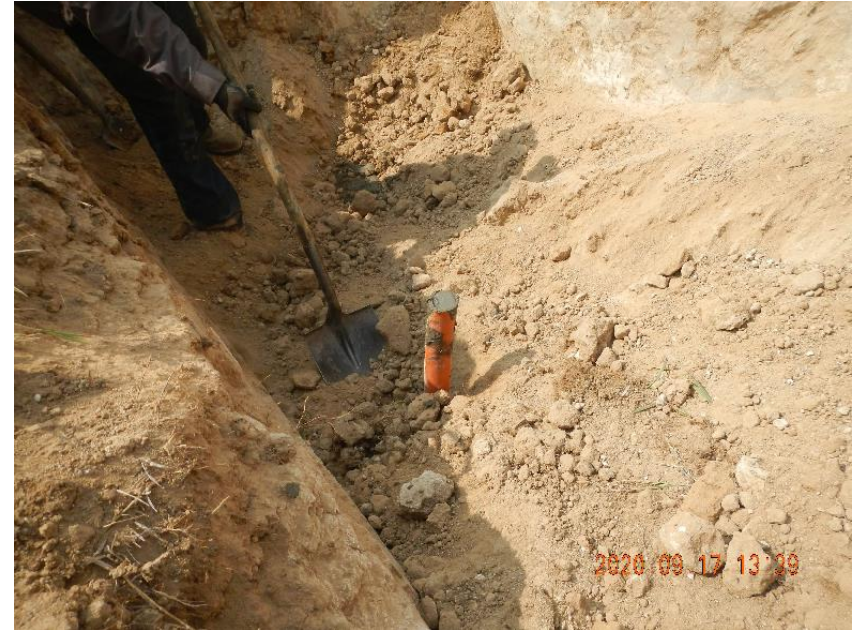
Photo 10: Cement plugging risers for abandonment.

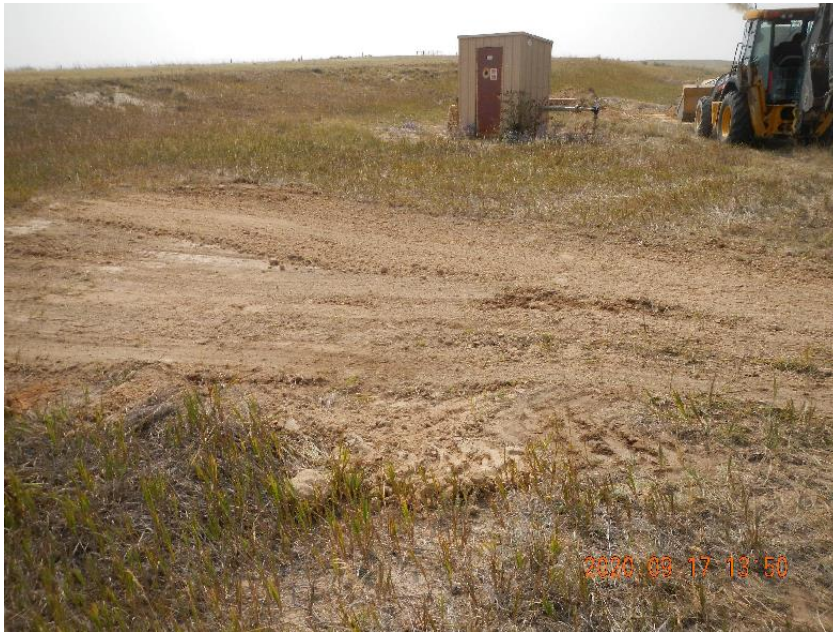
Photo 11: Backfilled and dressed excavation site on E side of meter run shed.

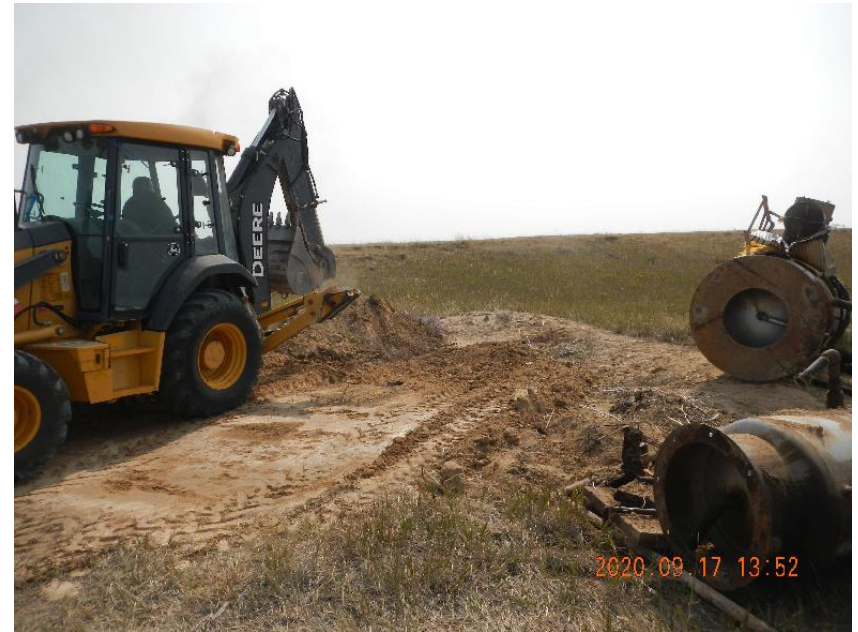
Photo 12: Backfilling excavation site at heater treater site.

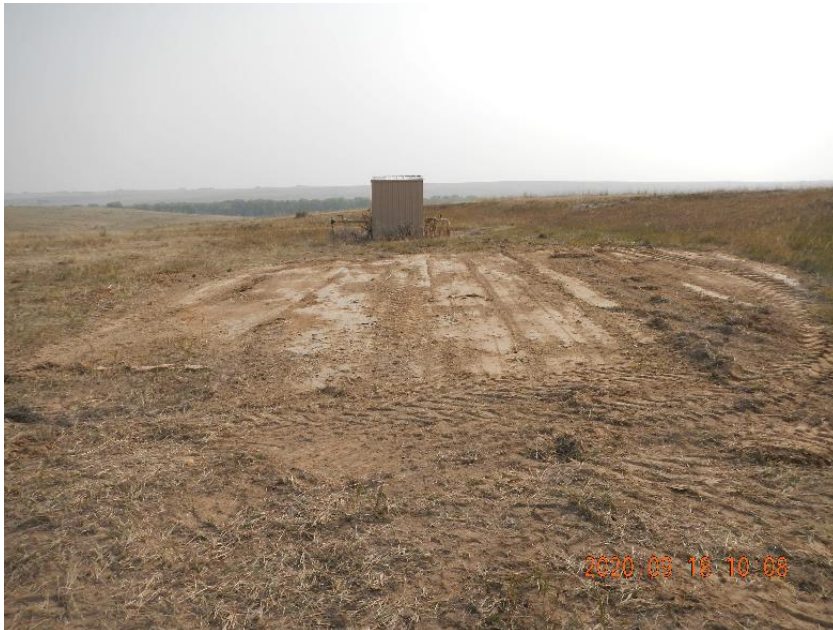
Photo 13: Backfilled and dressed excavation at heater treater site.

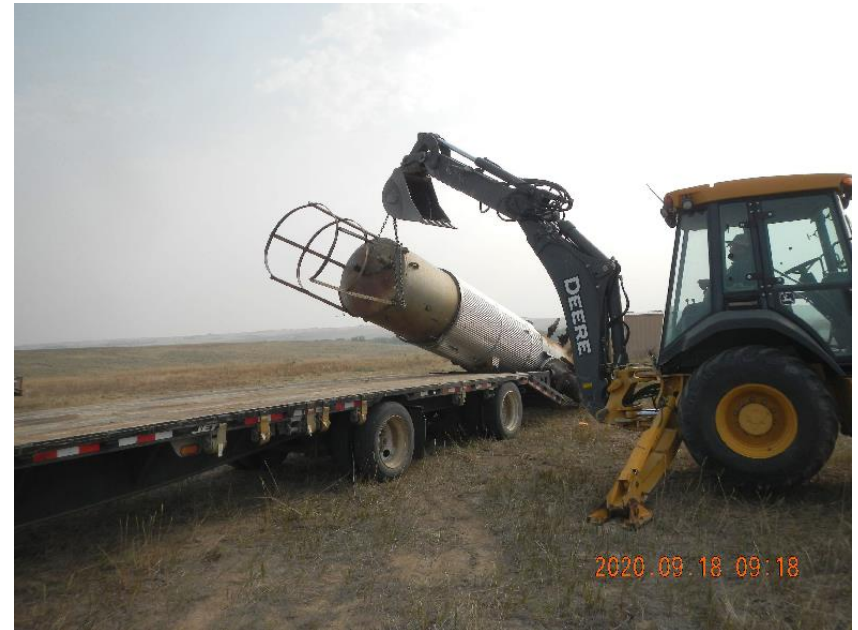
Photo 14: Loading heater treater for haul off.

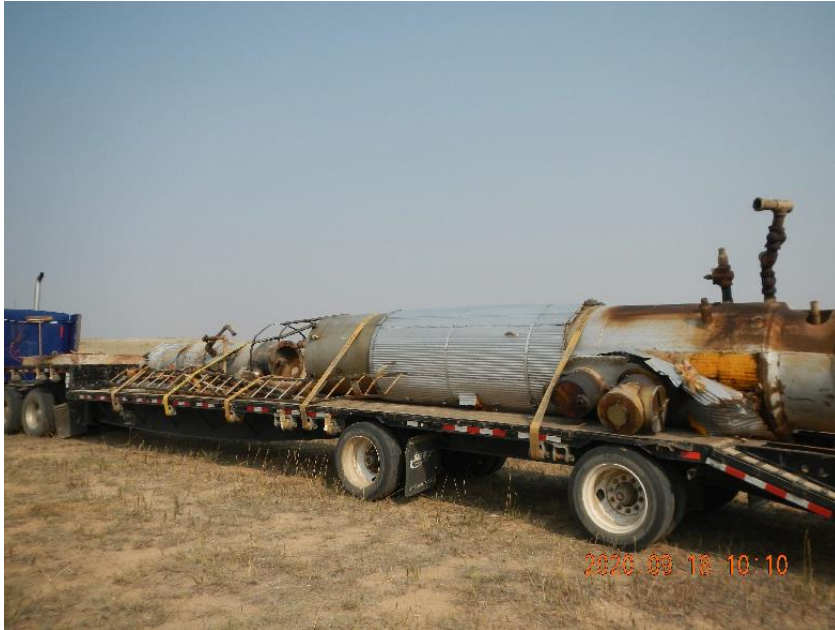
Photo 15: Treater, pipe, pipe fittings, and debris loaded for removal from location.

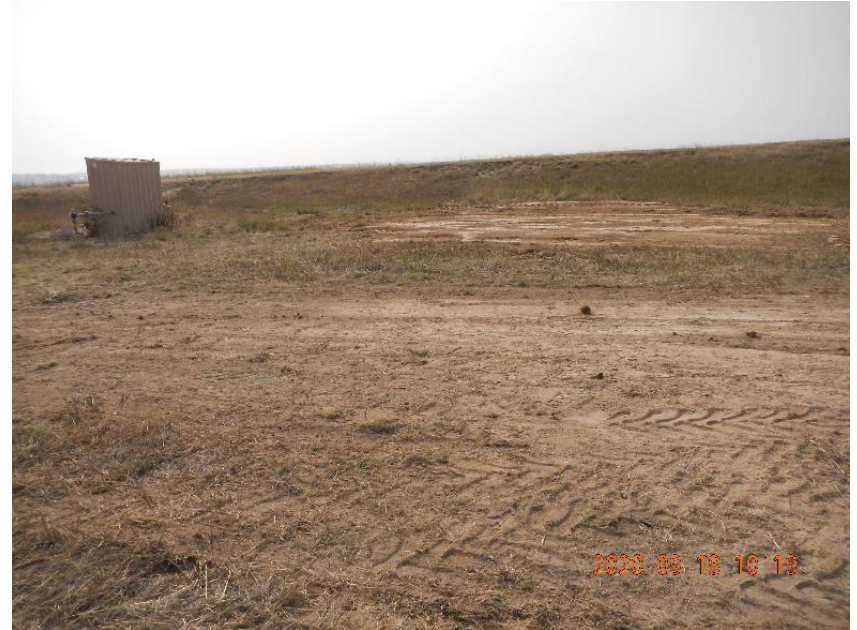
Photo 16: View of redressed excavation sites.

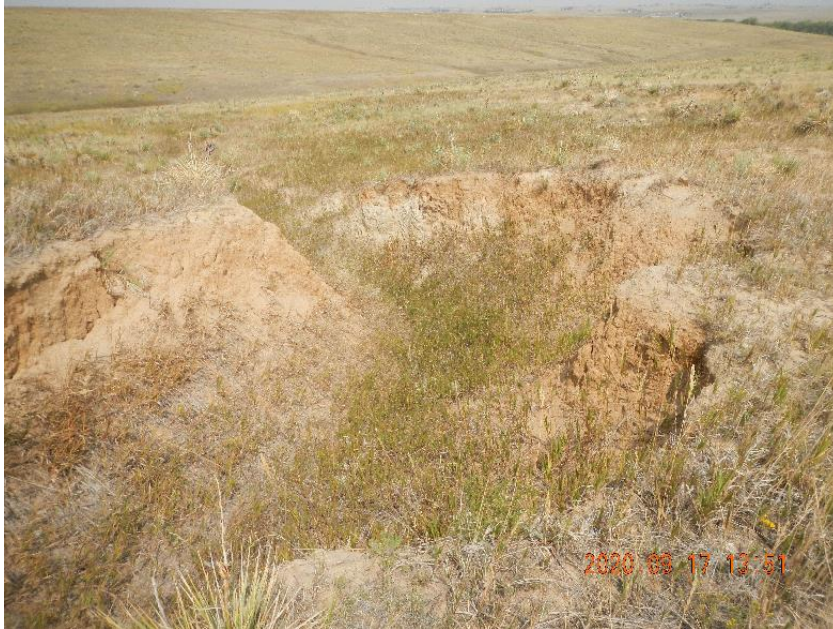
Photo 17: View of erosion gully off NE side of location.

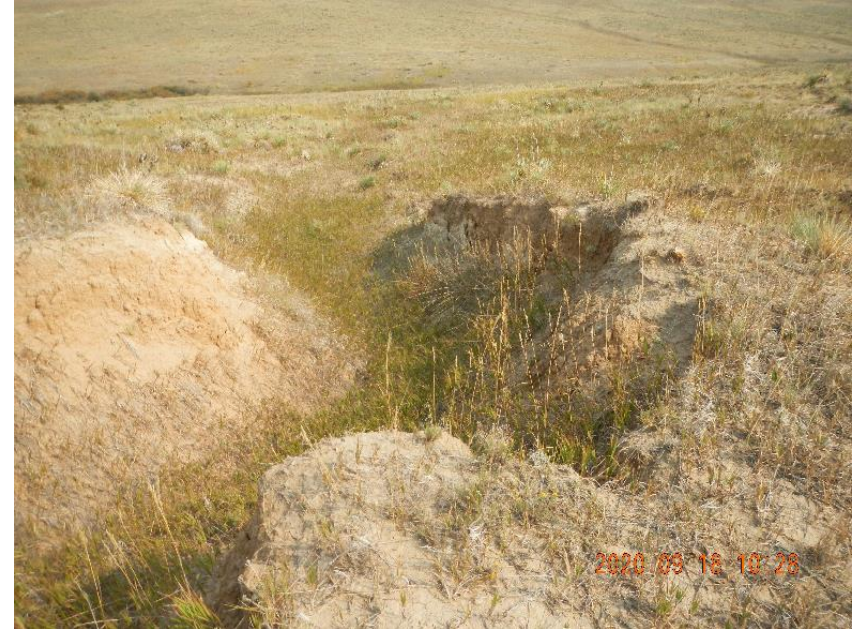
Photo 18: Additional view of erosion gully looking further down slope.

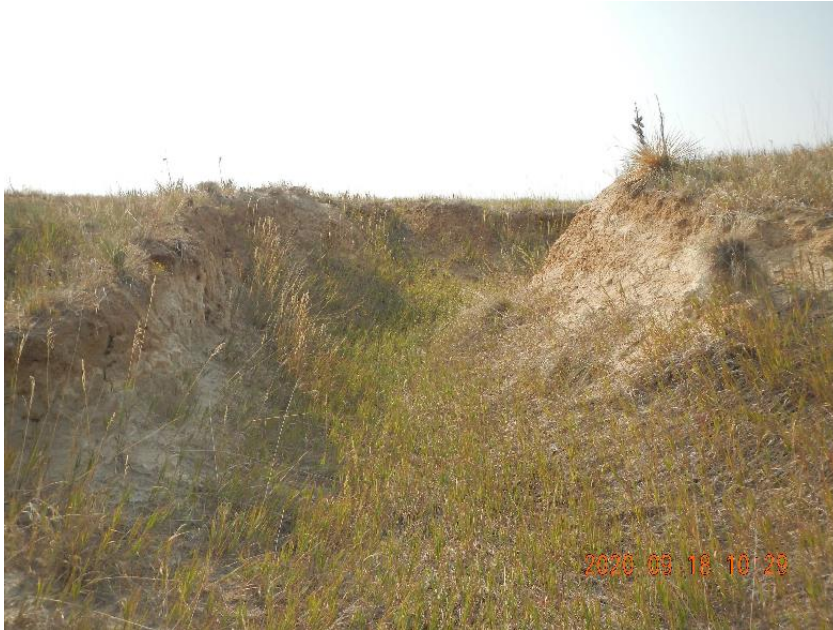
Photo 19: View from inside erosion gully looking up slope.

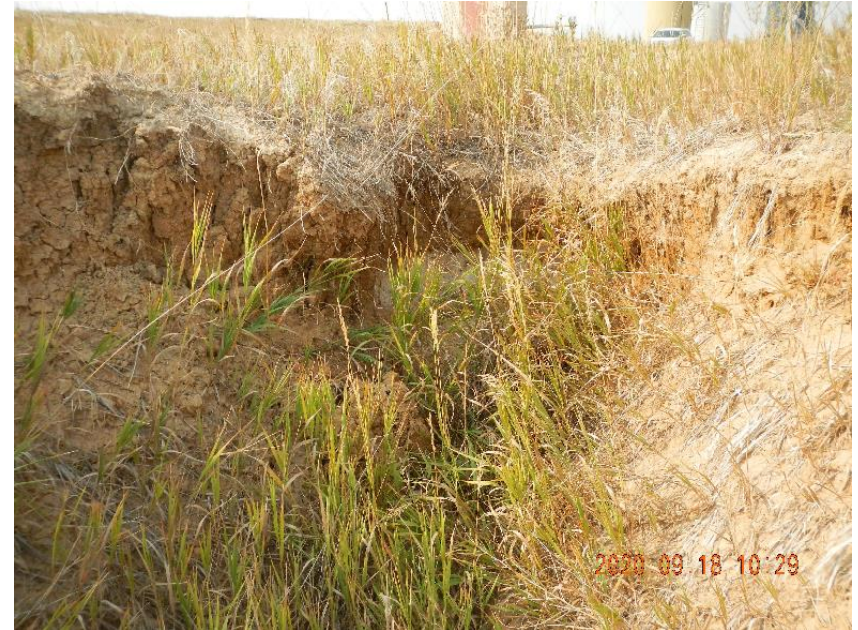
Photo 20: View from inside erosion gully looking at top of erosion.
