Reclamation Inspection

September 18, 2020

Operator: KERR MCGEE OIL & GAS ONSHORE LP #47120

Complaint #: 200449186

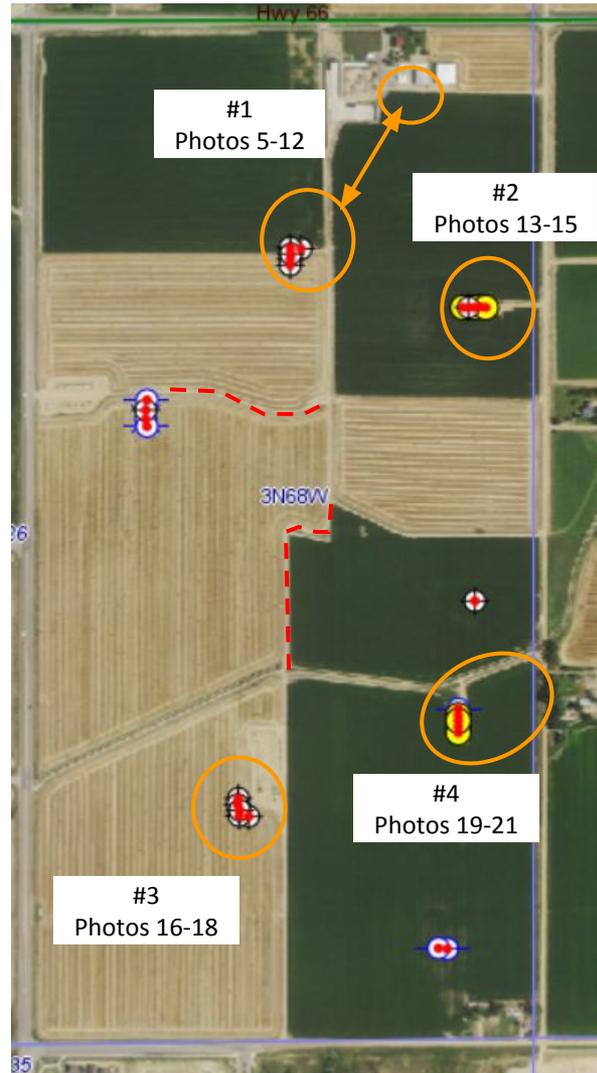
Photo 1. COGCC GISOnline aerial imagery taken 2019. Imagery illustrates four locations (#1-#4 orange circles) in addition to access roads (red-dashed line) with reclamation compliance issues associated with a complaint. Refer to Photos 2, which illustrates a 1967 aerial imagery overview of the area demonstrating its condition prior to oil and gas activity.

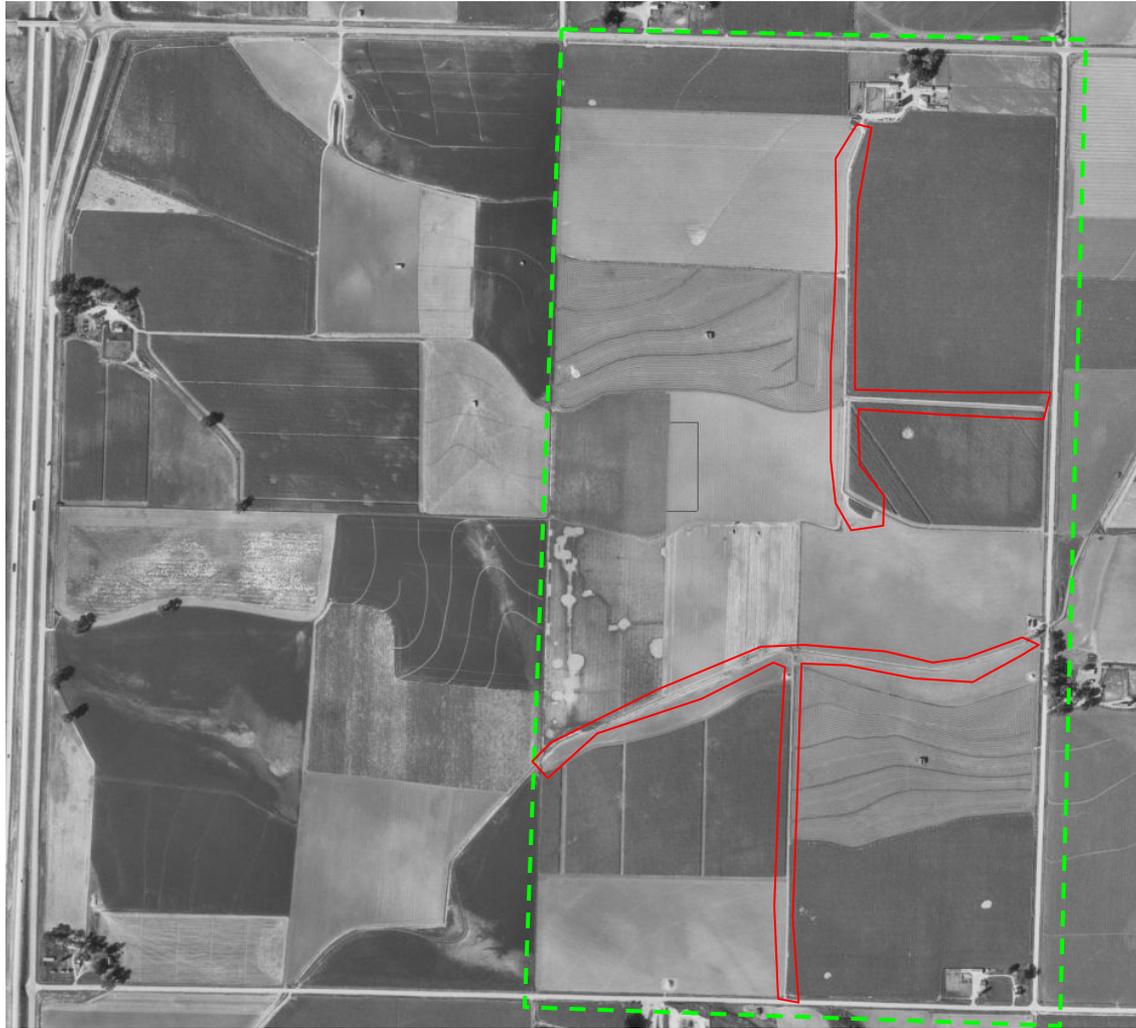
Photo 2. Aerial imagery taken September 20, 1967 illustrating an overview of the area (area within the green-dashed line) demonstrating its condition prior to oil and gas activity. The red polygon areas highlight areas of pre-existing roads prior to oil and gas. Refer to Photos 3 and 4 which are zoomed in areas of the above area.

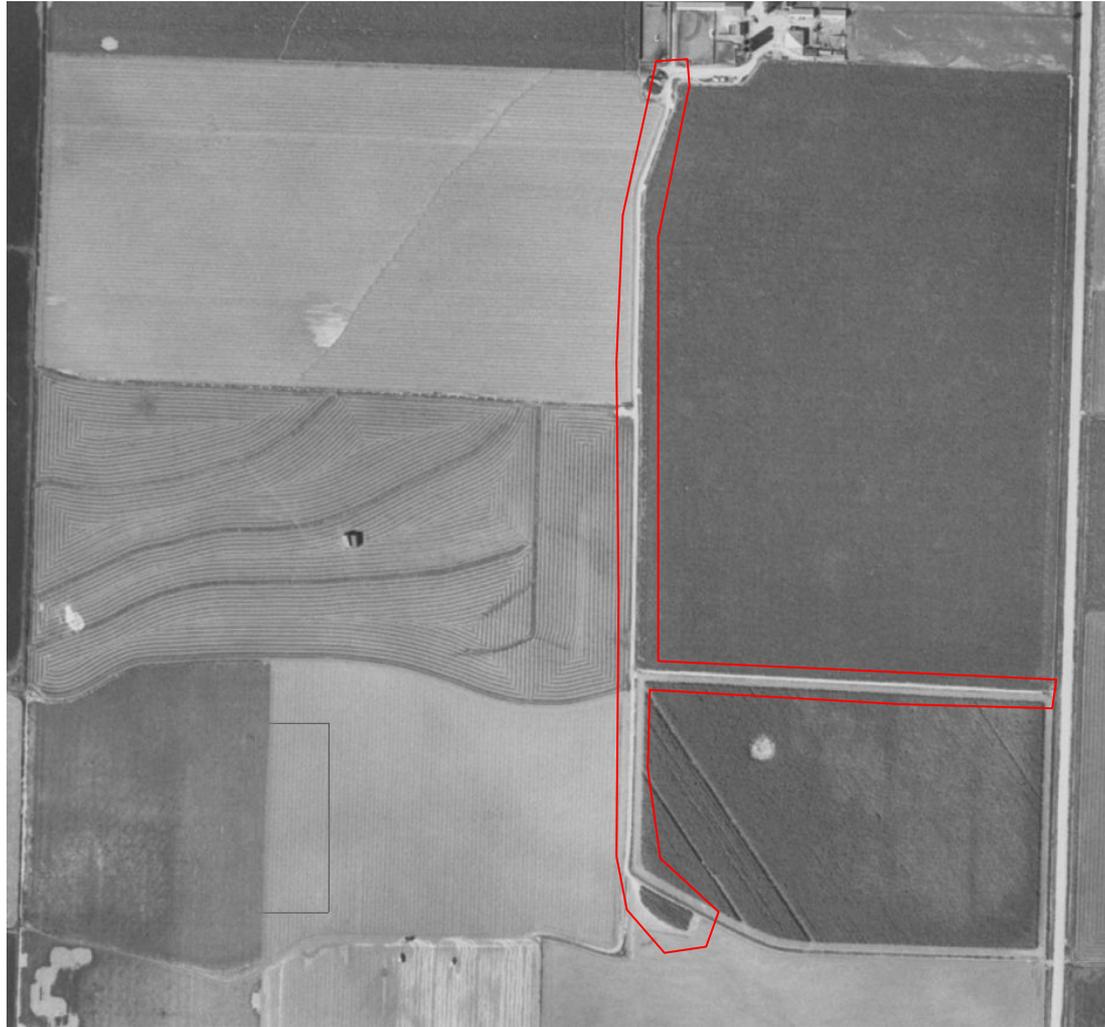
Photo 3. Zoomed in aerial imagery of the northern area taken September 20, 1967 illustrating an overview of the area demonstrating its condition prior to oil and gas activity. The red polygon areas highlight areas of pre-existing roads prior to oil and gas.

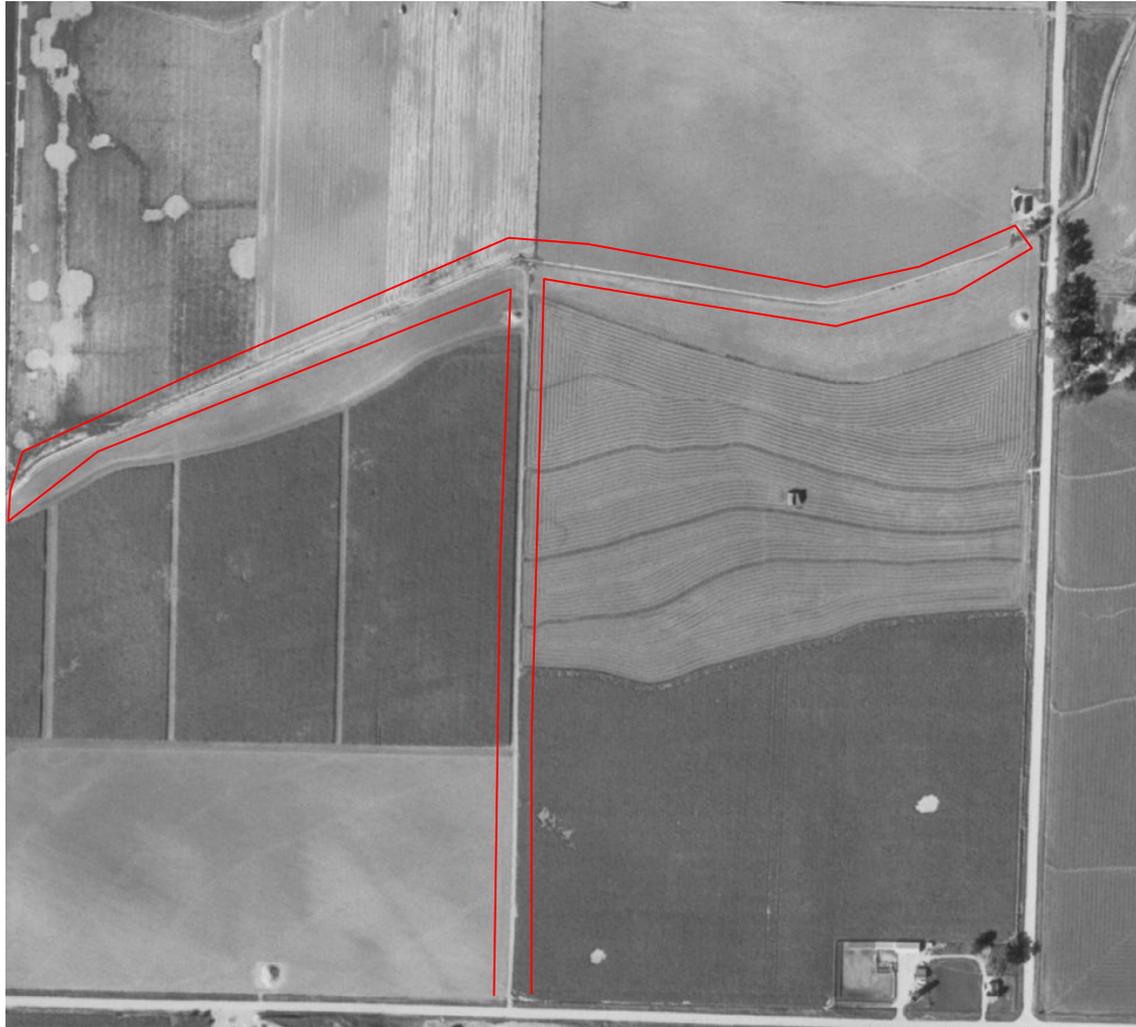
Photo 4. Zoomed in aerial imagery of the southern area taken September 20, 1967 illustrating an overview of the area demonstrating its condition prior to oil and gas activity. The red polygon areas highlight areas of pre-existing roads prior to oil and gas.

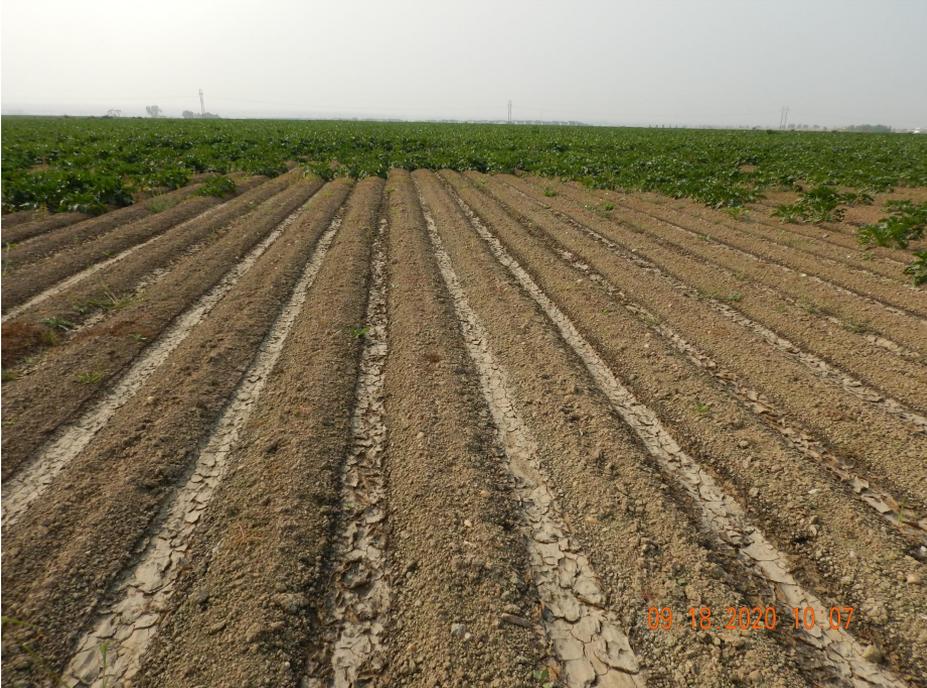
Photo 5. Photo taken from the southern plugged and abandoned (P&A) location, facing South. Photo illustrates the lack of crop growth (sugar beets). Sugar beets that are growing within the PA location are not reflective of reference area crop growth.

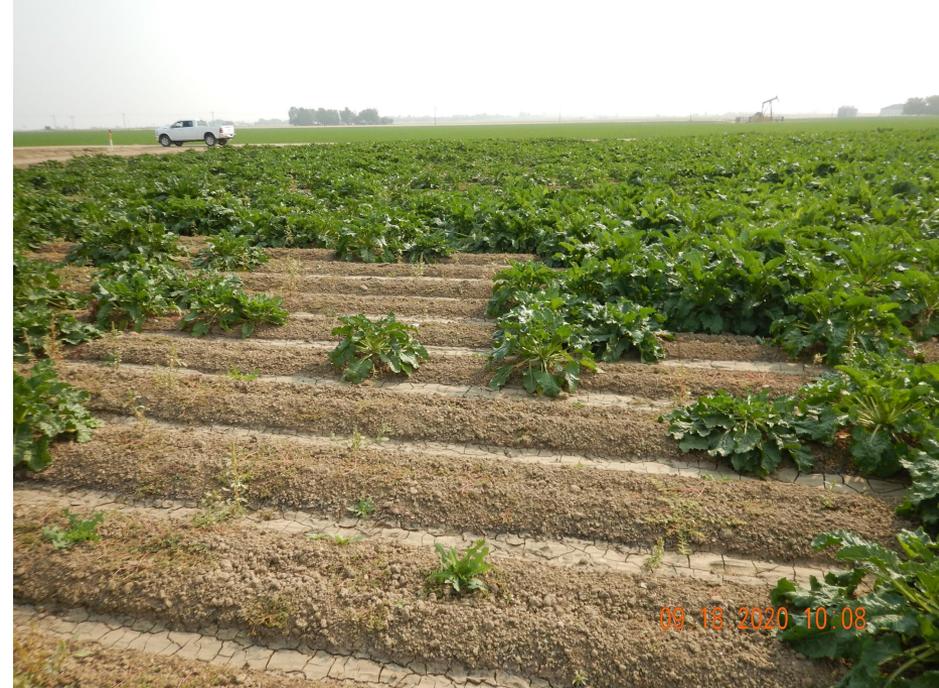
Photo 6. Photo taken from the southern plugged and abandoned location, facing East. See comments under Photo 5.

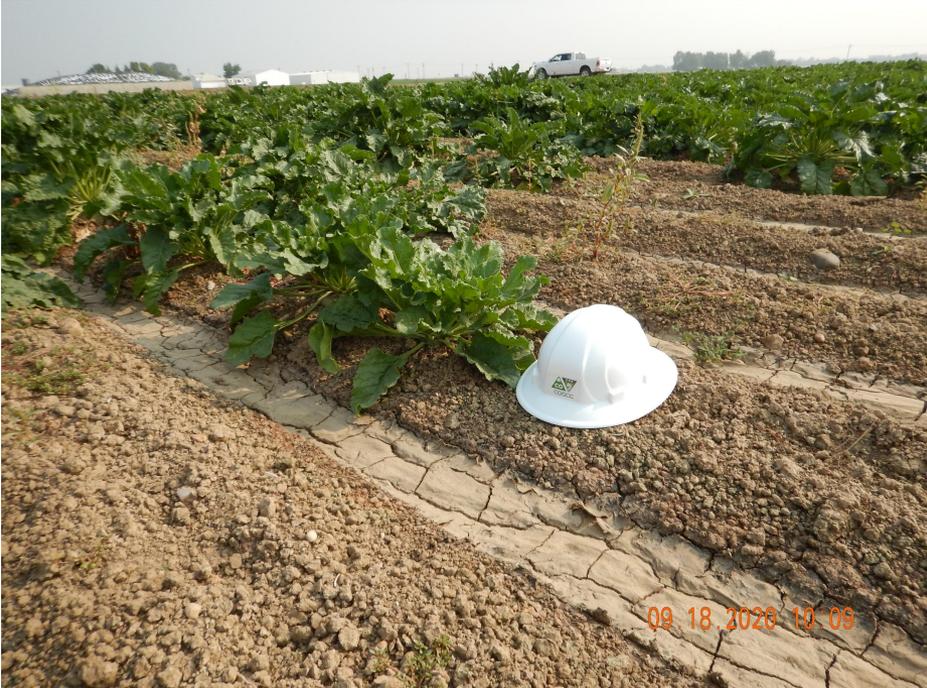
Photo 7. Photo taken from the southern plugged and abandoned location, facing East. Photo illustrates a stunted sugar beet not reflective of reference areas.

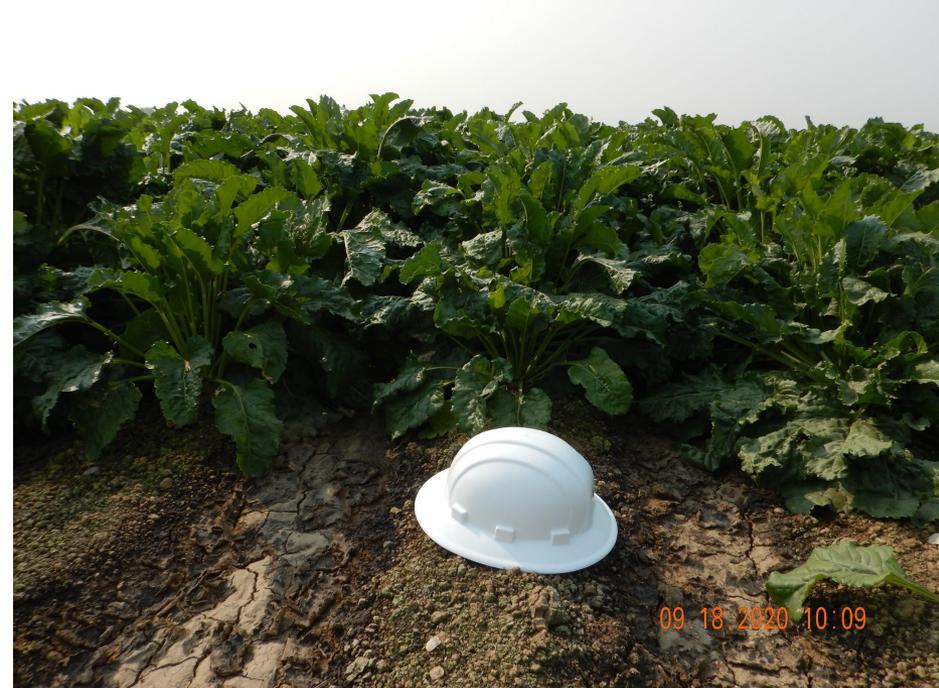
Photo 8. Photo taken from the adjacent reference area, facing South. Photo illustrates the crop deficiencies between the P&A crops versus the reference crops.

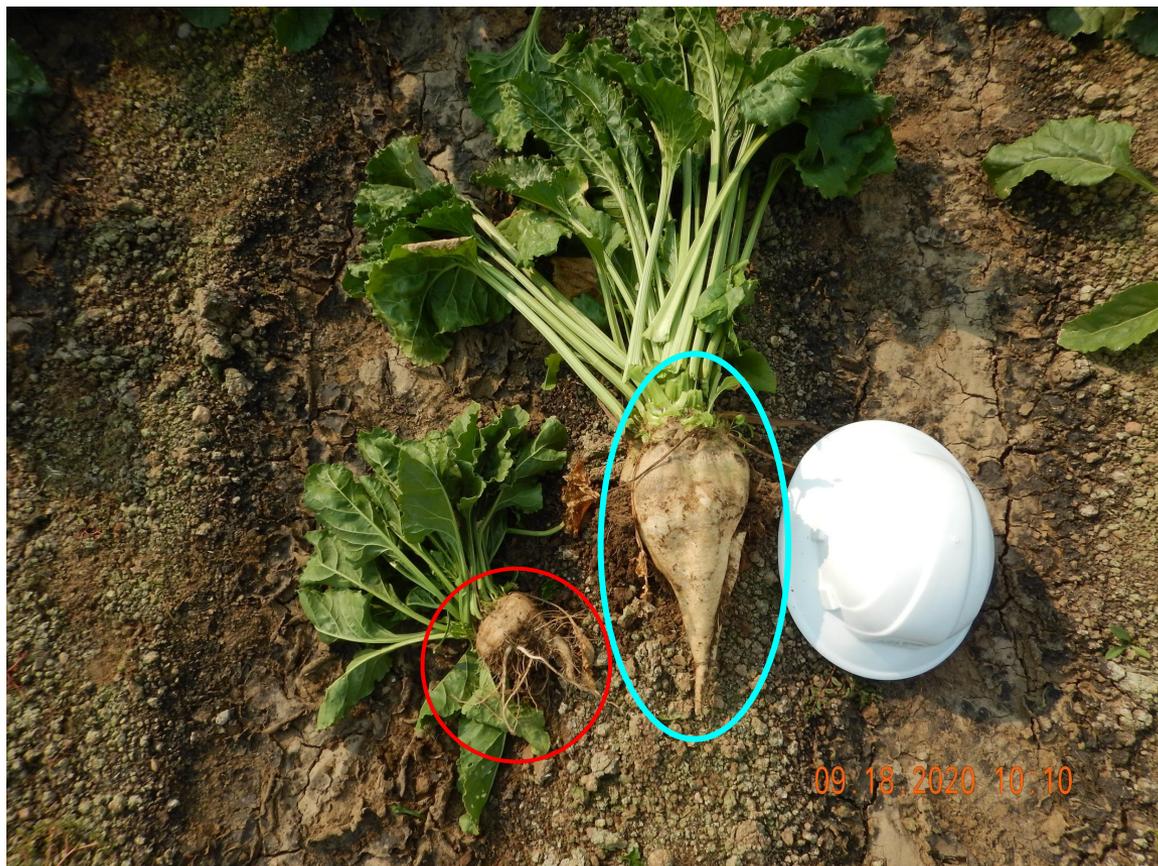
Photo 9. Photo taken of a sugar beet from the P&A area (red circle) and from the reference area (blue circle).

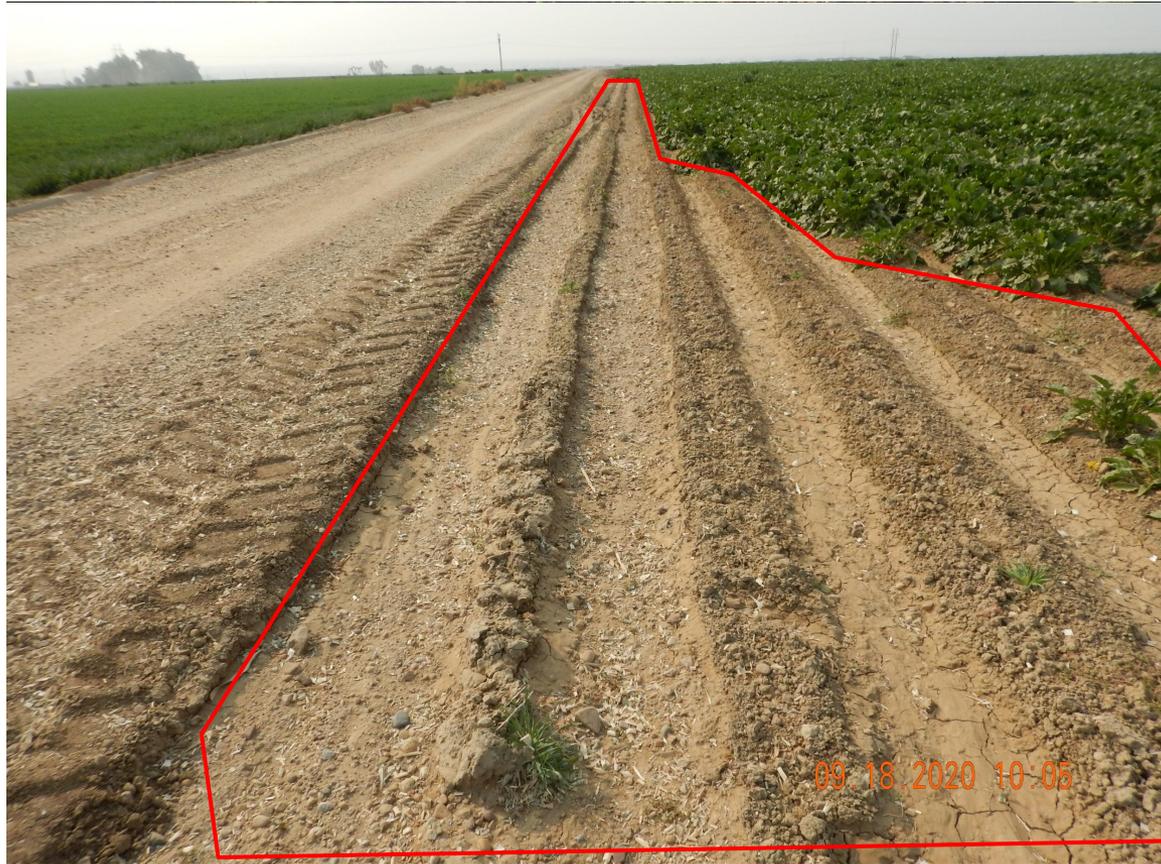
Photo 10. Photo taken from the eastern P&A location, facing South. Photo illustrates portions of the crop field have not been reclaimed (red polygon).

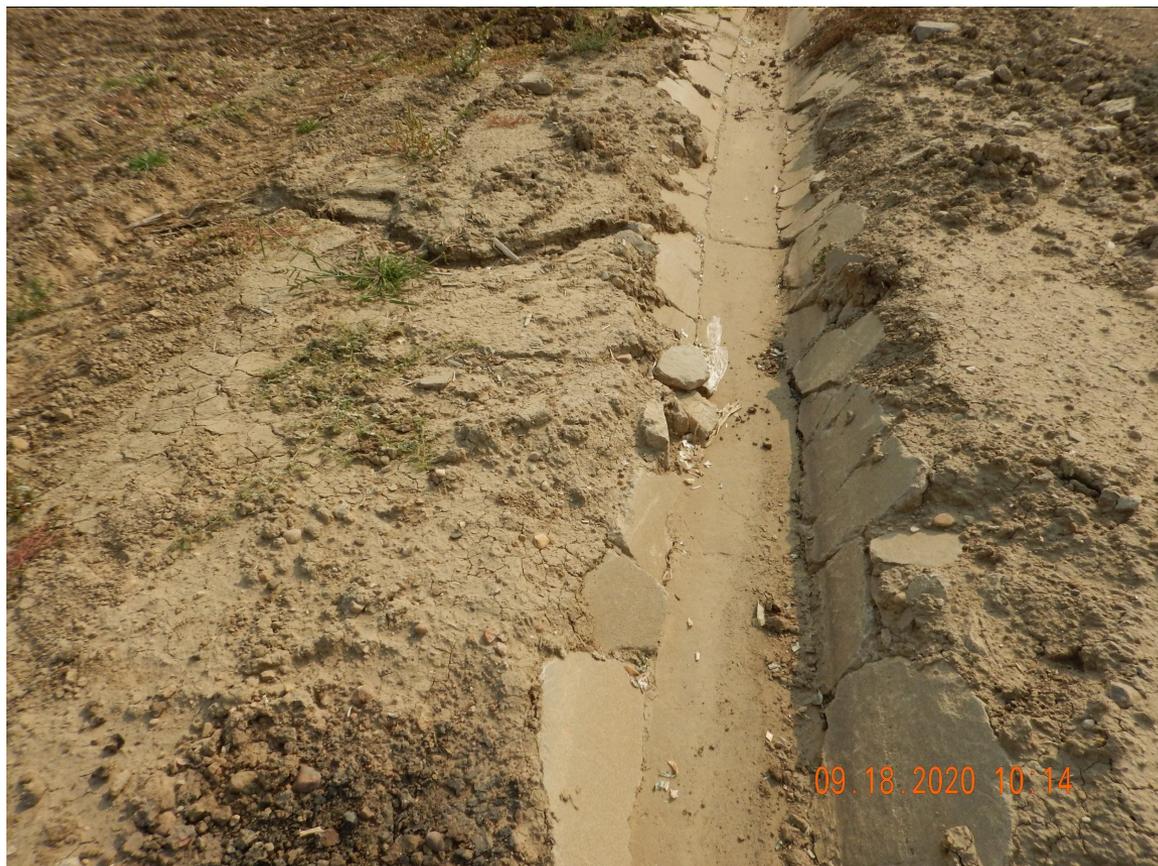
Photo 11. Photo taken from the P&A location. Photo illustrates a damaged irrigation ditch from plugging operations.

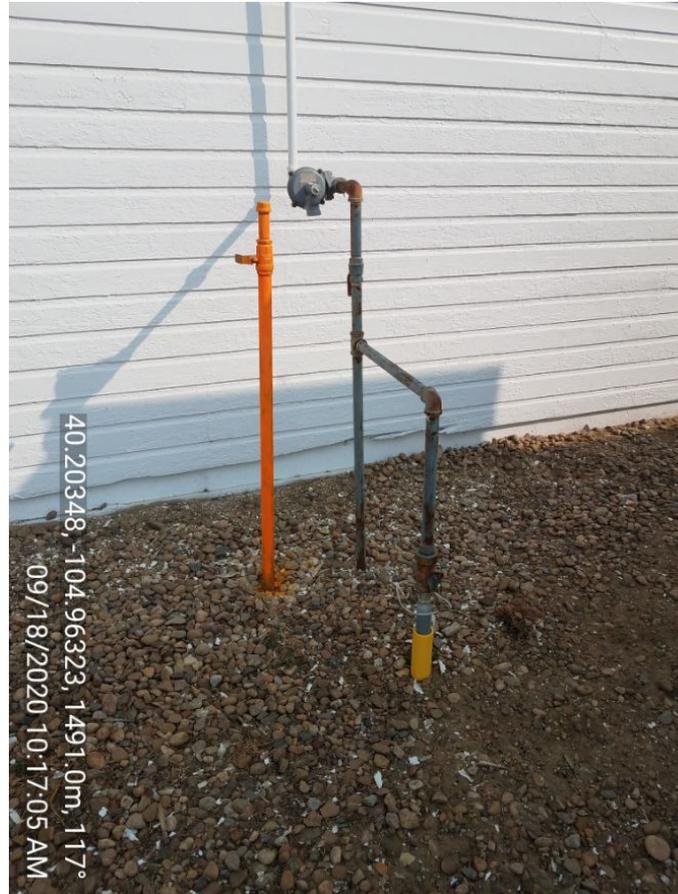
Photo 12. Photo taken from the nearby residence (refer to Photo 1). Photo illustrates an out of service riser related to a domestic tap which has not been abandoned per Rule 1105.

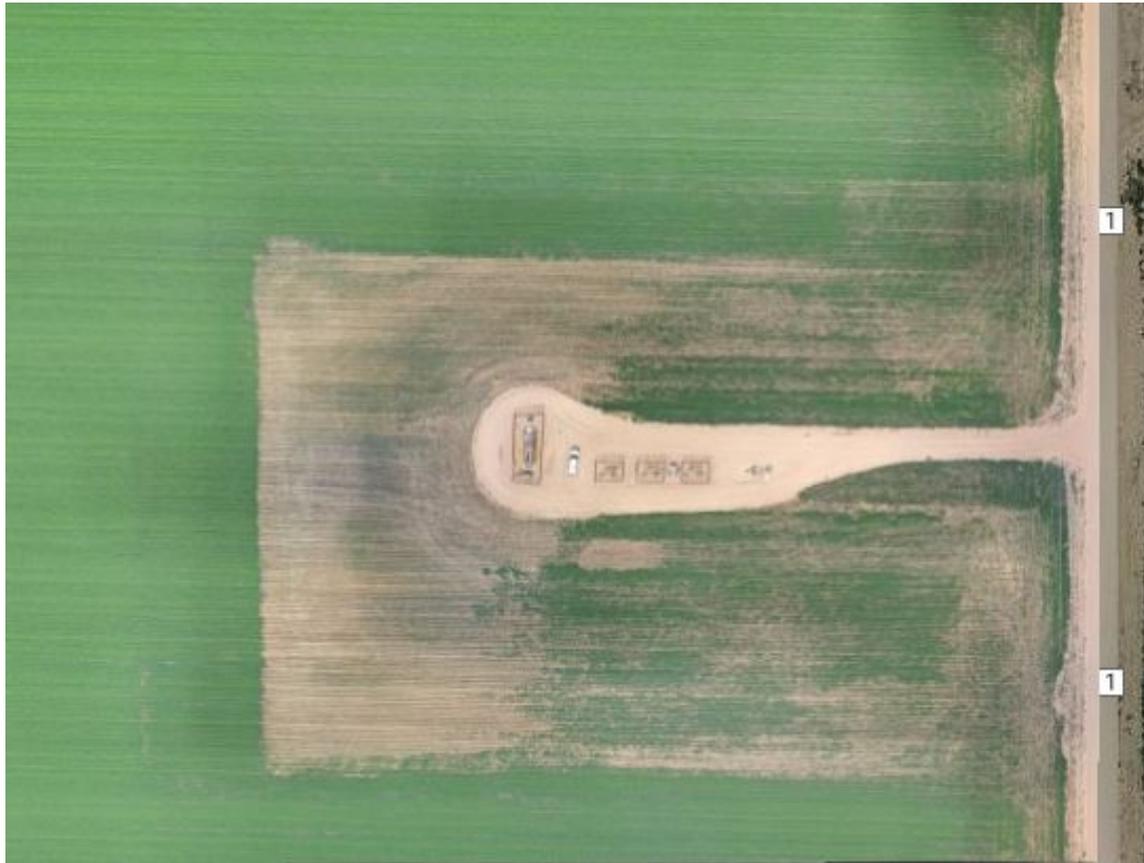
Photo 13. COGCC drone aerial imagery from 9/18/2020. Imagery illustrates interim reclamation areas are not reflective of reference area crop growth.

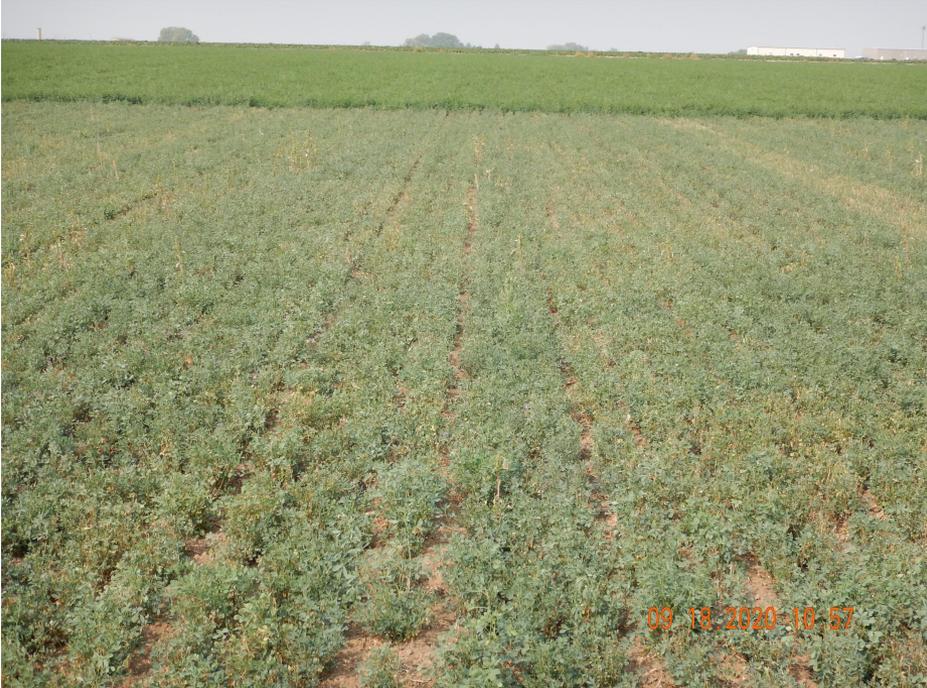
Photo 14. Photo taken from the western interim reclamation area, facing West. Photo illustrates crop growth within the interim area is not reflective of reference area crop growth.

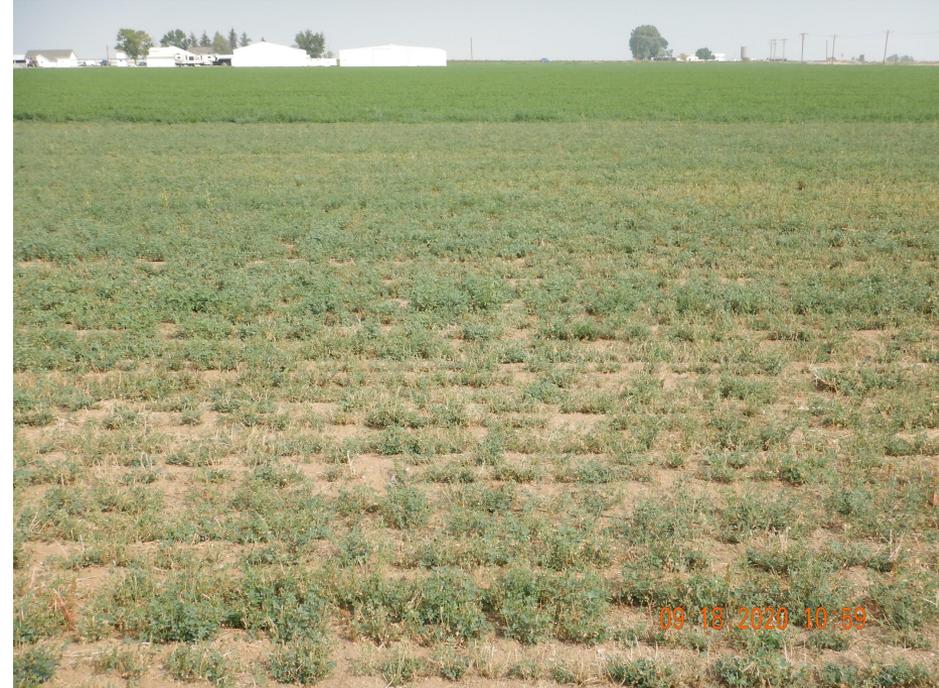
Photo 15. Photo taken from the northern interim reclamation area, facing North. See comments under Photo 14.

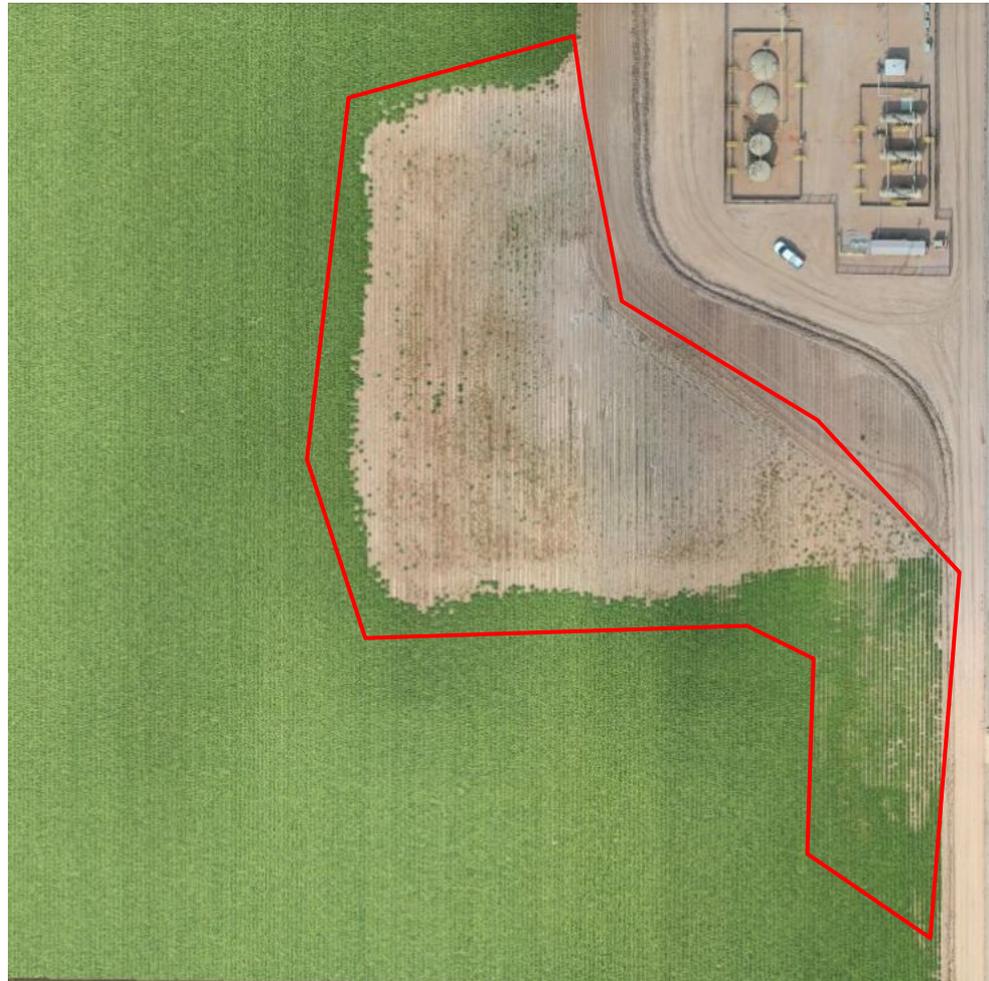
Photo 16. COGCC drone aerial imagery from 9/18/2020. Imagery illustrates the plugged and abandoned (P&A) location is not reflective of reference area crop growth. This P&A location includes wells and the original tank battery along the southeastern polygon.

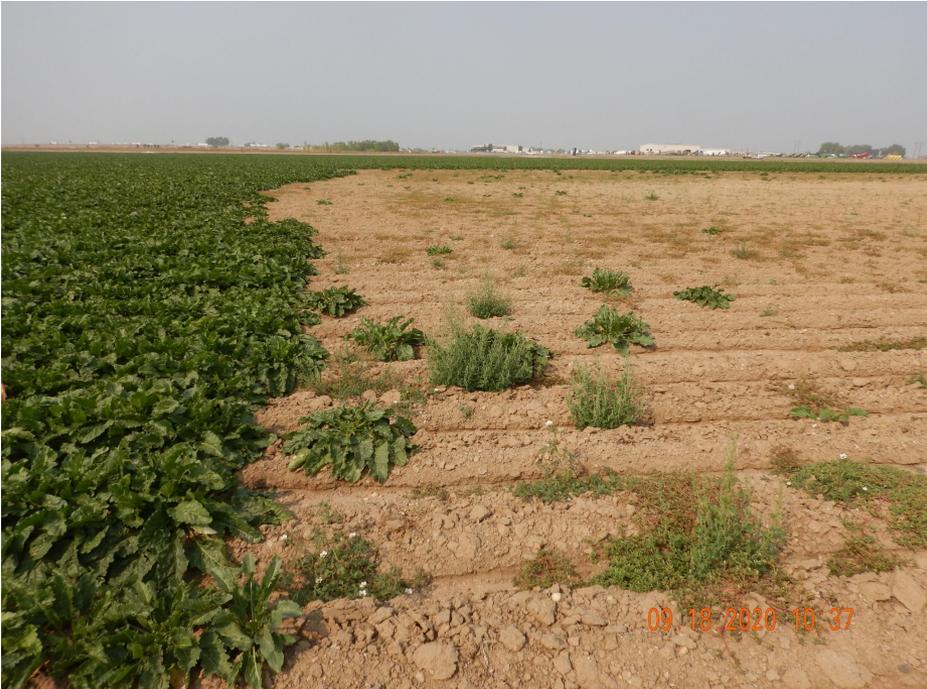
Photo 17. Photo taken from the southeastern P&A area, facing West. Photo illustrates the lack of crop growth within the P&A area.

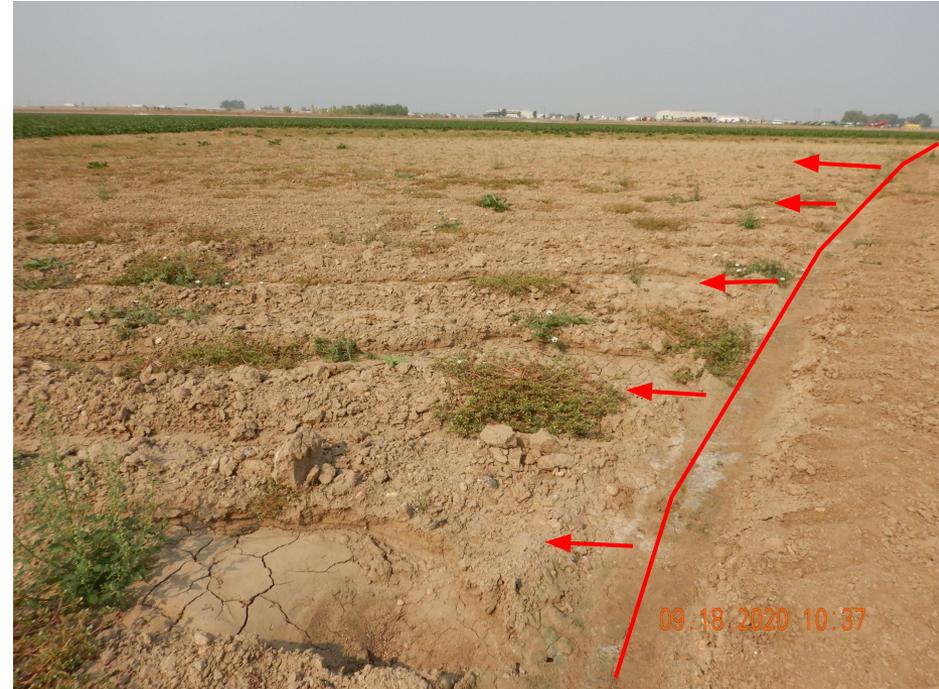
Photo 18. Photo taken from the eastern P&A area, facing West. See comments under Photo 17.

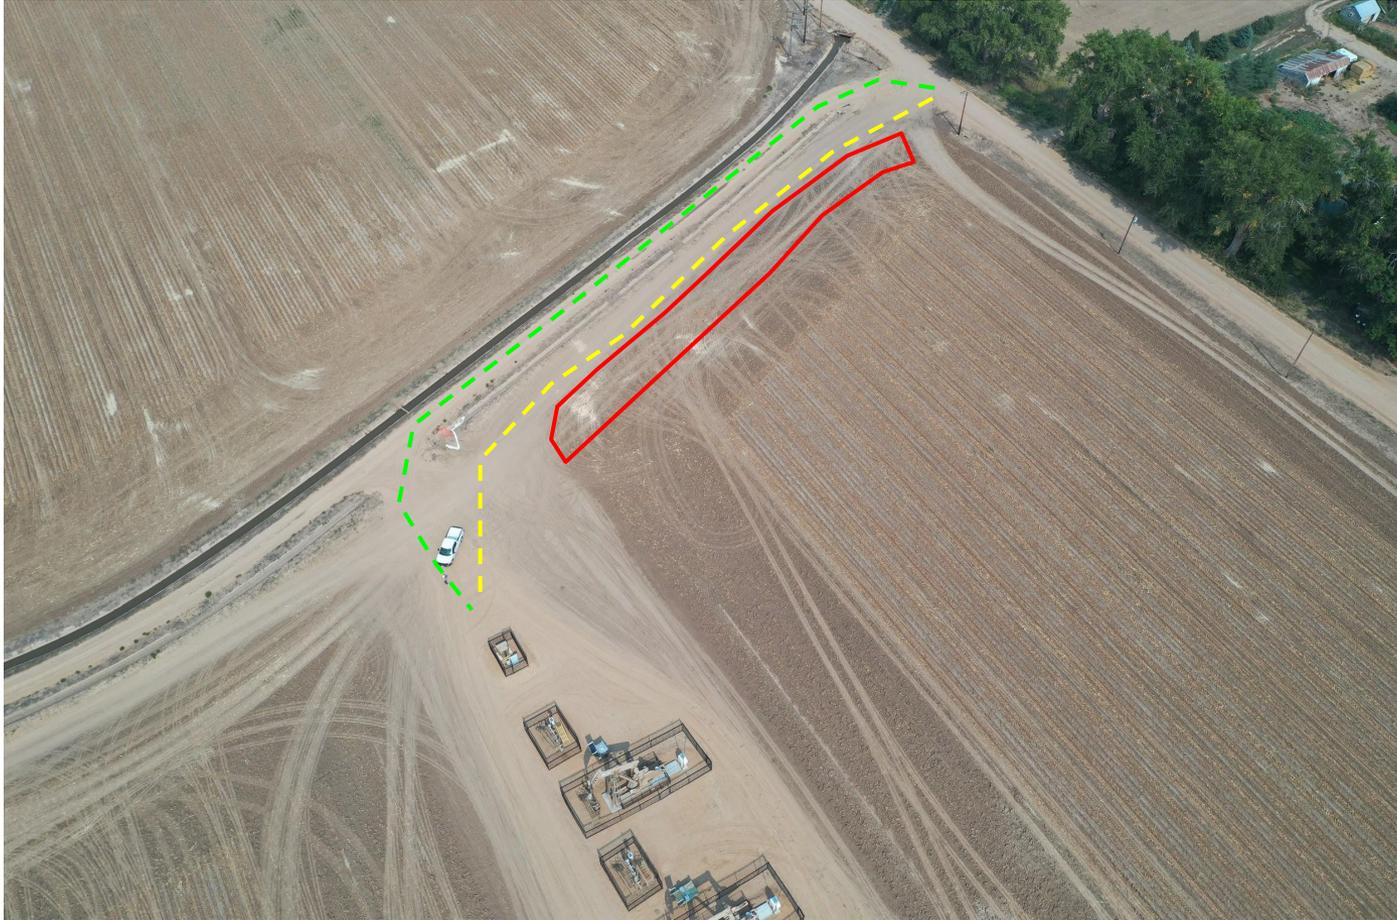
Photo 19. COGCC drone aerial imagery from 9/18/2020. Imagery illustrates an approximate crop area (red polygon) where the surface owner stated crop deficiencies due to subsequent oil and gas operations. Crop has already been harvested so COGCC staff could not document crop growth. Per a surface owner statement, Operator typically uses the northern access road (green dashed line) but the access was too narrow to perform subsequent operations and utilized a southern access route (yellow dashed line).

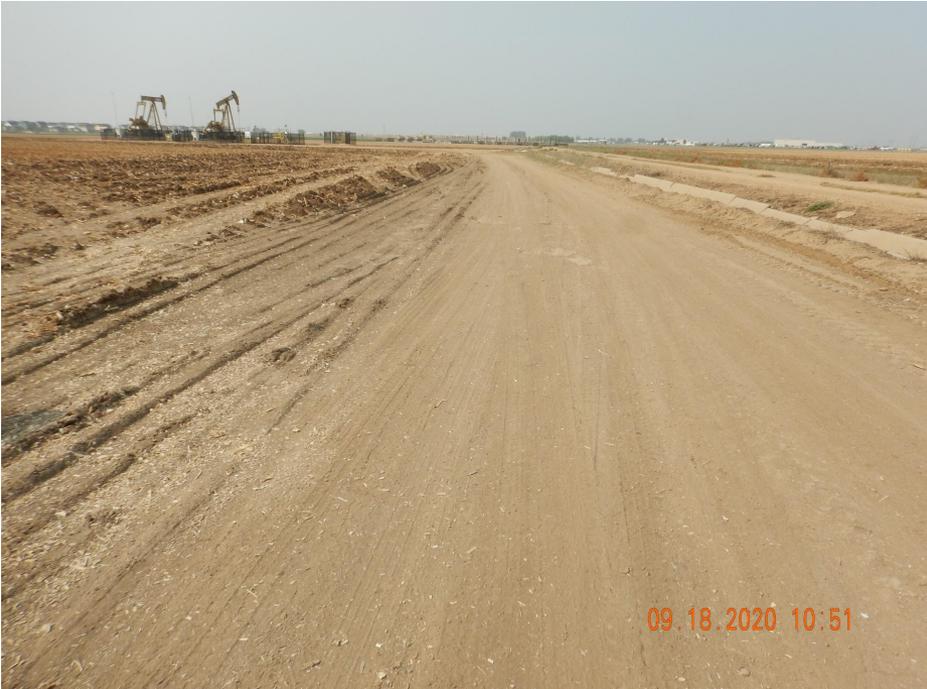
Photo 20. Photo taken from the southern route (orange dashed line), facing West.

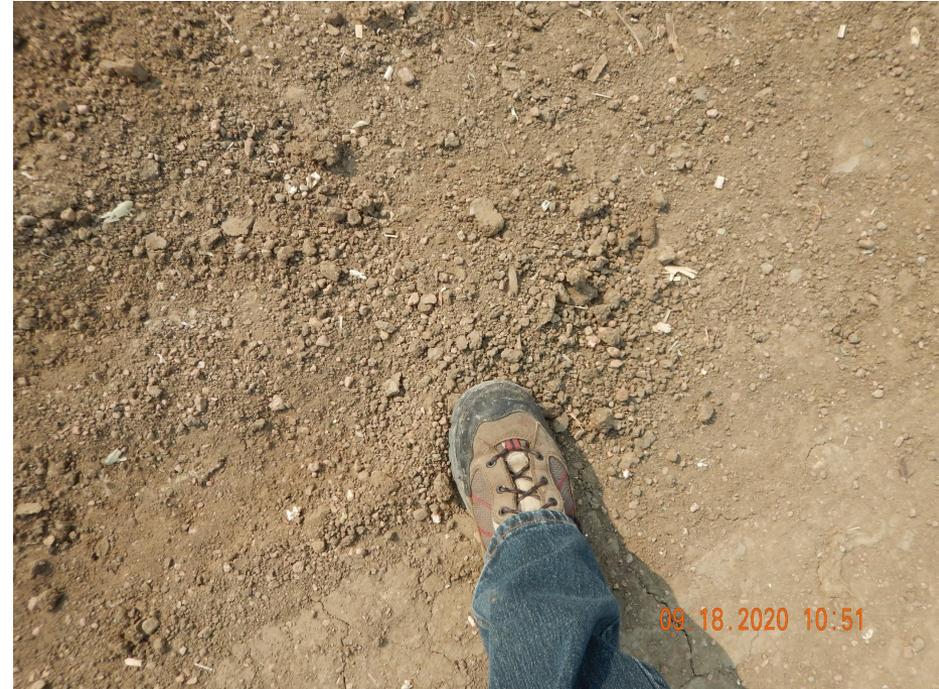
Photo 21. Photo taken from the southern route (orange dashed line). Photo illustrates some gravel present which might indicate it was utilized to perform subsequent oil and gas operations.
