Inspection Photos
Operator: Enduring Resources
API: 067-07467
Date: 9/23/2020

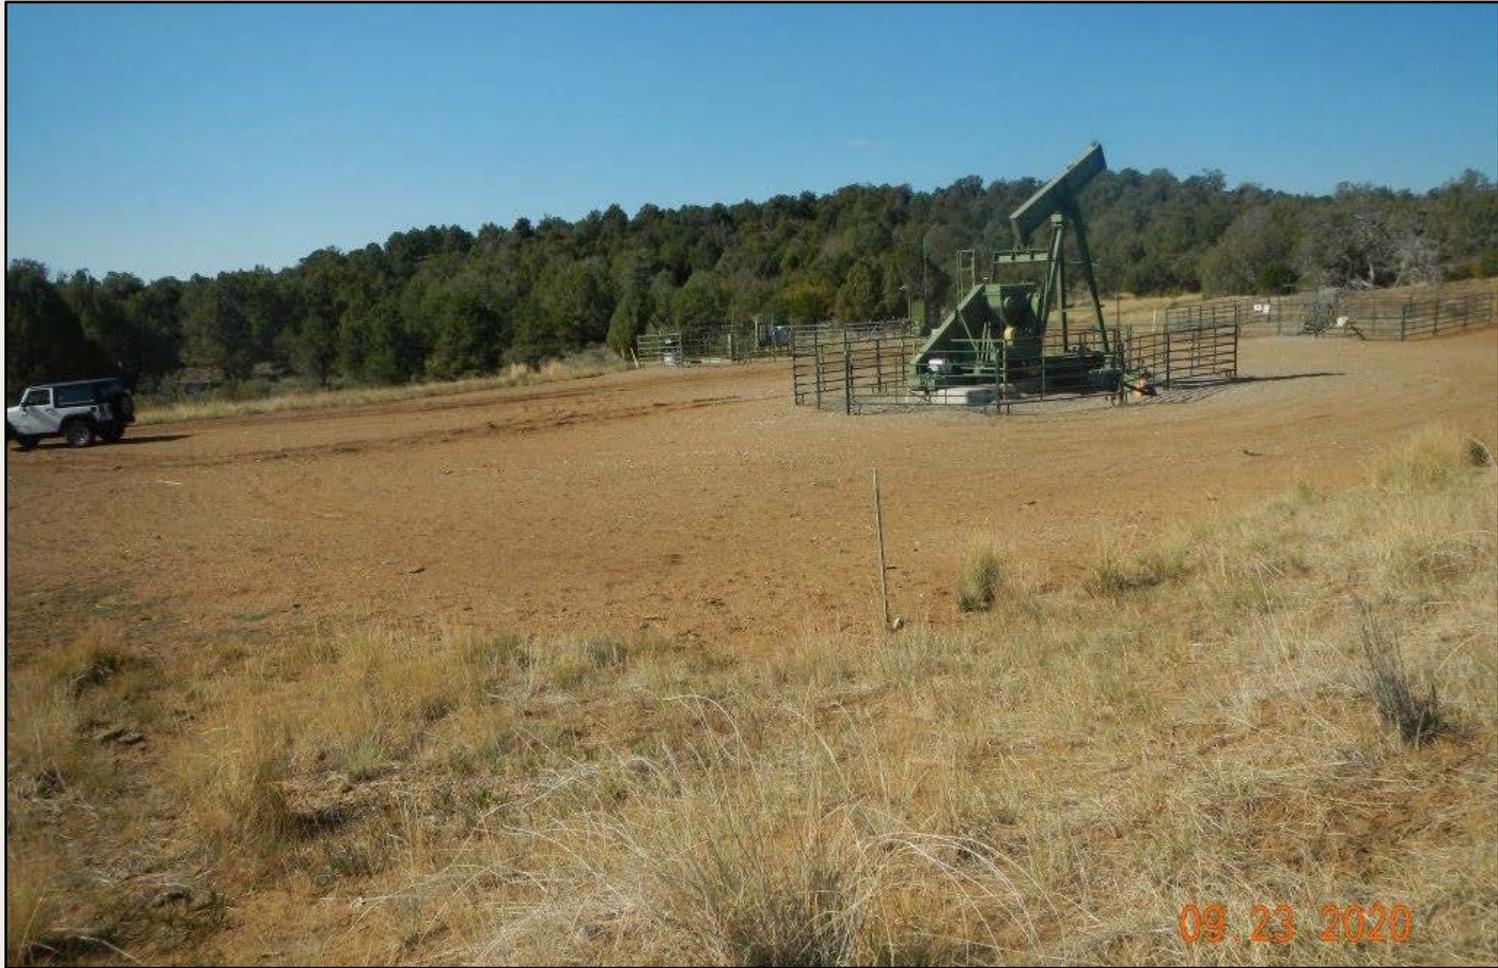
Photo 1. View of the project area from the southeastern corner facing center.

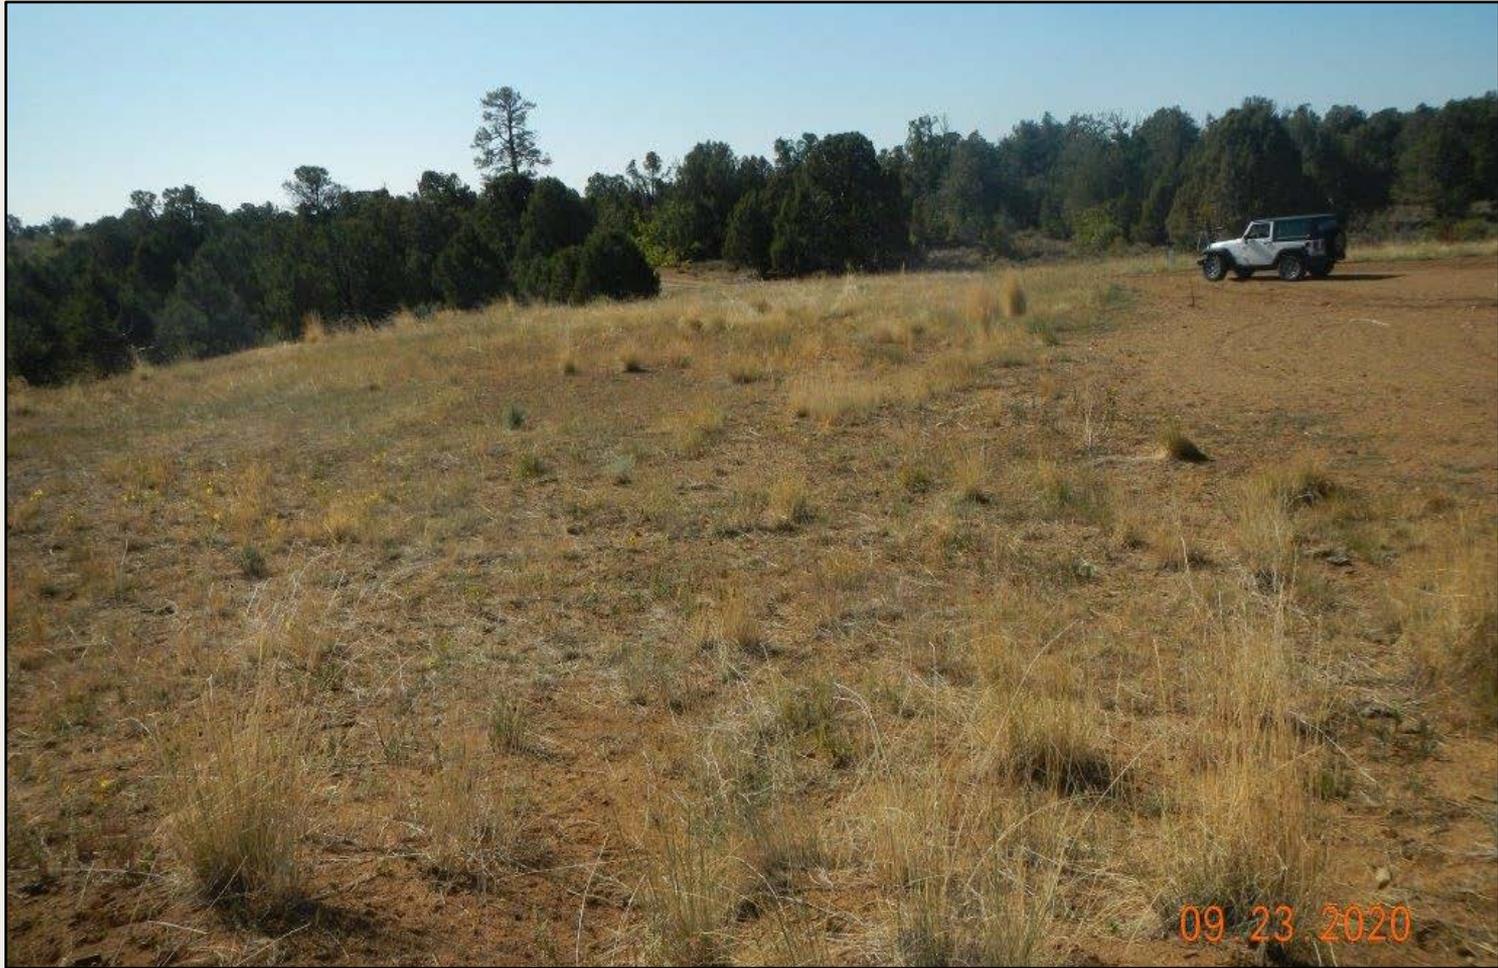
Photo 2. View of the southern fill slope from the southeastern edge facing westward. Revegetation is progressing with grasses such as western wheatgrass, crested wheatgrass, and intermediate wheatgrass.

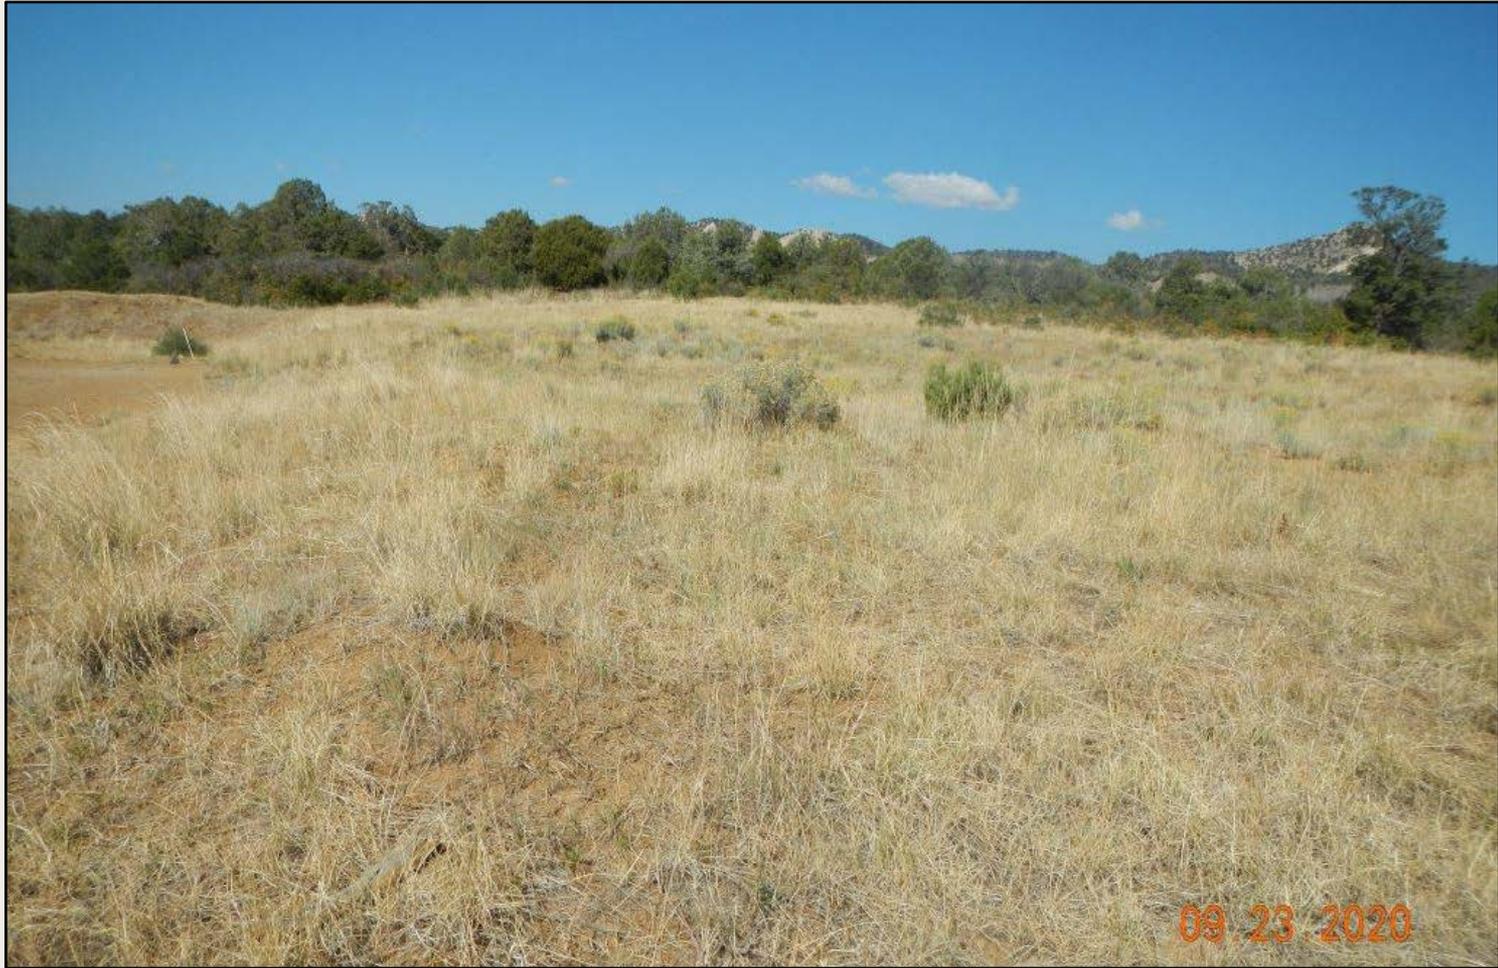
Photo 3. View of the northern project area the northeastern corner facing westward.

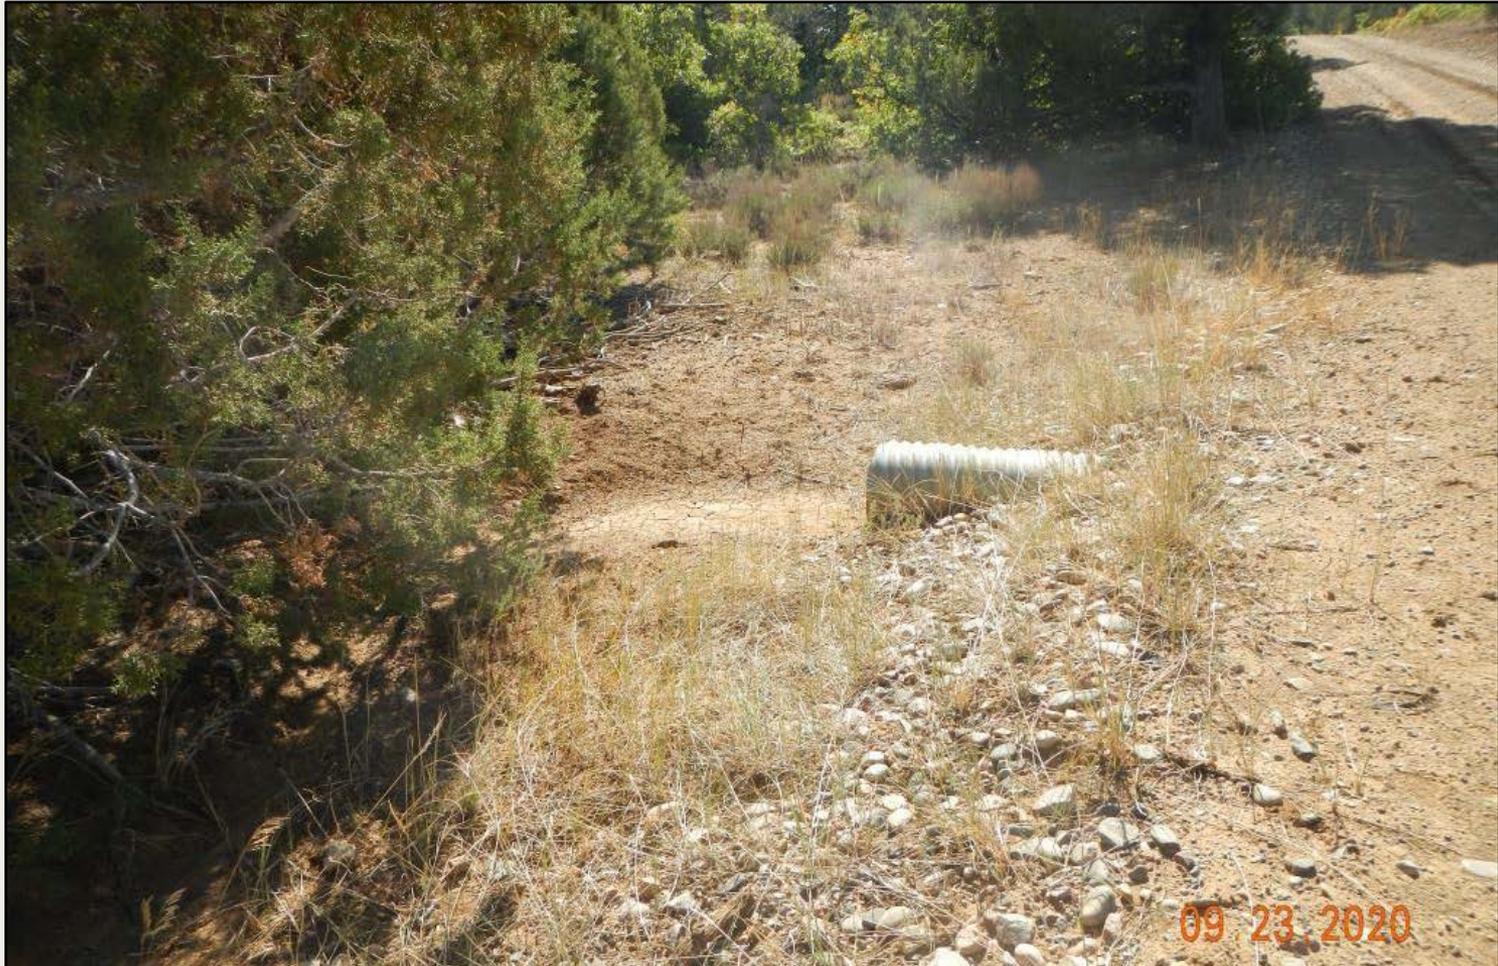
Photo 4. View of culvert outlet near the well pad entrance, appears to be stabilized at this time.

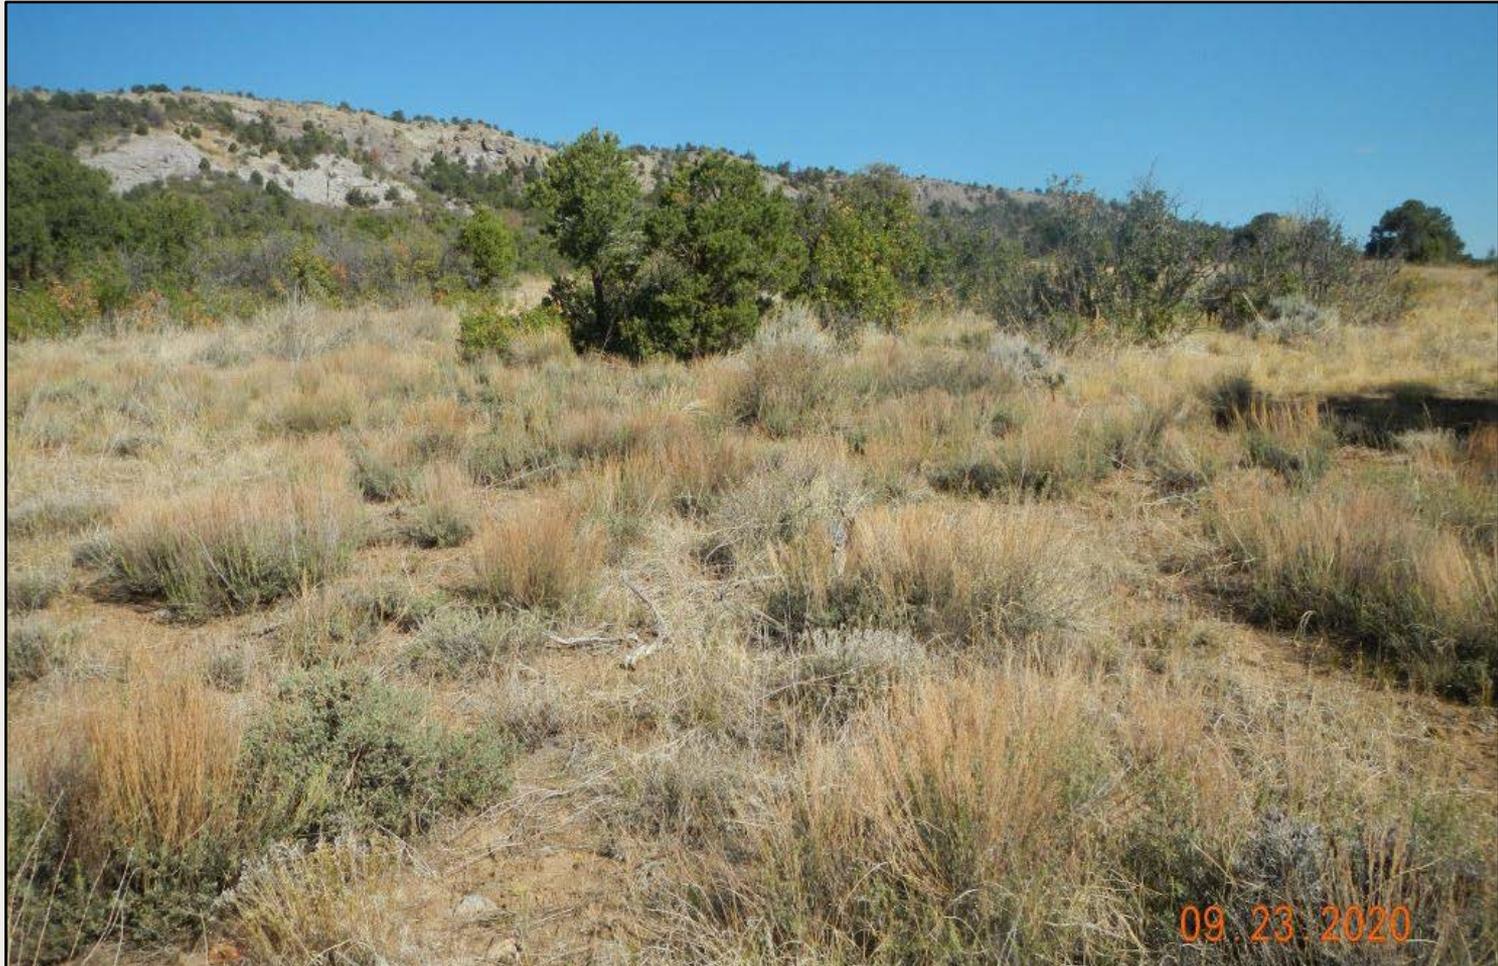
Photo 5. View of the reference area comprised of open pinyon and juniper woodland with black sage and grasses/forbs in the understory such as western wheatgrass, Indian ricegrass, and penstemon.
