# Inspection Photos

Operator: Enduring Resources  
API: 067-08401  
Date: 9/23/2020

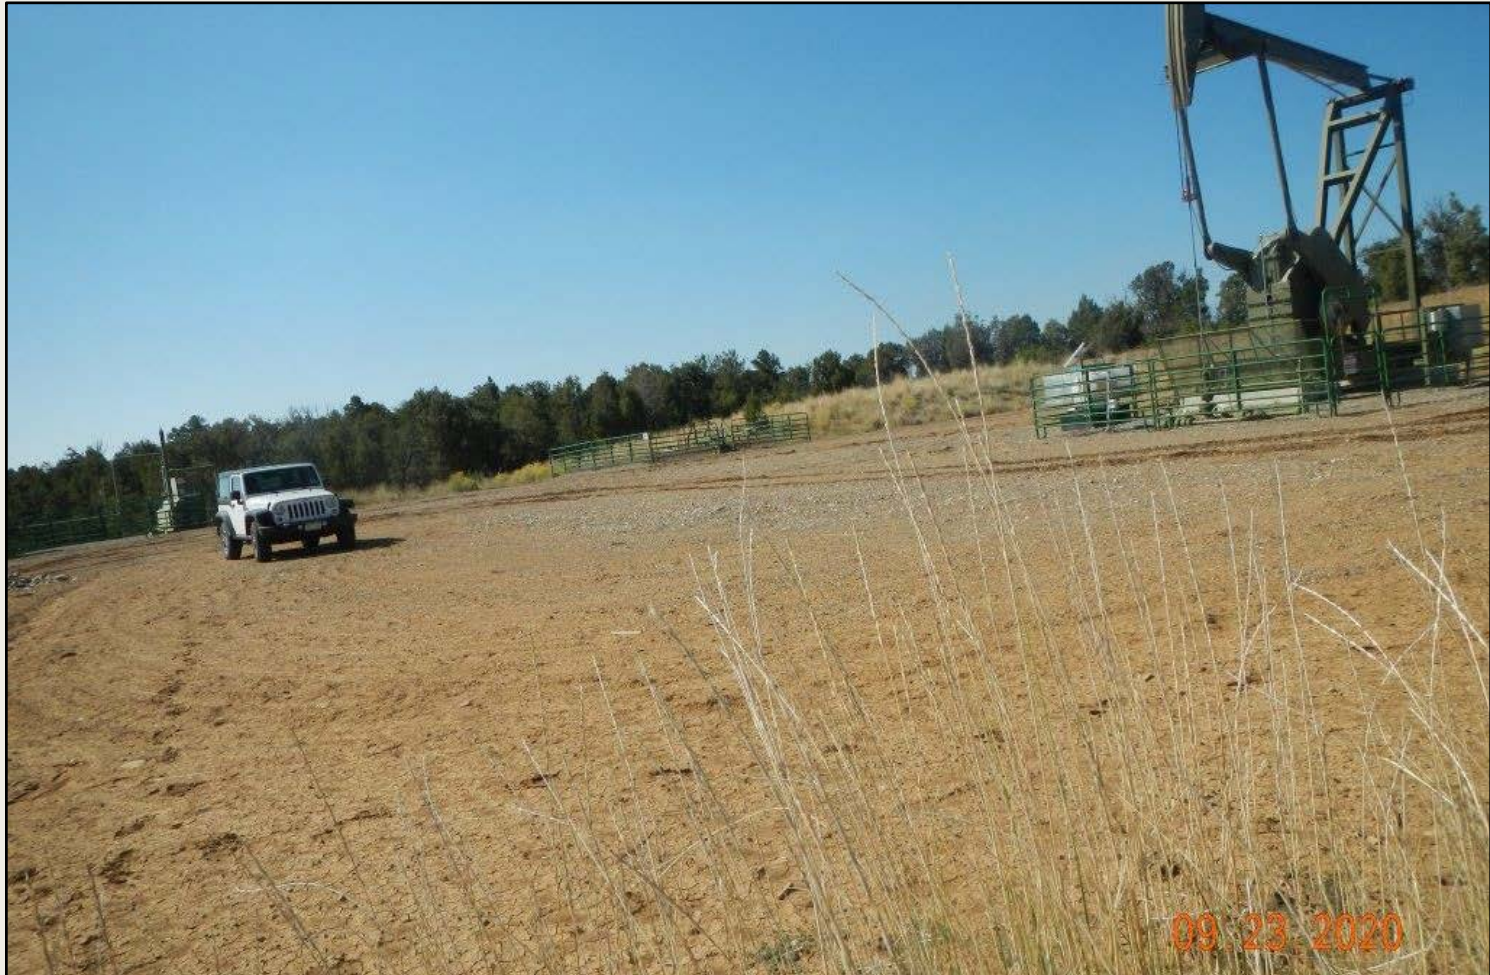
Photo 1. View of the project area from the northeastern corner facing center.

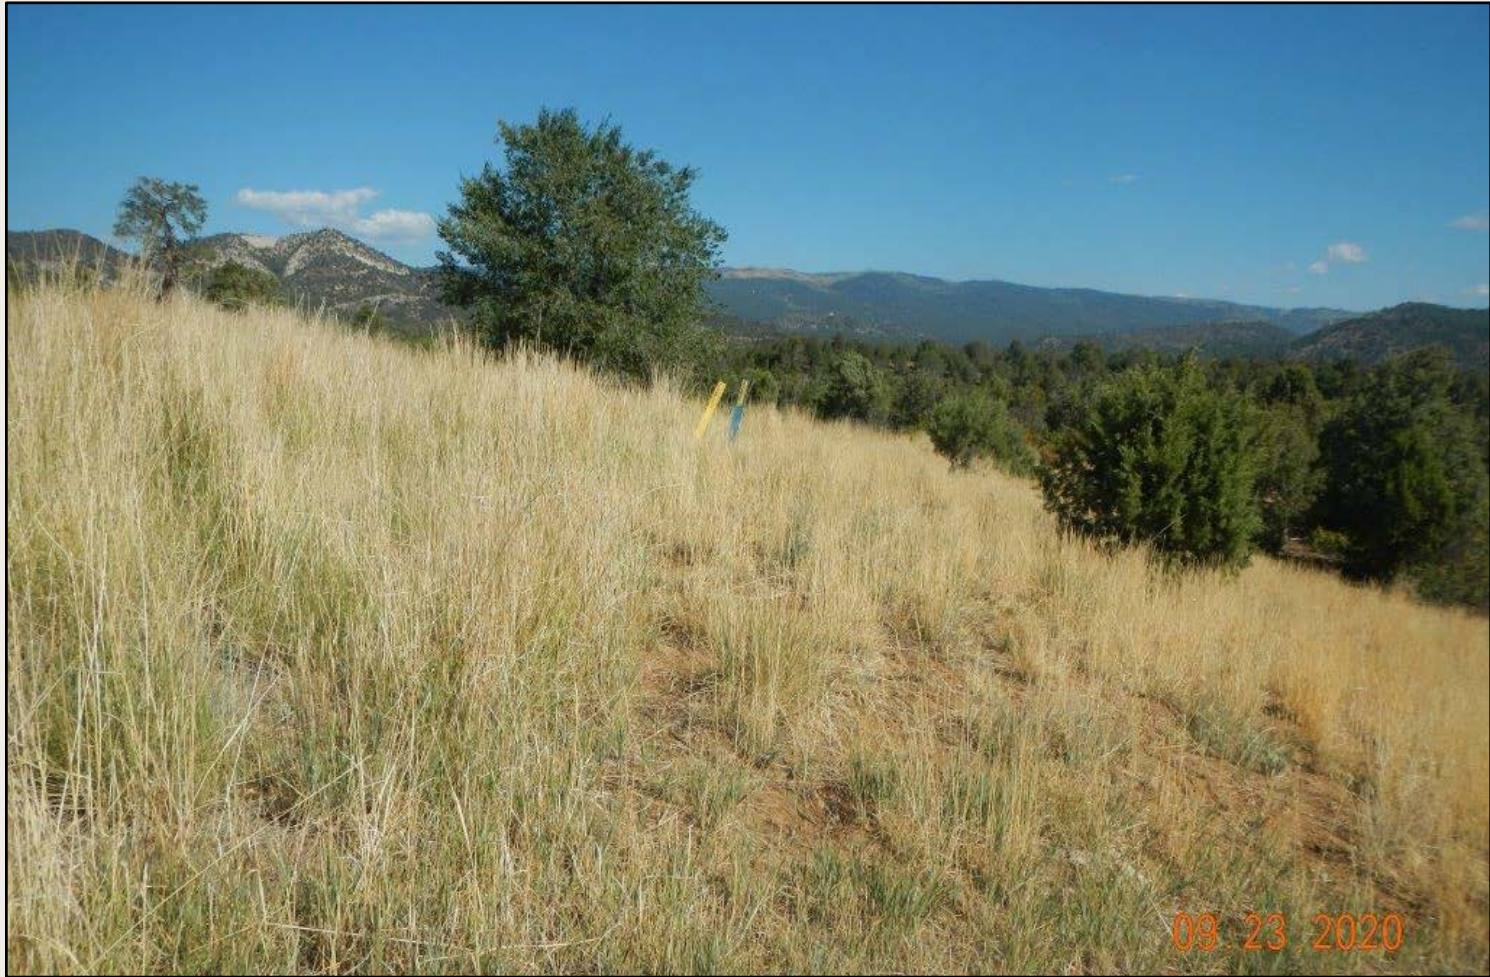
Photo 2. View of the eastern fill slope from the southeastern corner northward. Revegetation is progressing with grasses such as western wheatgrass, crested wheatgrass, and intermediate wheatgrass.

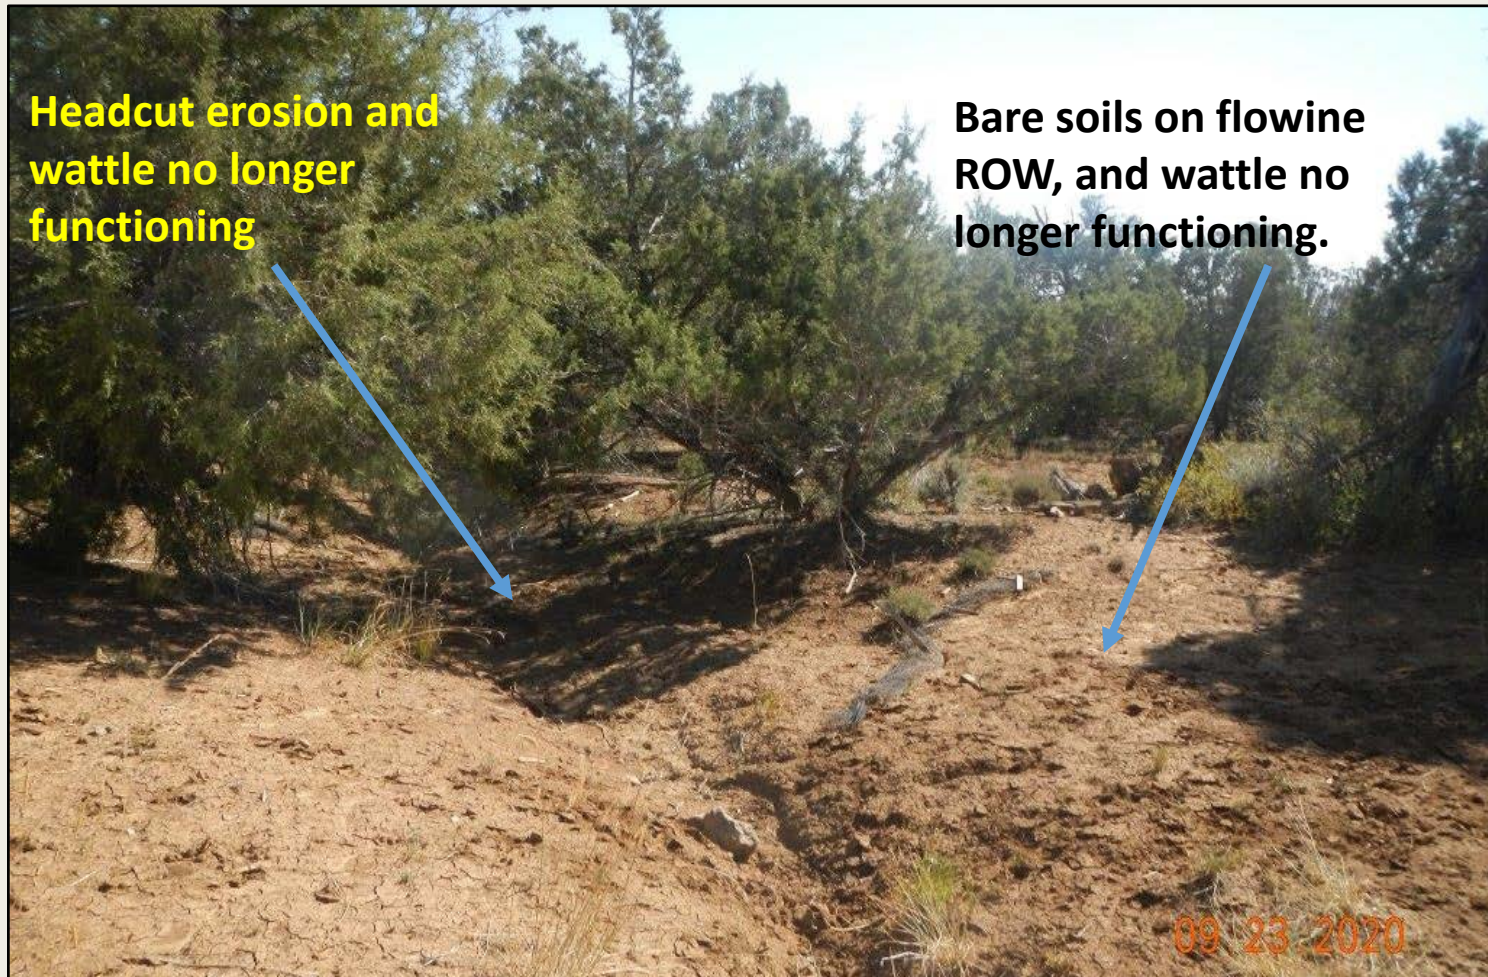
Photo 3. View of erosional channel/head-cut (approximately 2ft wide and 2-3 ft deep) in the southeastern corner of the project area. BMPs in this portion of the drainage are no longer functioning and do not appear adequate. Headcut erosion is occurring where concentrated stormwater flows off of the project area and adjacent pipeline alignment.

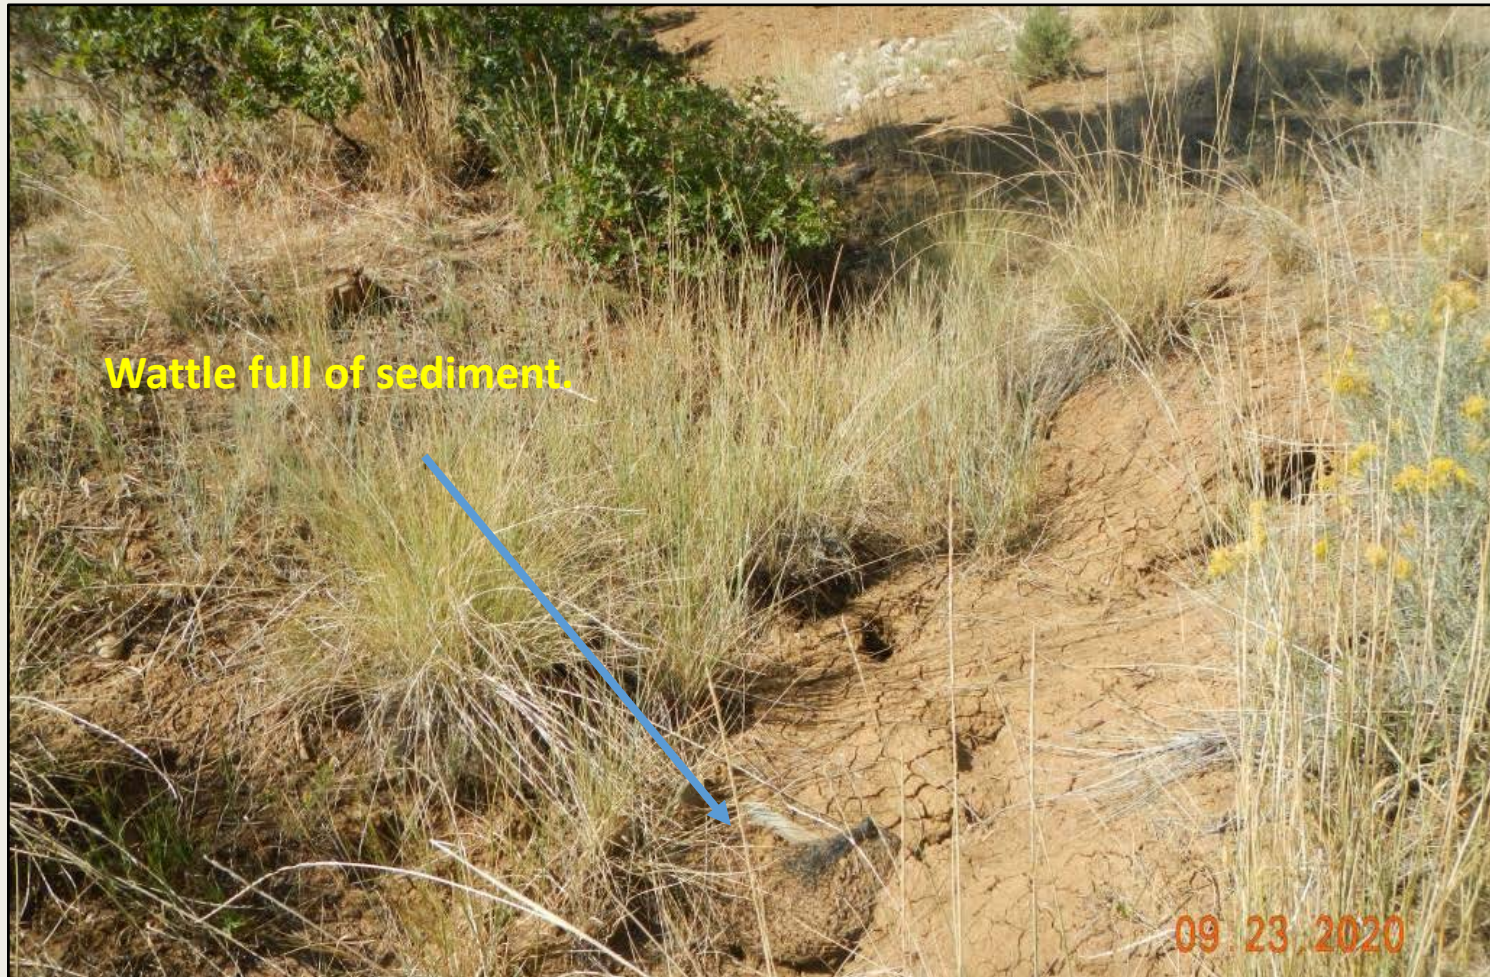
Photo 4. View of wattle in the drainage channel that is full of sediment and no longer functioning. BMP upstream of channel appears to be functioning at this time.

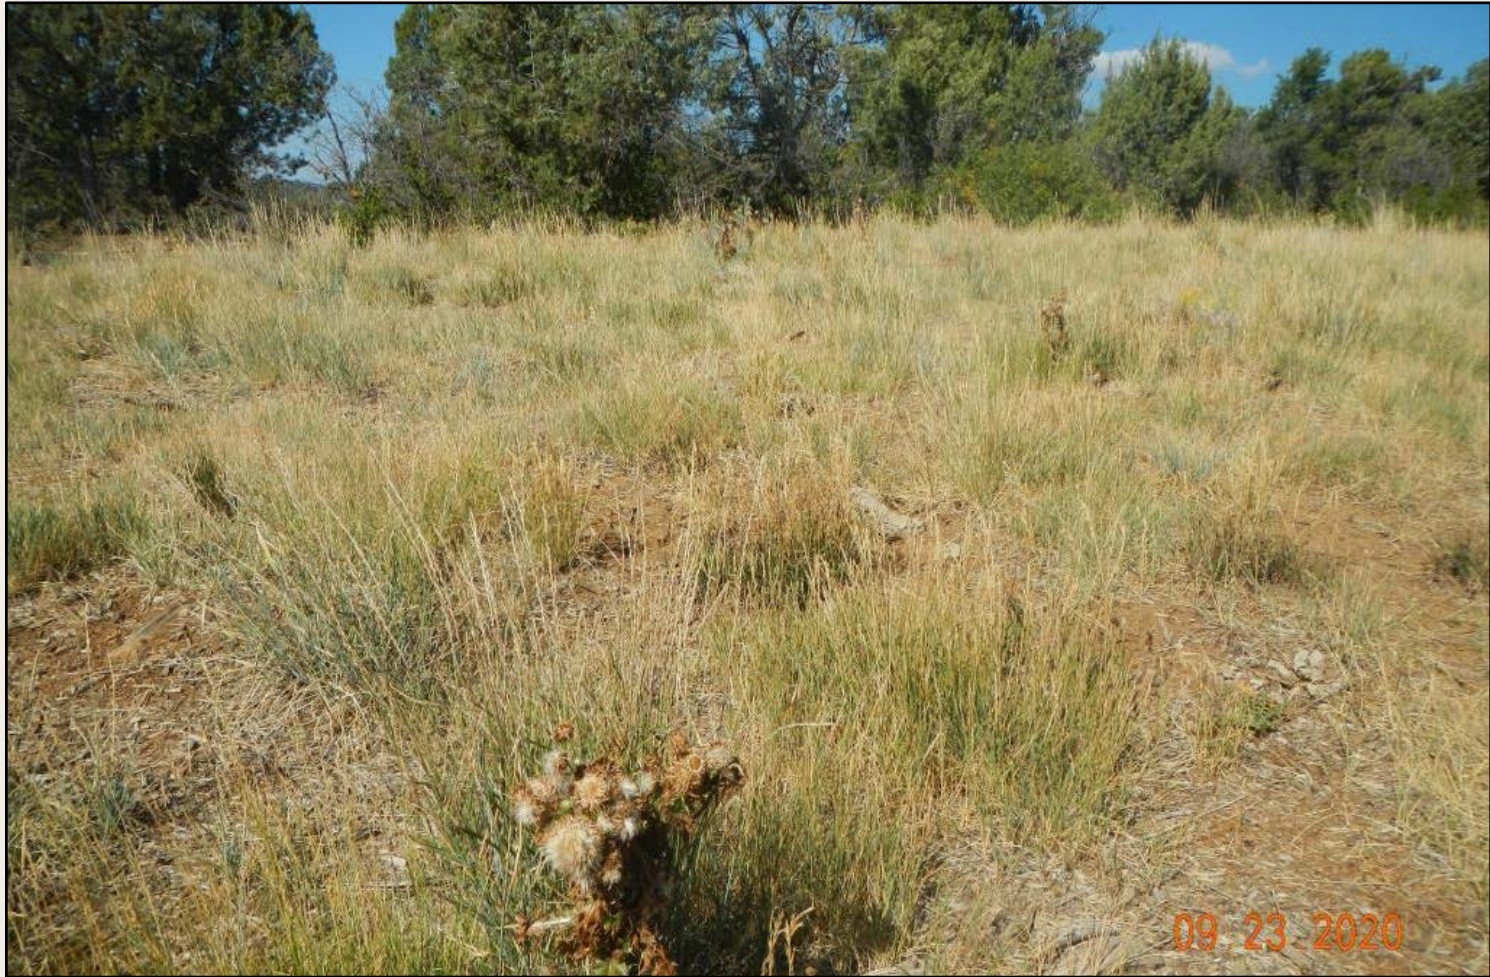
Photo 5. View of the southwestern project area. Weeds are largely controlled, however scattered musk thistles appear to have been treated after flowering and seedheads are present. Subsequent monitoring and treatment will likely be needed here.

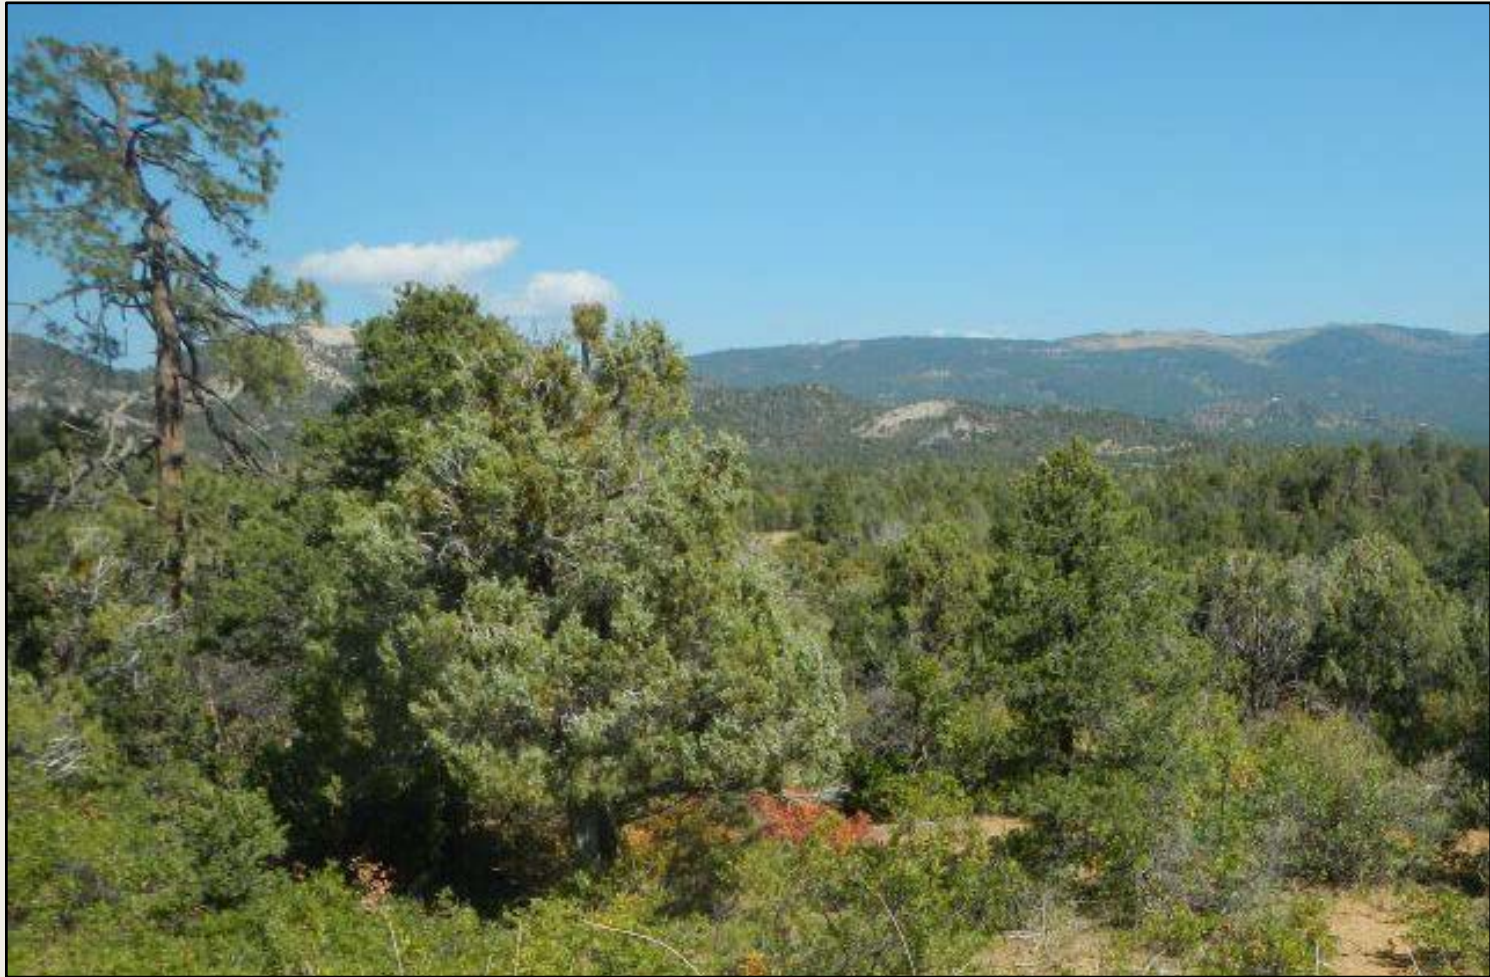
Photo 6. View of the reference area comprised of pinyon and juniper woodland with understory of shrubs such as gambel oak, antelope bitterbrush, mountain mahogany, and squaw apple, as well as grasses and forbs such as western wheatgrass, squirreltail, and buckwheat.
