Inspection Photos
Spill ID 449632
Remediation Project 10149
Inspection Date: 9/16/2020
All Photos taken by Kris Neidel

COLORADO
Oil & Gas Conservation
Commission
Department of Natural Resources

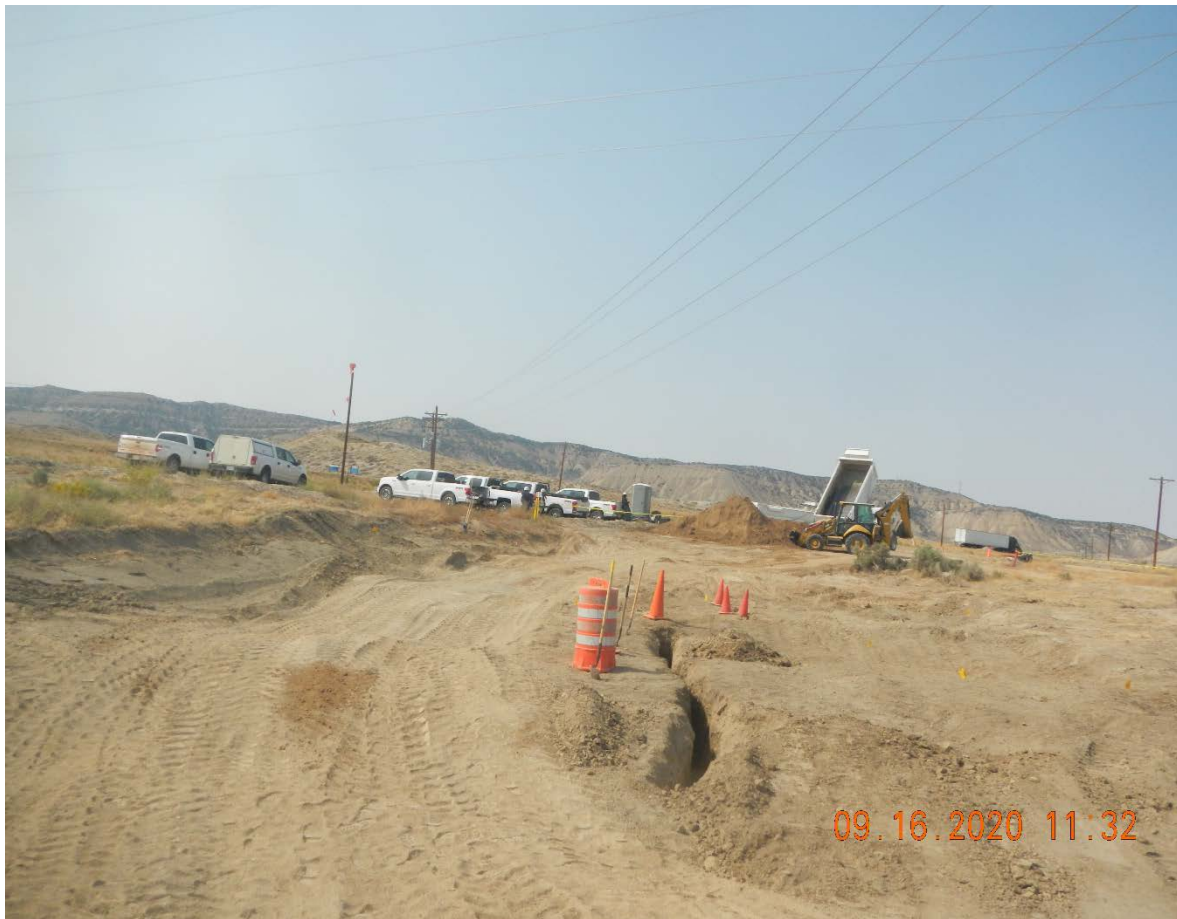
Photo #1 Photo taken standing in the “bow”. Dump truck is unloading fill material. The trench in center of photo was done with hydrovac to expose 3 abandon lines that are in center of pit

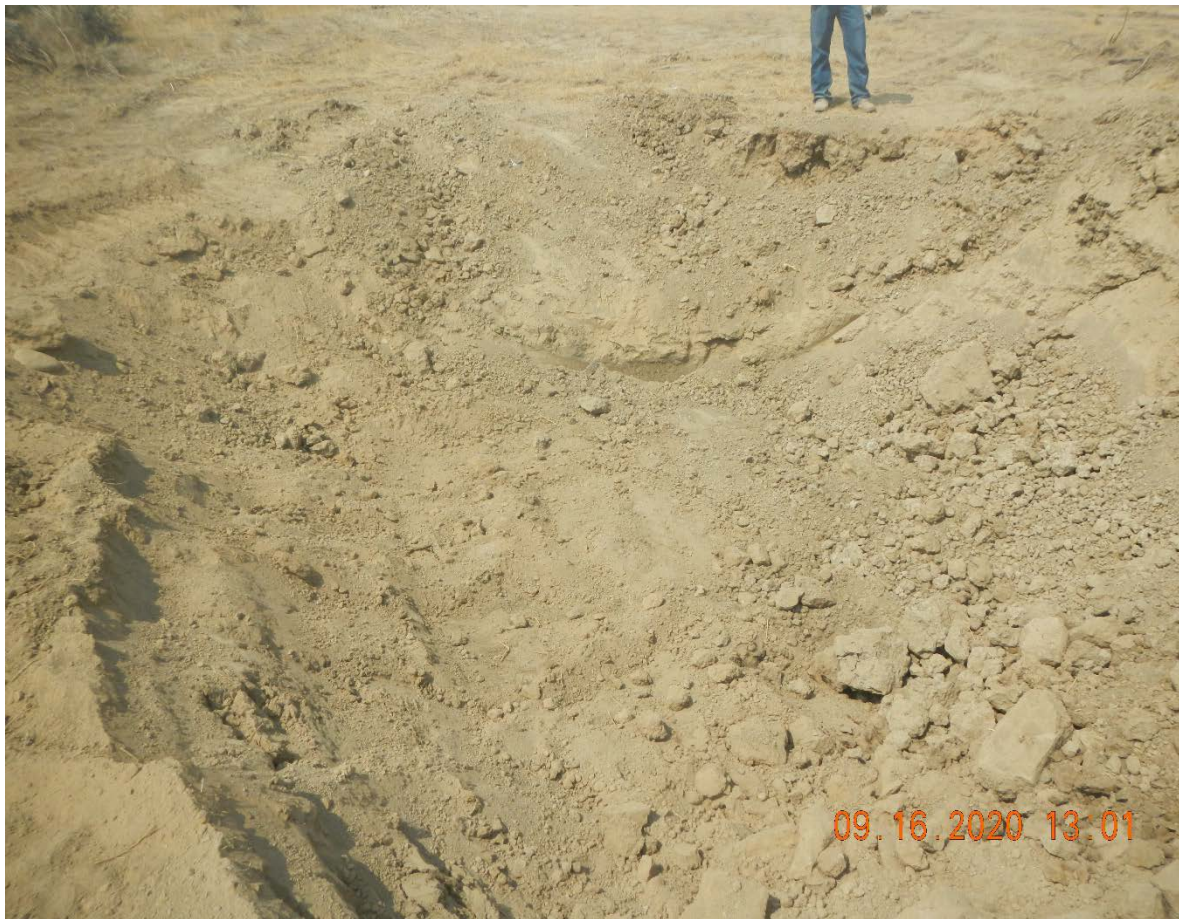
Photo #2 area of excavation in bowl. It was determined that further excavation is required.

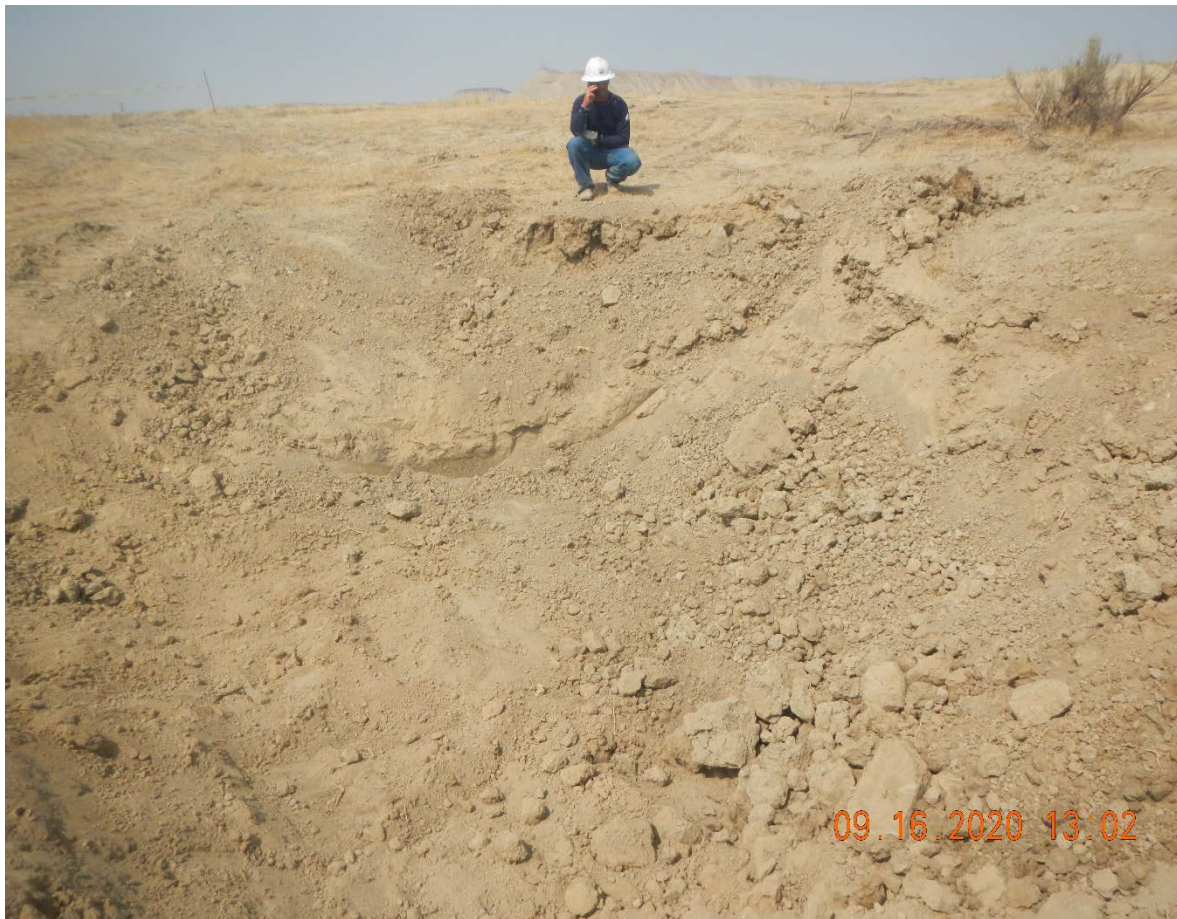
Photo #3 area of excavation in bowl. It was determined that further excavation is required.

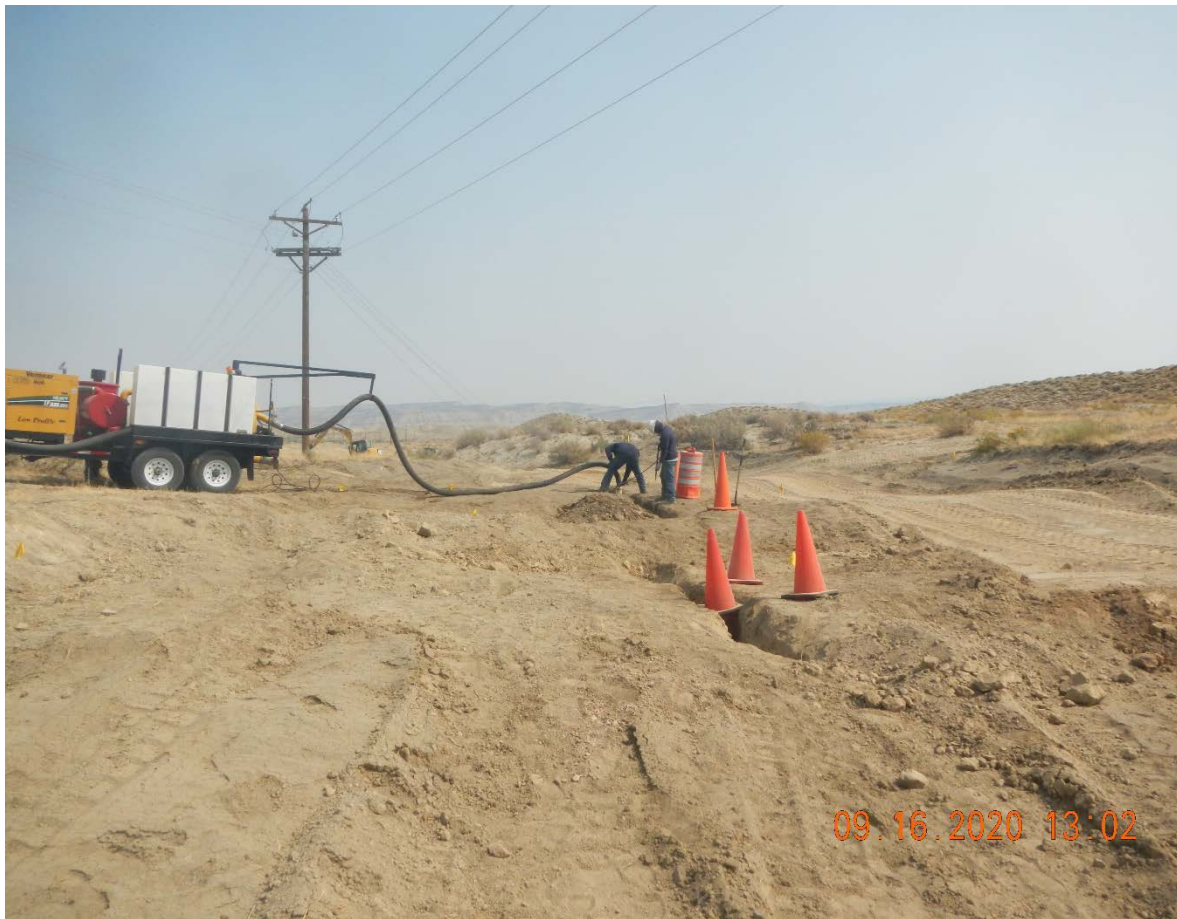
Photo #4 Standing in the “bow” looking down the spill path (north east). Crew hydrovacing for 3 abandon flowlines.

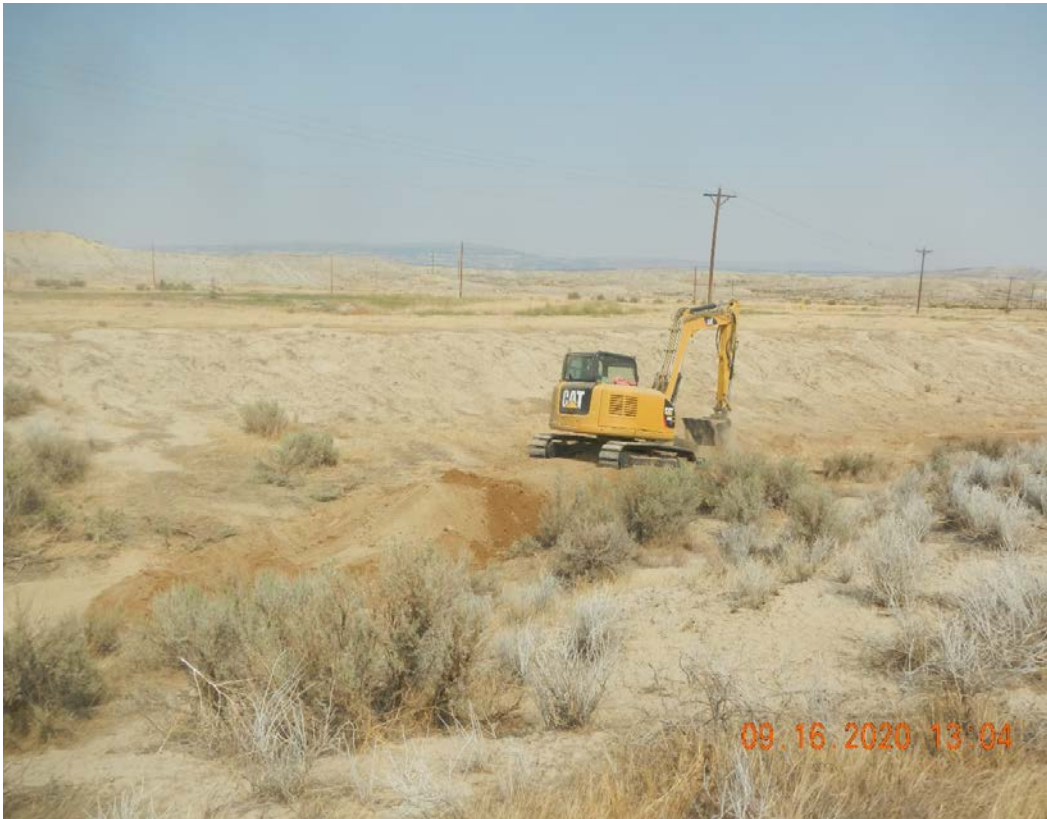
Photo #5 Crews were; excavating approximately 2 feet of existing spill path (creek bed), bucket blending fill and impacted soil(loader dump soil where excavator was storing soil), tilling the blended soil, tilling the bottom of excavation, adding a 4-6" lift of blended soil, tilling the blended soil with native, then repeating the addition of blended soil and tilling until final grade was obtained. This process progressed upstream.

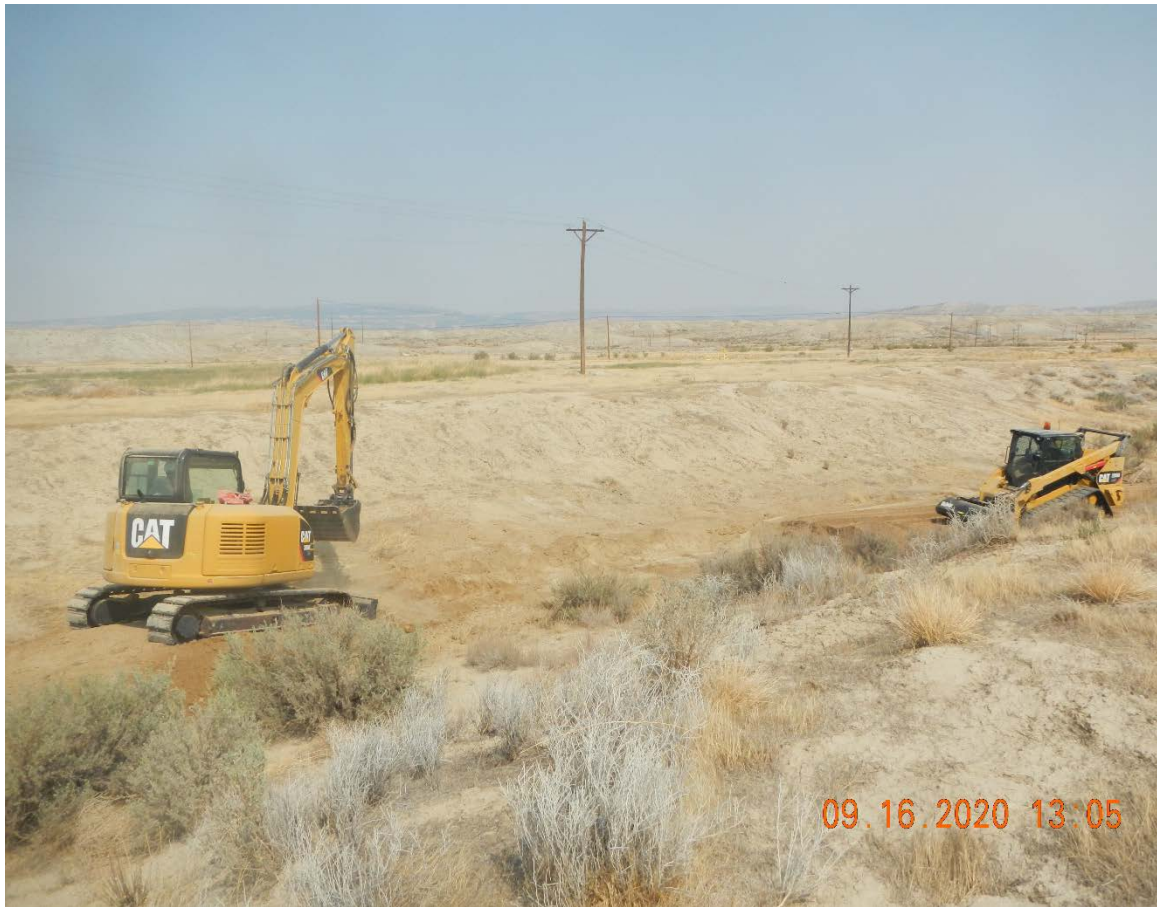
Photo #6 Crews were; excavating approximately 2 feet of existing spill path (creek bed), bucket blending fill and impacted soil(loader dump soil where excavator was storing soil), tilling the blended soil, tilling the bottom of excavation, adding a 4-6" lift of blended soil, tilling the blended soil with native, then repeating the addition of blended soil and tilling until final grade was obtained. Work was progressing from the right of the photo to left.

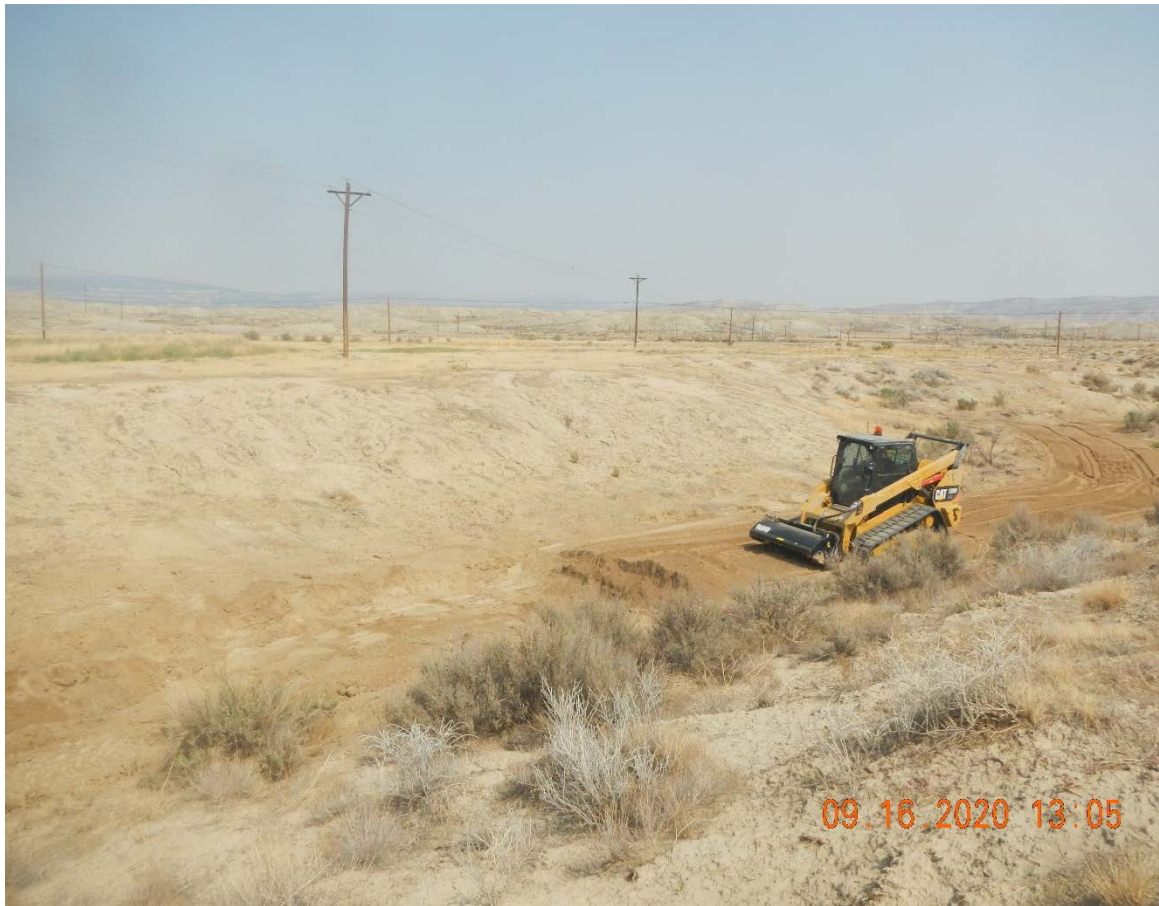
Photo #7 Area behind skid mounted tiller is final grade/final blended soil.

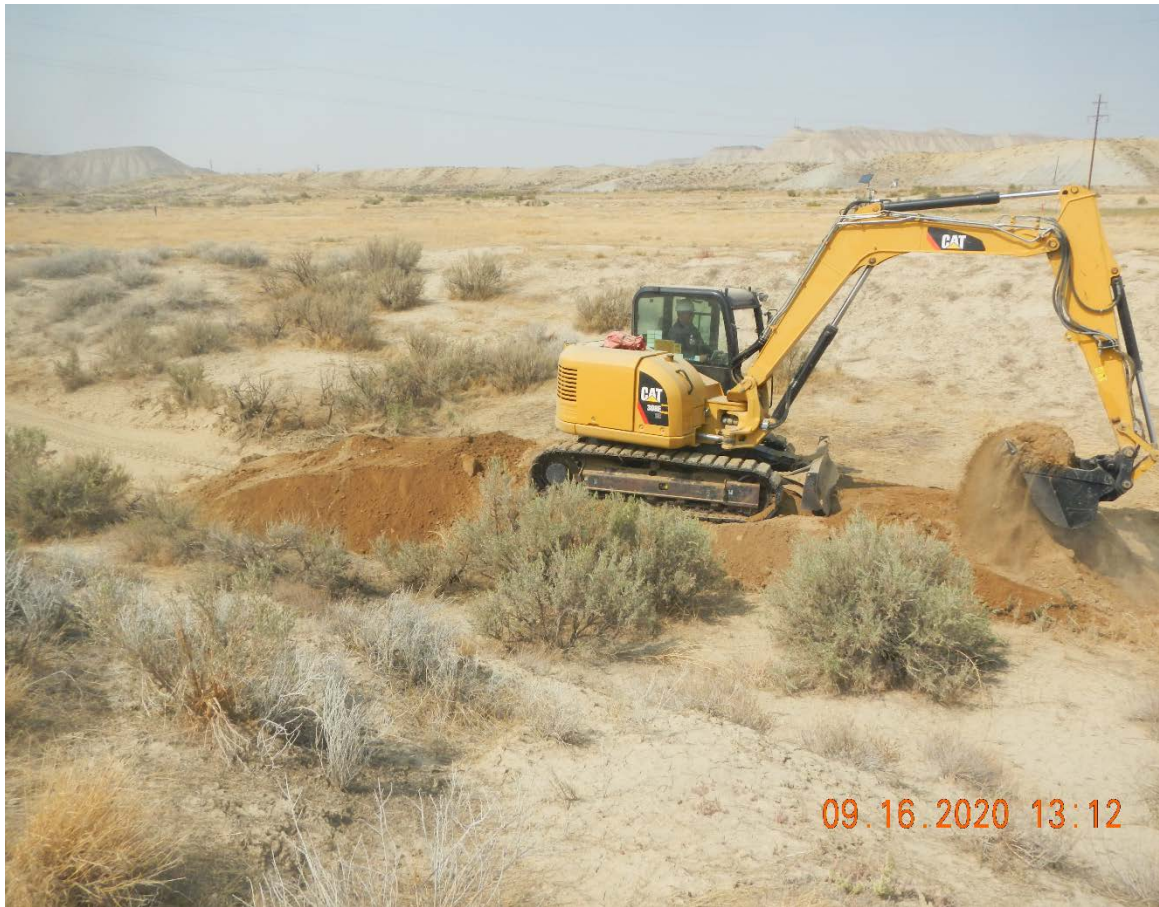
Photo #8 mini track hoe is further blending excavated soil and fill soil.

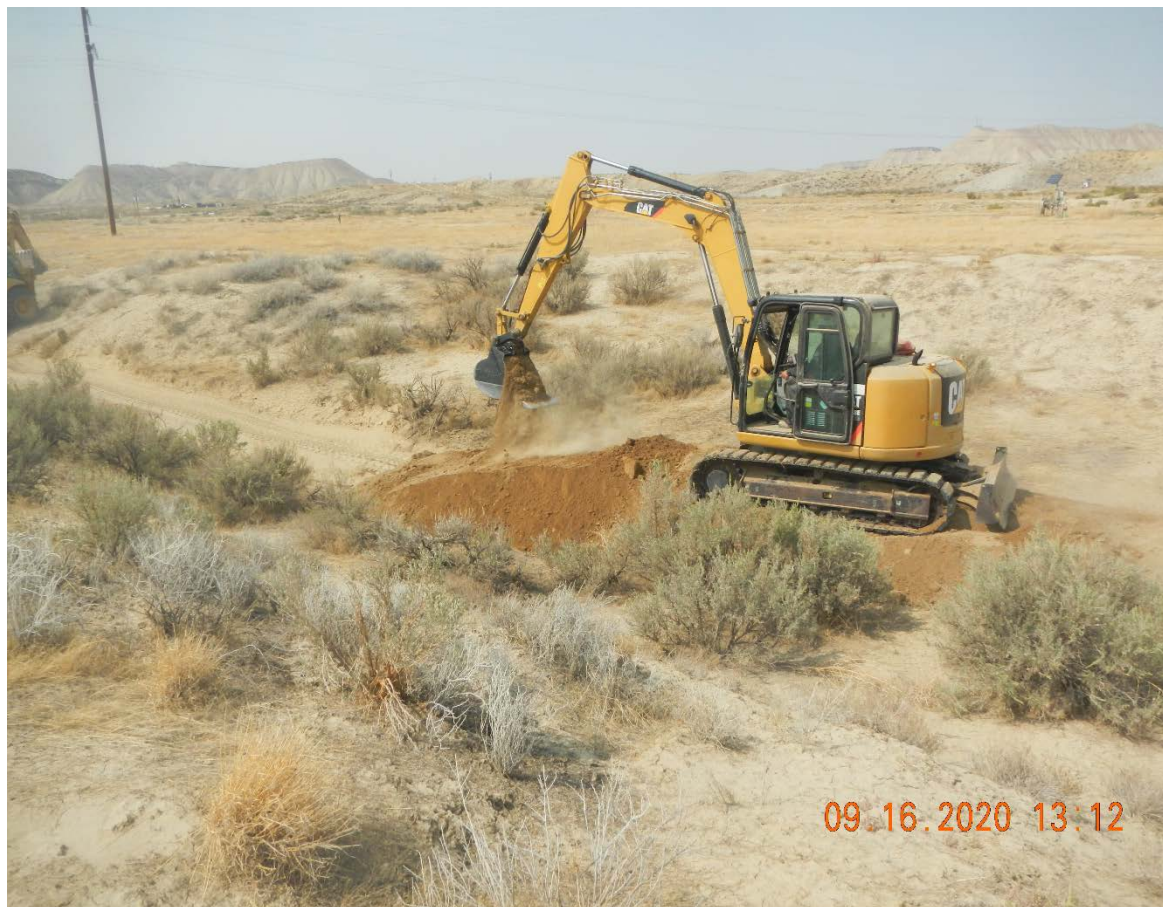
Photo #9 mini track hoe is further blending excavated soil and fill soil.

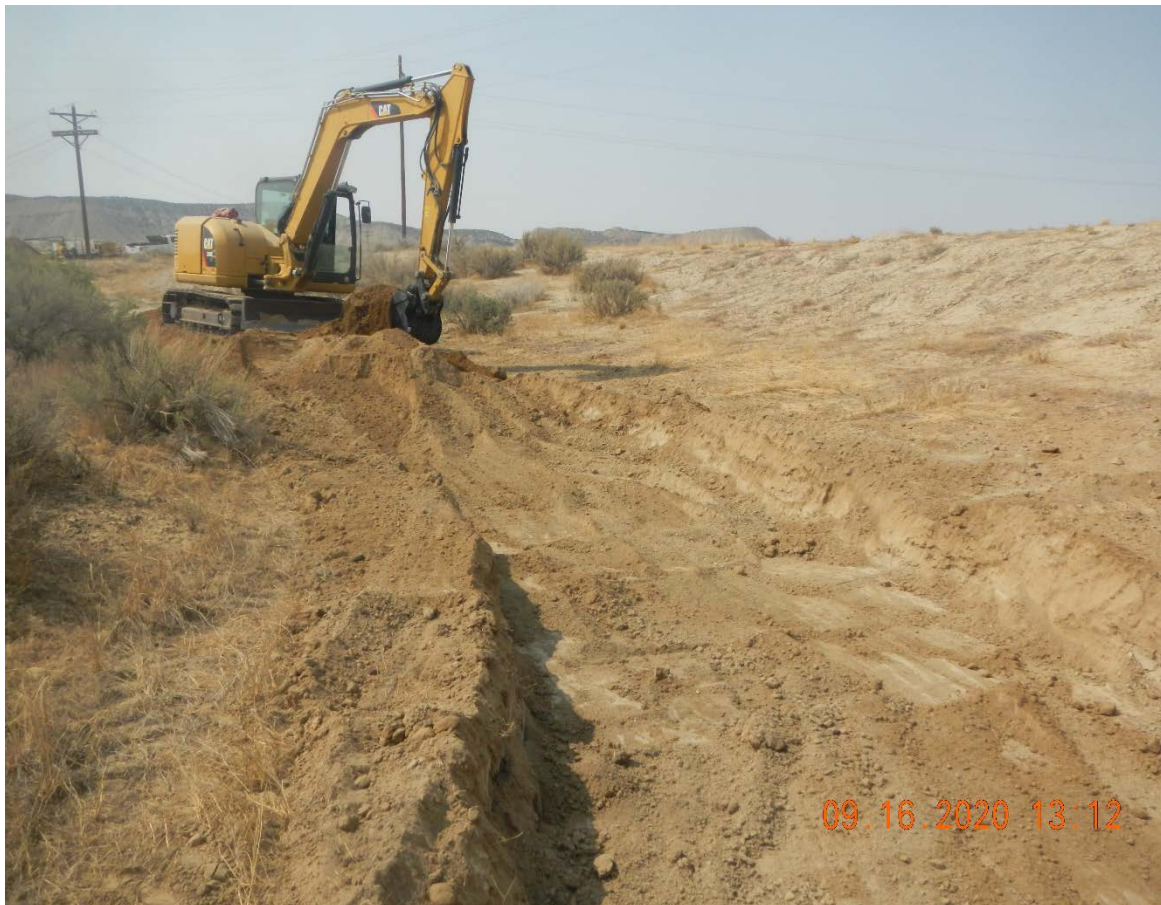
Photo #10 bottom of excavation.

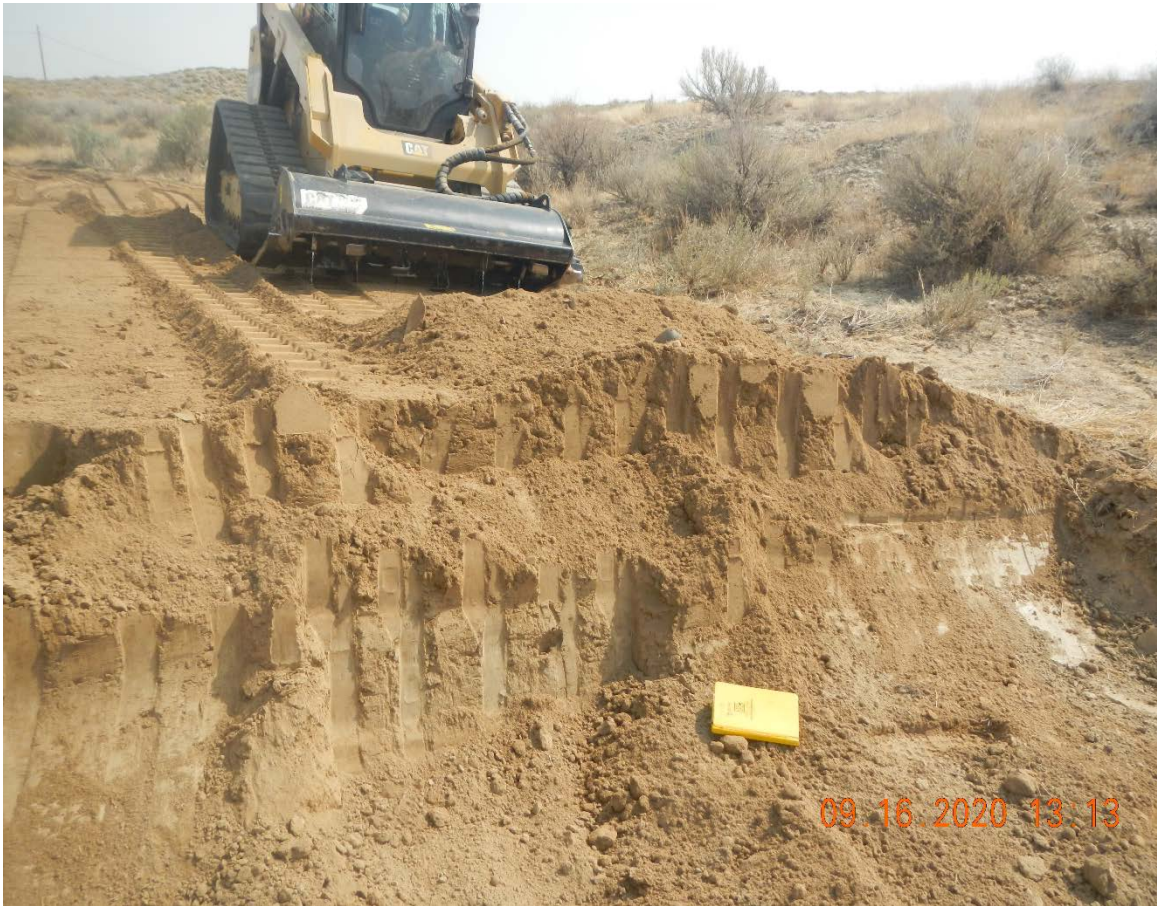
Photo #11 skidsteer is parked on final grade (see photo #7).
Photo shows elevation between excavation and final
blended/grade.

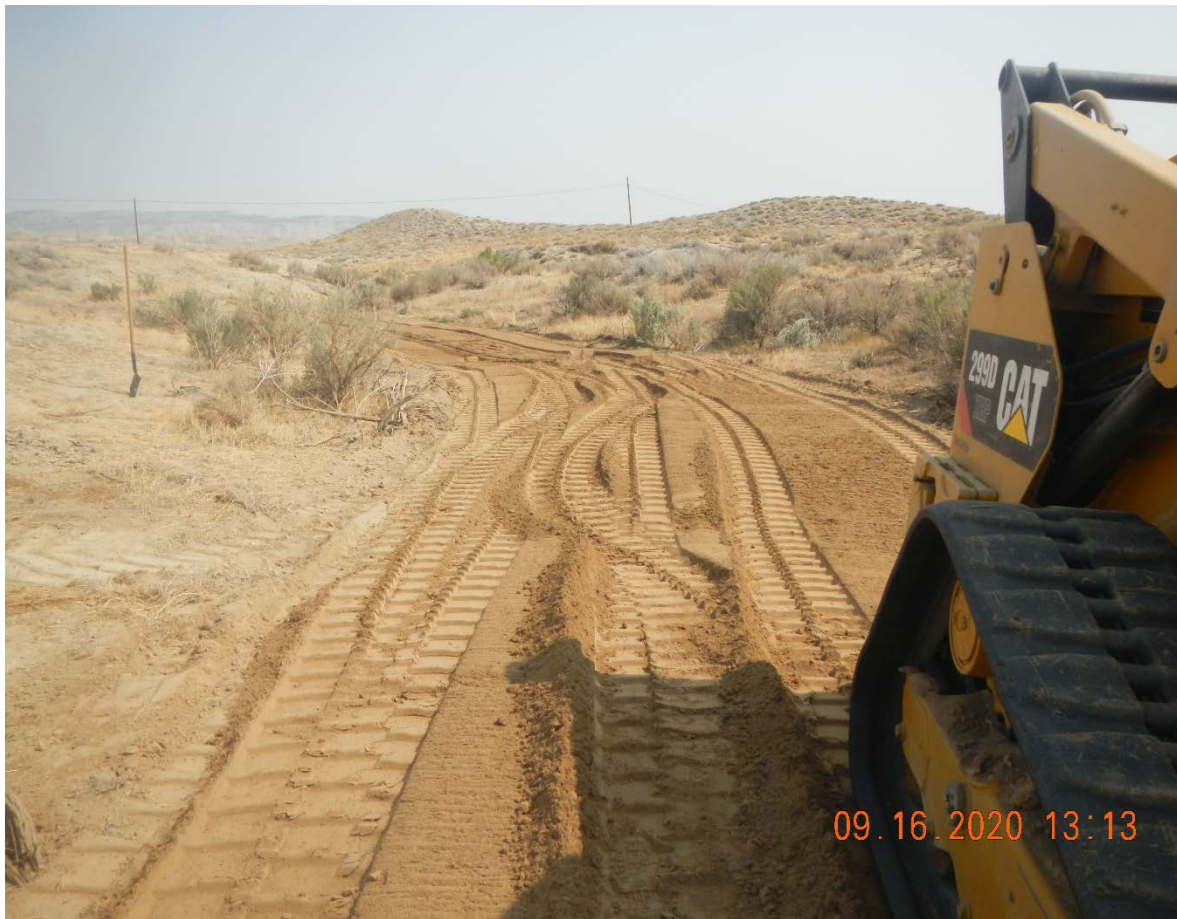
Photo #12 looking downstream at final grade. Part of division 1.

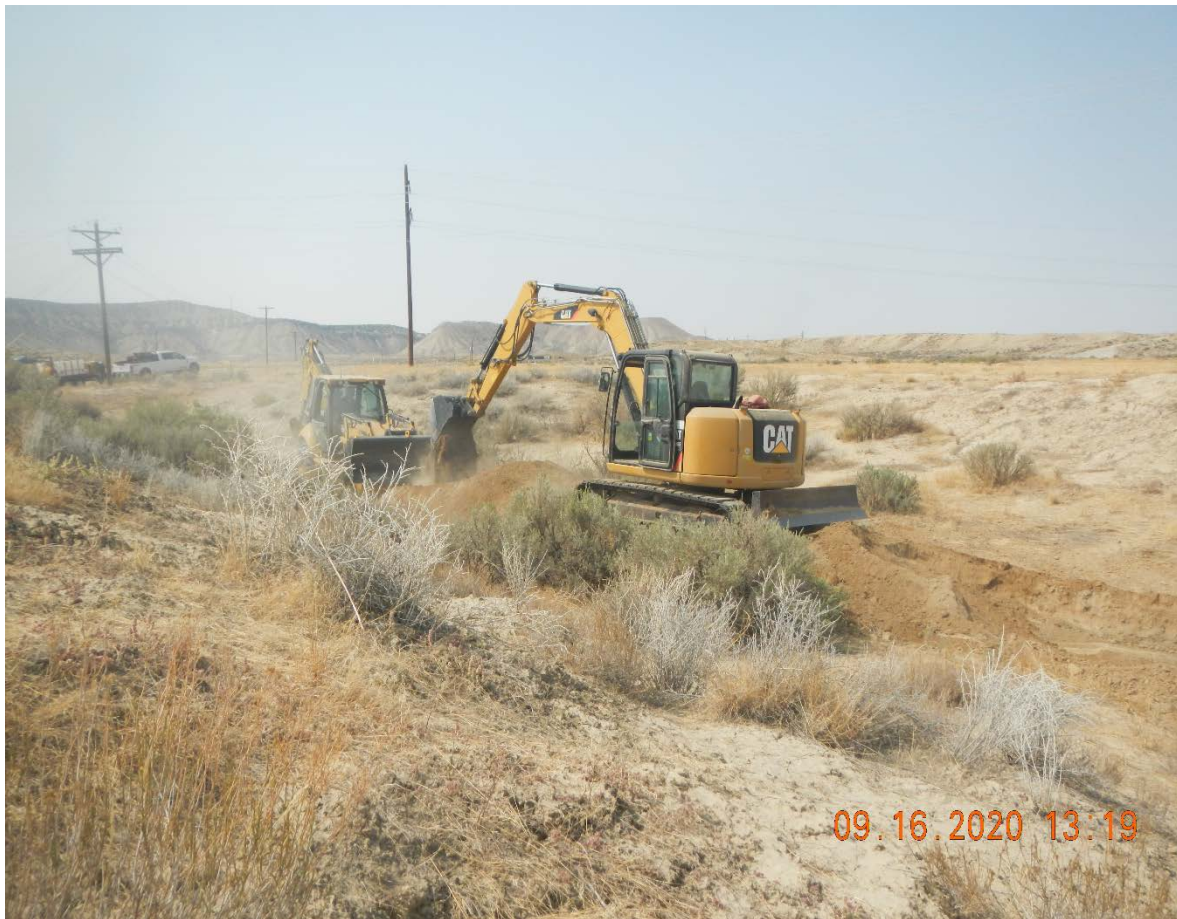
Photo #13 blending of fill and excavated soil with buckets.

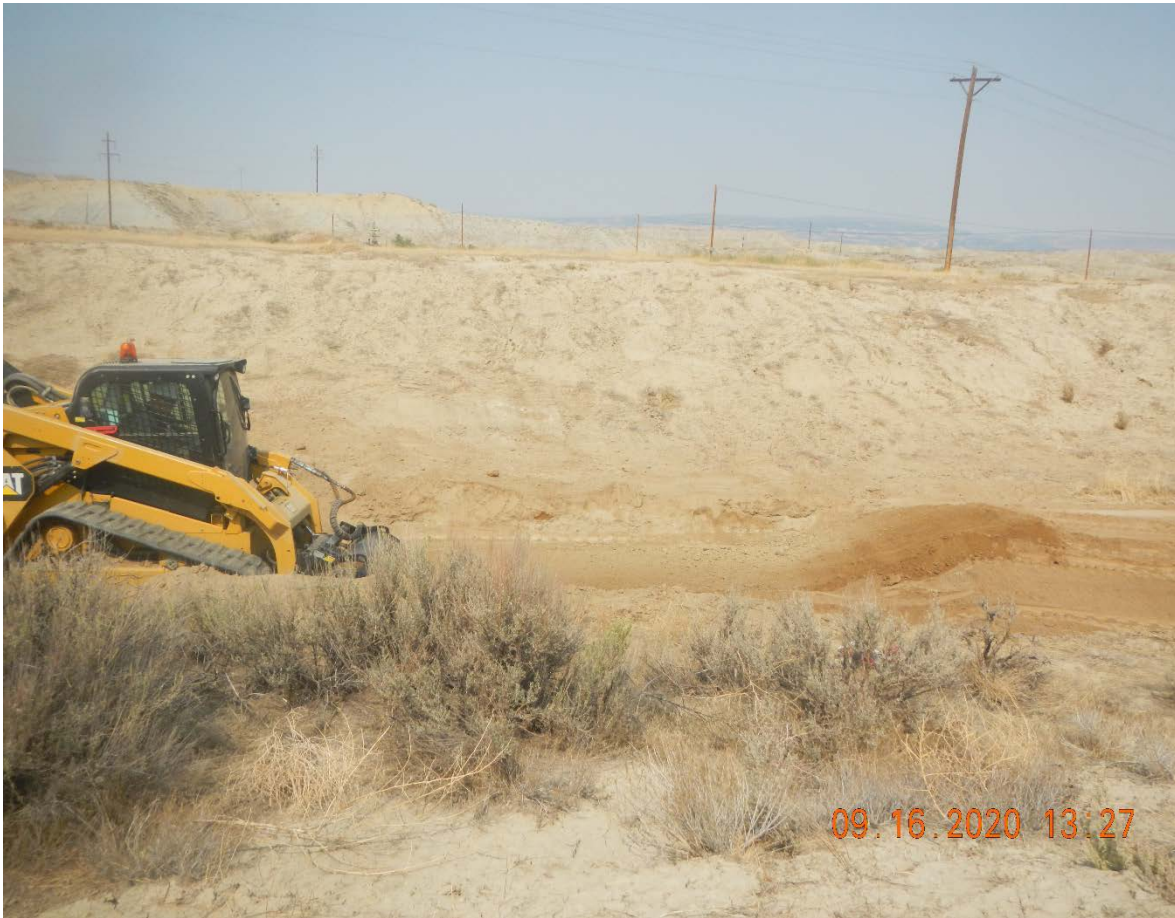
Photo #14 bottom of excavation was tilled prior to placing the first lift of blended soil. After each (approximately 4" lift) was placed back in excavation area, the lift was tilled to incorporate with bottom of excavation.

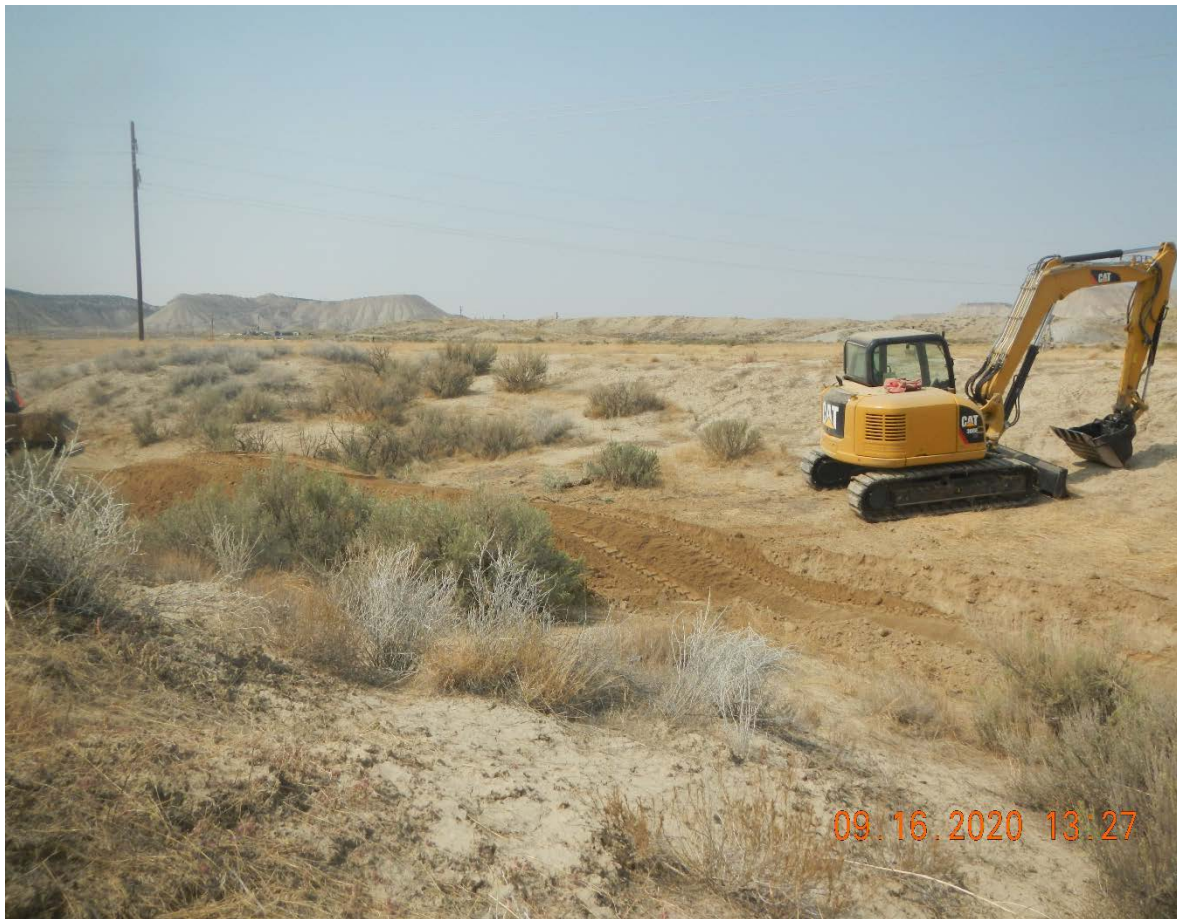
Photo #15 continuing to blend, fill, till.

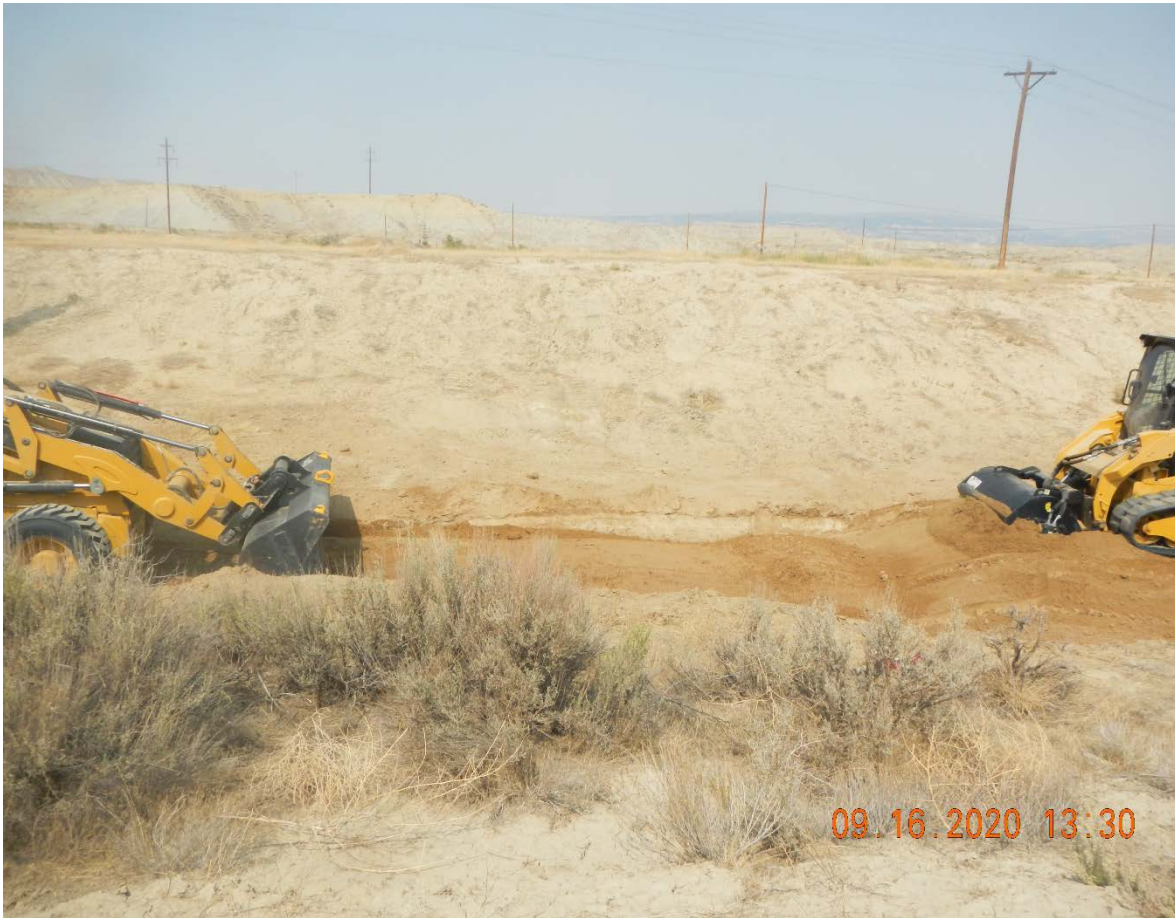
Photo #16 pushing in fill and tilling

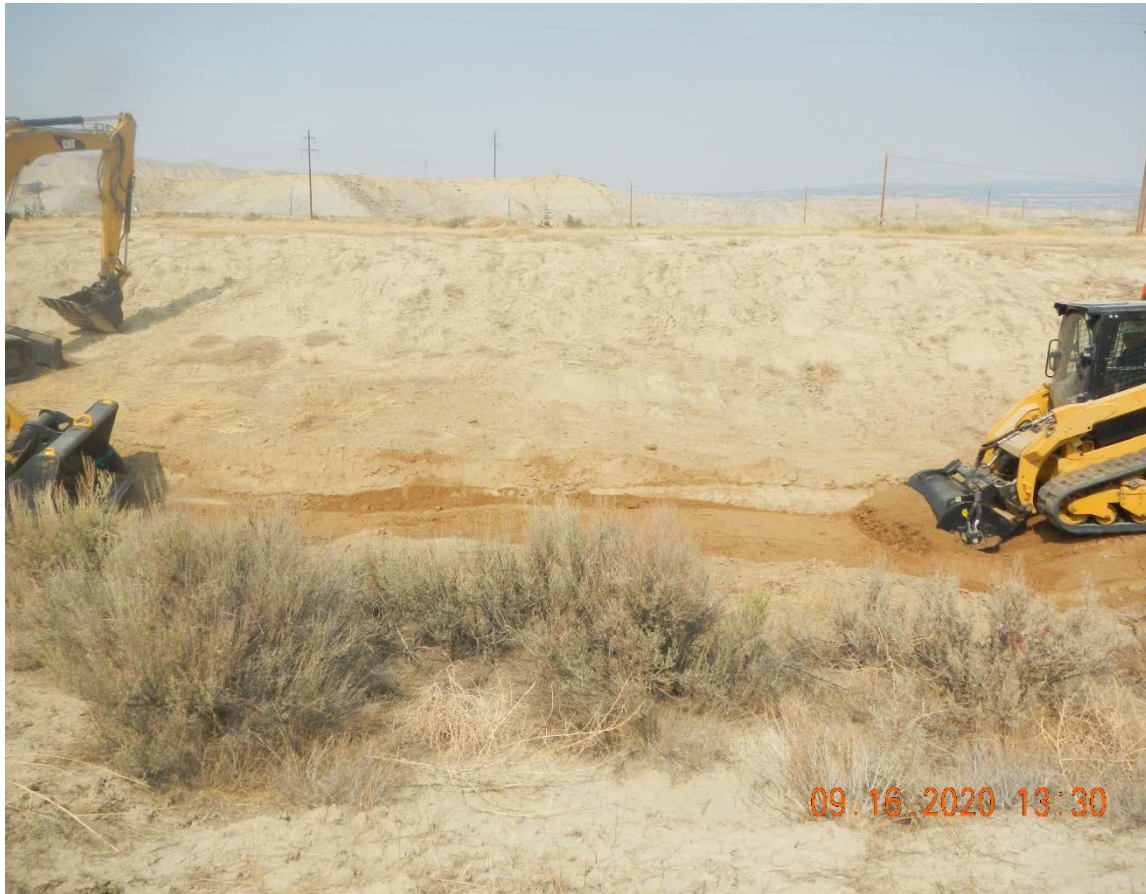
Photo #17 tilling fill blend

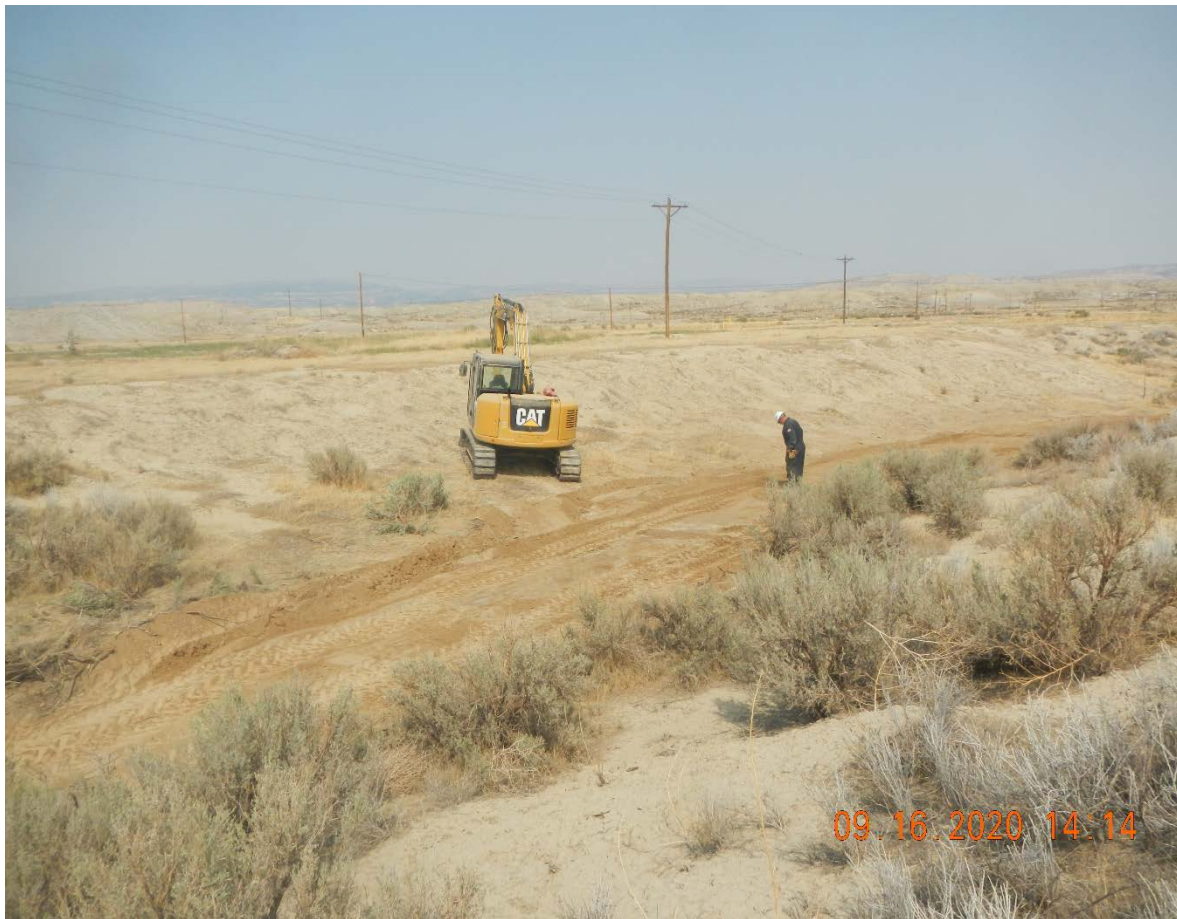
Photo #18 crew inspecting fill.
