Issue Report

Keller 20-13, 125-07340

Report created on September 22, 2020

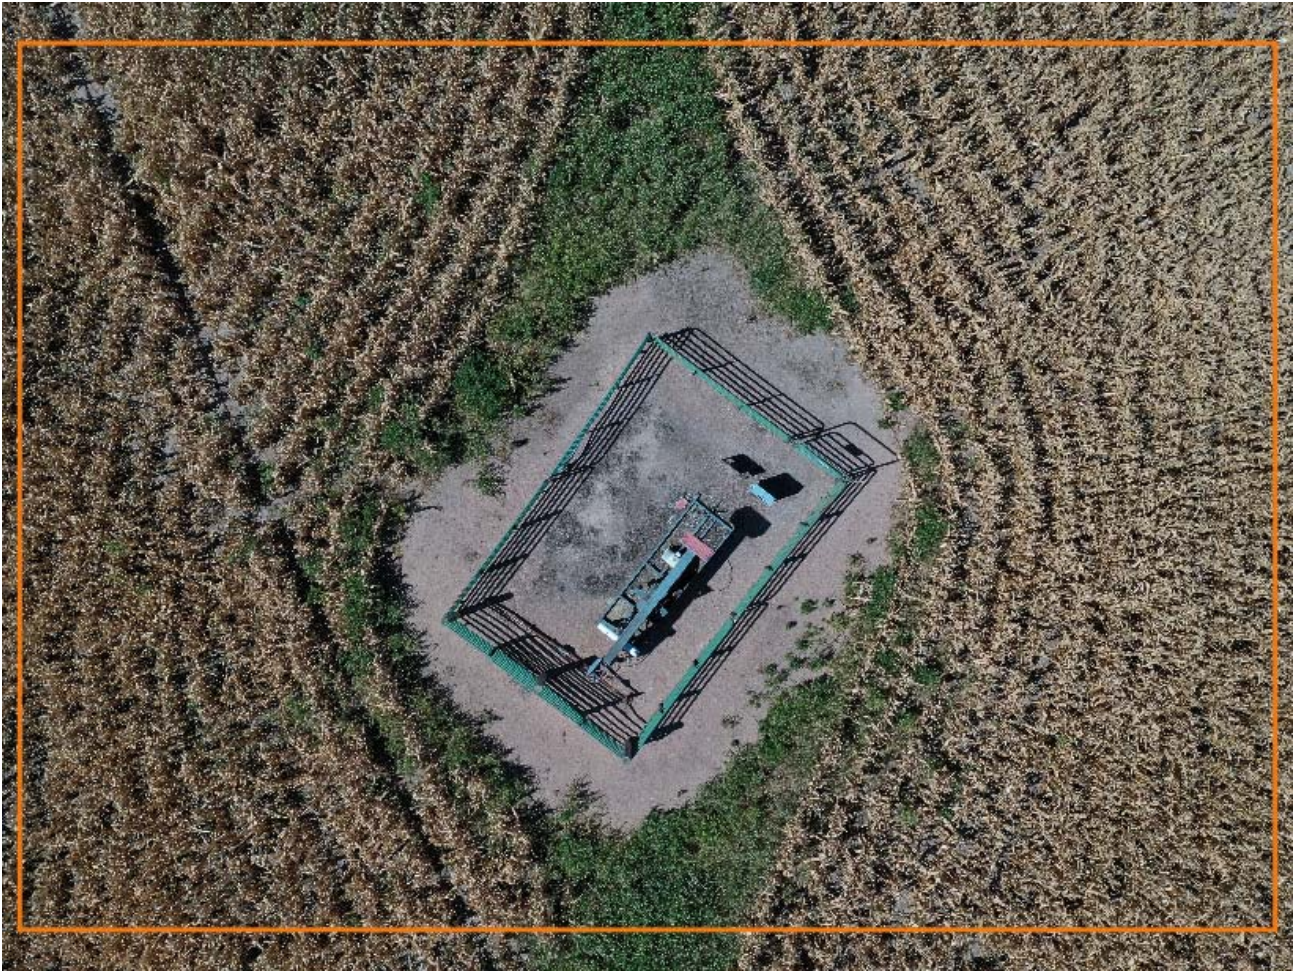
No. 2 OPEN**Captured:** Sep 2, 2020 at 12:02pm

**Type**
Missing Part**Lat/Long**
39.88014, -102.48155**Summary**
No access, seasonal inspection.**Created**
Sep 22, 2020 at 2:40pm by Craig Quint

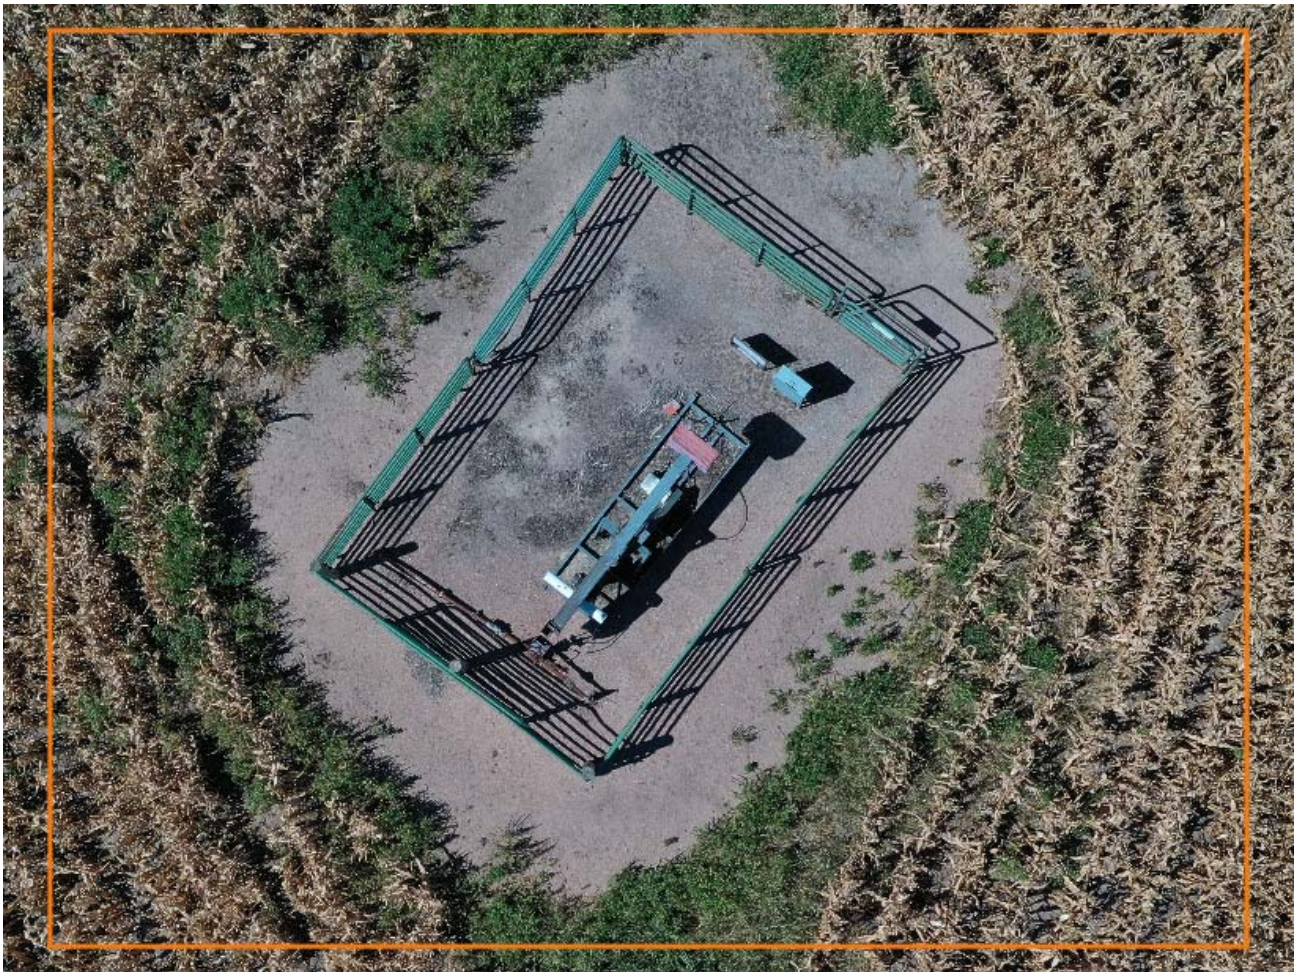
No. 1 OPEN*Captured: Sep 2, 2020 at 12:02pm*

**Type**
Other**Lat/Long**
39.88014, -102.48150**Summary**
Pumping unit fenced with steel panels in corn field.**Created**
Sep 22, 2020 at 2:38pm by Craig Quint
