Inspection Photos

API: 05-061-06480

Operator: MURFIN DRILLING COMPANY INC

Inspection Date: 9/24/2020

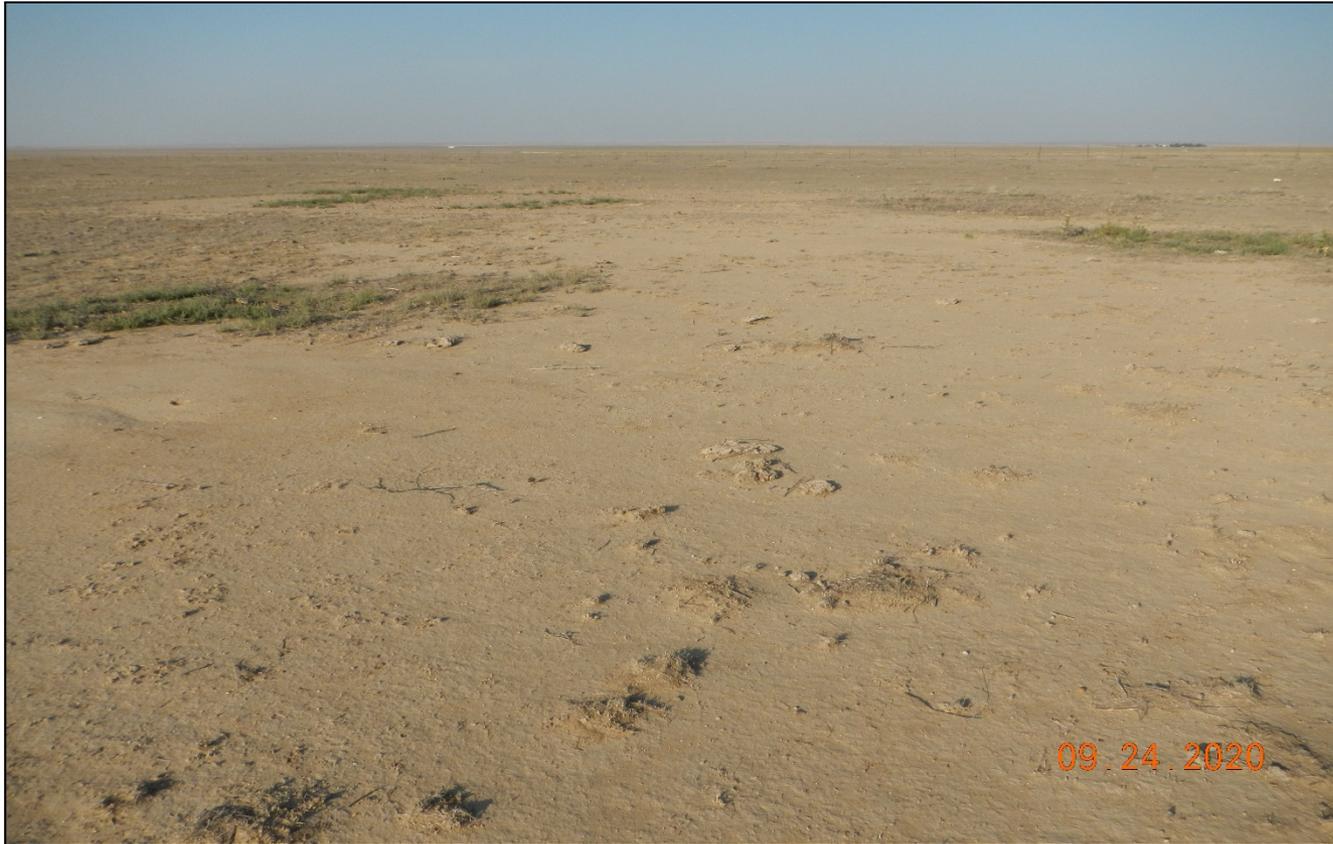
Photo 1. Facing west toward the location. Vegetation is not establishing and there are areas bare of vegetation which indicate soil potential soil issues.

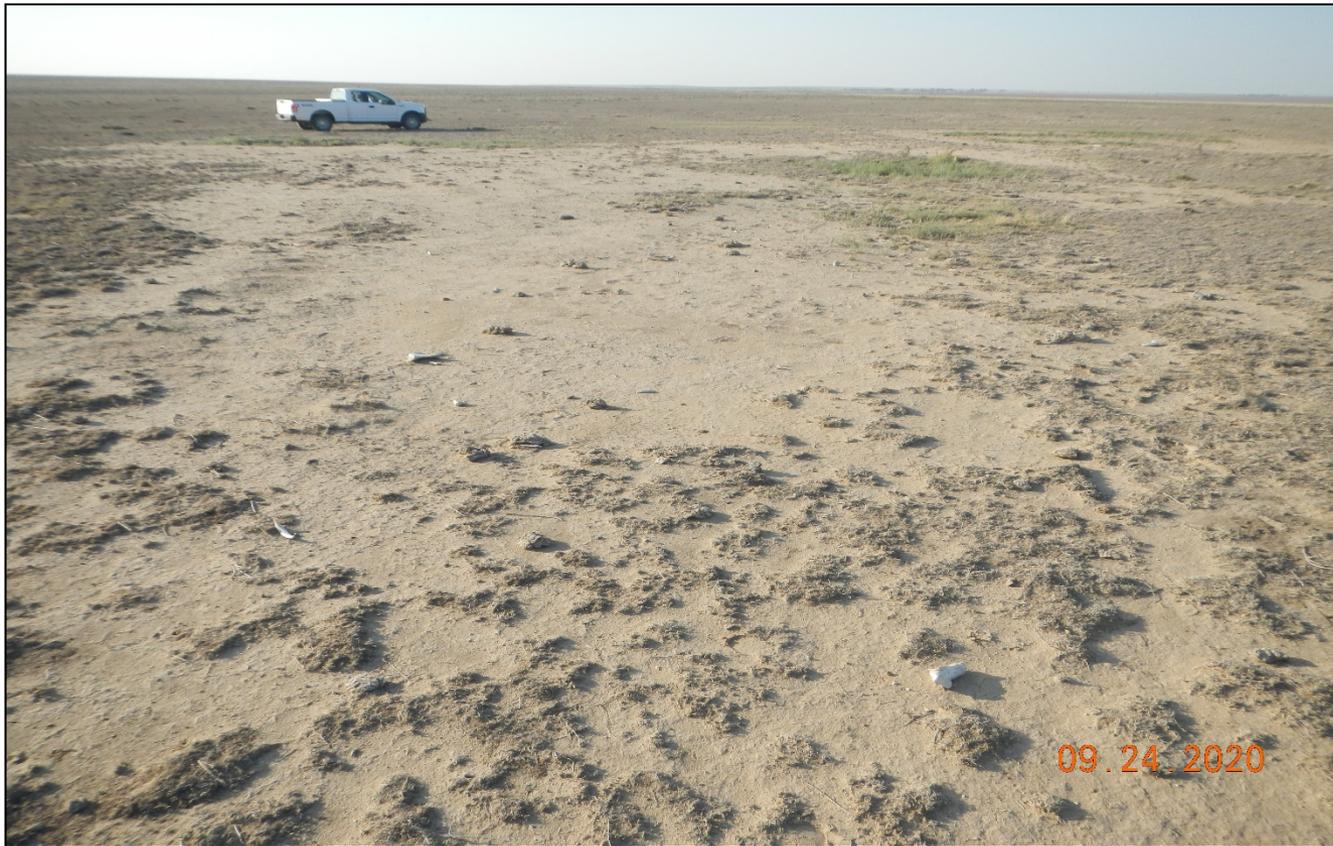
Photo 2. Facing south toward the location.

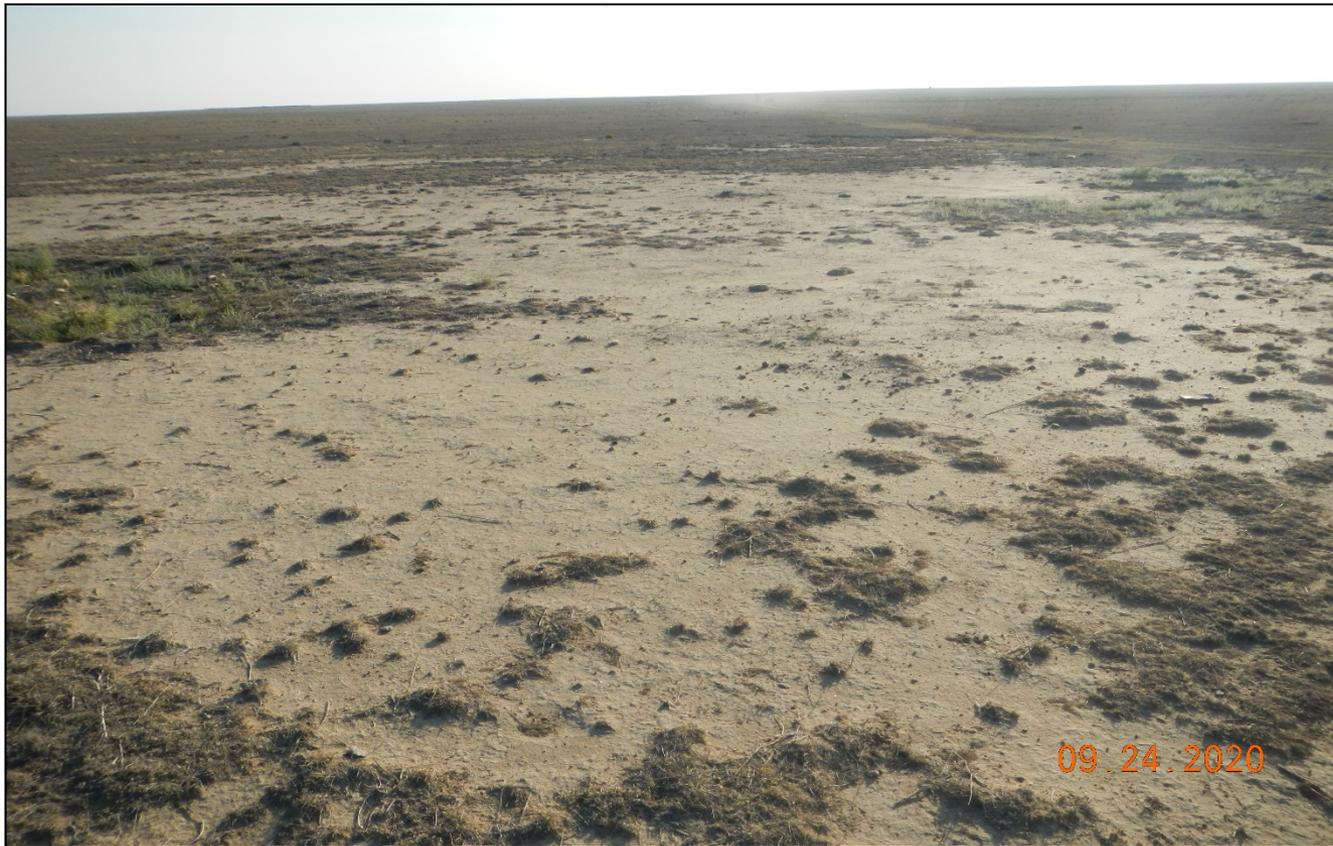
Photo 3. Facing east at the location.

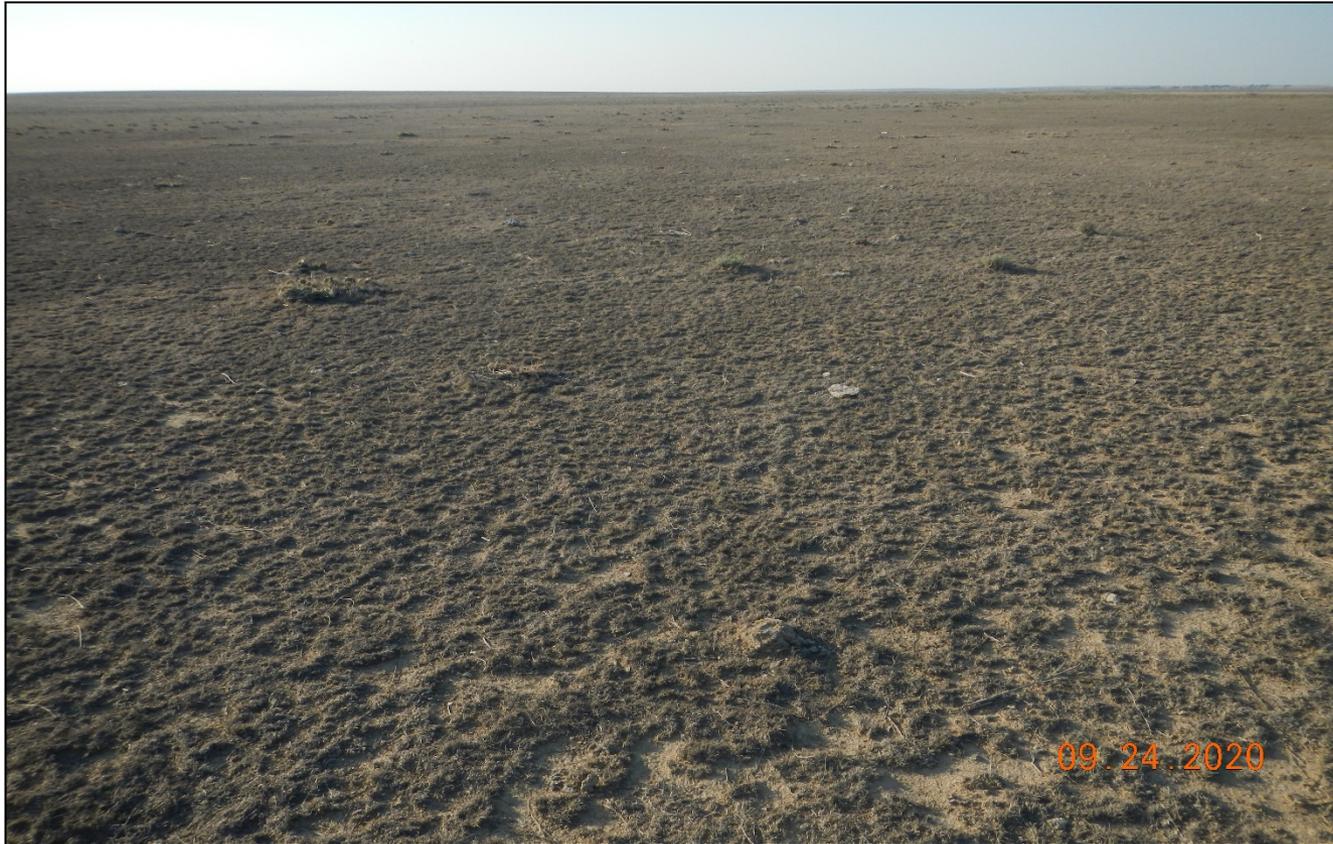
Photo 4. Facing south toward the surrounding undisturbed area which shows a uniform vegetation cover consisting of Blue grama, Sand dropseed, Prairie threeawn among other species.
