DC-3 Off-Location Flowline Right-of-Way(ROW) Photo Log

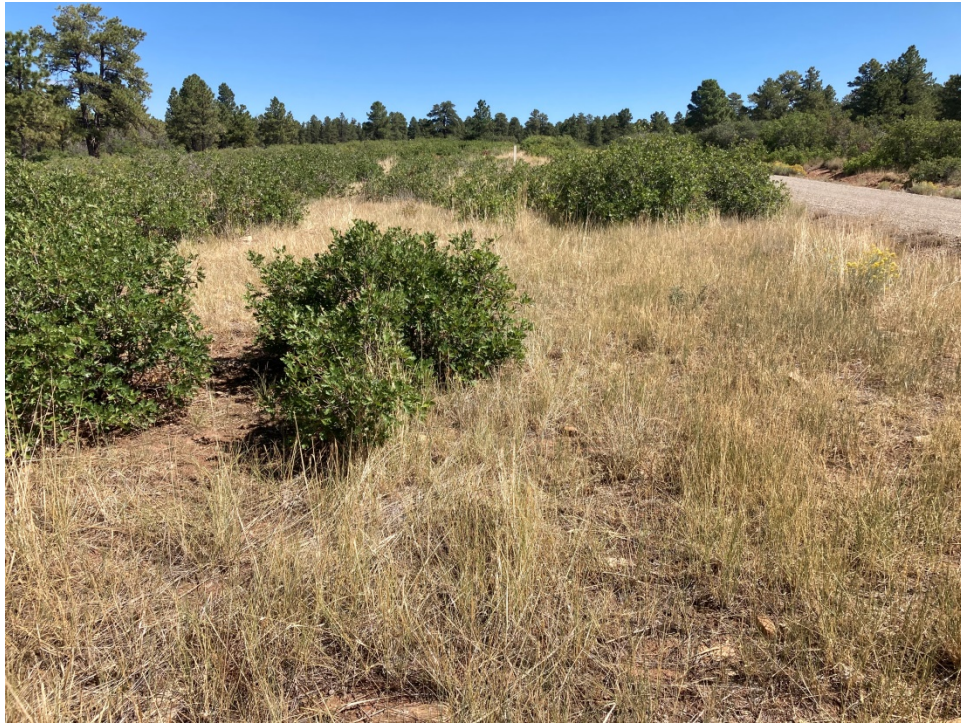
Photo 1: DC-3 ROW near DC-3 Location.

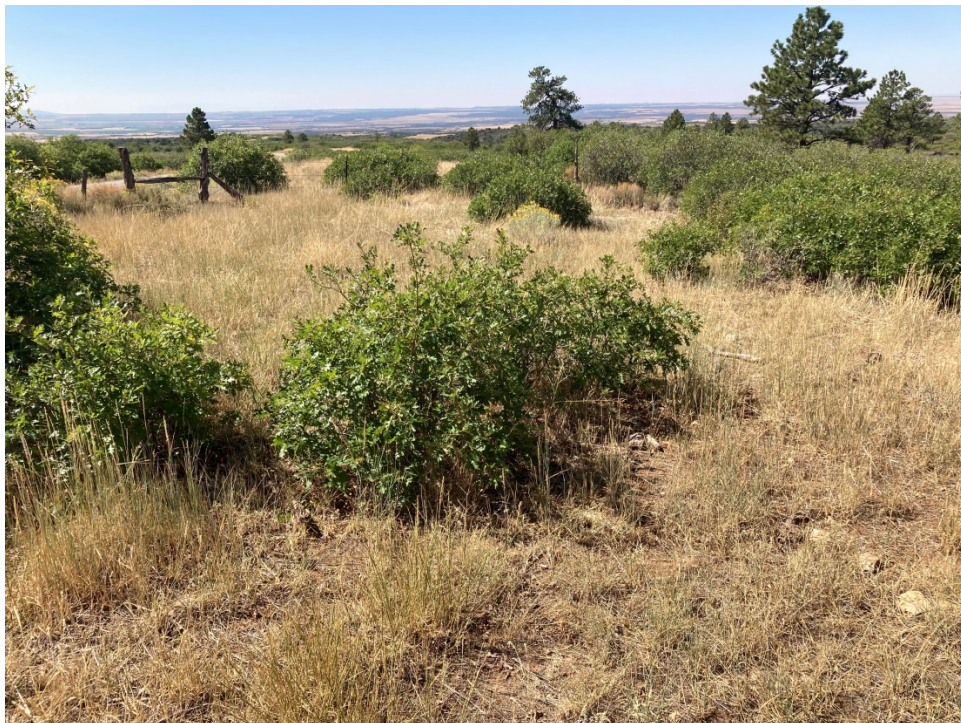
Photo2: DC-3 ROW looking south. Note the Gambel Oak establishing on the DC 3 ROW.

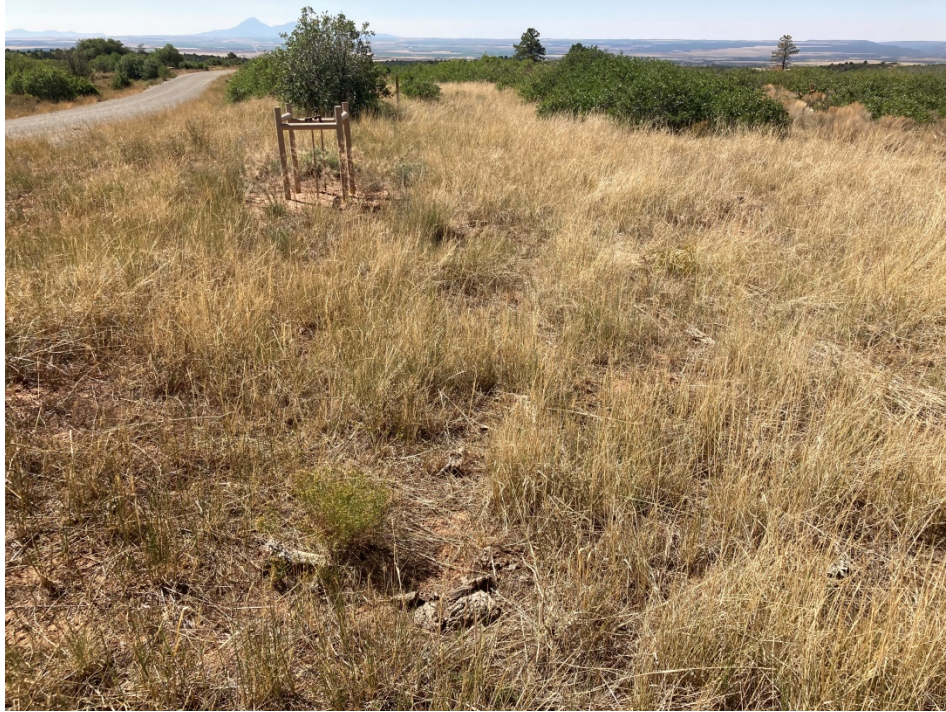
Photo 3: DC-3 ROW near Dolores CTY RD 15.

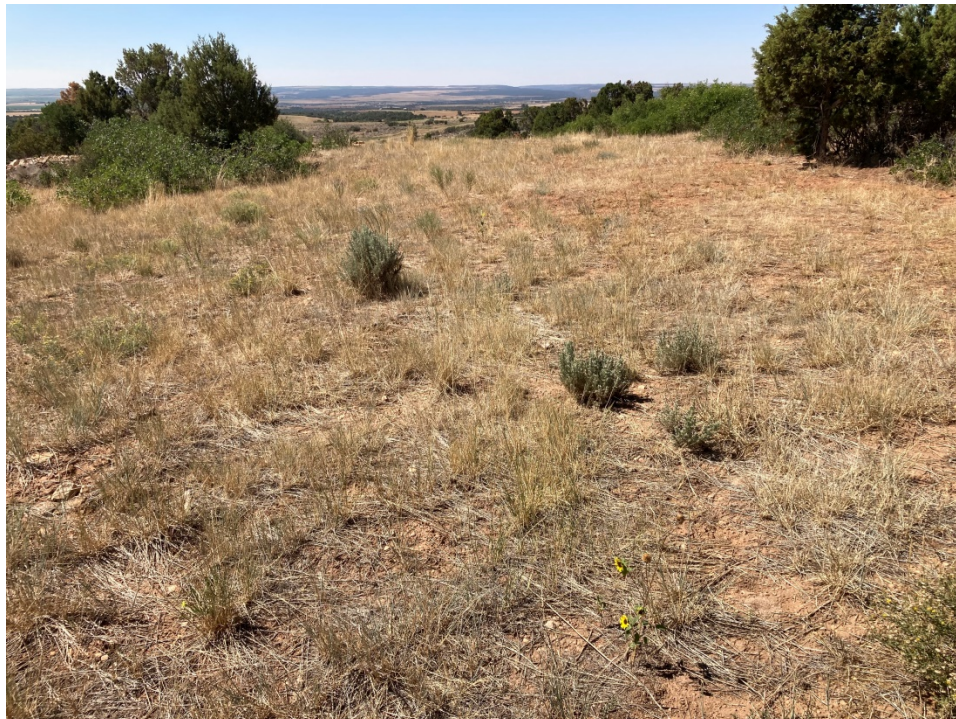
Photo 4: DC-3 ROW looking south. Note the Sage Brush establishing of the DC-3 ROW.
