Inspection Photos

API: 05-061-06713

Operator: THOMAS L SPRING LLC

Inspection Date: 9/24/2020

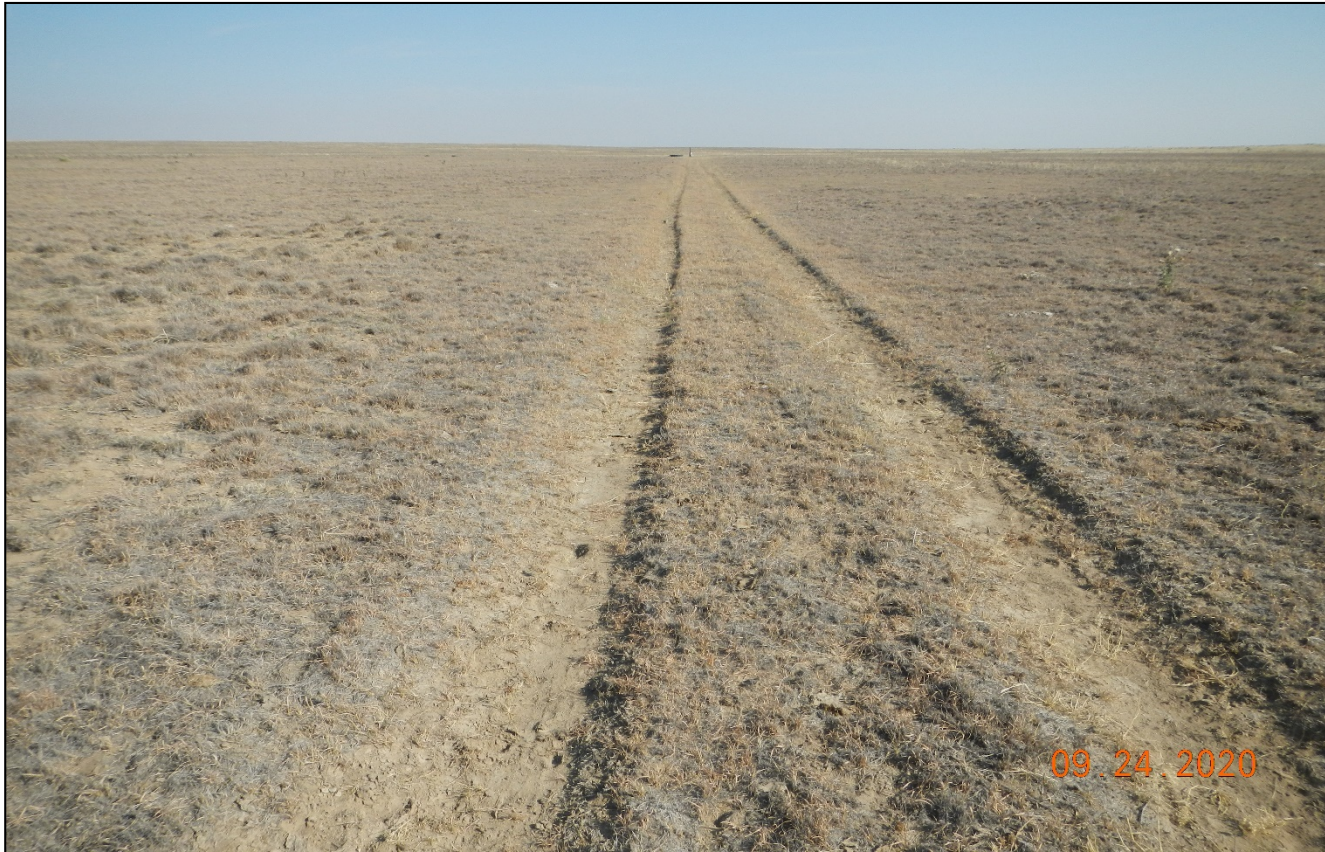
Photo 1. Facing north along the access road. The vehicle ruts needs to be graded out and reclaimed.

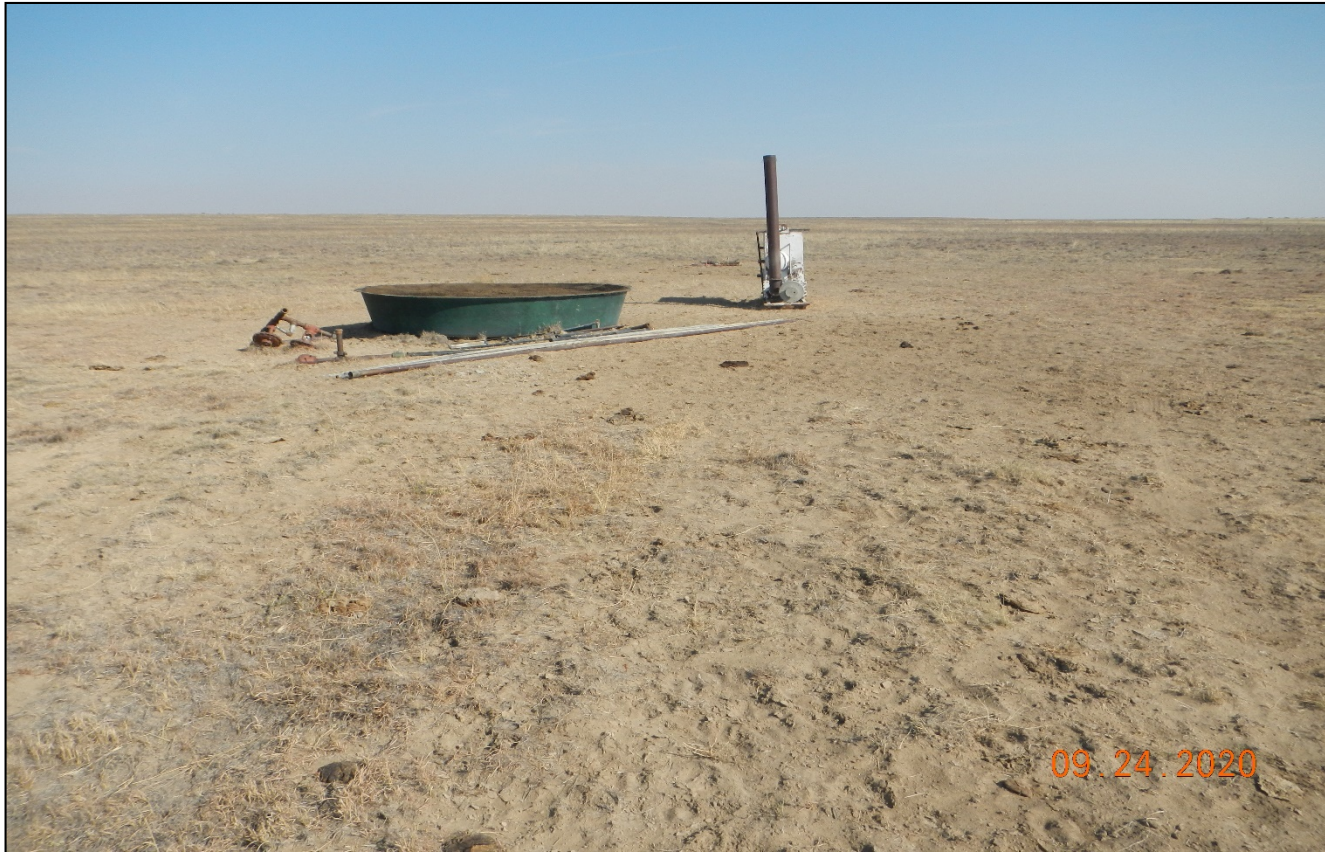
Photo 2. Facing north toward the location. Equipment has not been removed and location is not reclaimed.

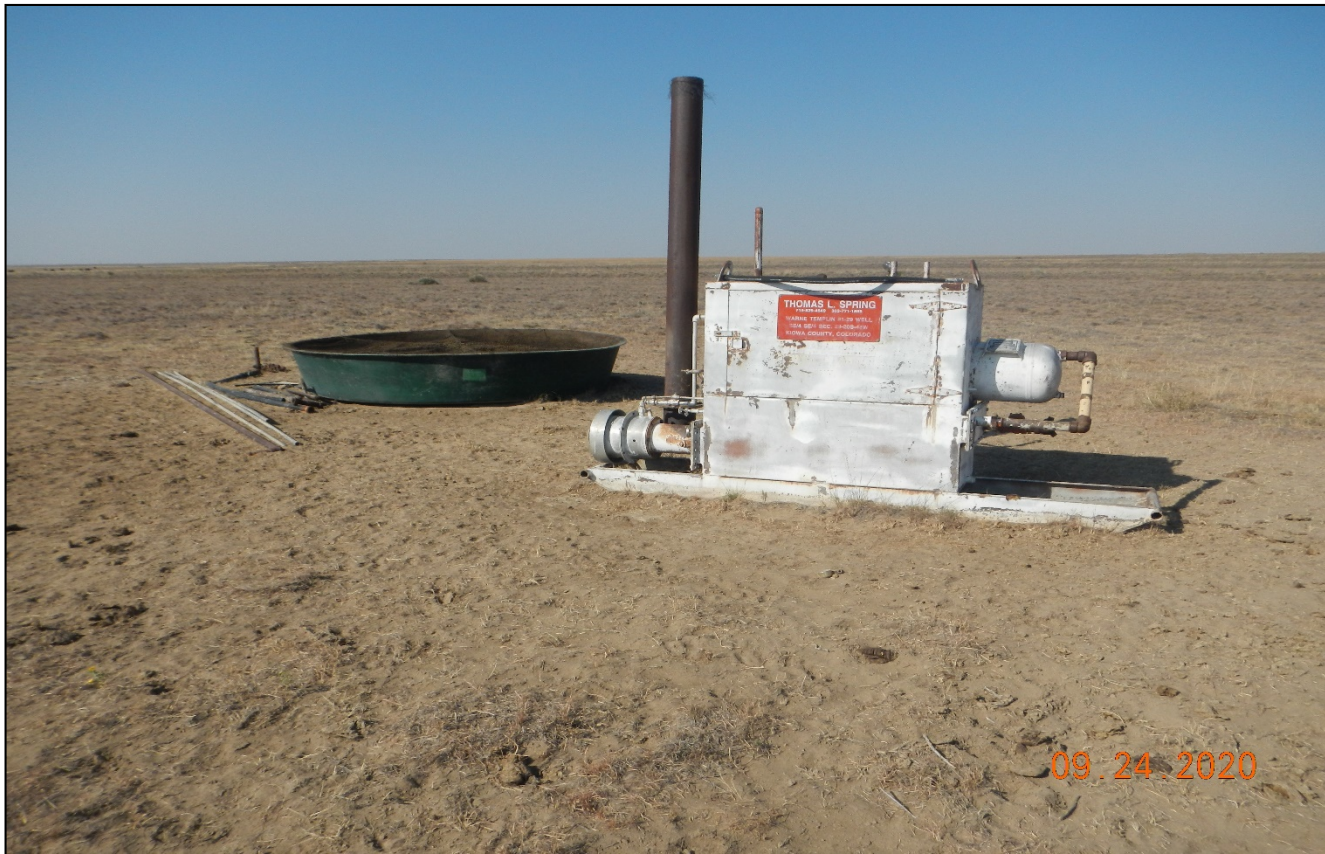
Photo 3. Facing east at the location. Equipment needs to be removed.

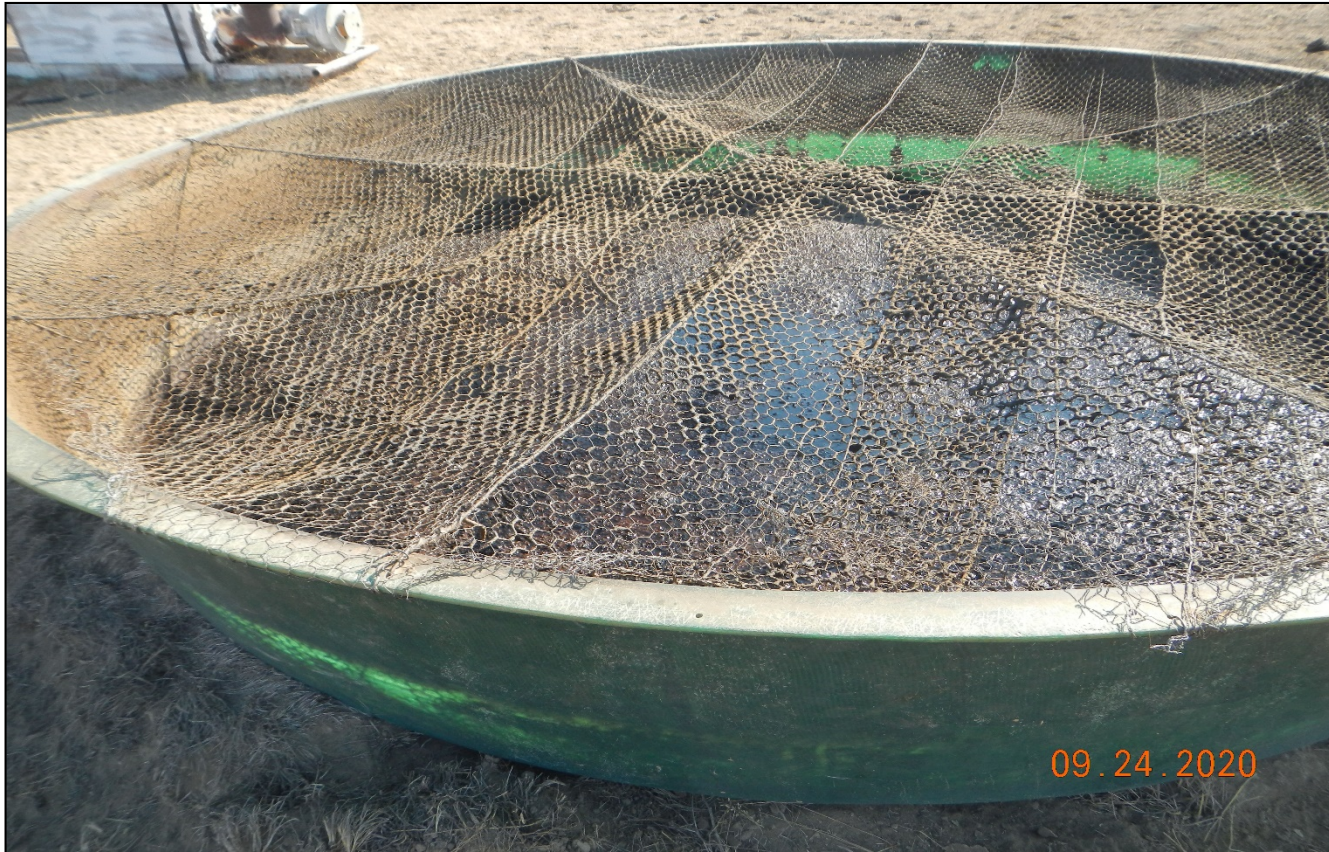
Photo 4. There is oil in the tank which needs to be properly disposed.

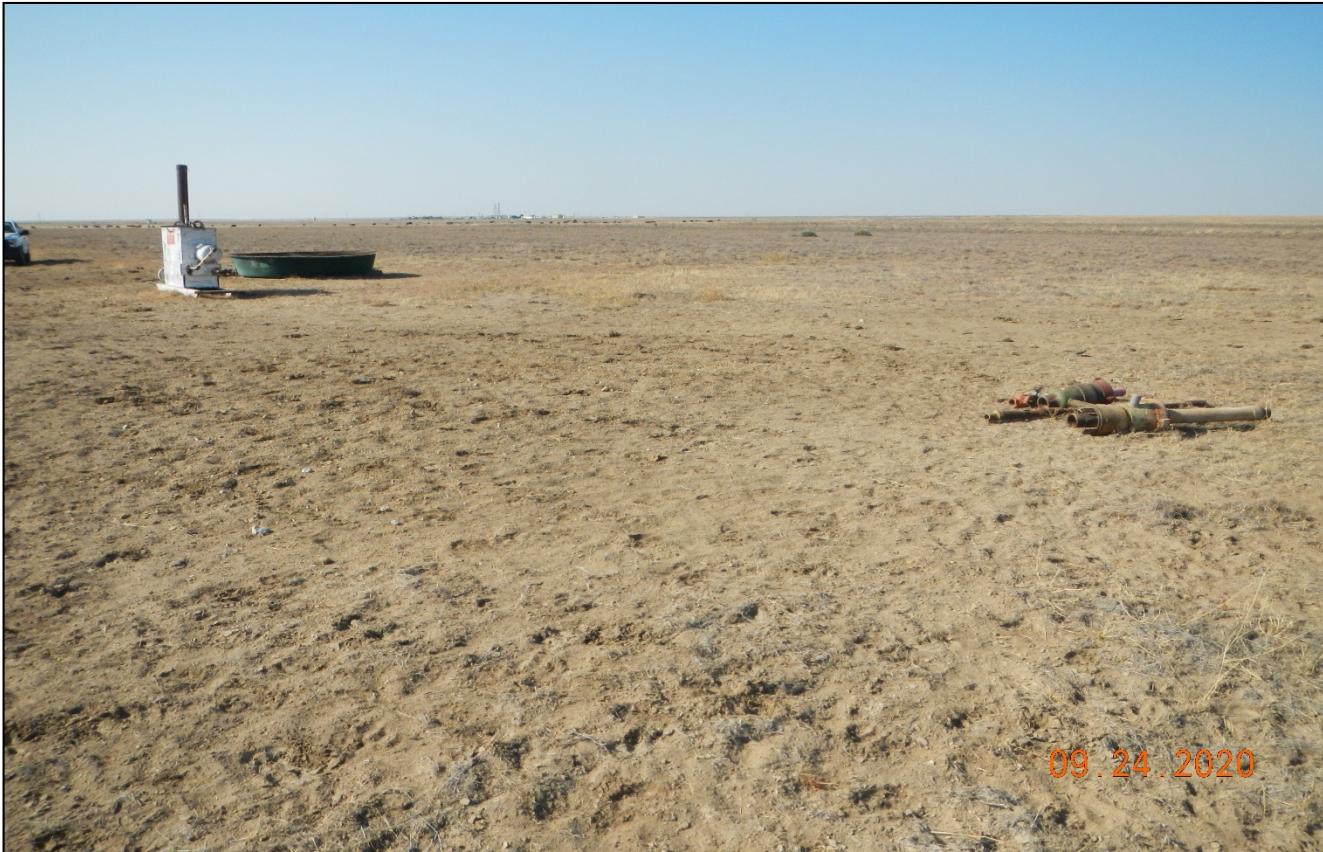
Photo 5. Facing southwest at the location. The location needs to be decompacted and reclaimed.

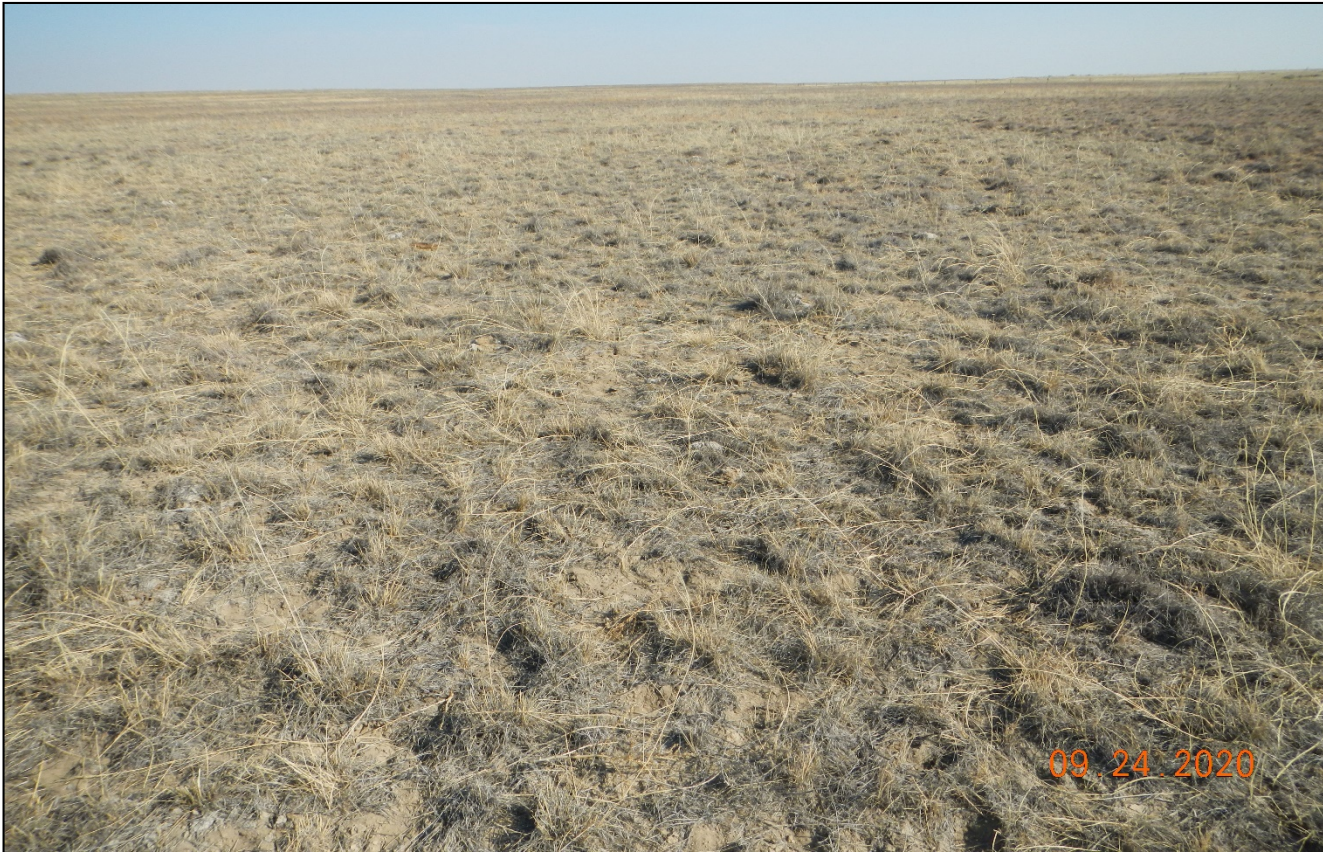
Photo 6. Facing north toward the surrounding undisturbed area which shows a uniform vegetation cover consisting of Blue grama, Sand dropseed, Prairie threeawn among other species.
