Inspection Photos

API: 05-011-06108

Operator: THOMAS L SPRING LLC

Inspection Date: 9/24/2020

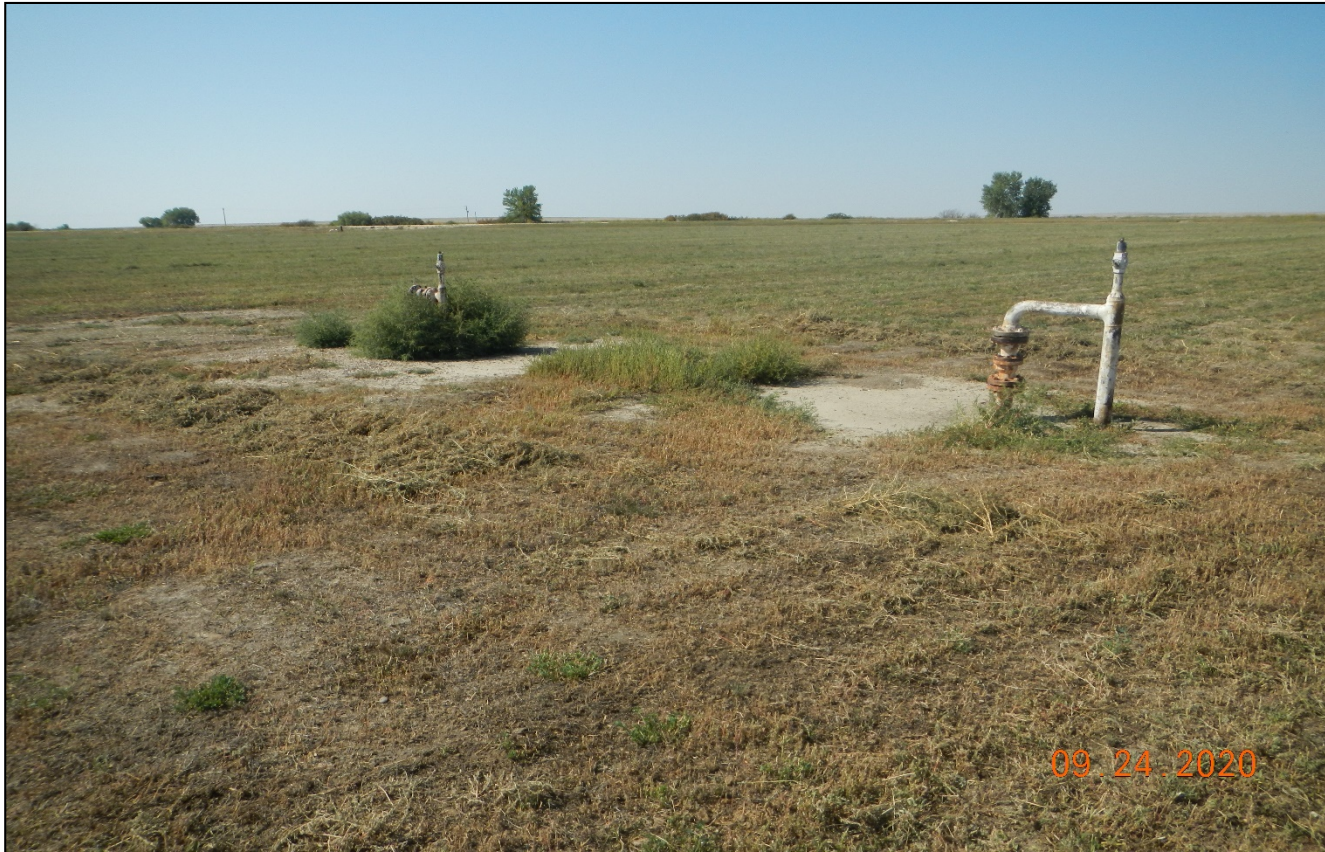
Photo 1. Facing southwest at the location. There are pipe risers that have not been removed and are interfering with farming operations.

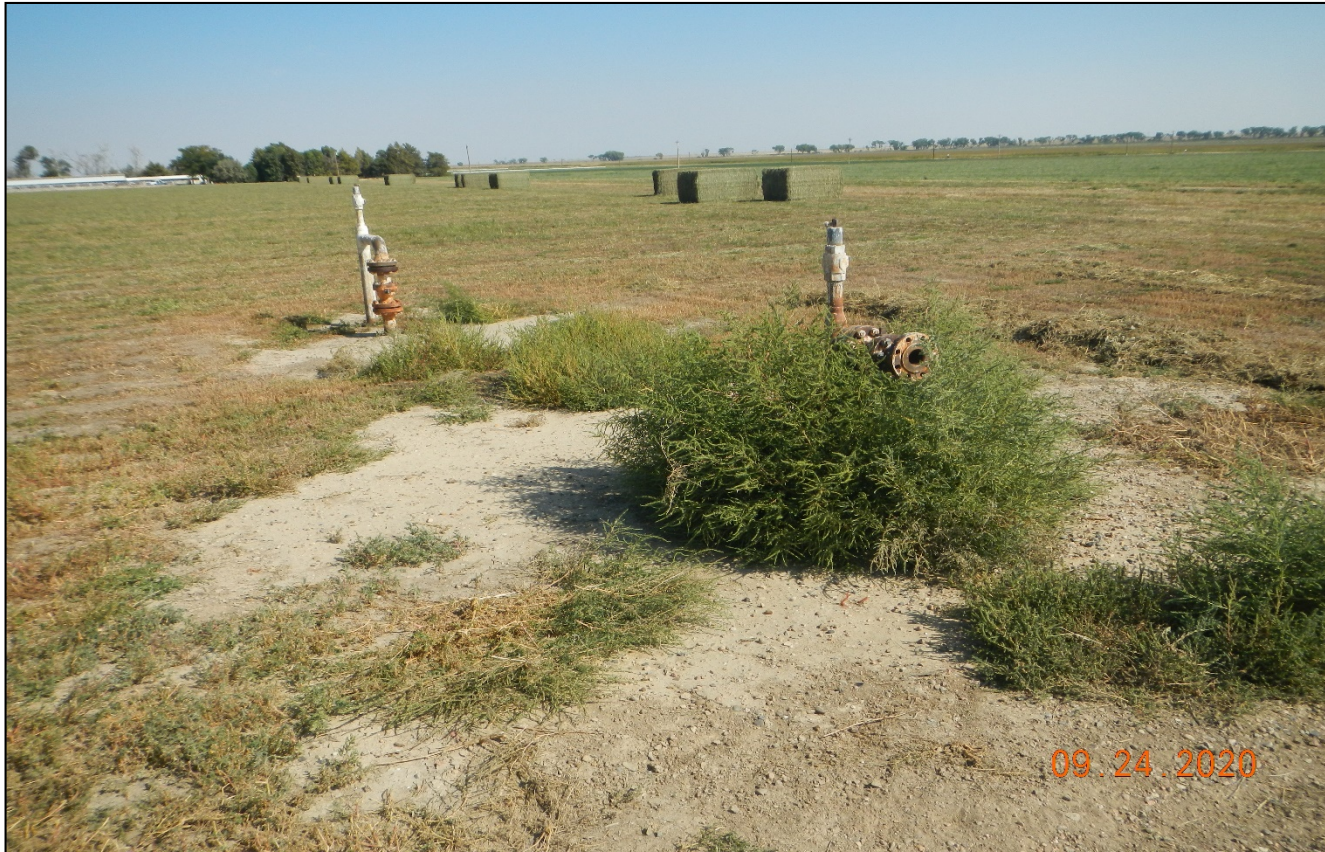
Photo 2. Facing northeast at the location. Abandoned risers need to be removed.

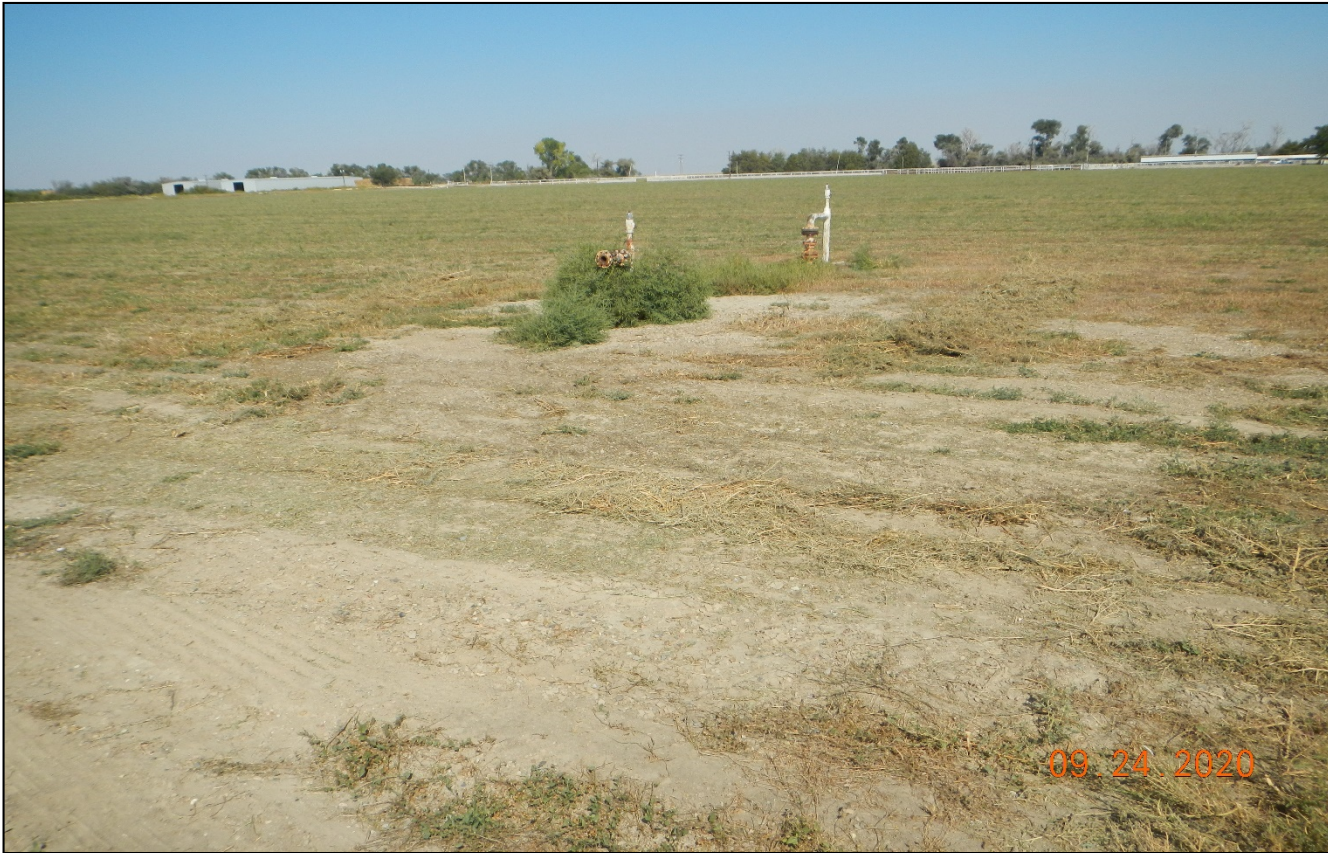
Photo 3. Facing northwest at the location. The crop has not reestablished and needs to be reclaimed.
