Inspection Photos

API: 05-011-06046

Operator: STRACHAN EXPLORATION INC

Inspection Date: 9/24/2020

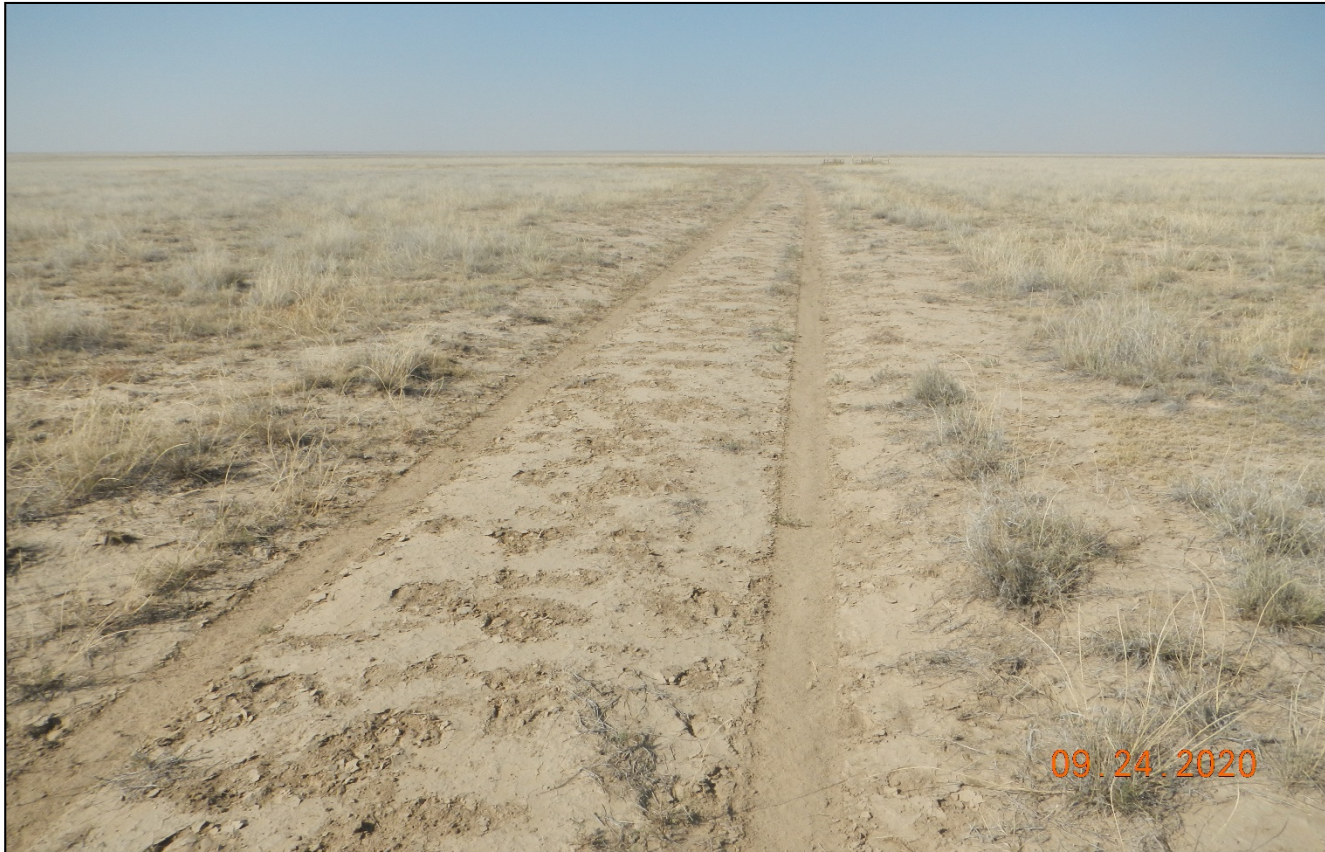
Photo 1. Facing west along the access road. The access road has not been reclaimed.

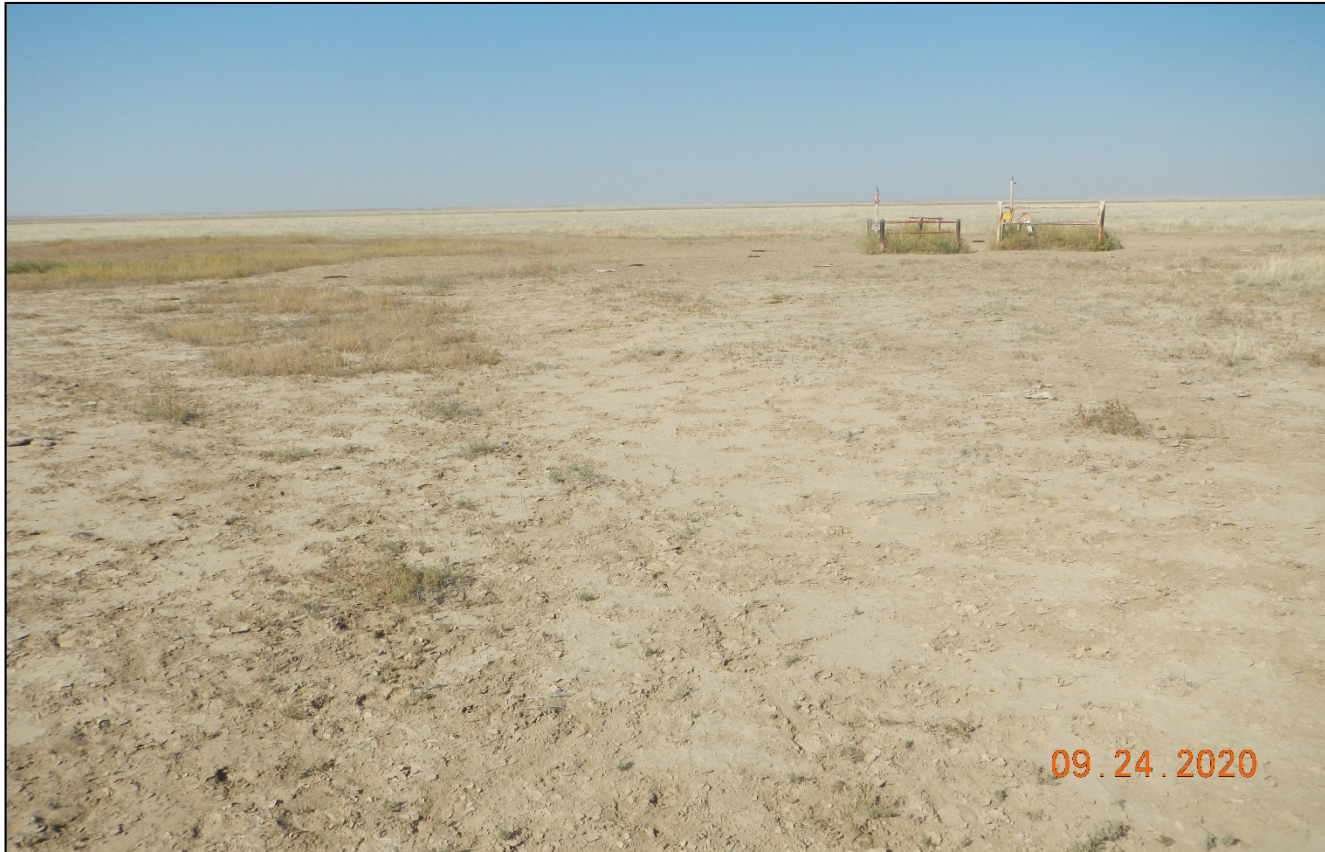
Photo 2. Facing west toward the location. The location has not been reclaimed and soils are bare of vegetation. There is equipment that remains at the north side of the location.

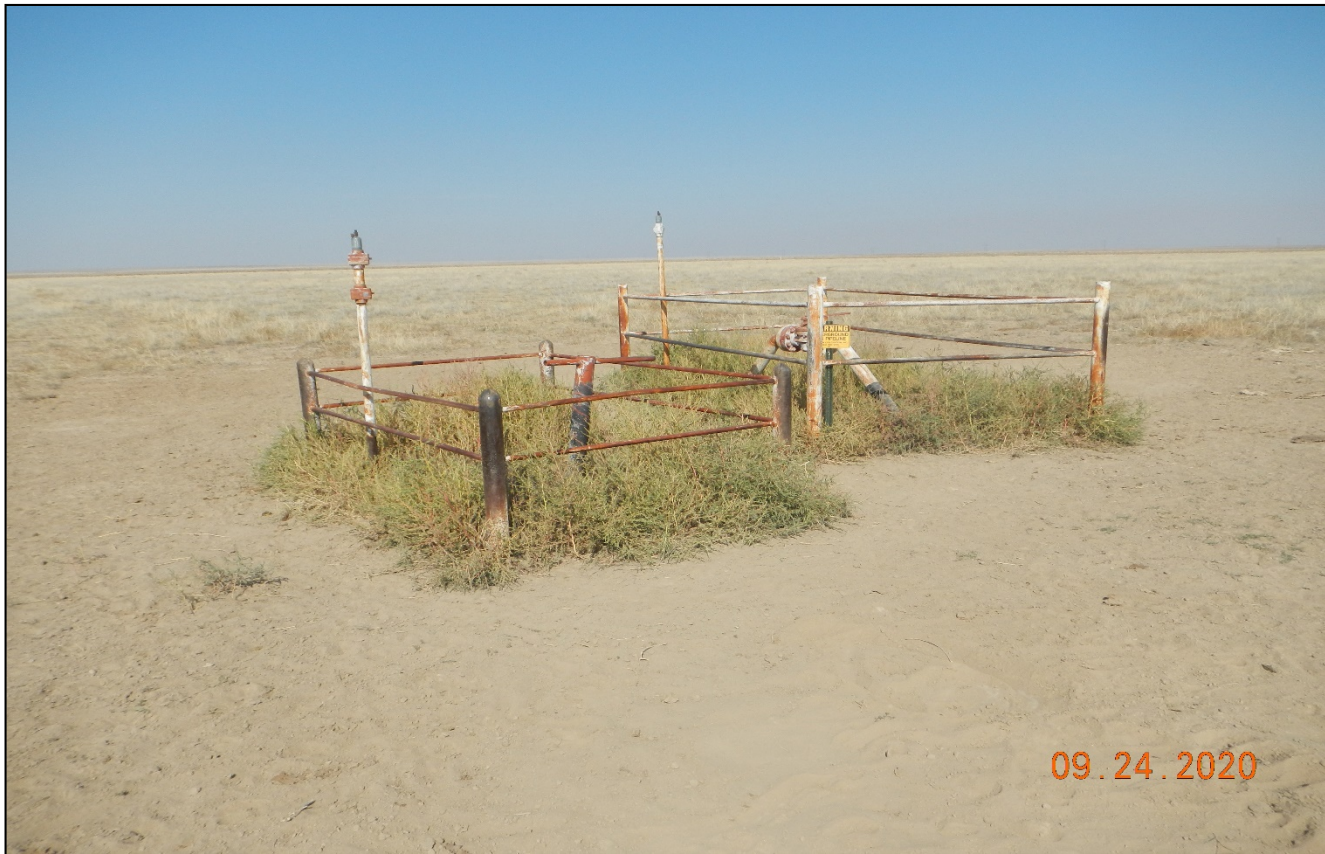
Photo 3. There is pipe risers associated with the former well site that have not been removed.

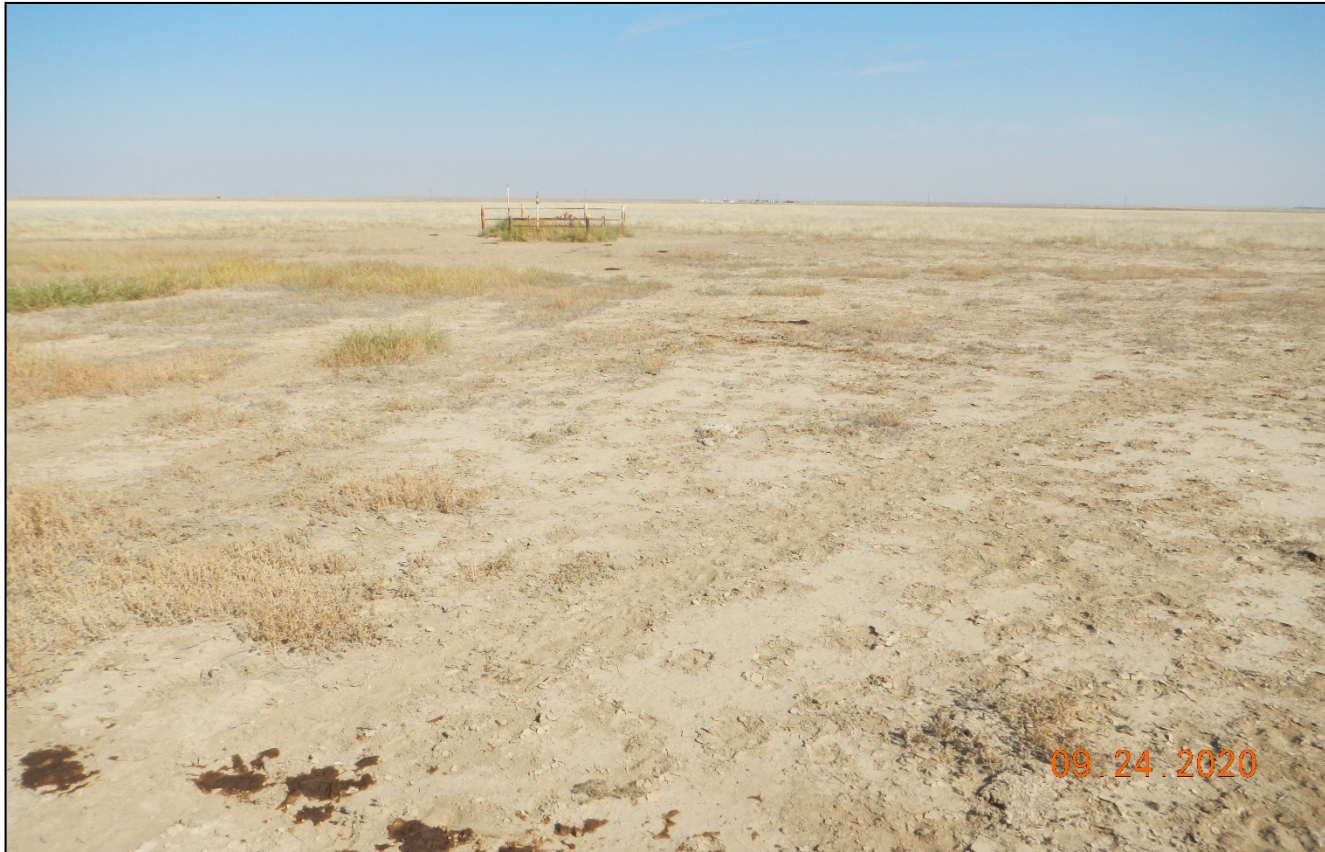
Photo 5. Facing north toward the location. The location has not been reclaimed and soils are bare of vegetation.

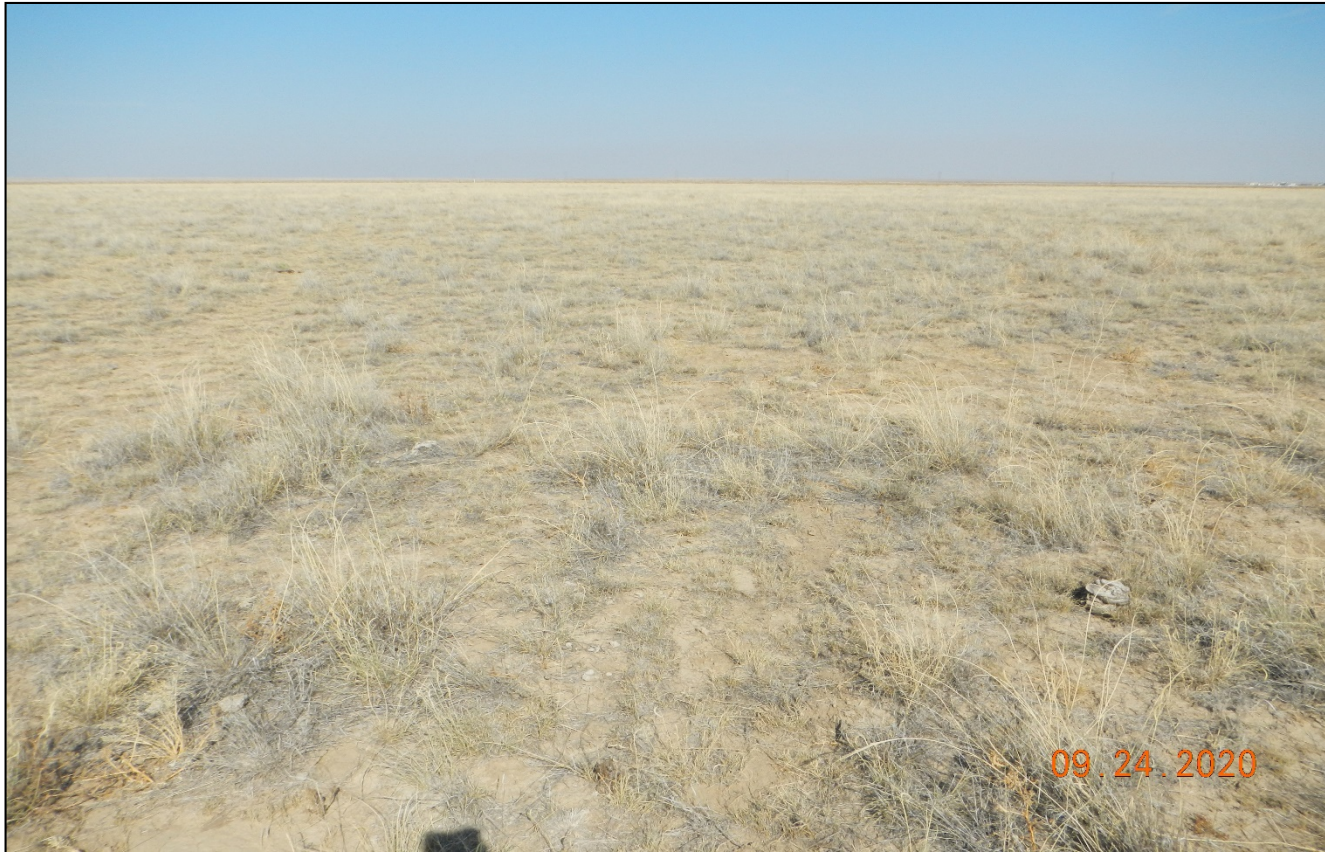
Photo 6. Facing northwest toward the surrounding undisturbed area which shows a uniform vegetation cover consisting of Blue grama, Sand dropseed, Prairie threeawn among other species.
