KP Kauffman - COGCC Inspection Photos
Location: UPPR 43 PAN AM G Consolidation #2 OLF Release
Spill ID # 478086 Date 9/28/2020

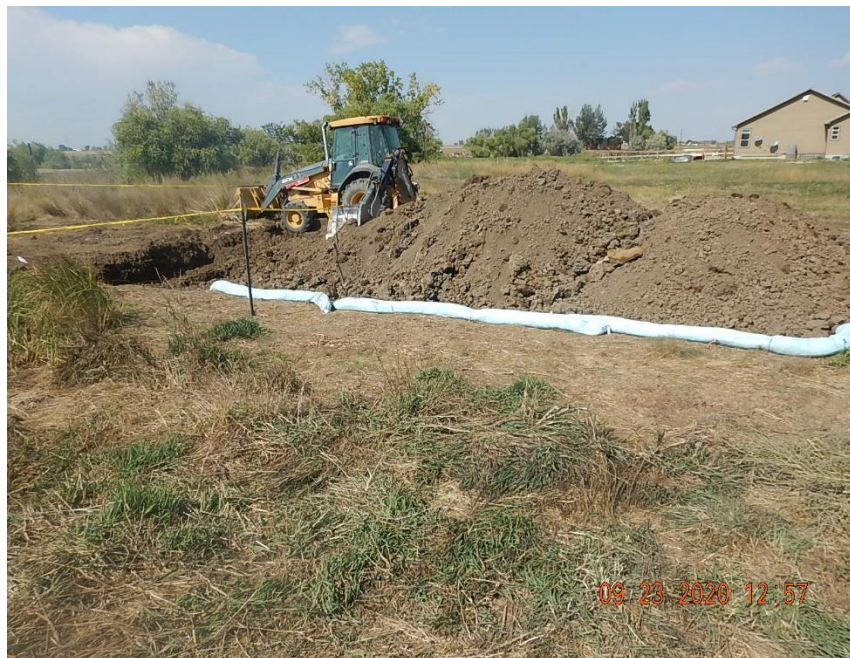
View of area of release and excavation activity on the north side of WCR 4; view north.

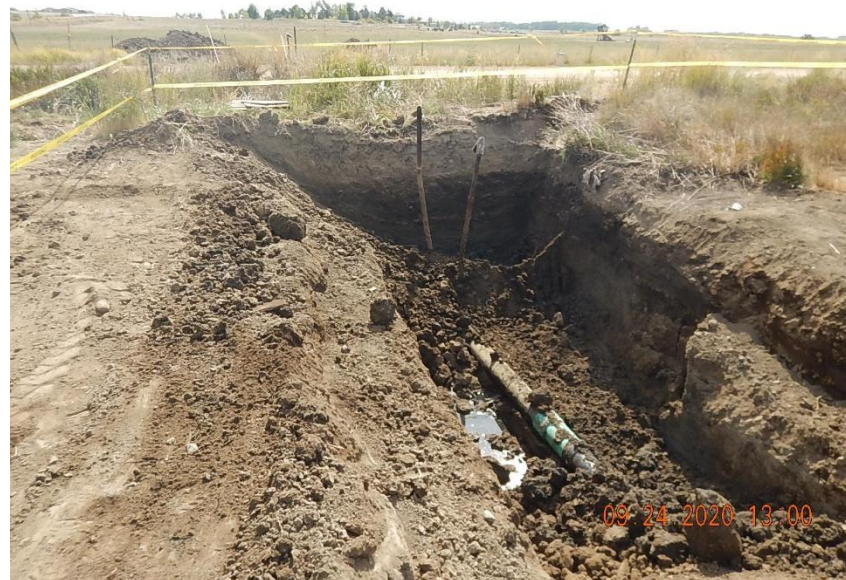
View of flowline exposed in excavation and pooled hydrocarbons; looking south.

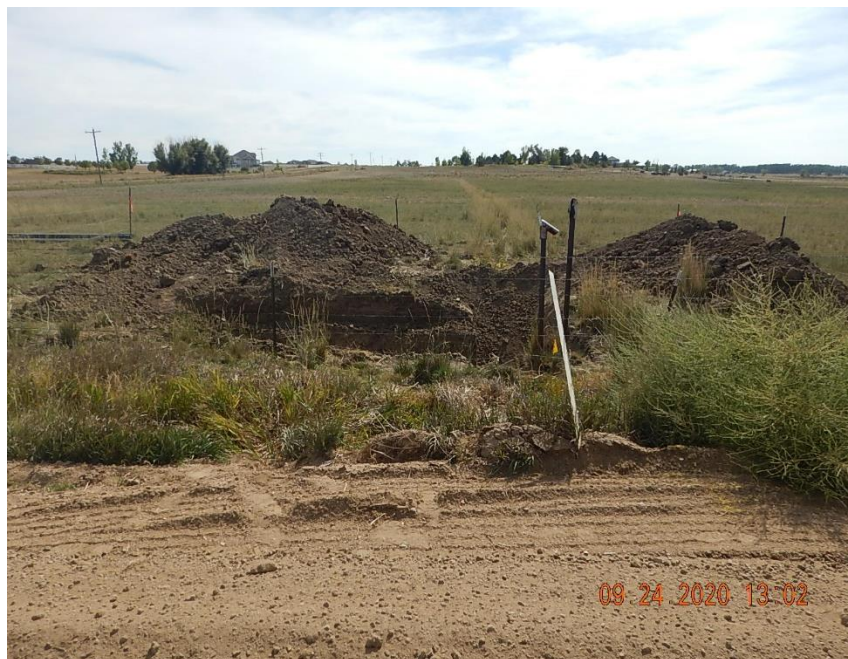
**View of second excavation on the south side of WCR 4;
looking south.**

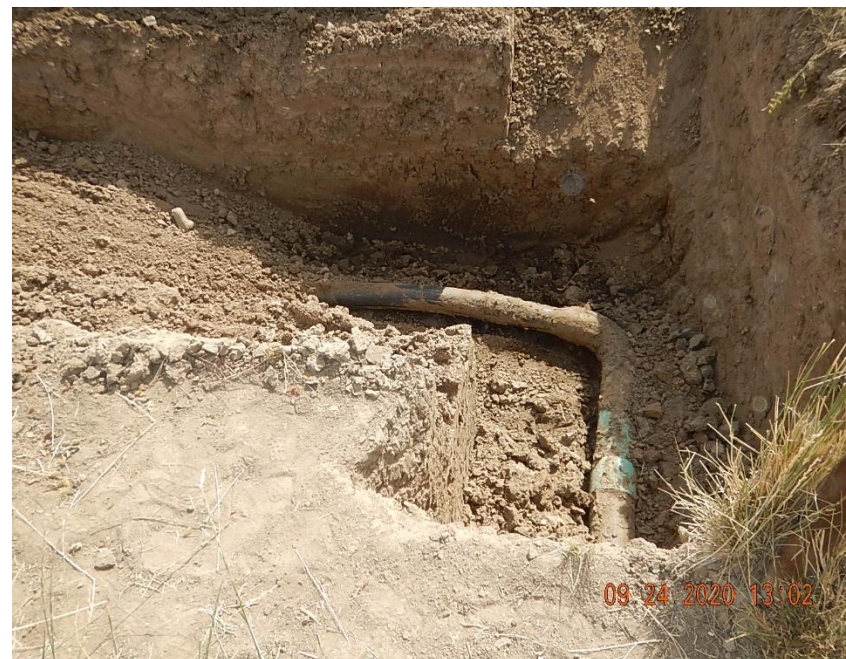
Close up view of flowline exposed in south excavation

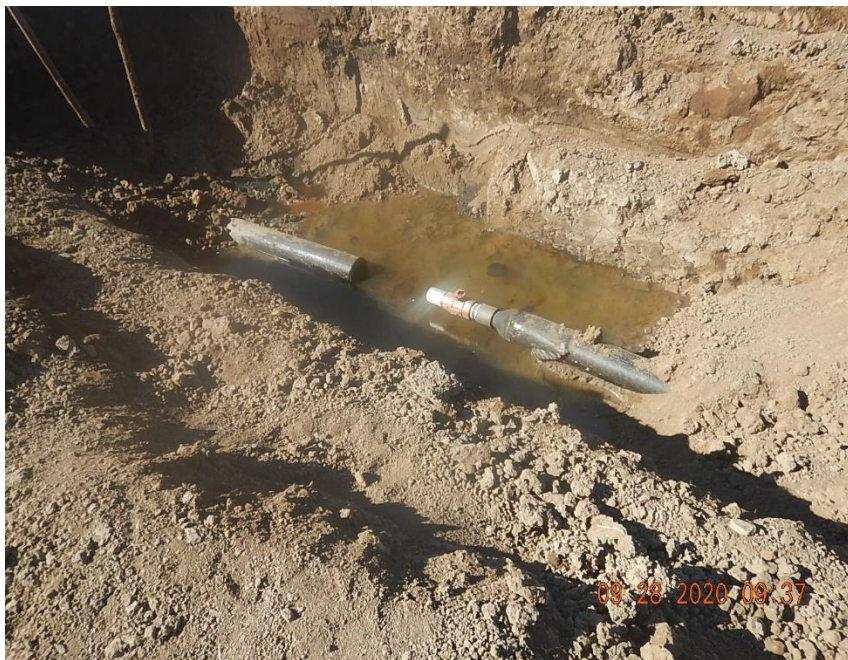
View of valve and bullplug installed at north excavation.

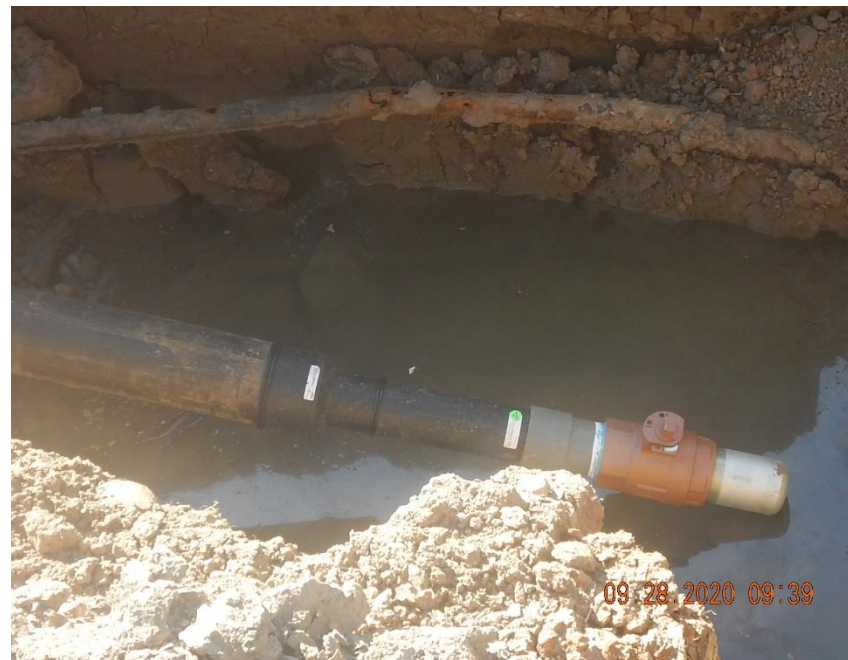
**View of valve and bullplug installed at south excavation;
Historically abandoned flowline also present in excavation.**

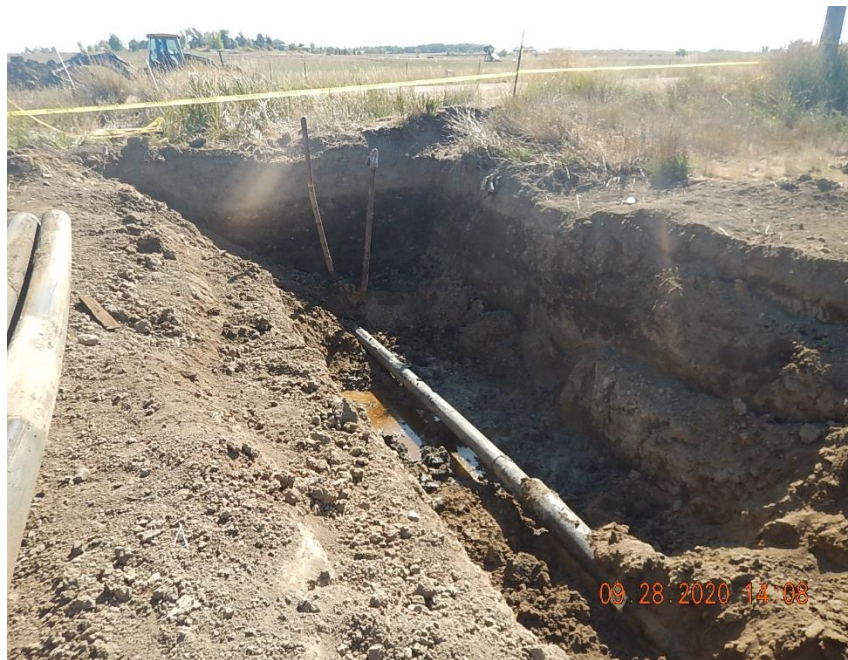
View of replacement section of flowline (new HDPE) that has been pulled under WCR 4 through casing pipe from south to north excavations.

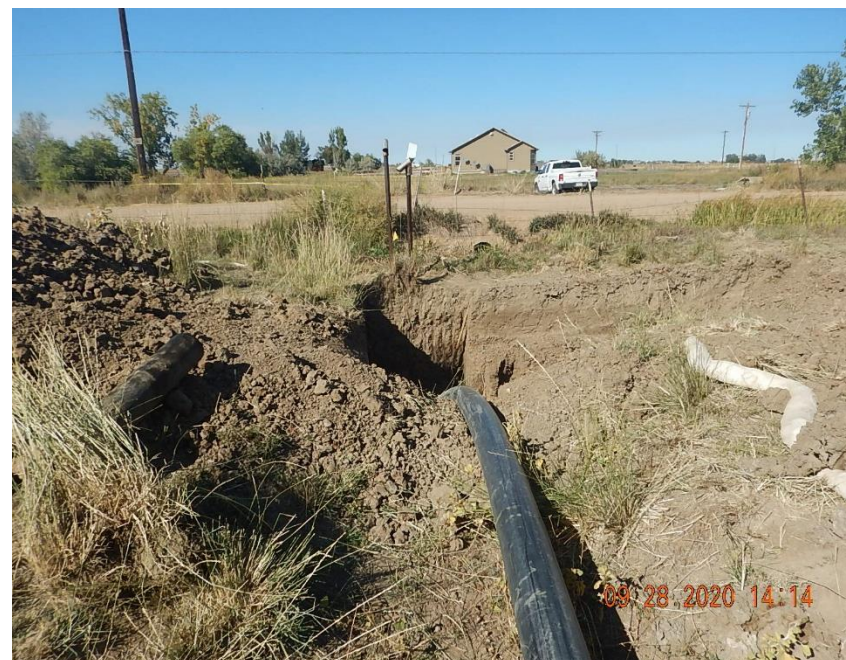
View from south excavation across WCR 4; looking north Replacement section of flowline being installed.
