Inspection Photos
Operator: BP America
API: 067-07431
Date: 9/29/2020

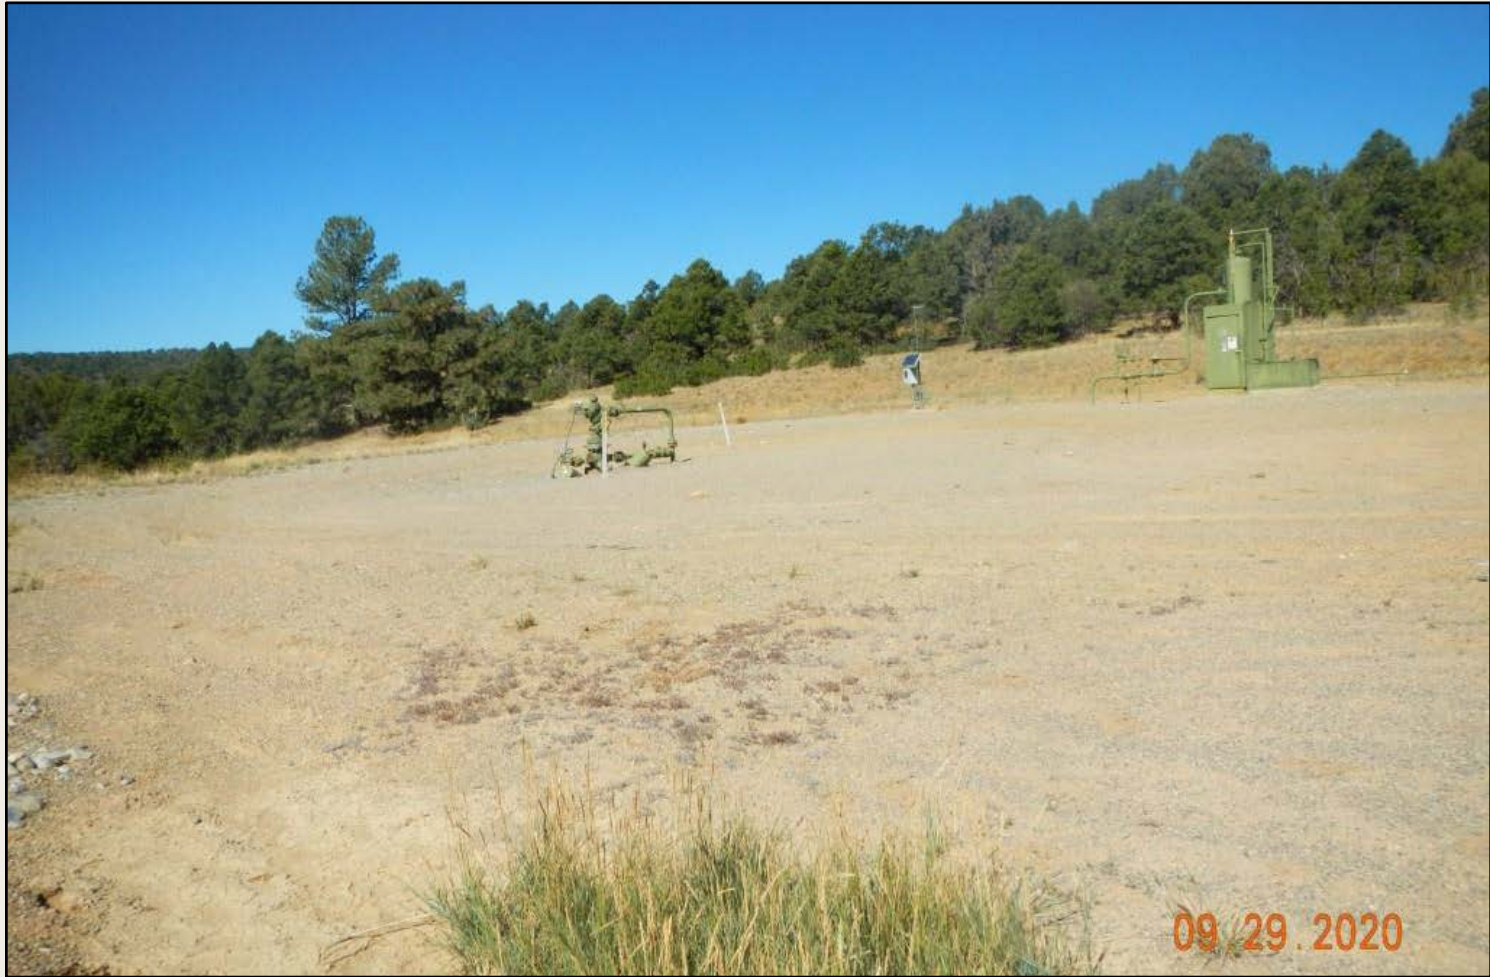
Photo 1. View of the project area from the southeastern corner facing center.

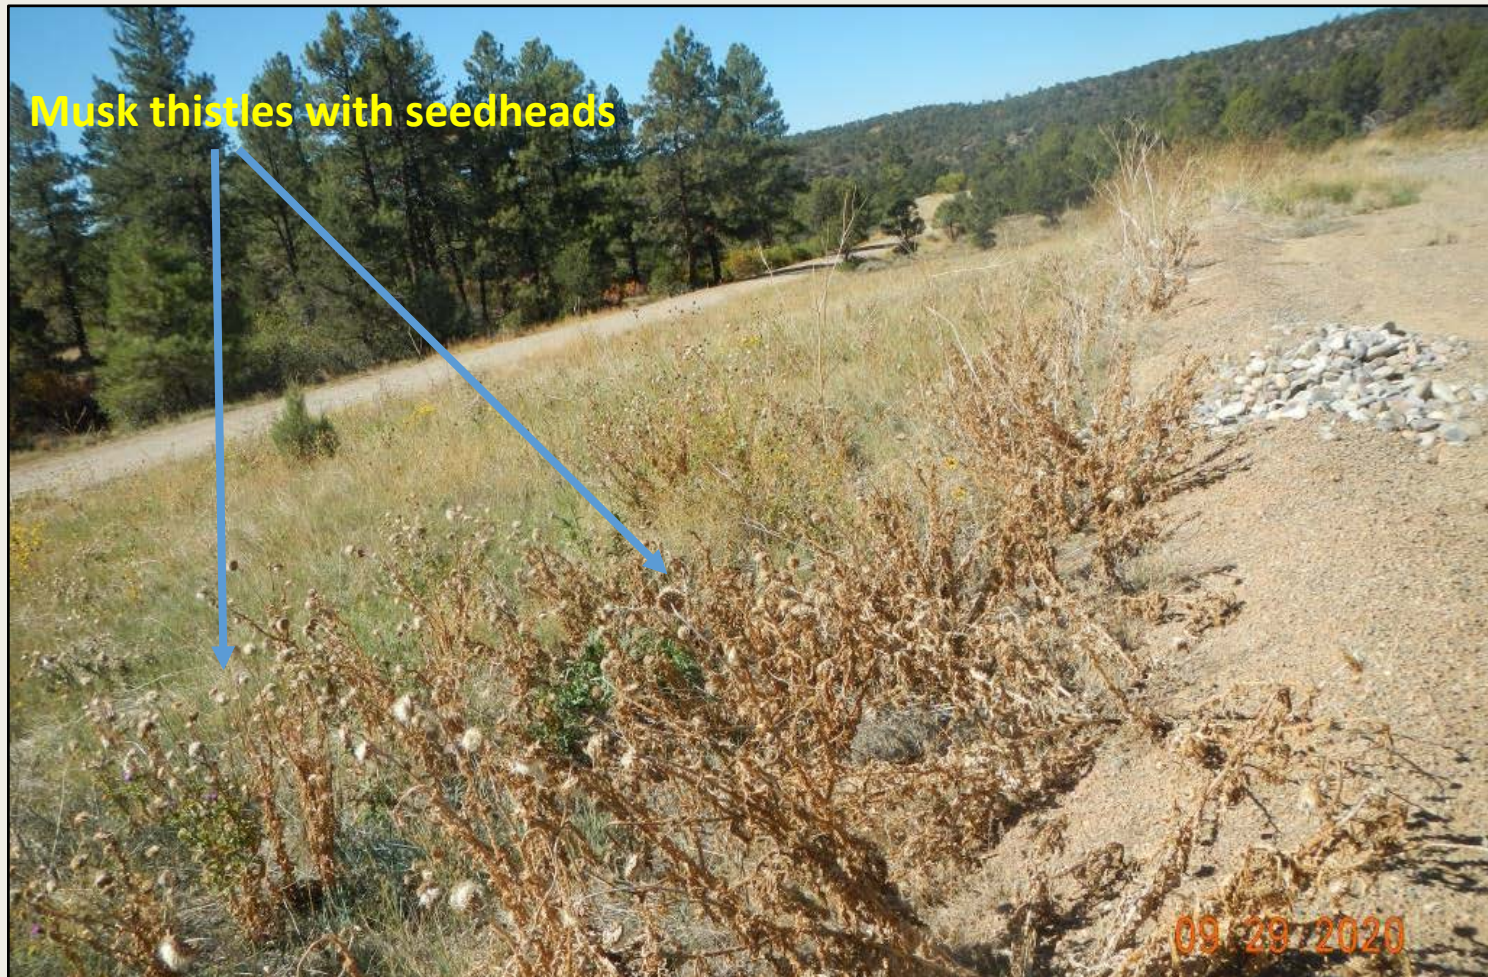
Photo 2. View of the southern project area from the southeastern corner facing westward. Revegetation is progressing, largely with western wheatgrass and crested wheatgrass. Musk thistle appear to be treated in a post-flowering condition with mature seedheads.

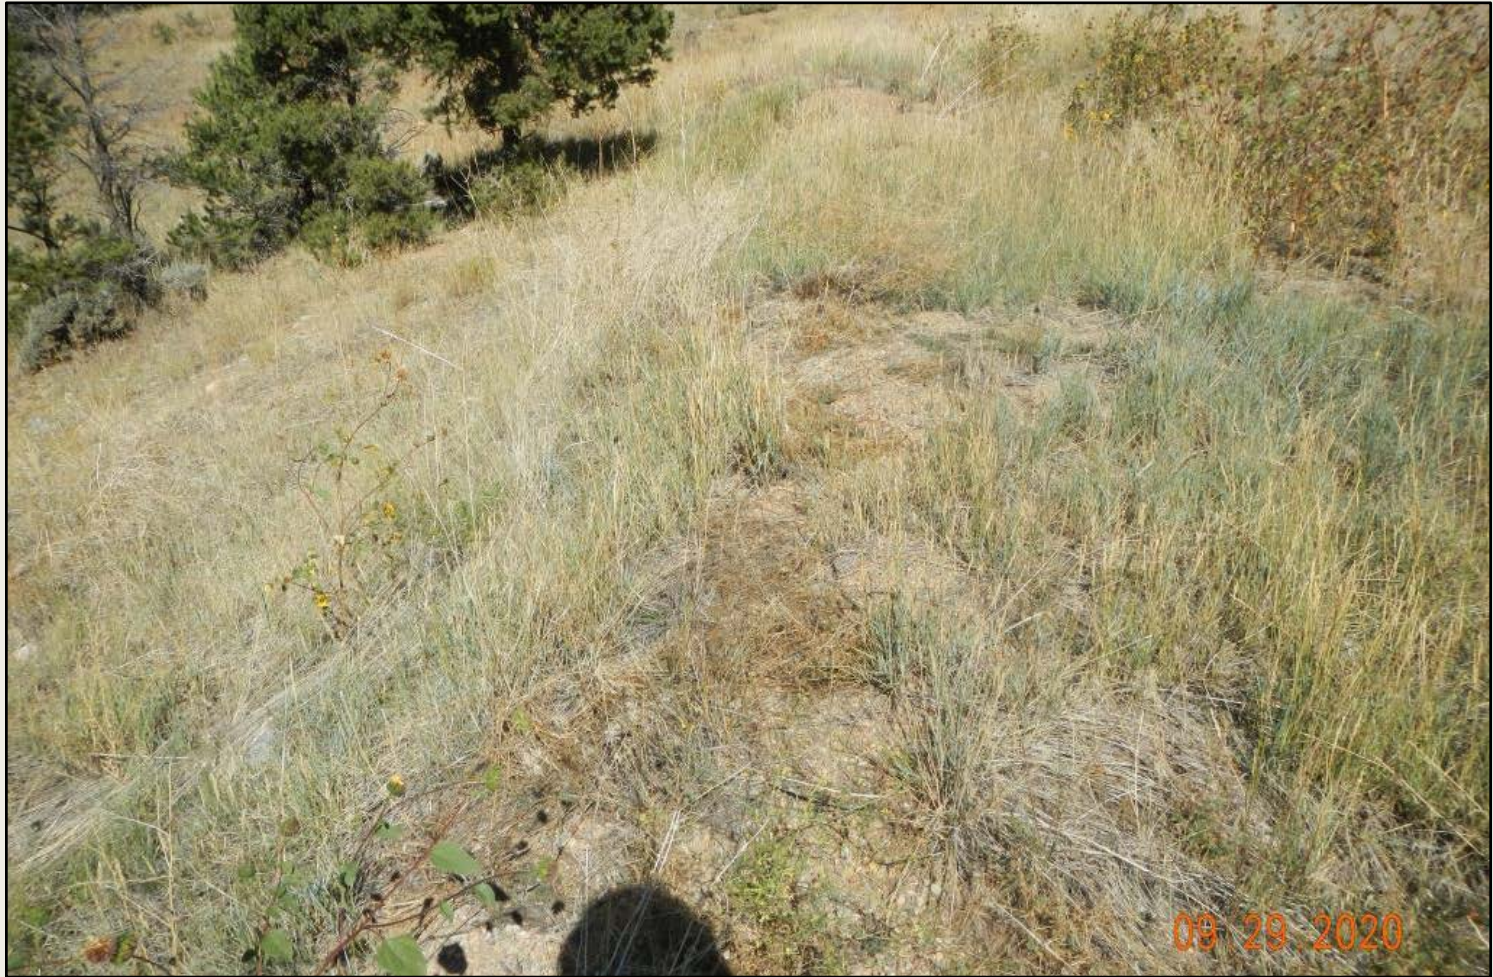
Photo 3. View of the western project area from the southwestern corner facing northward.

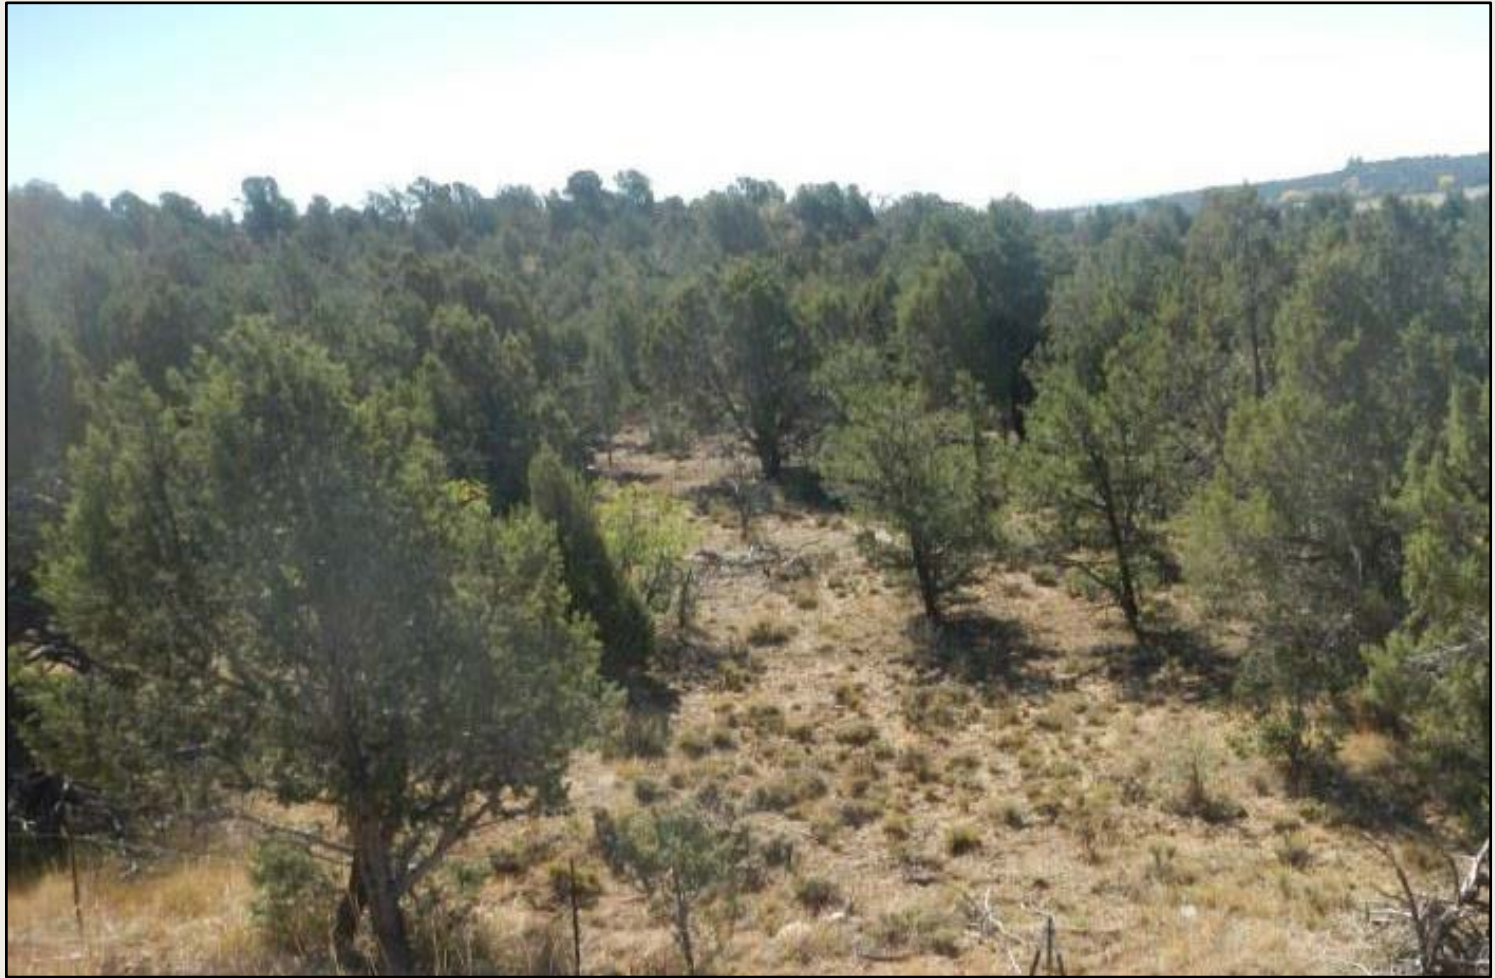
Photo 4. View of the reference area comprised of pinyon and juniper woodland with understory of black sagebrush, western wheatgrass, and gambel oak.
