Inspection Photos

Location Name: MARALEX RESOURCES INC SOUTH SHALE RIDGE-68S98W /14NENE

Location ID: 324270

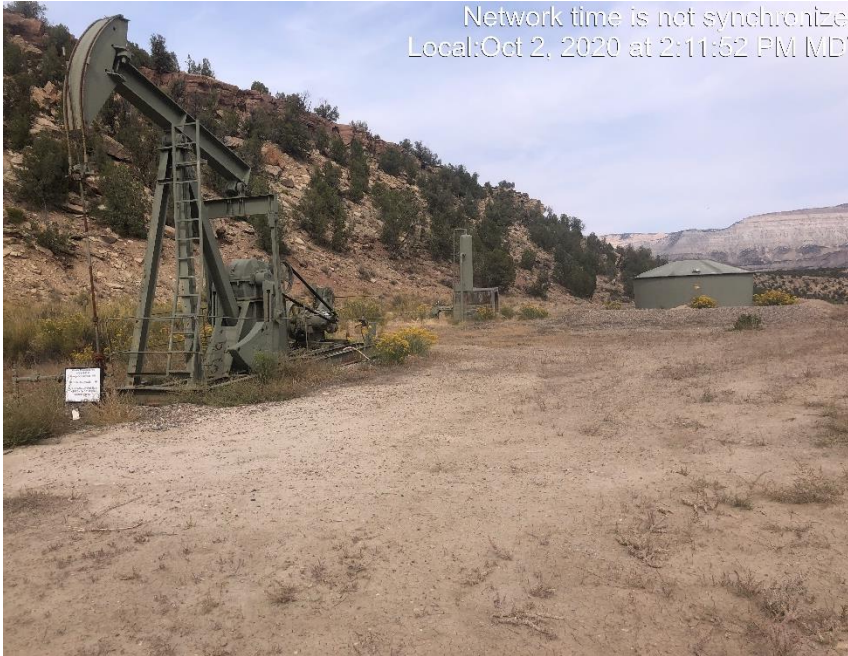
Photo #1974 from entrance to location.

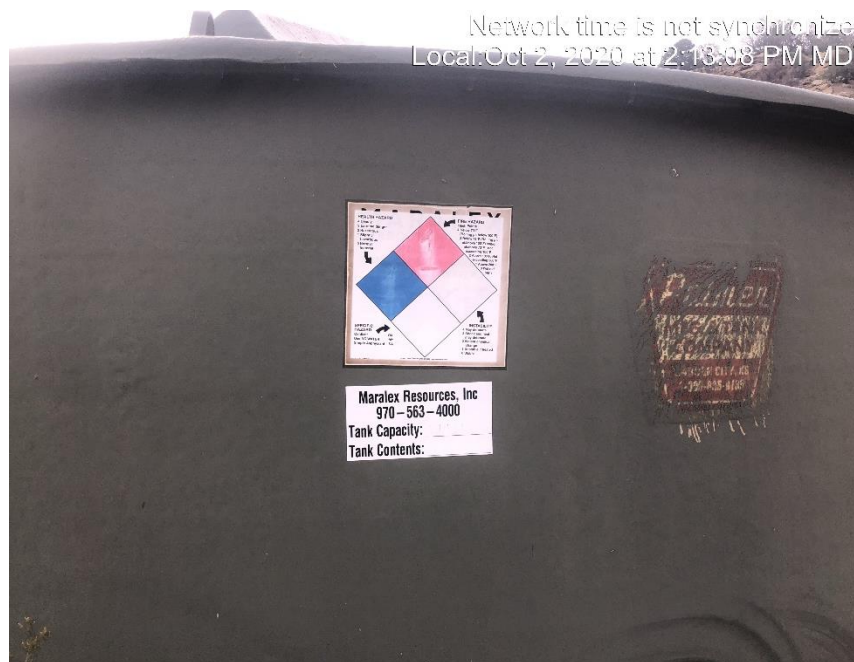
Photo #1976 Tank label weathered and not legible.

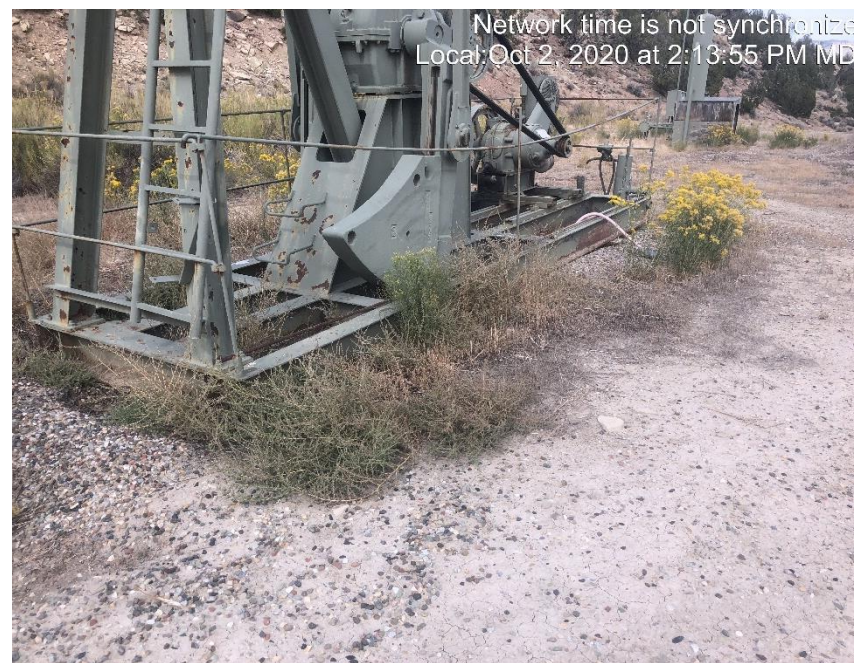
Photo #1978 Multiple places with debris and weeds on location.

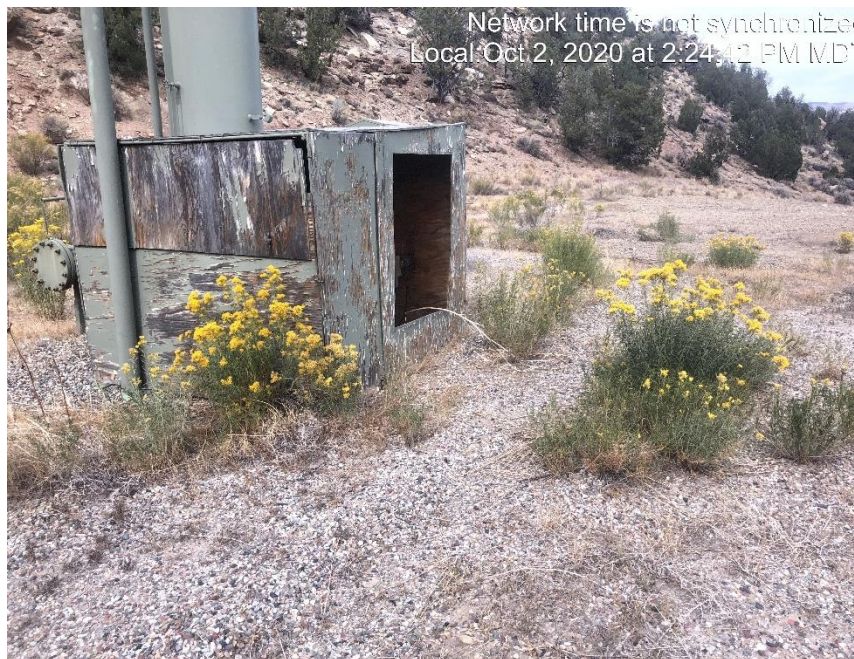
Photo #1979 Multiple places with debris and weeds on location.

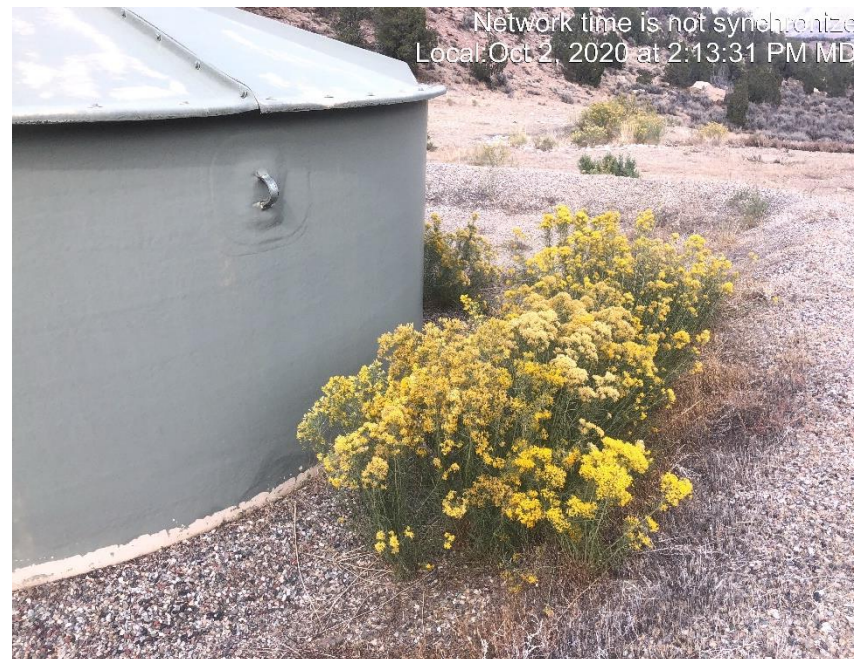
Photo 31977 Secondary containment not adequate weeds growing inside tank containment.
