Inspection Photos

Location Name: MARALEX RESOURCES INC SOUTH SHALE RIDGE-68S98W /14NENE

Location ID: 312598

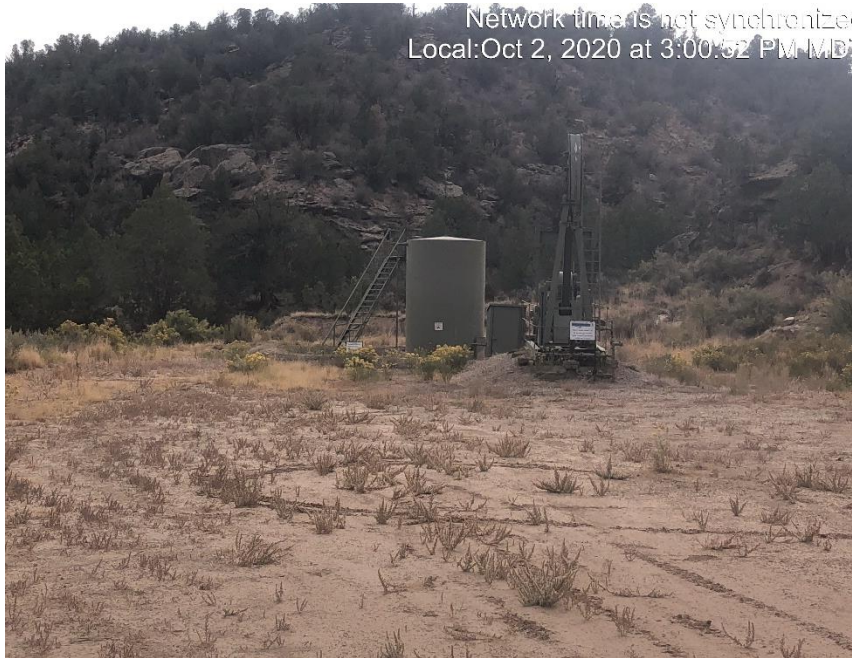
Photo #1983 from entrance to location.

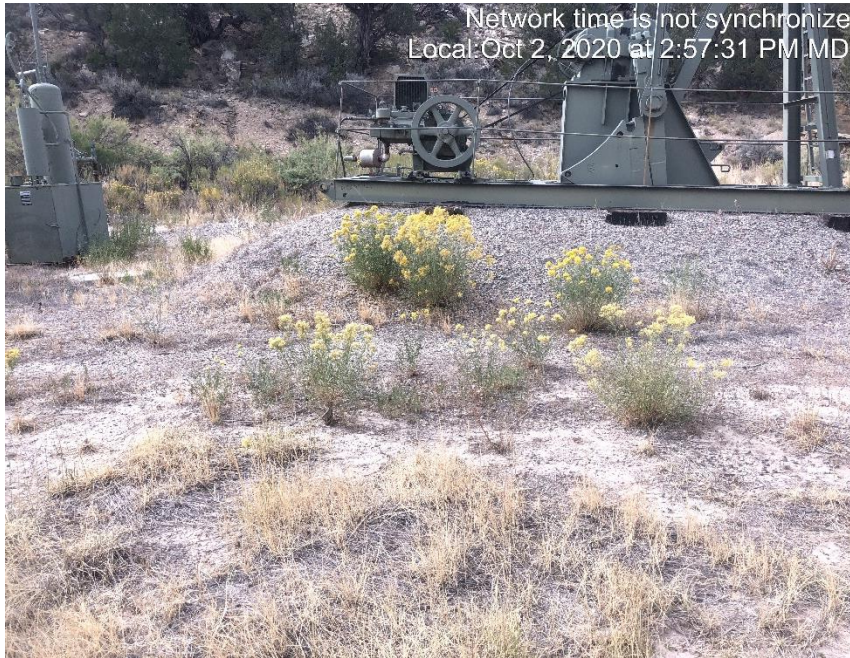
Photo #1981 Multiple places with weeds and debris on location.

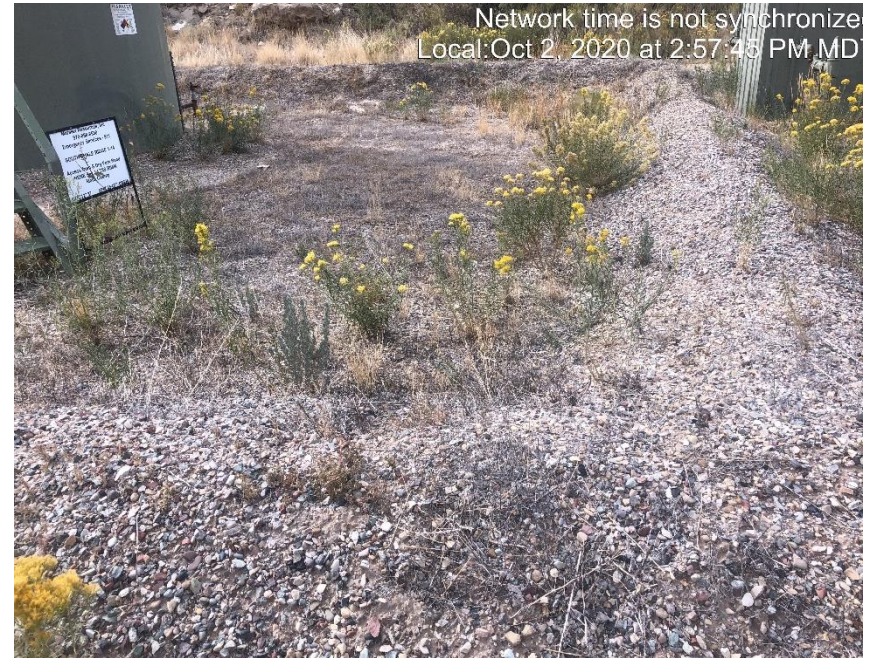
Photo #1982 Secondary containment not adequate weeds growing inside tank containment.
