Inspection Photos  
Operator: BP America  
API: 067-06285  
Date: 9/29/2020

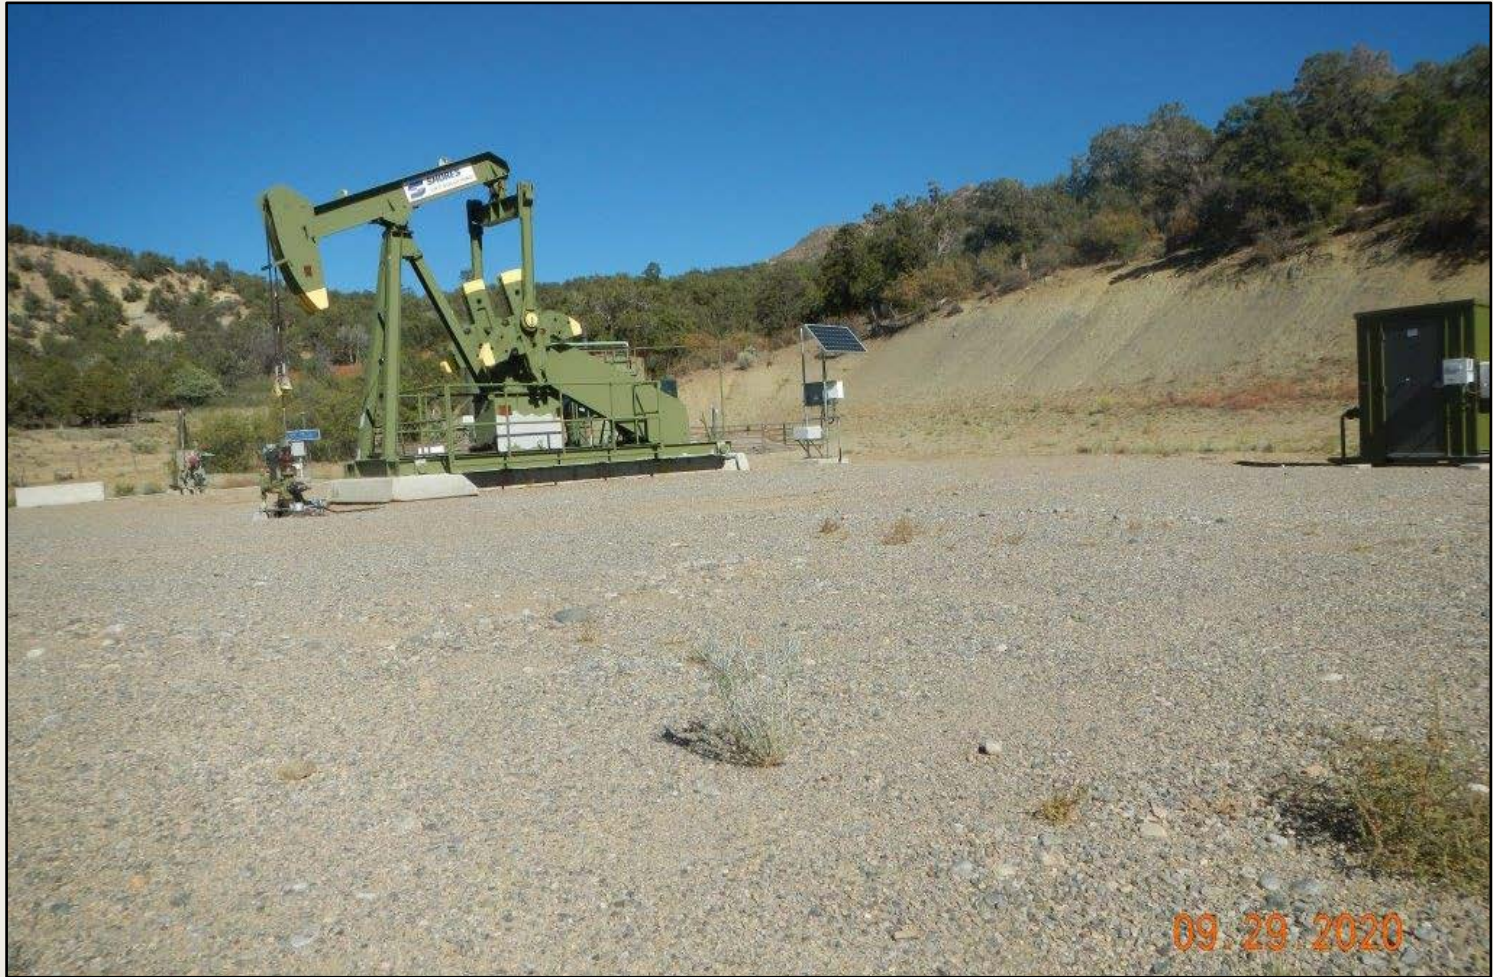
Photo 1. View of the project area from the western corner facing center.

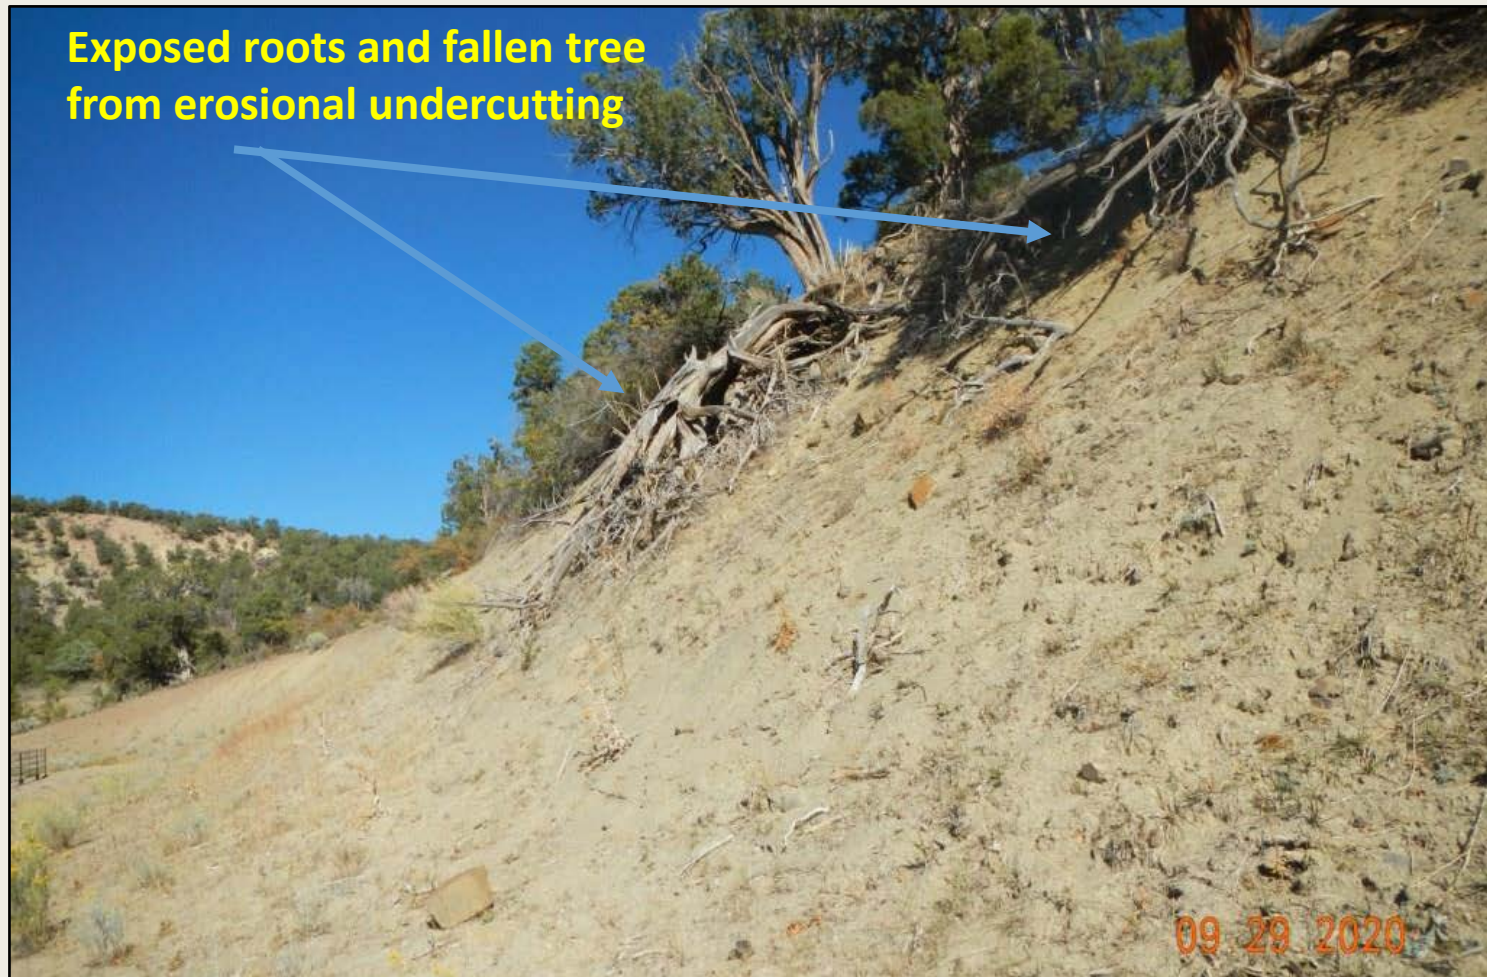
Photo 2. View of the eastern cut-slope facing northward. Undercutting of vegetation observed at the top of the slope.

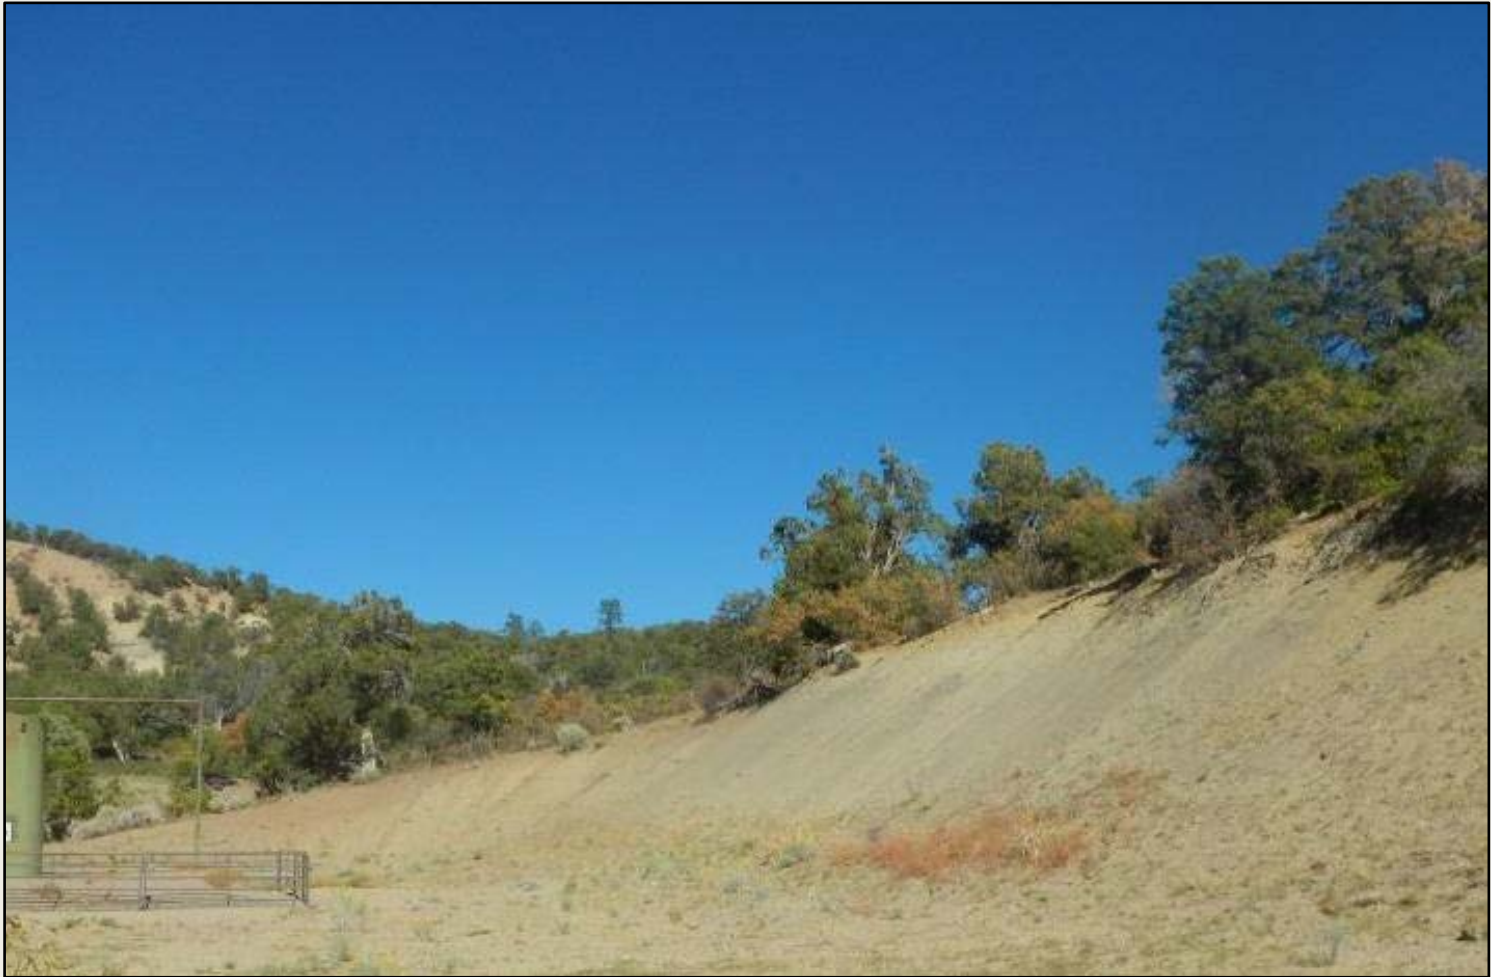
Photo 3. View of the northeastern portion of the well pad cut-slope showing bare soils with little desirable vegetation present.

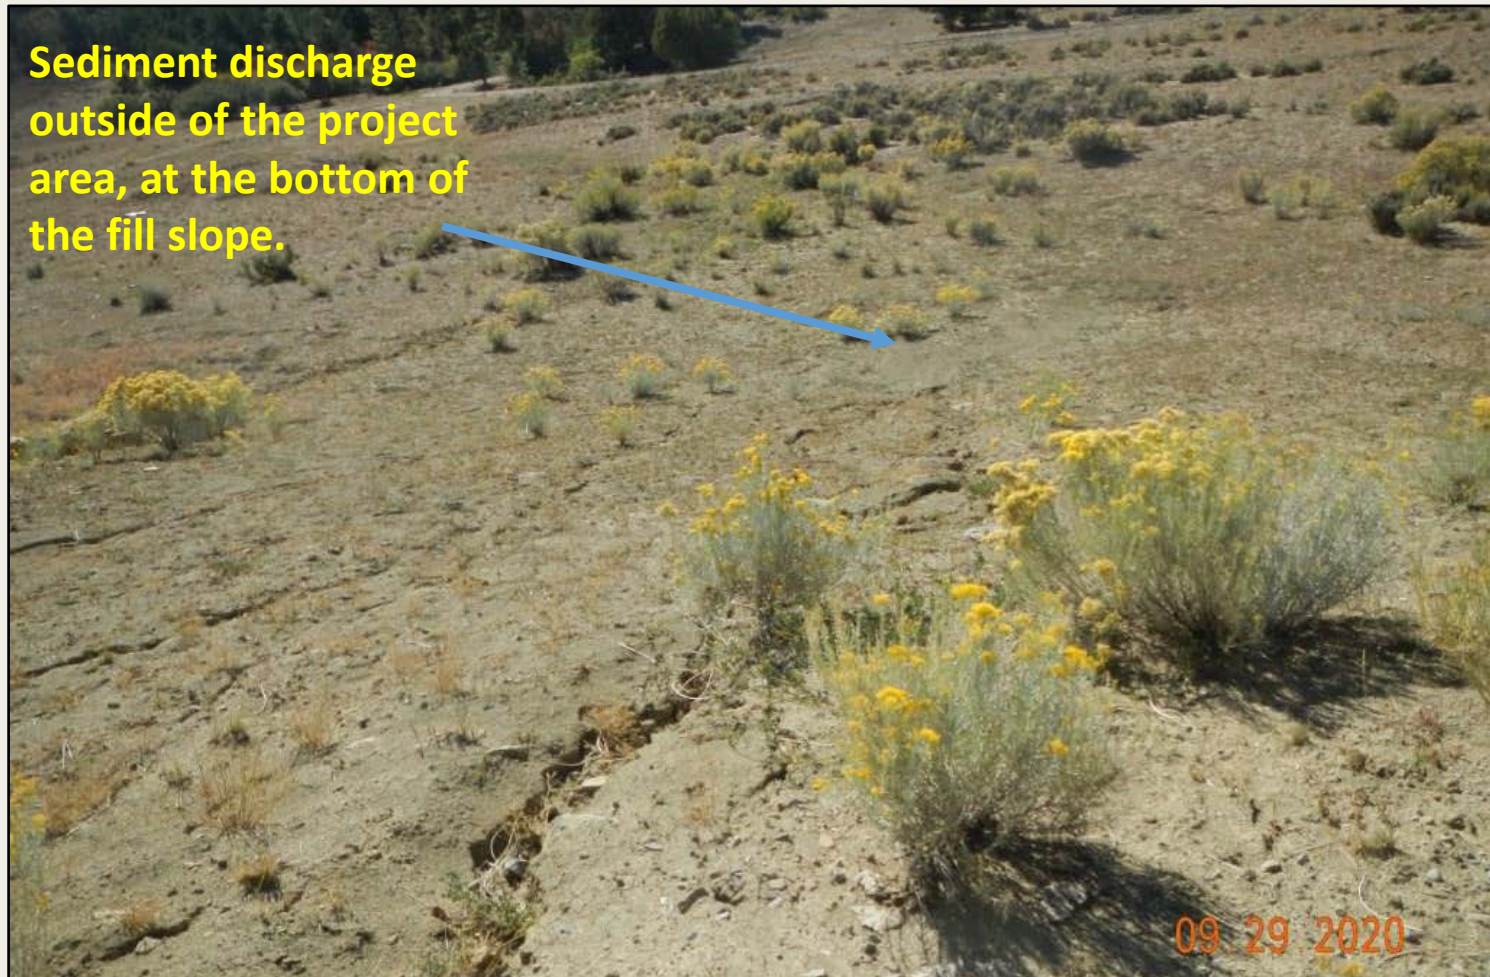
Photo 4. View of erosional rilling within the southwestern project area, facing down-slope.

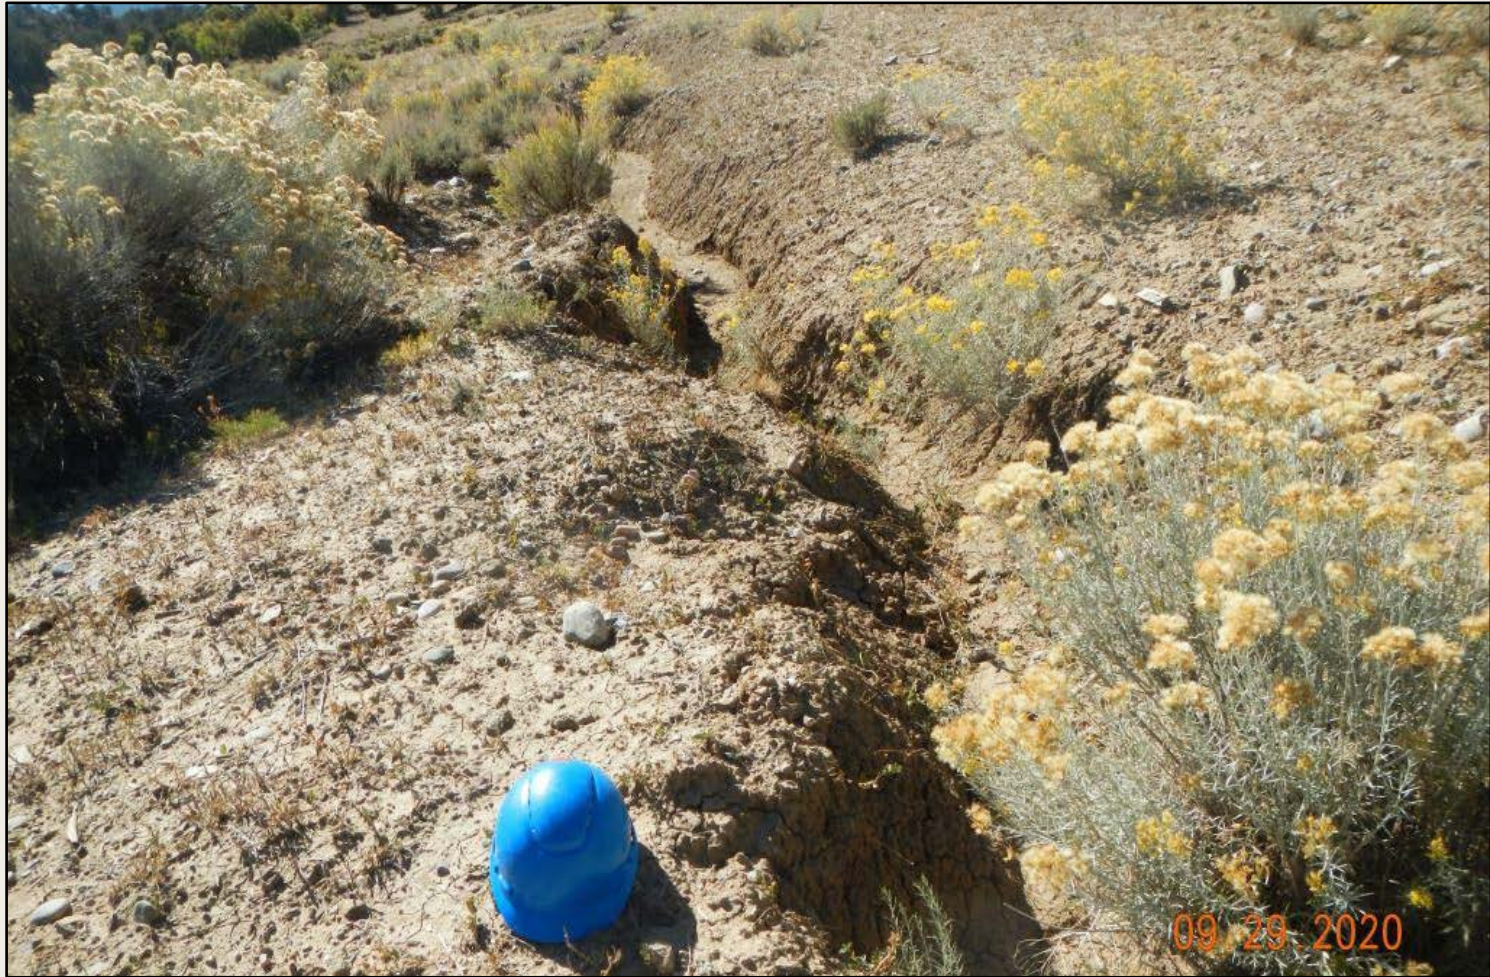
Photo 5. View of erosional channel approximately 2.5 feet wide and 3 feet deep at culvert outlet near well pad entrance. Erosional headcut is present here that needs to be stabilized.

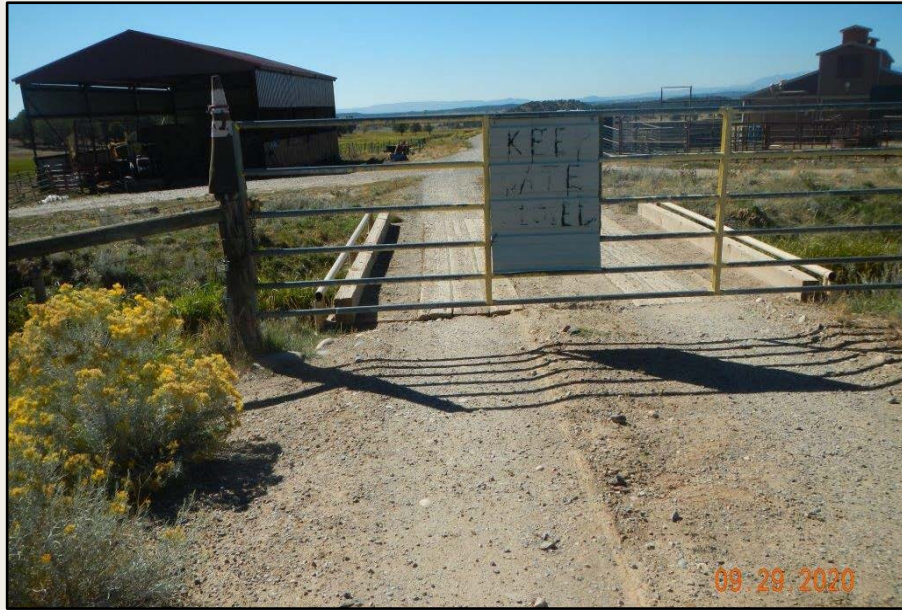
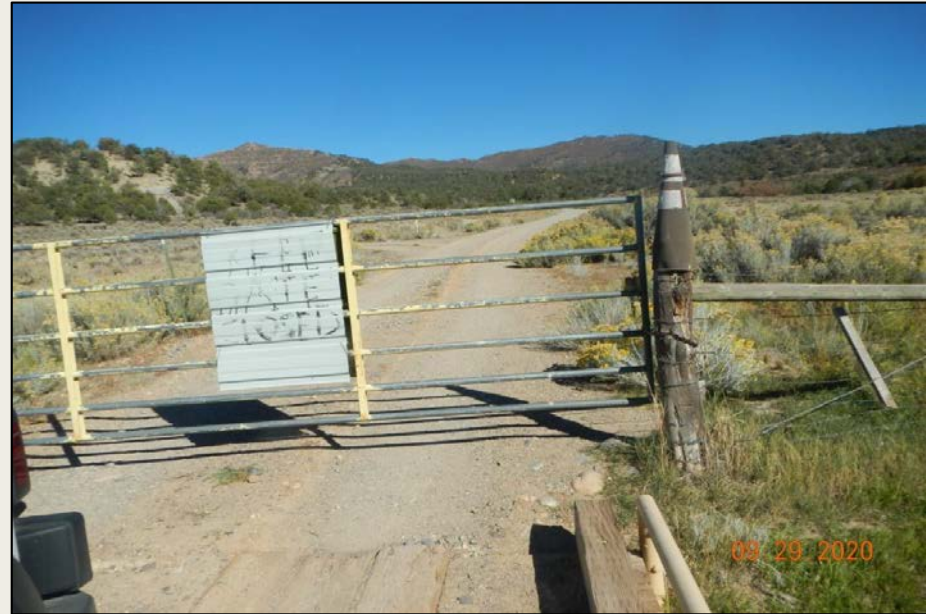
Photos 7/8. Closed gate coming in (left) and leaving (right).
