COLORADO
Oil & Gas Conservation
Commission
Department of Natural Resources

Calamity Ridge 4401D A23 1N100 API: 05-103-10561
Inspection: 700403759

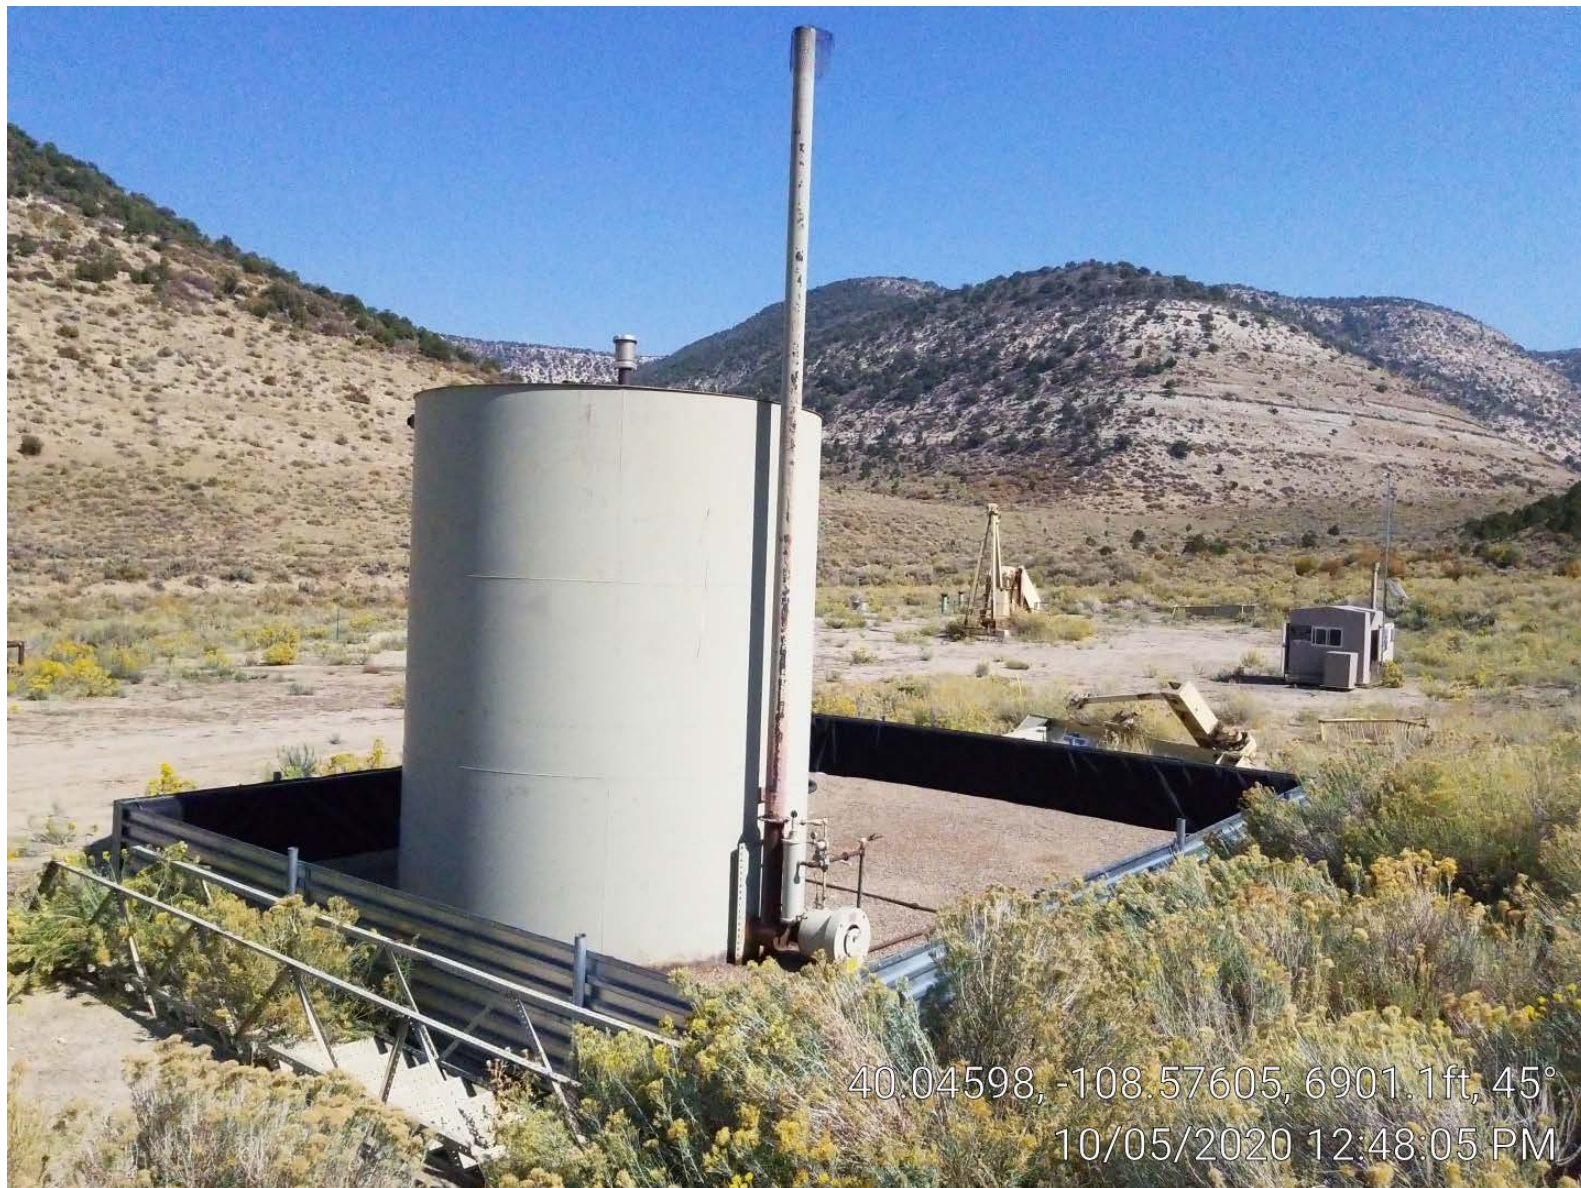
Photo 1. Location.

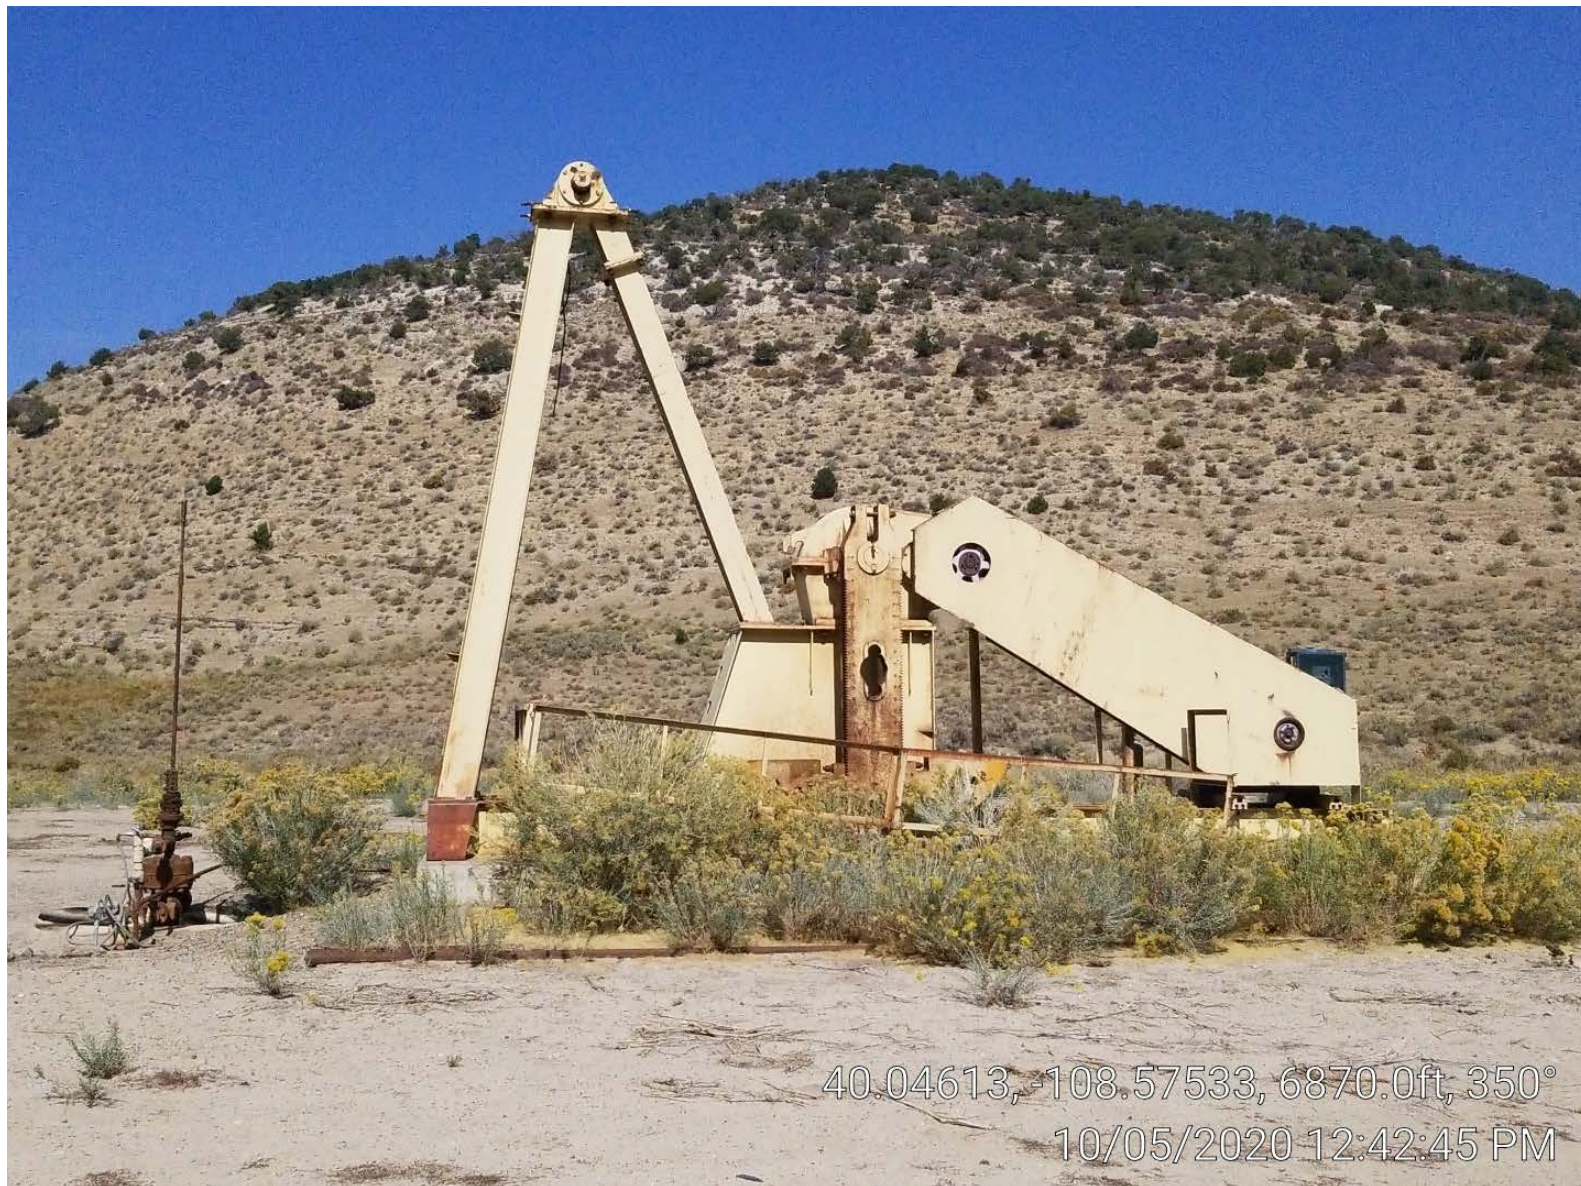
Photo 2. Pump jack.

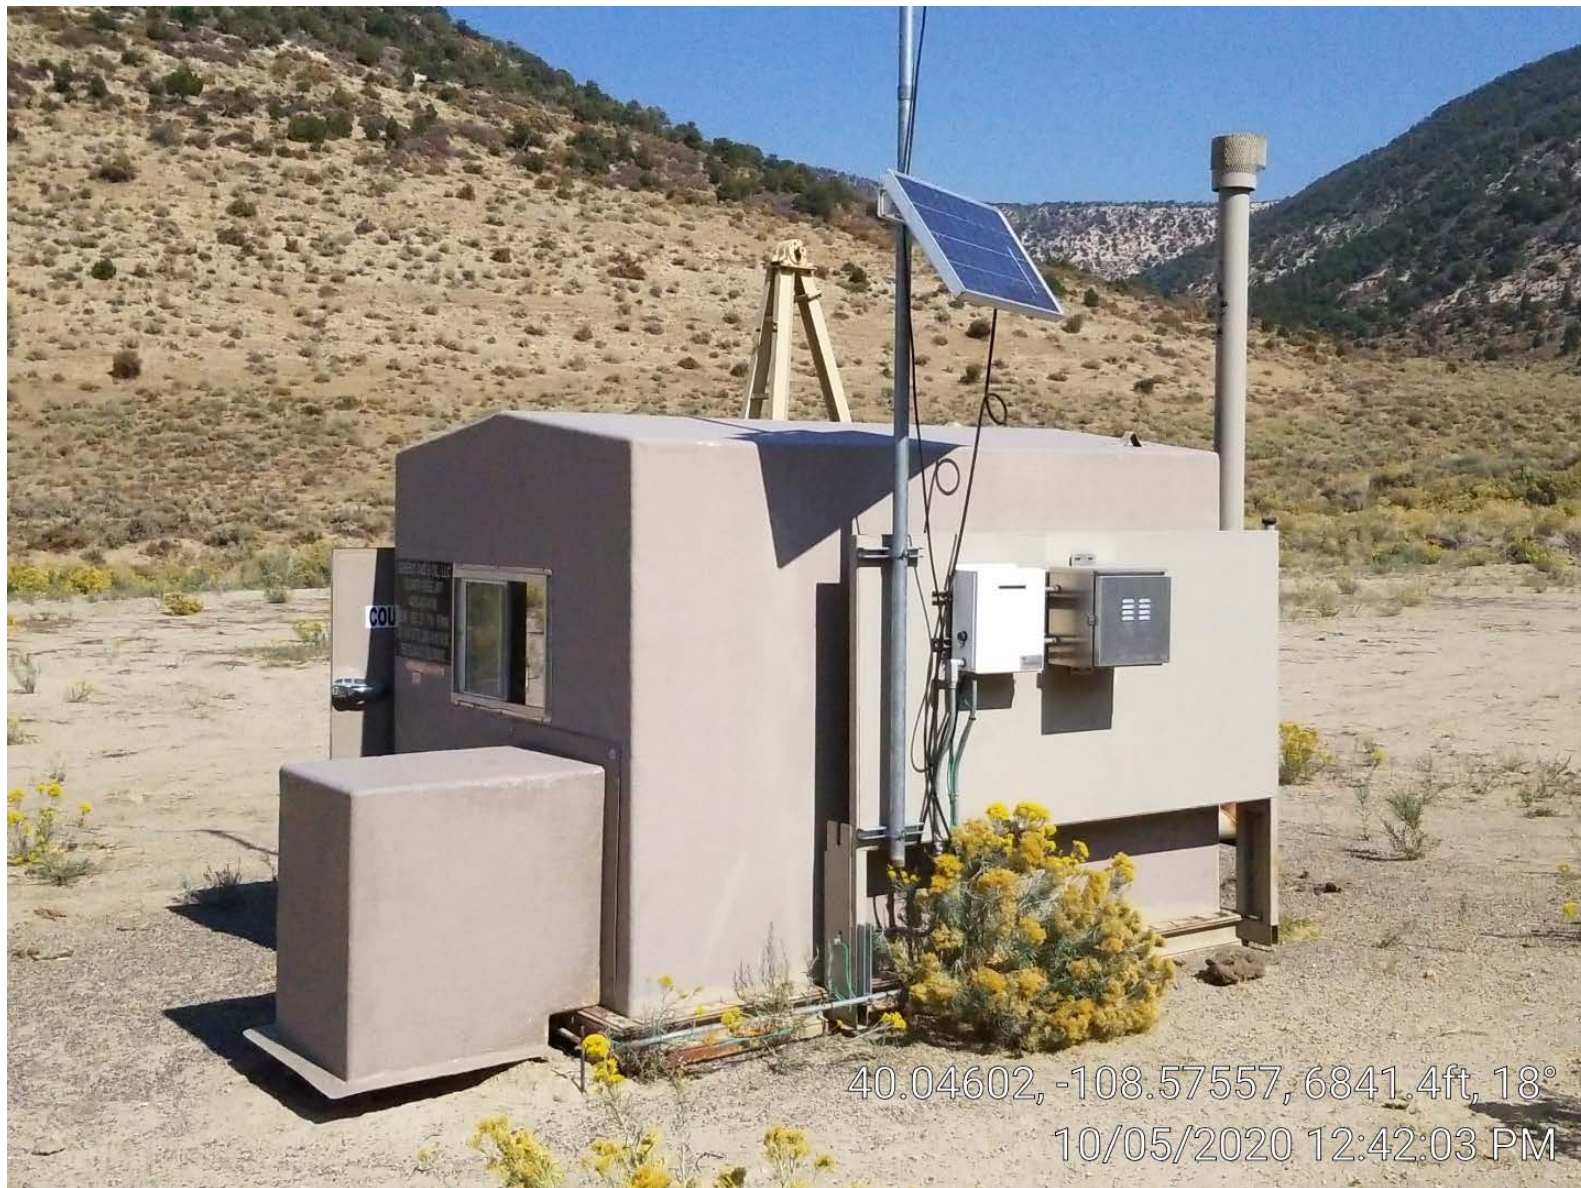
Photo 3. Meter building.

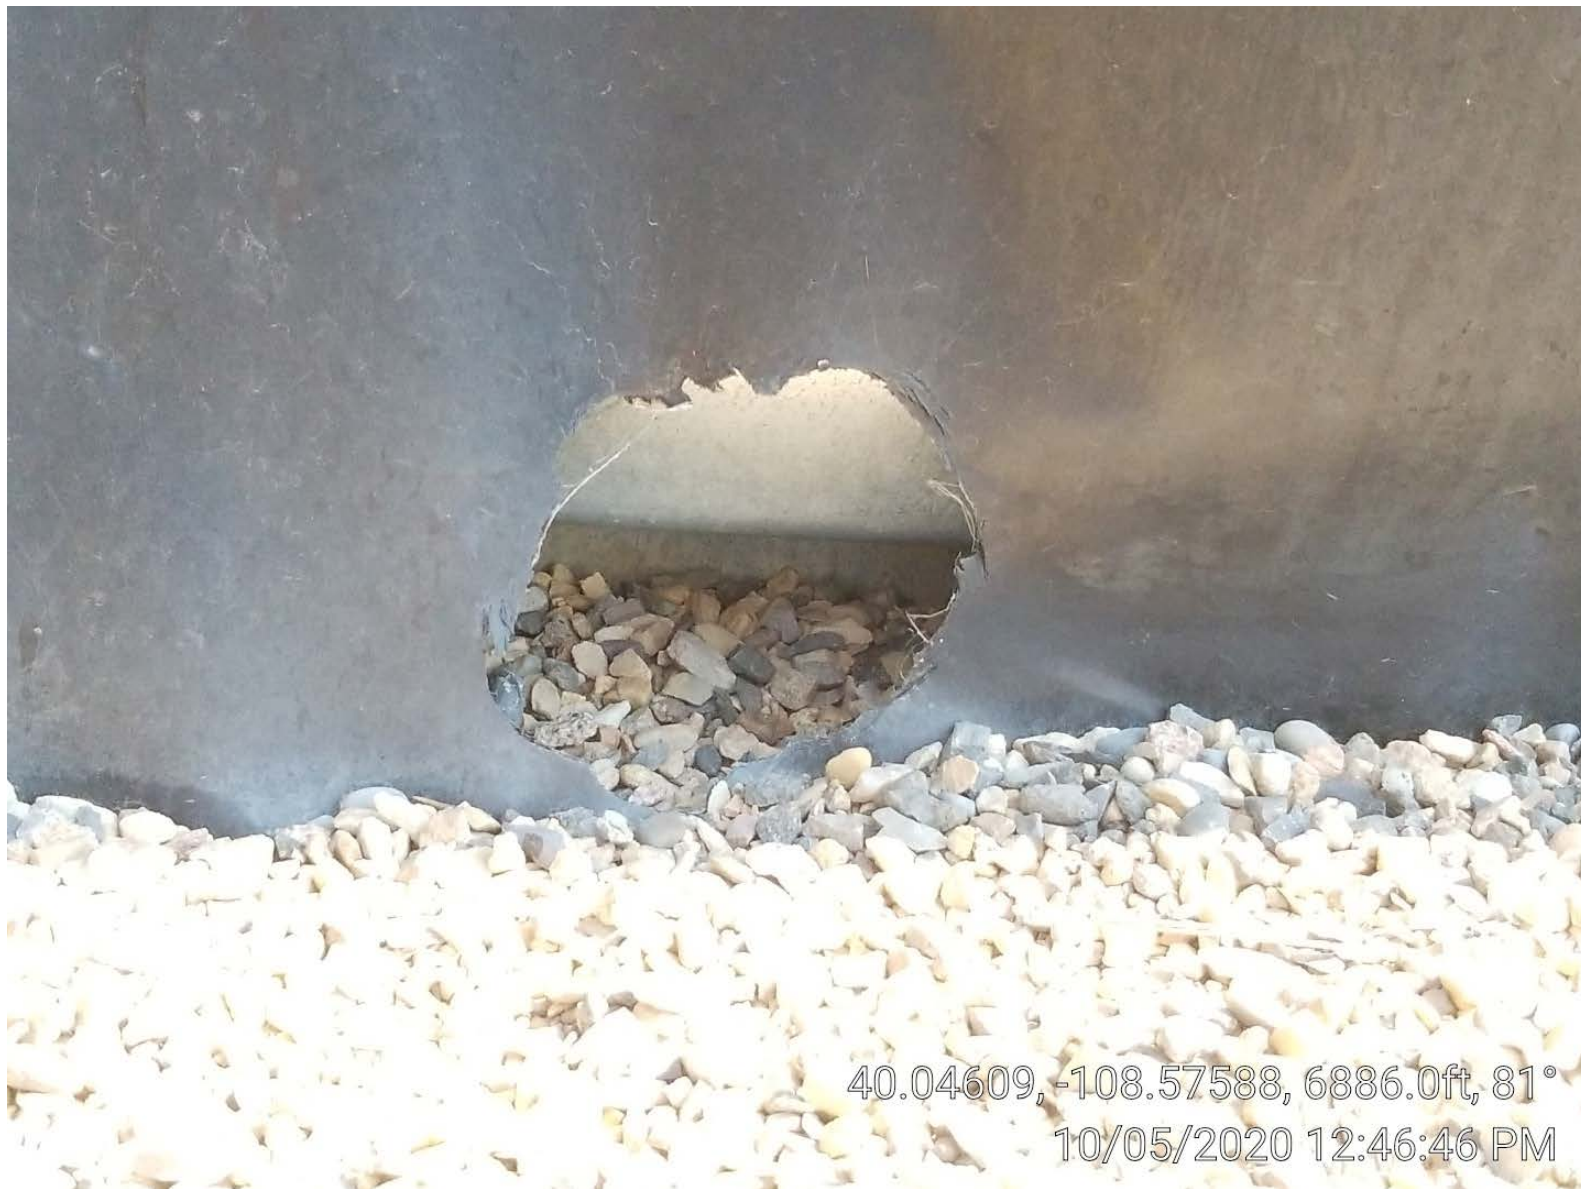
Photo 4. Tank secondary containment liner.

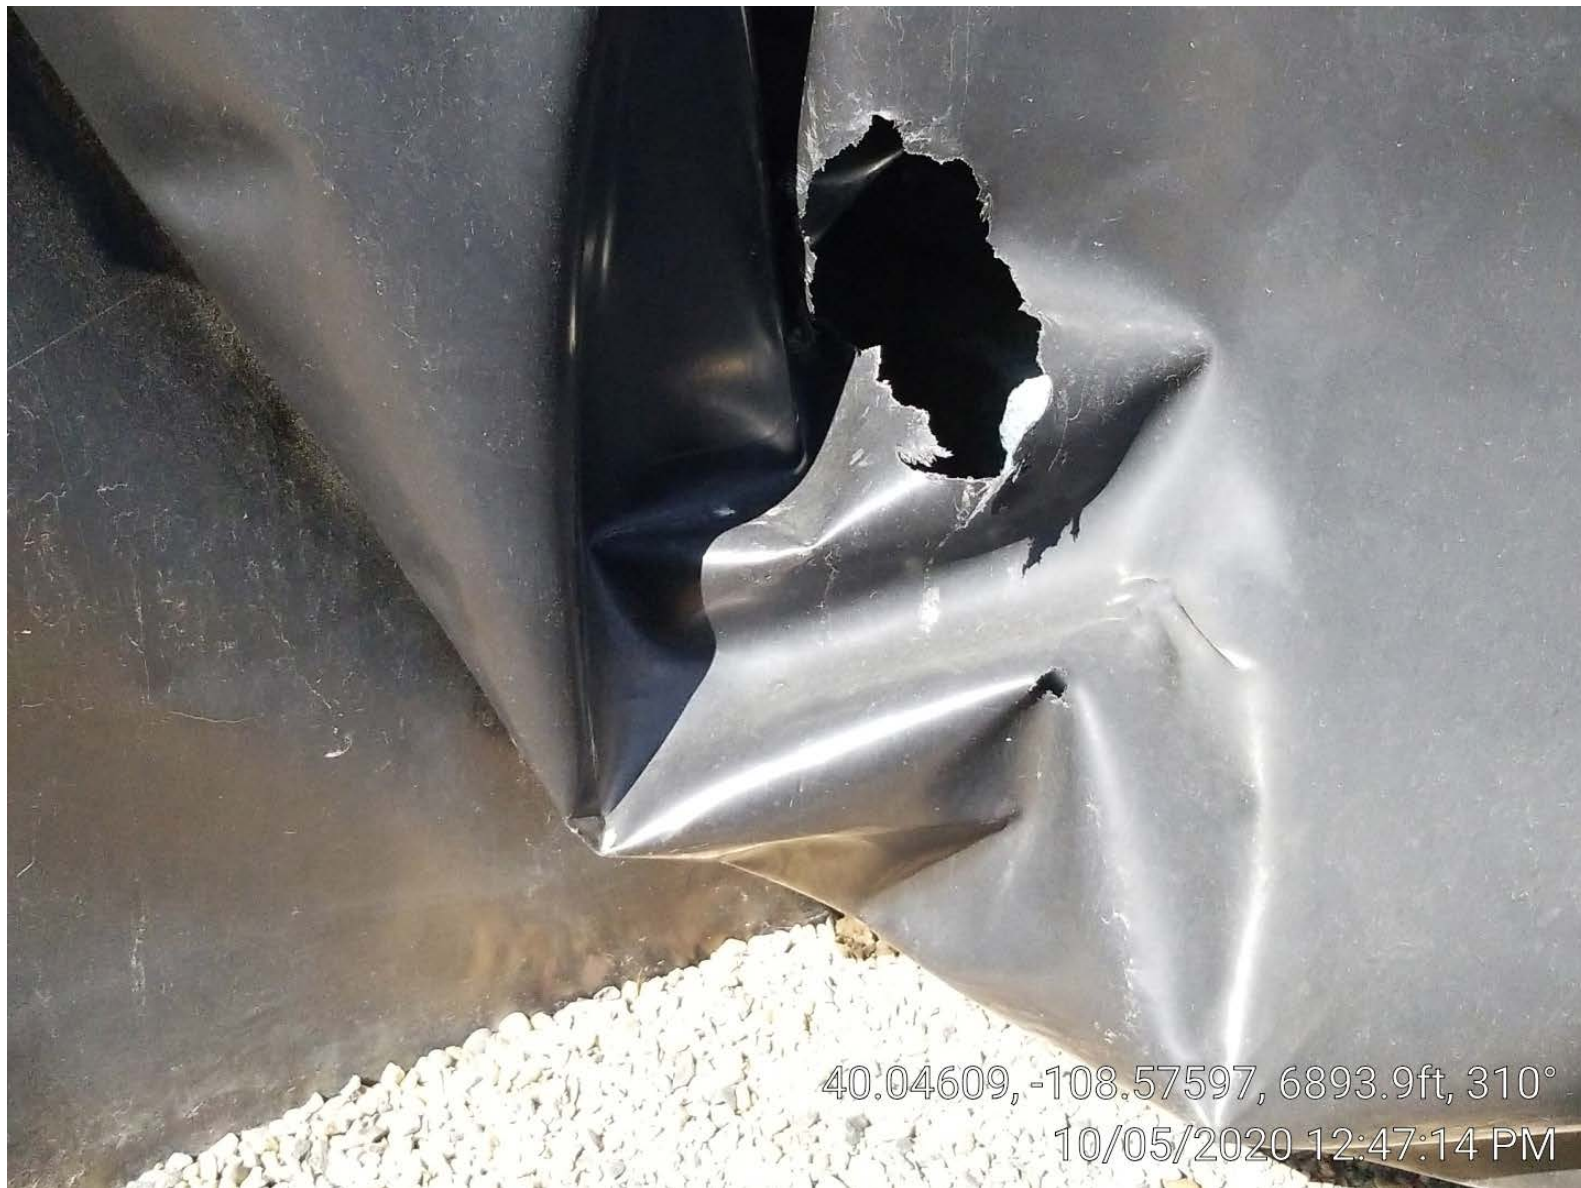
Photo 5. Tank secondary containment liner.

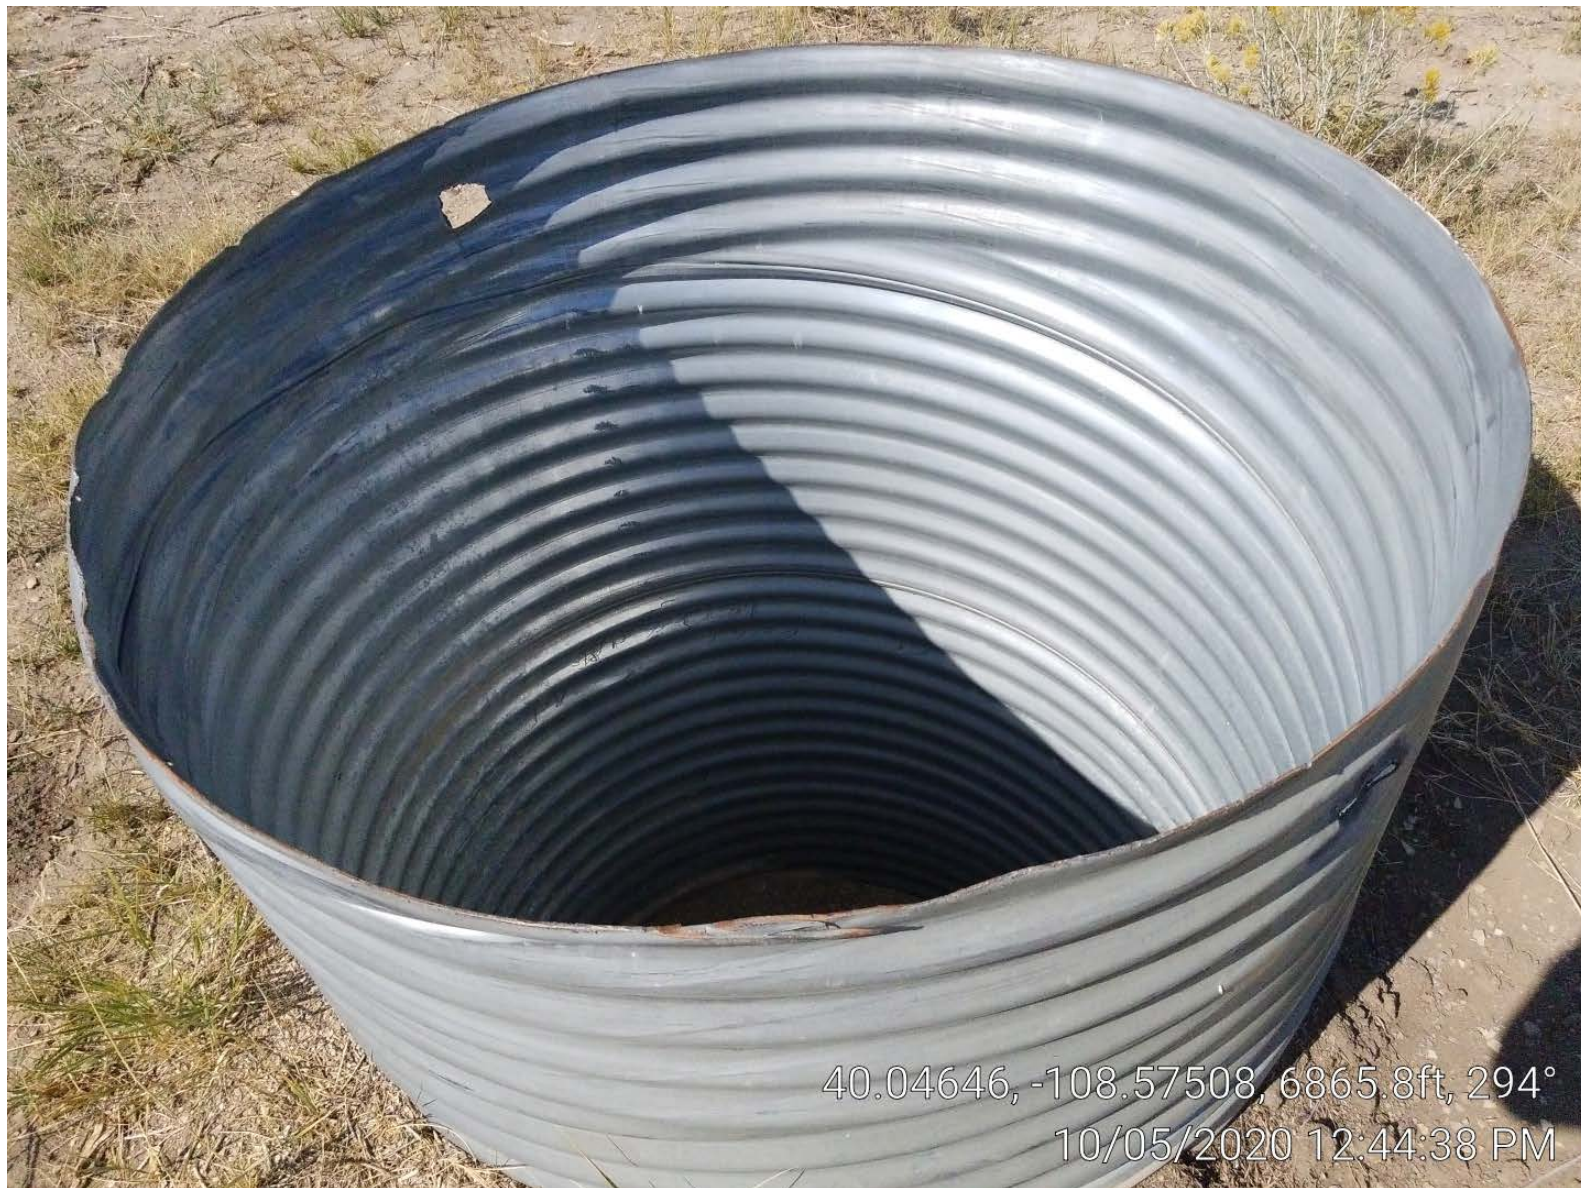
Photo 6. Valve can.

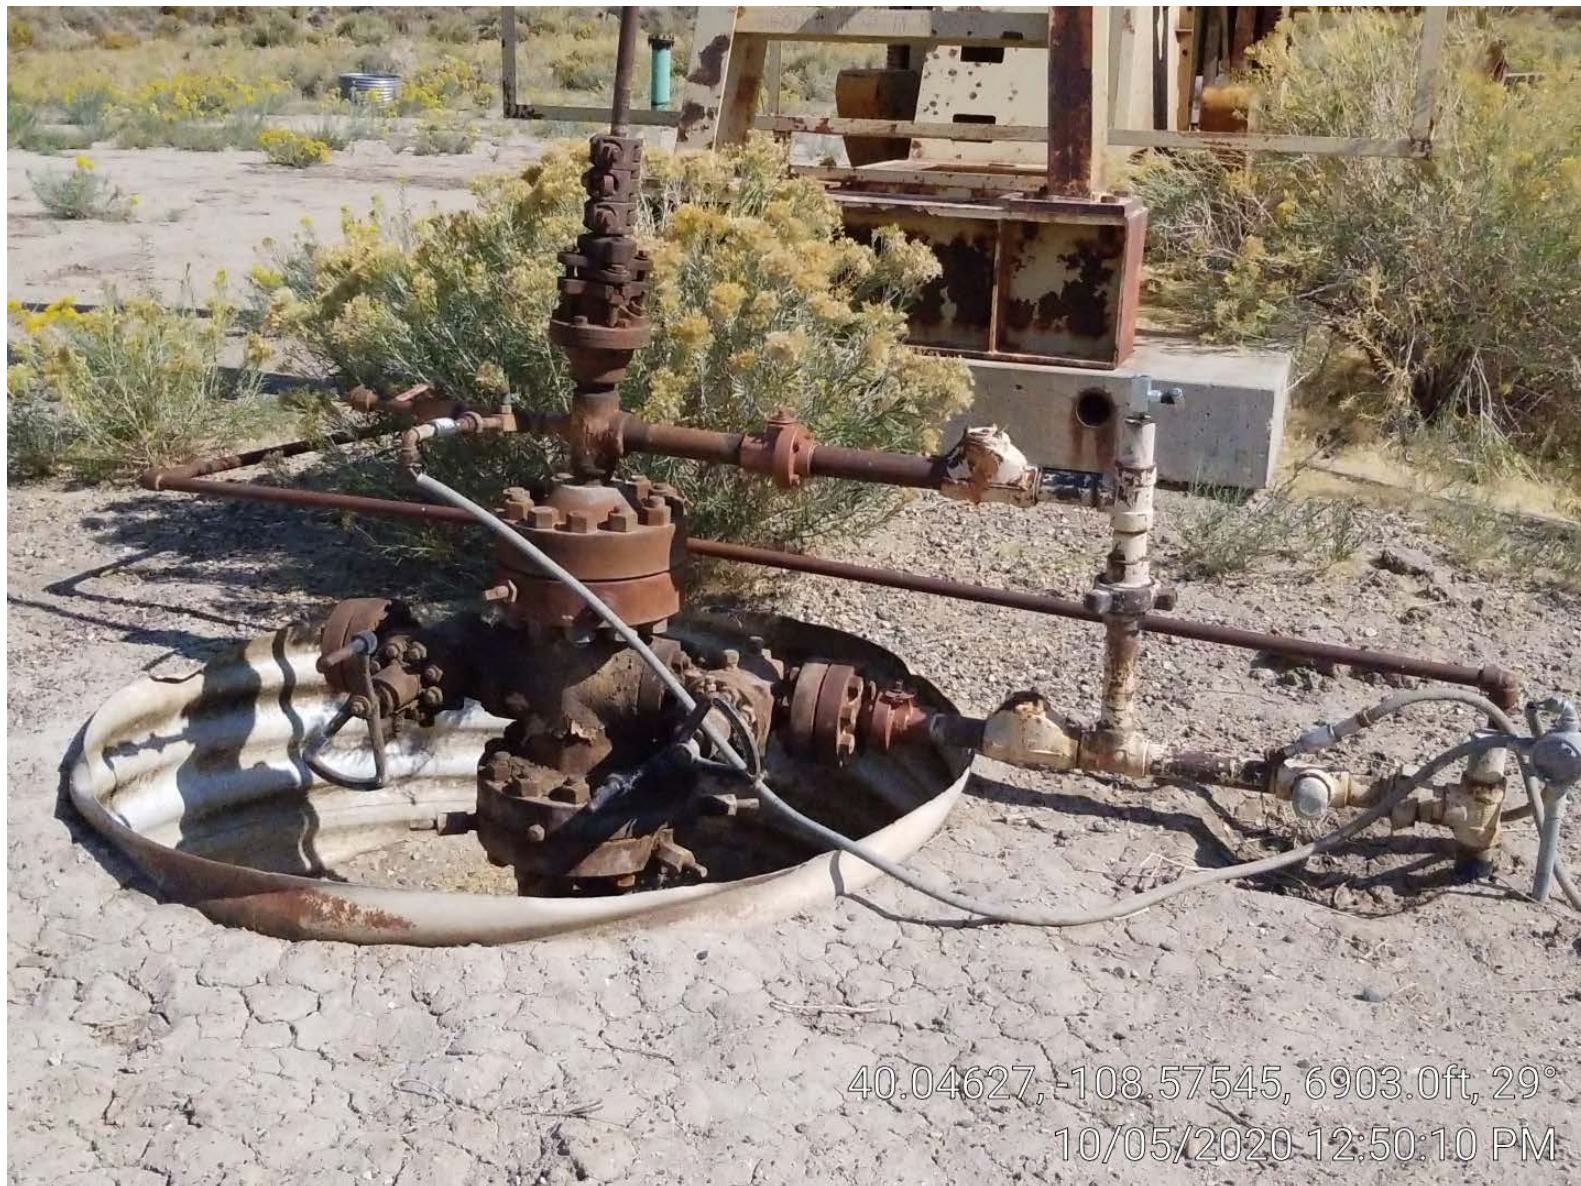
Photo 7. Well head.
