Inspection Photos

ID: 321225

Operator: THOMAS L SPRING LLC

Inspection Date: 9/24/2020

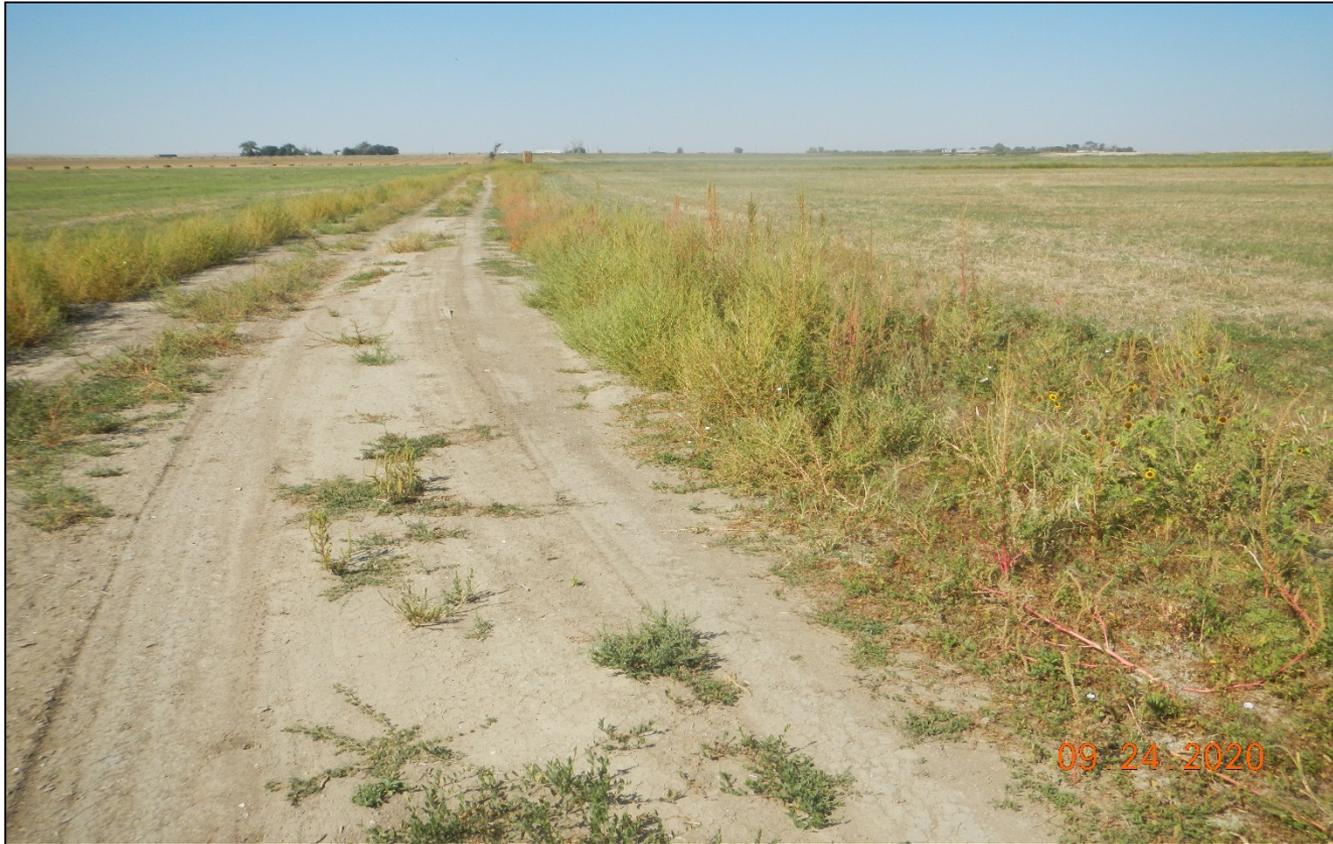
Photo 1. Facing west along the access road. The access road has not been reclaimed and there is undesirable weeds along the roadside.

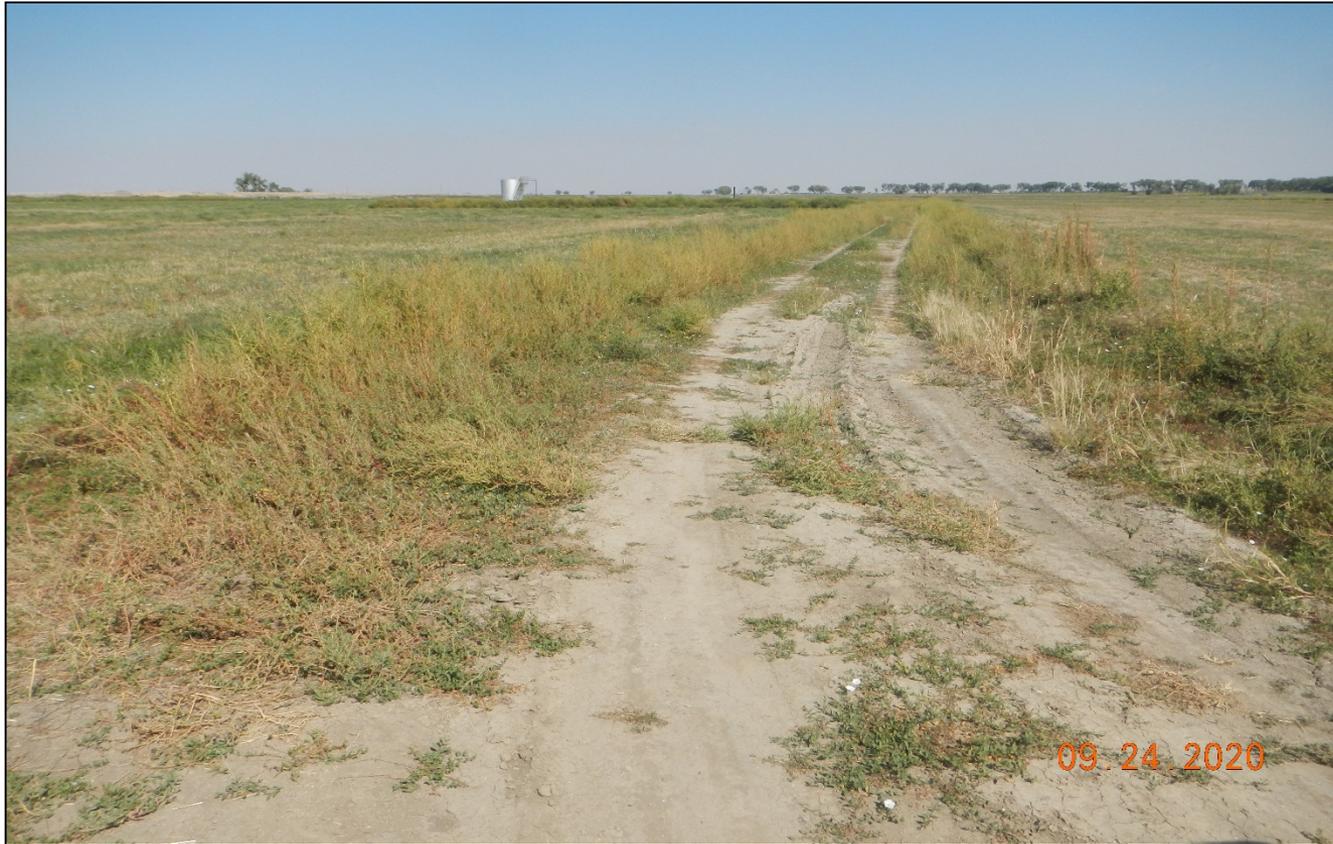
Photo 2. Facing north along the access road. The access road has not been reclaimed and there is undesirable weeds along the roadside.

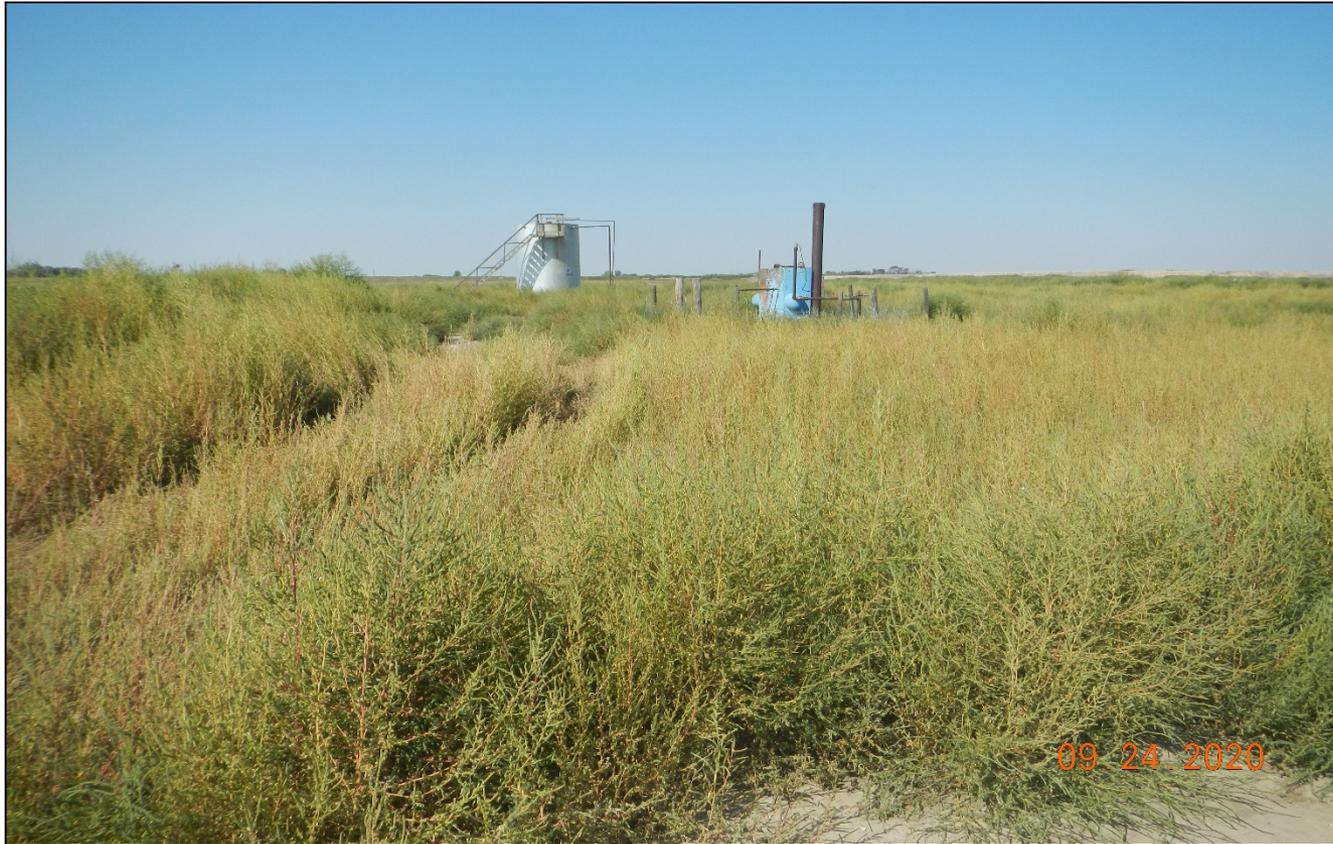
Photo 3. Facing northwest toward the location. There is undesirable weeds (Kochia) throughout the entire location which has grown to 4-6 feet tall.

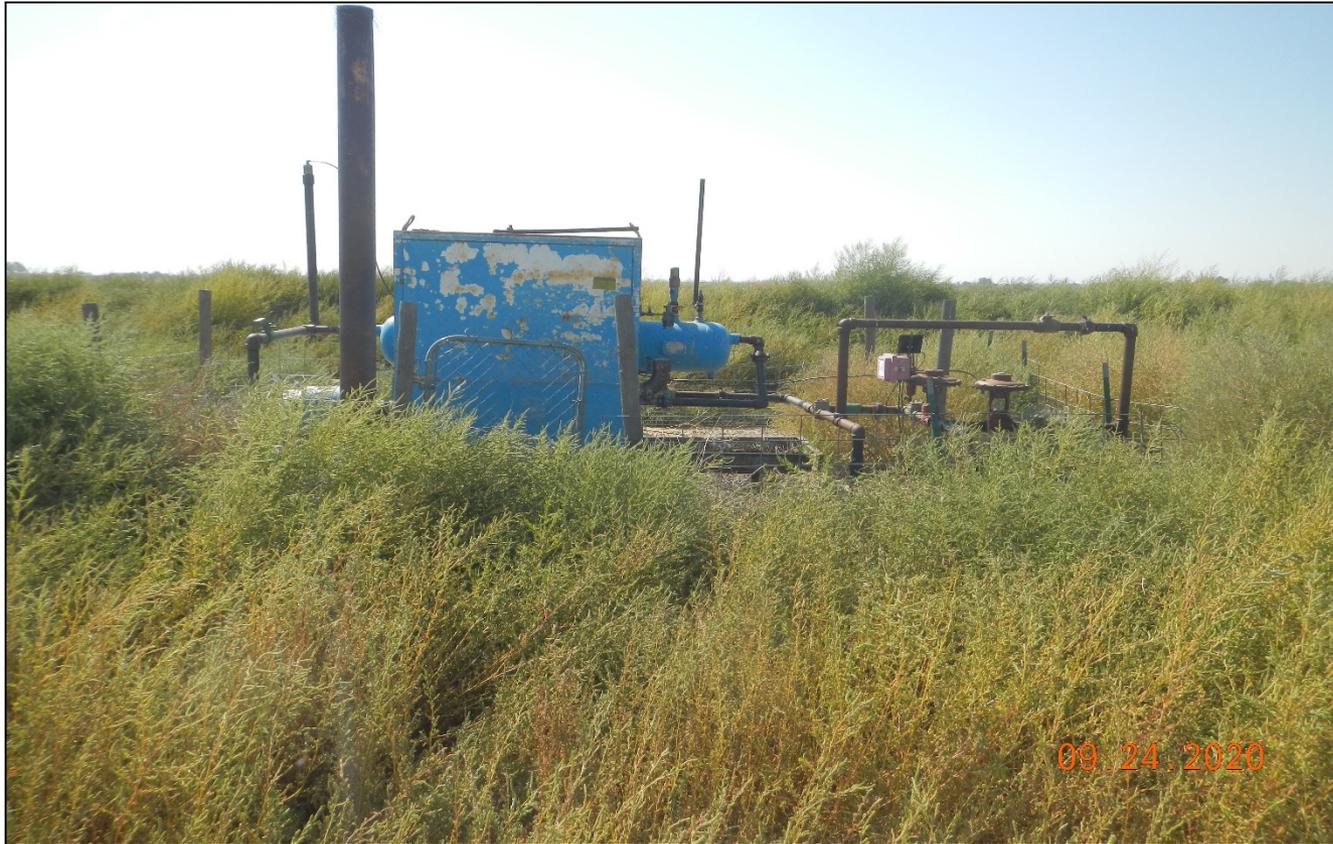
Photo 4. There is equipment that remains at the location that has not been removed. The weeds have grown around the equipment and are a fire hazard.

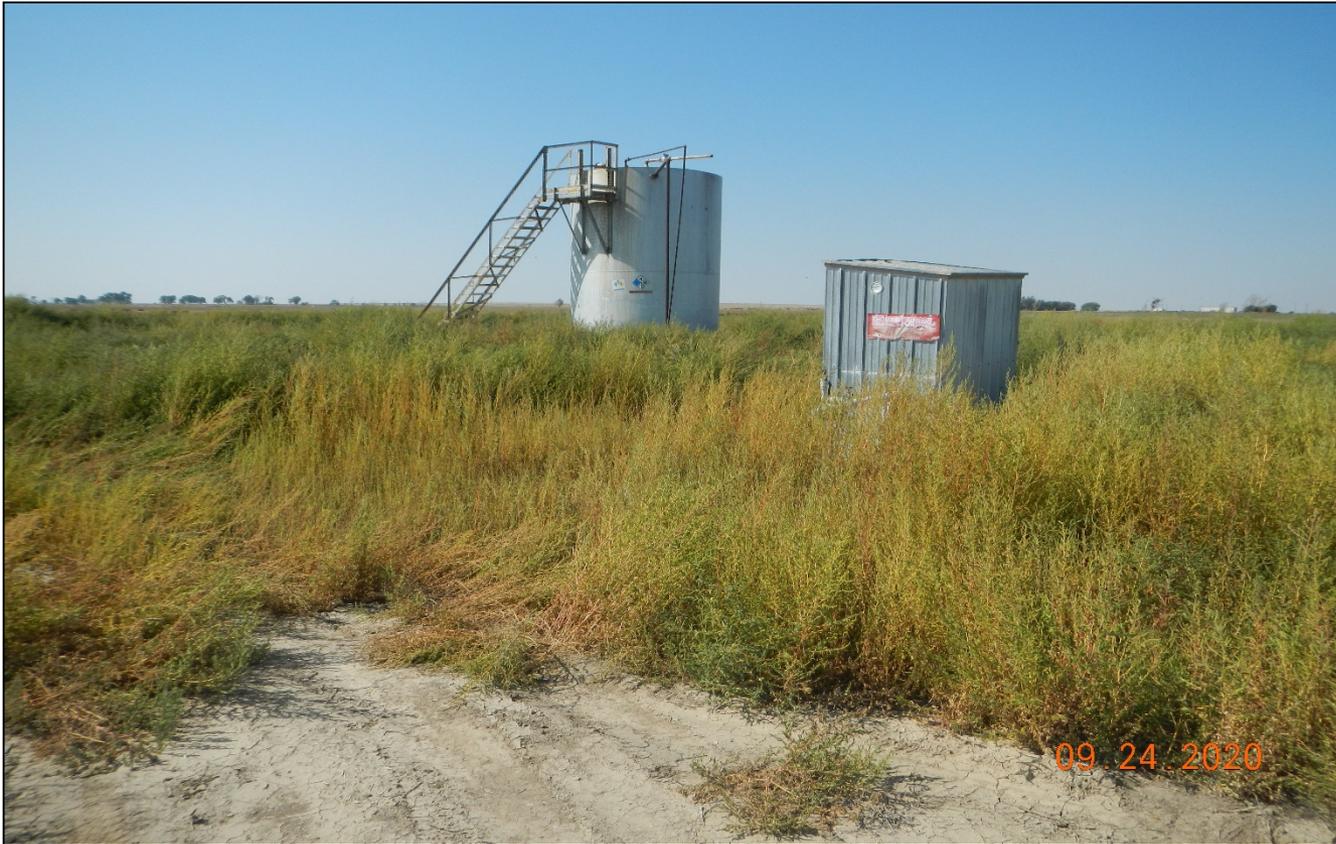
Photo 5. Facing southwest at the location. The meter shed and tank battery remains. All equipment should have been removed within 3 months of abandonment.

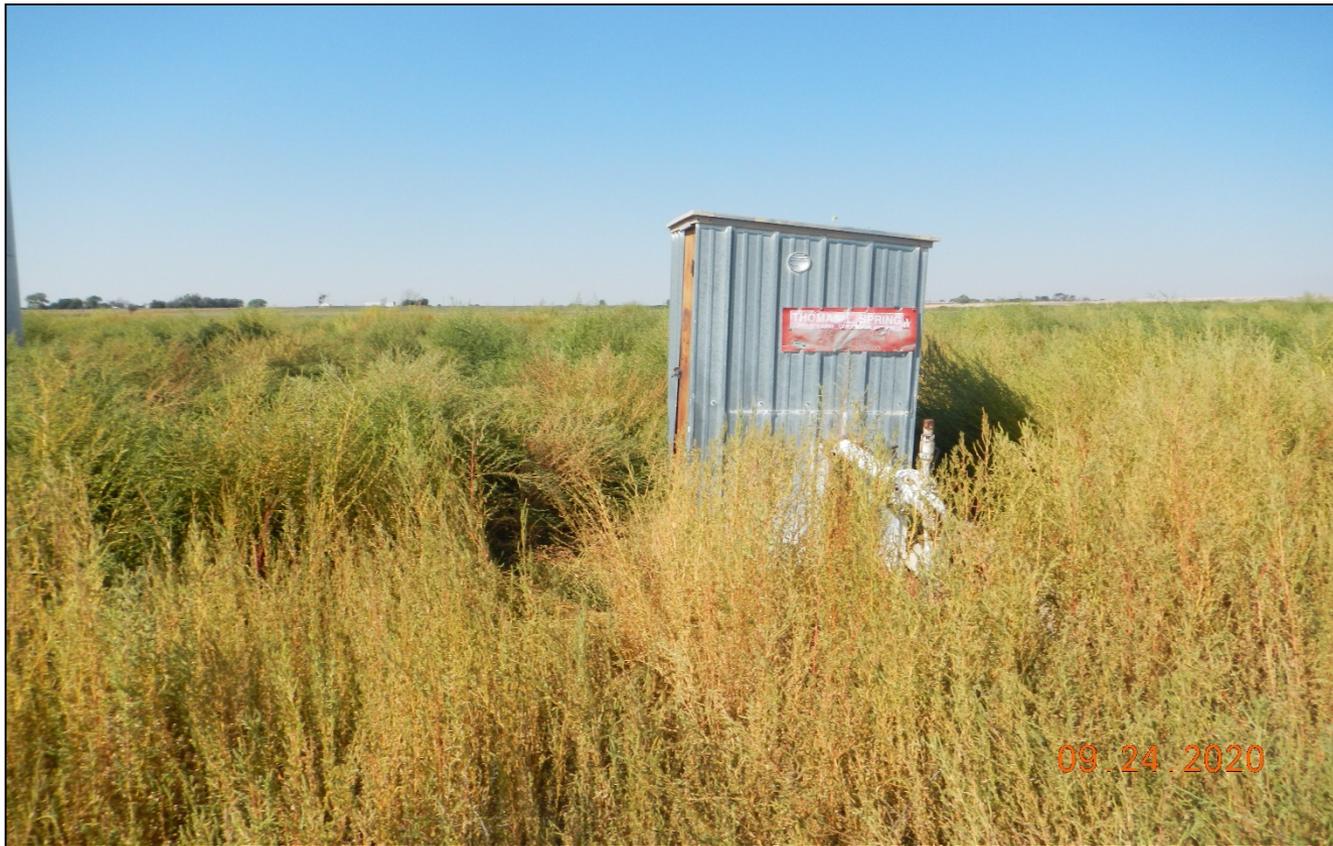
Photo 6. The locastion sign is faded and not legibile.

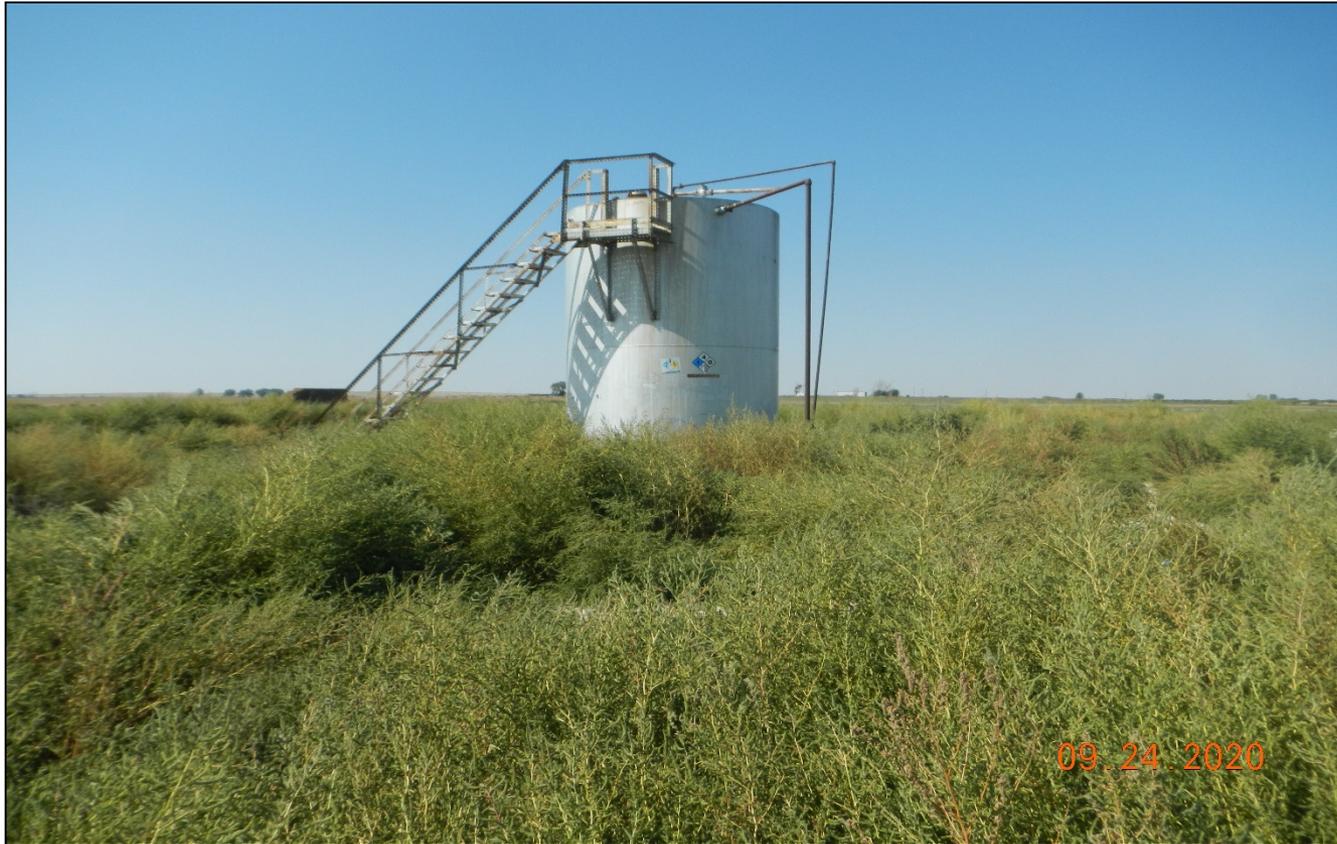
Photo 7. Facing toward the tank battery. The weeds are thick and overgrown that the surface of the location was not visible. It is unknown if there is secondary containment.

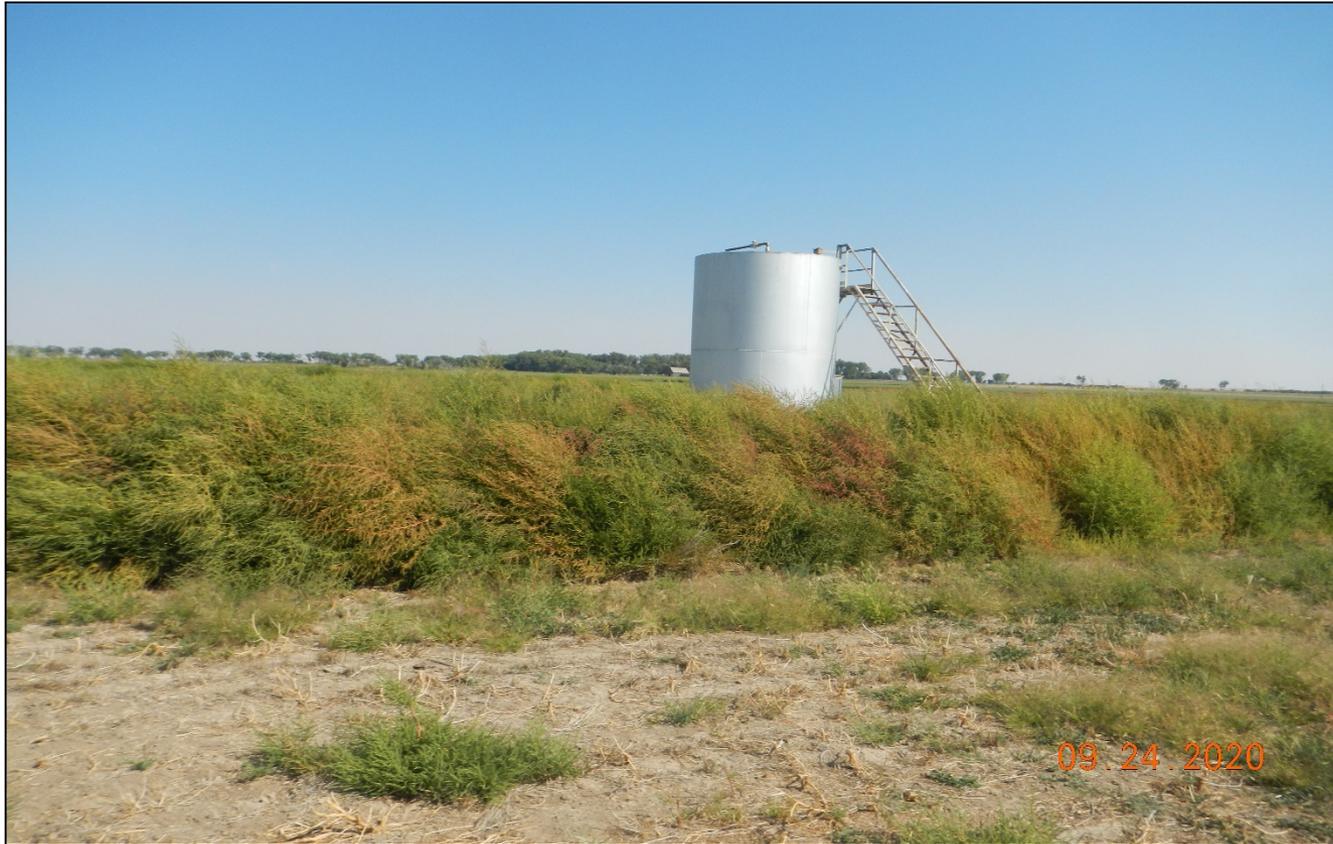
Photo 8. Facing northeast toward the location. The surrounding field has been mowed however the entire location is completely overgrown with Kochia.

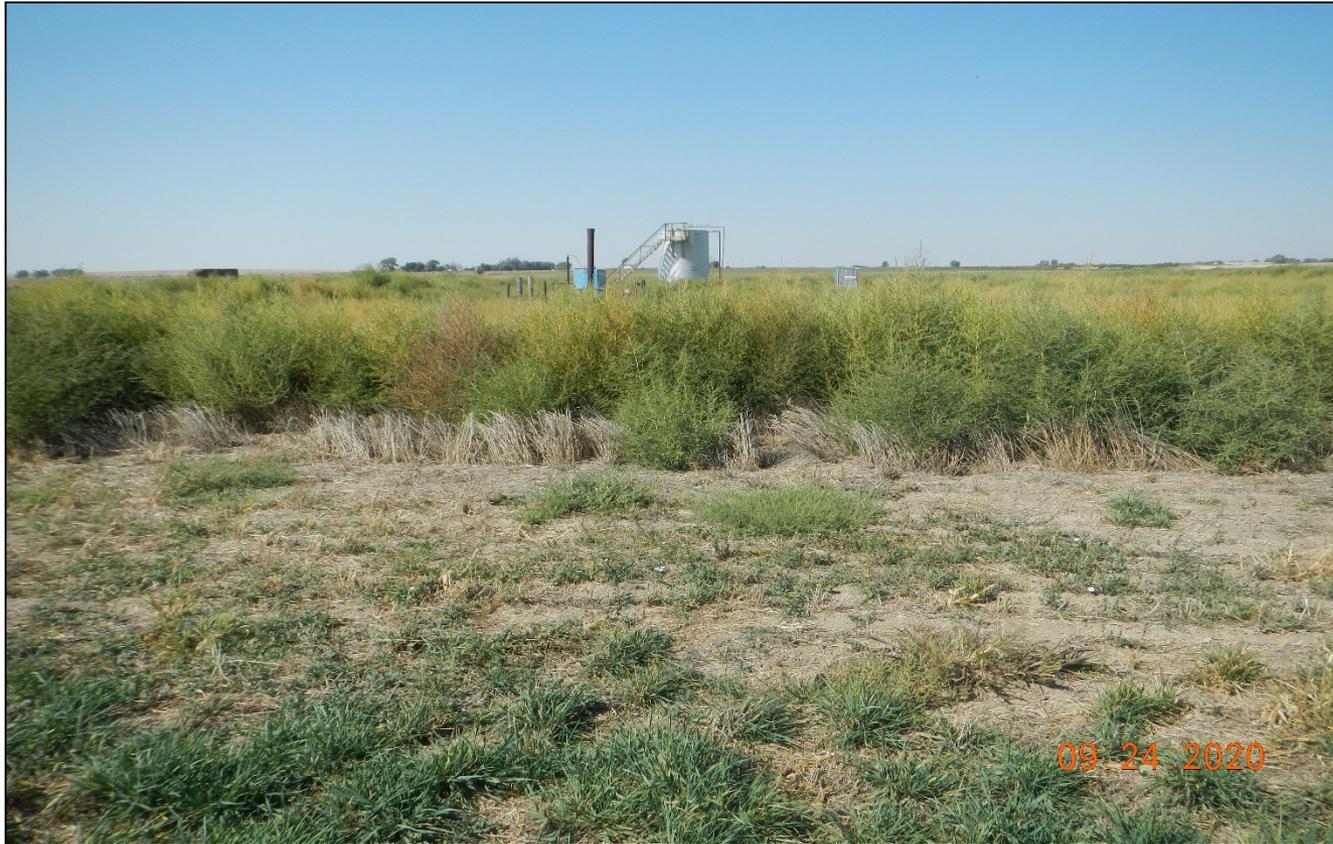
Photo 9. Facing west toward the location. The surrounding field has been mowed however the entire location is completely overgrown with Kochia.
