Inspection Photos

Location Name: MARALEX RESOURCES INC USA-69S98W /14SESE

Location ID: 312464

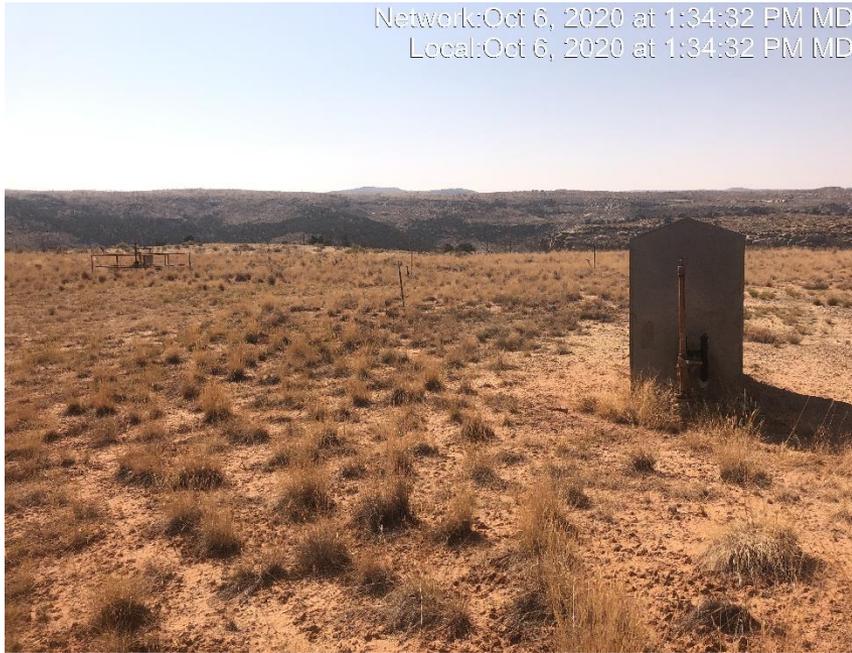
Photo #1986 from entrance to location.

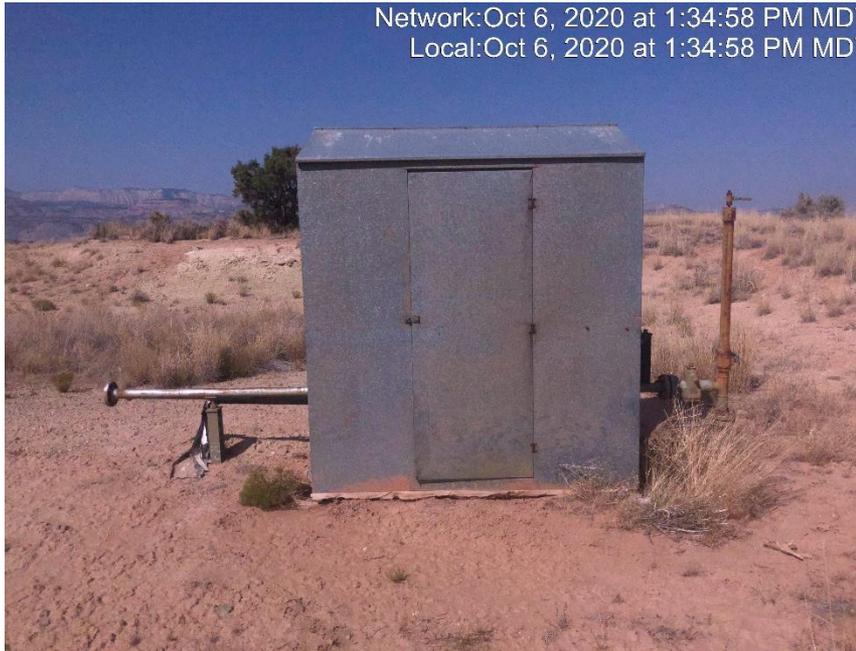
Photo #1987 Unused equipment.
