Inspection Photos

API: 071-07560

Operator: TIMBER CREEK OPERATING

Inspection Date: 10/1/2020

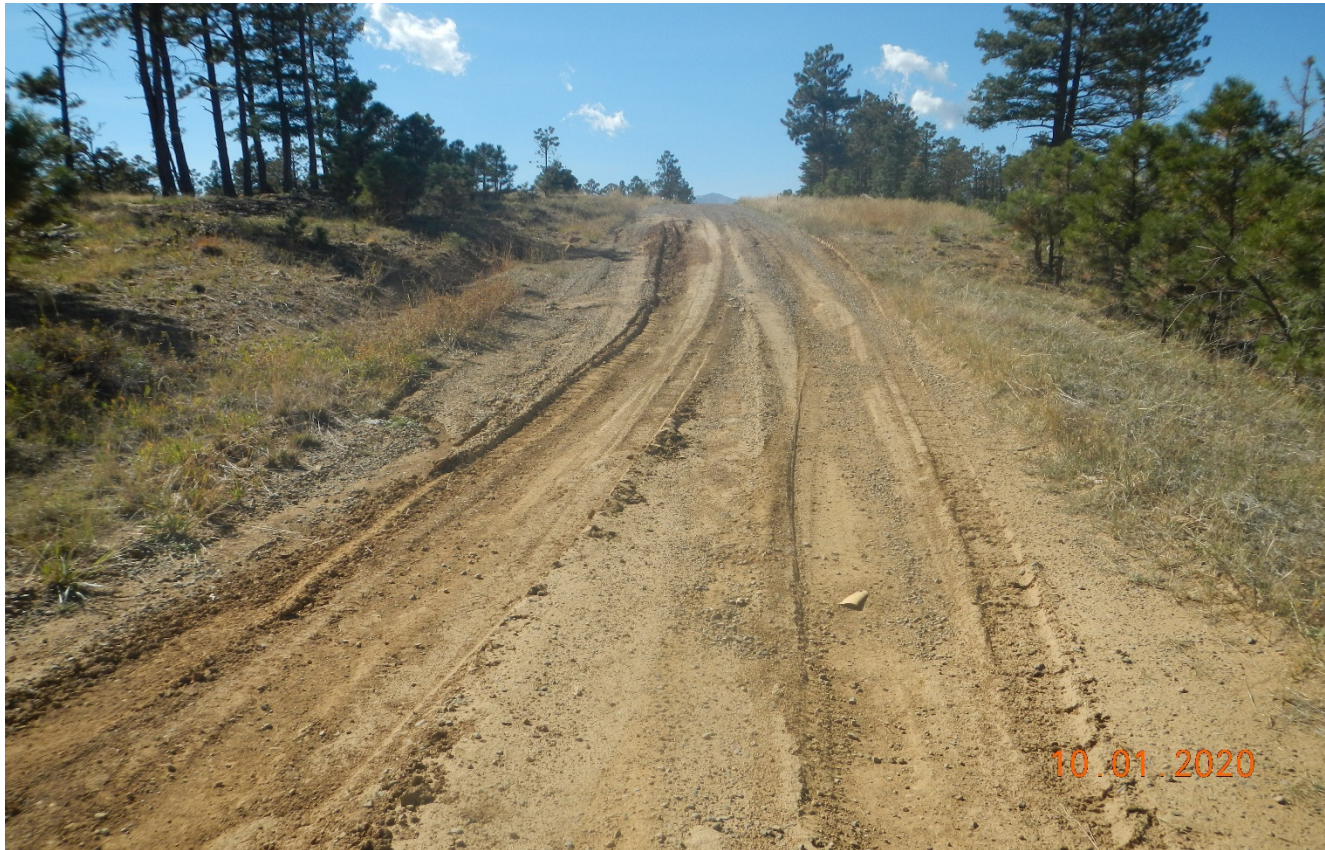
Photo 1. There is vehicle rutting along the road traveling to the location. The road needs to be maintained.

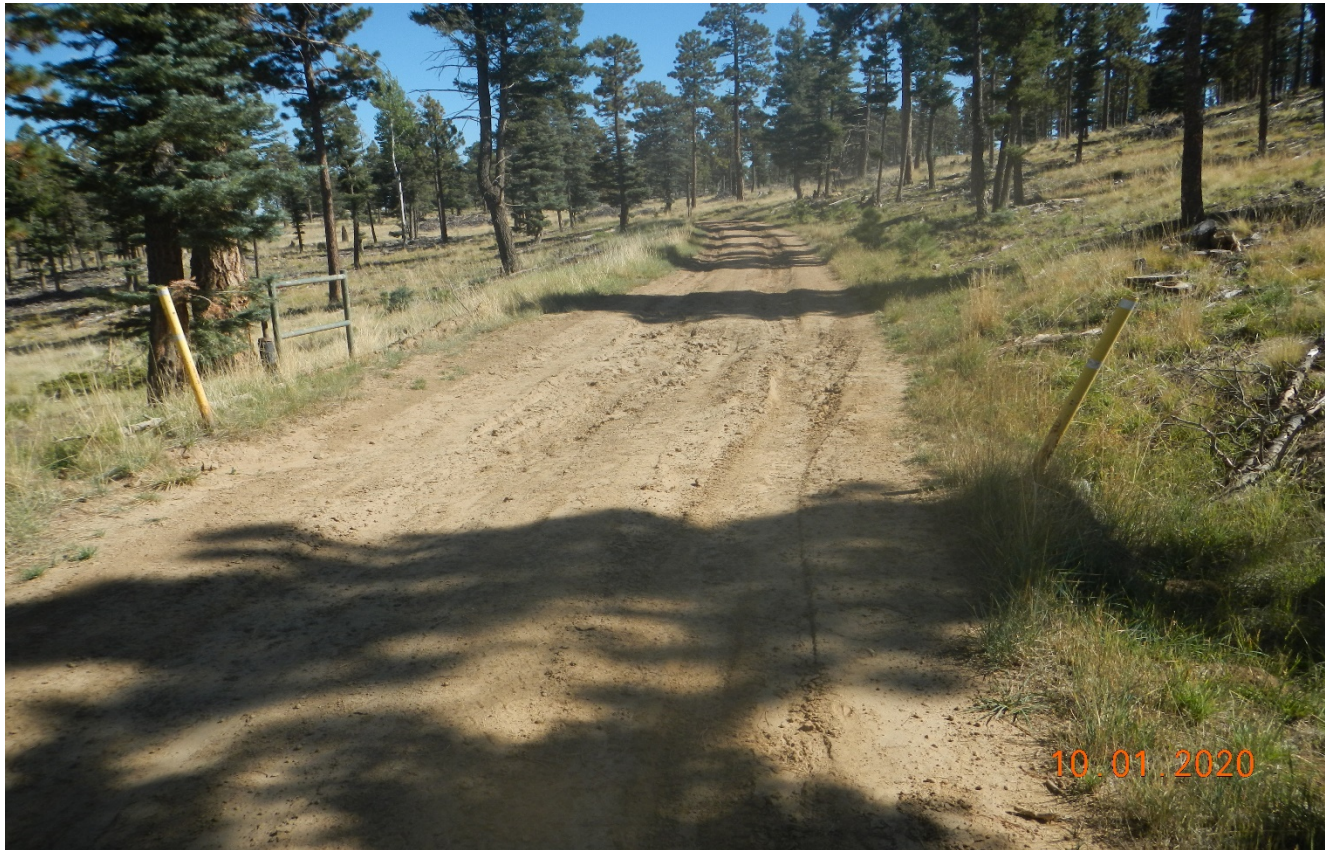
Photo 2. Facing southeast along the access road. There is a low spot in the road where stormwater appears to accumulate. This area needs to be repaired to allow proper drainage.

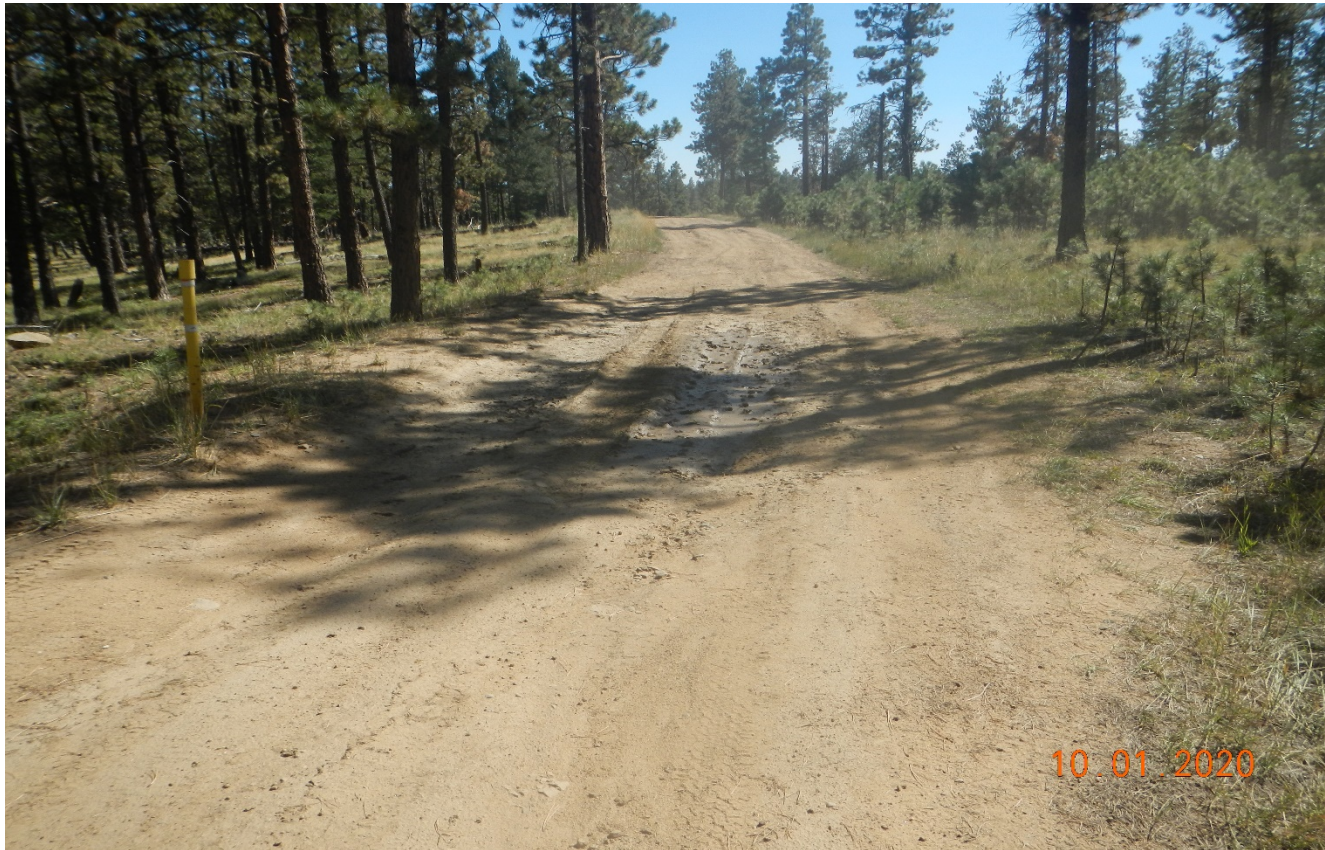
Photo 3. Likewise to previous photo. There is a low spot in the road where stormwater appears to accumulate where vehicles are widening the road to avoid this area. This area needs to be repaired to allow proper drainage.

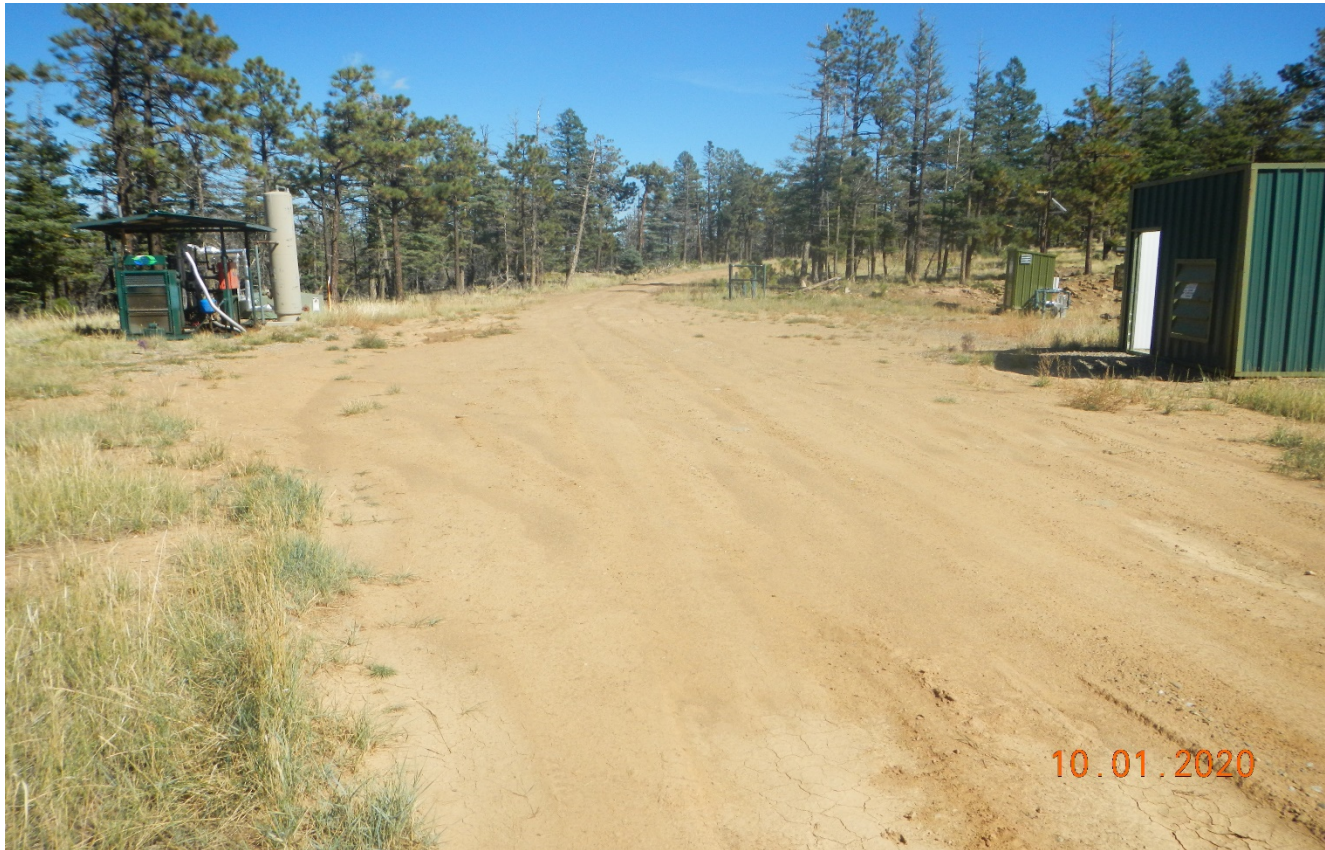
Photo 4. Facing east toward the location.

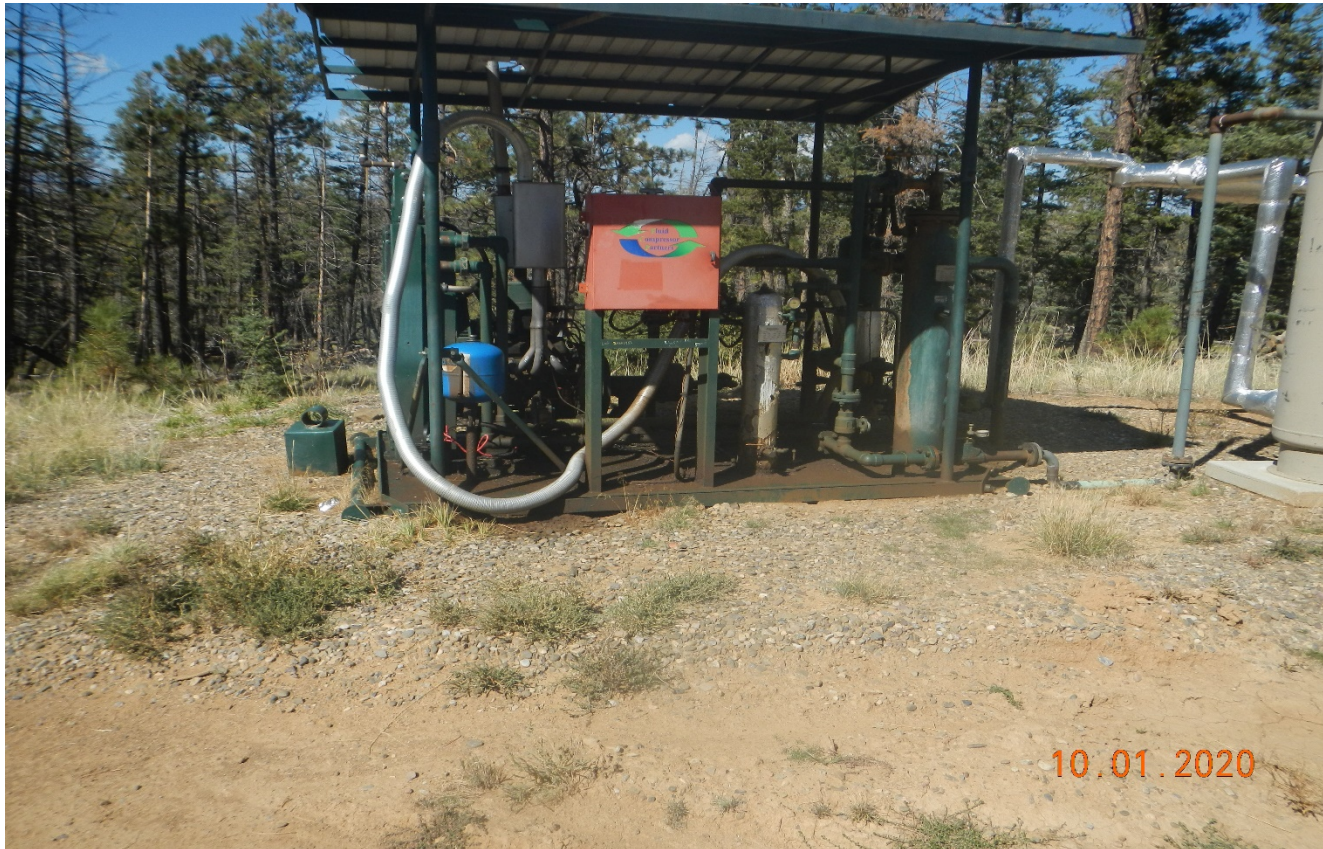
Photo 5. facing toward separator engine skid.

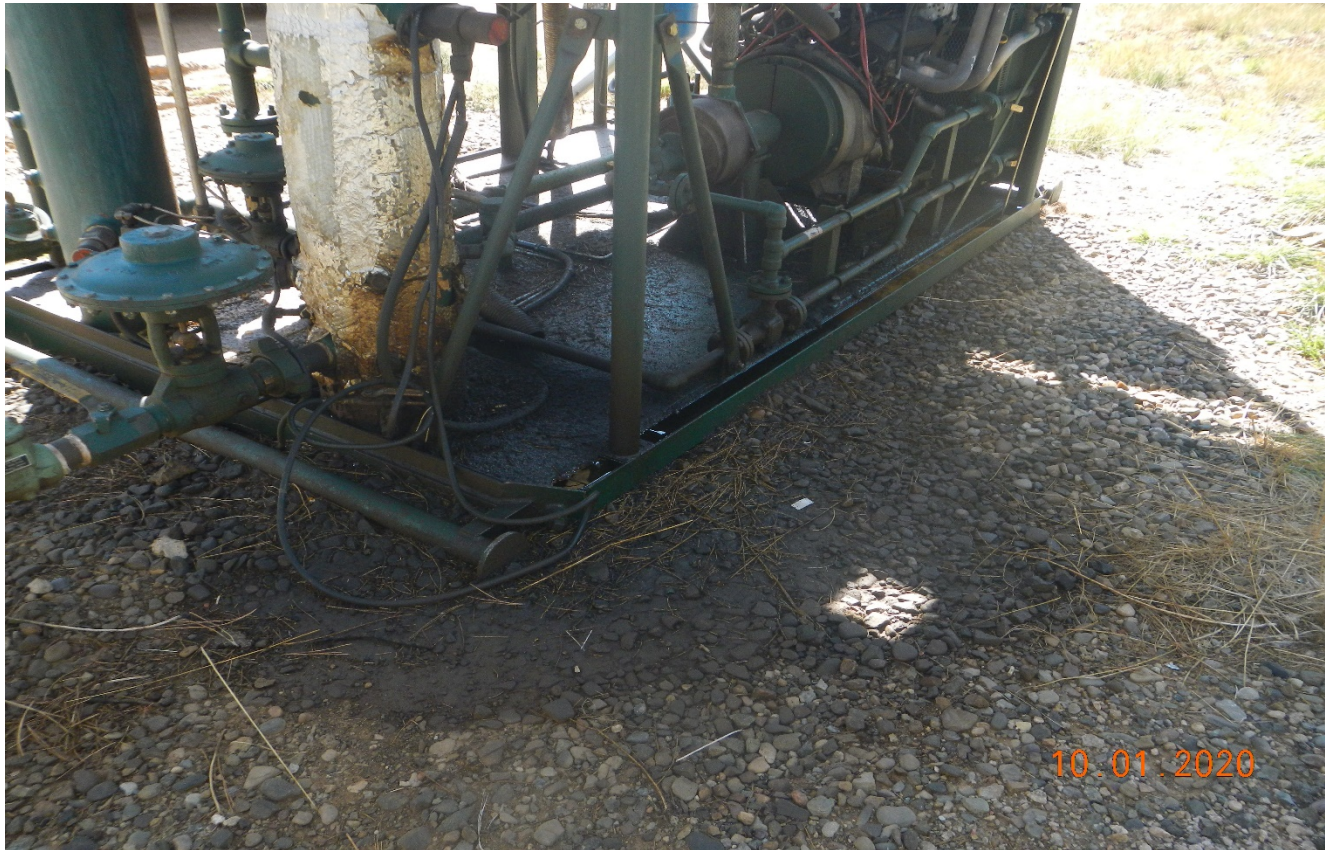
Photo 6. There is oil stained soils around the engine skid.
