Inspection Photos  
Operator: Logos Operating  
API: 067-05709  
Date: 10/1/2020

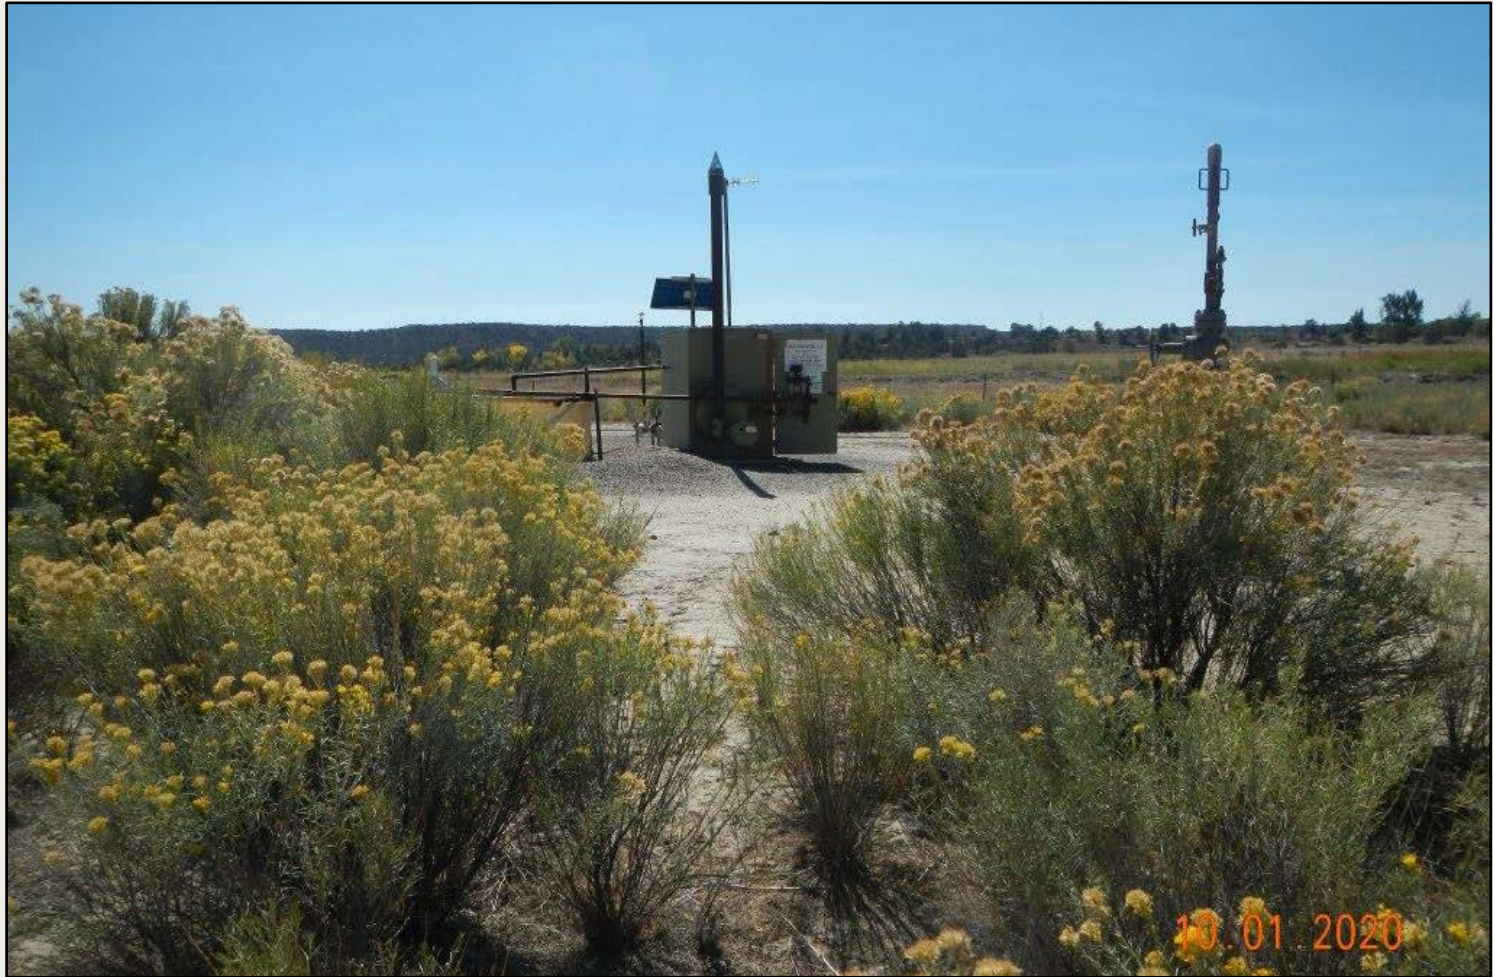
Photo 1. View of the project area from the northeastern corner facing center.

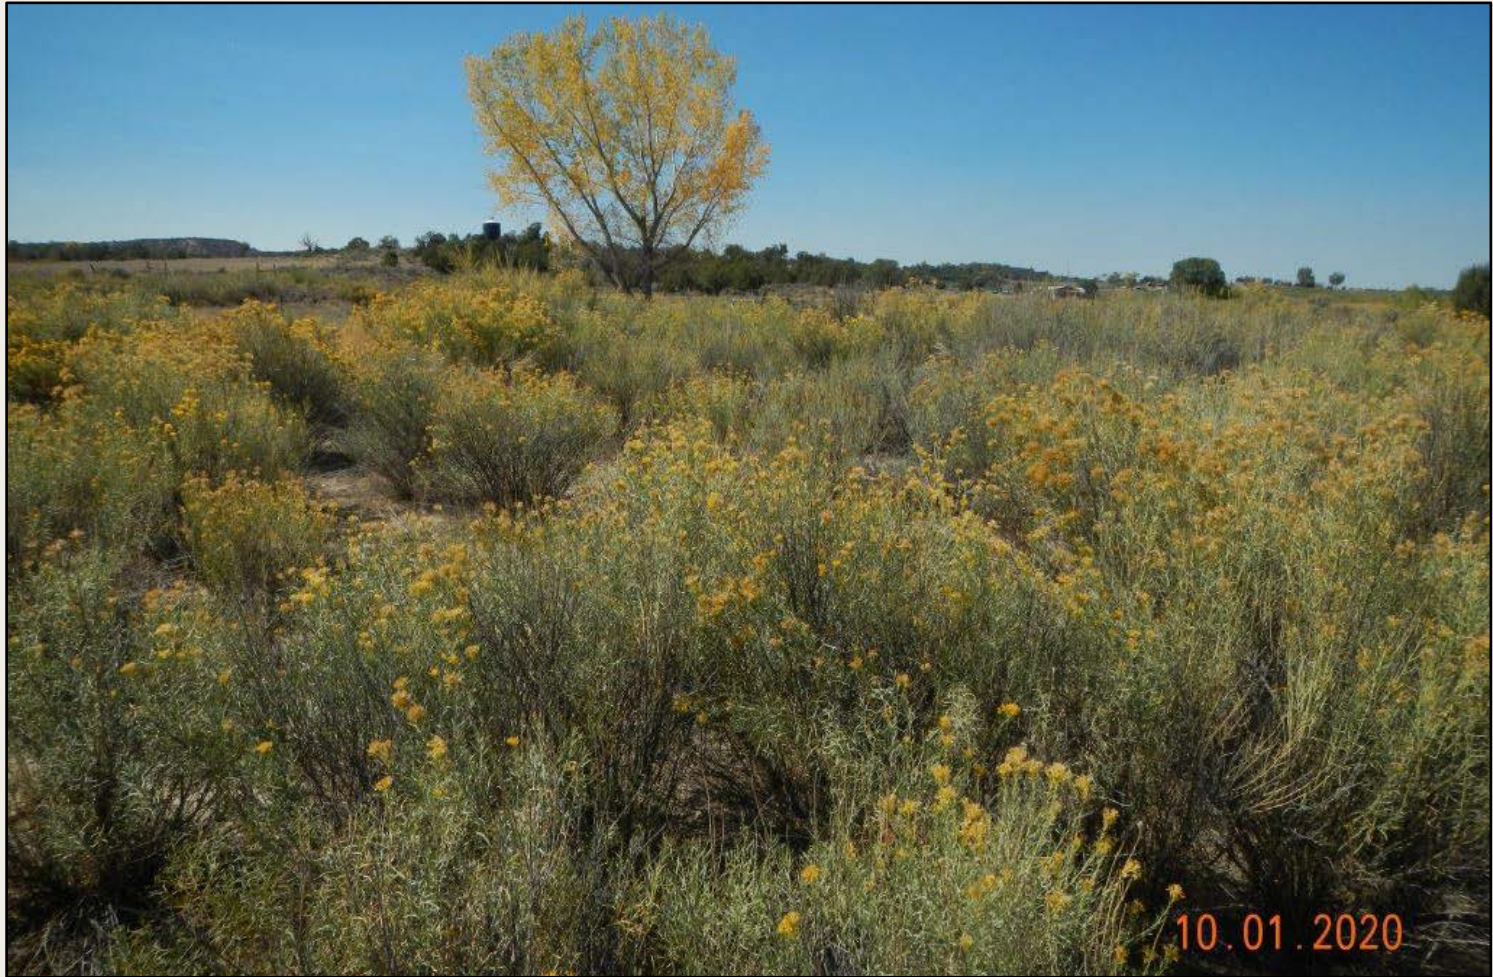
Photo 2. View of the southern project area from the northeastern corner facing westward. Vegetation appears to be progressing here largely with rubber rabbitbrush.

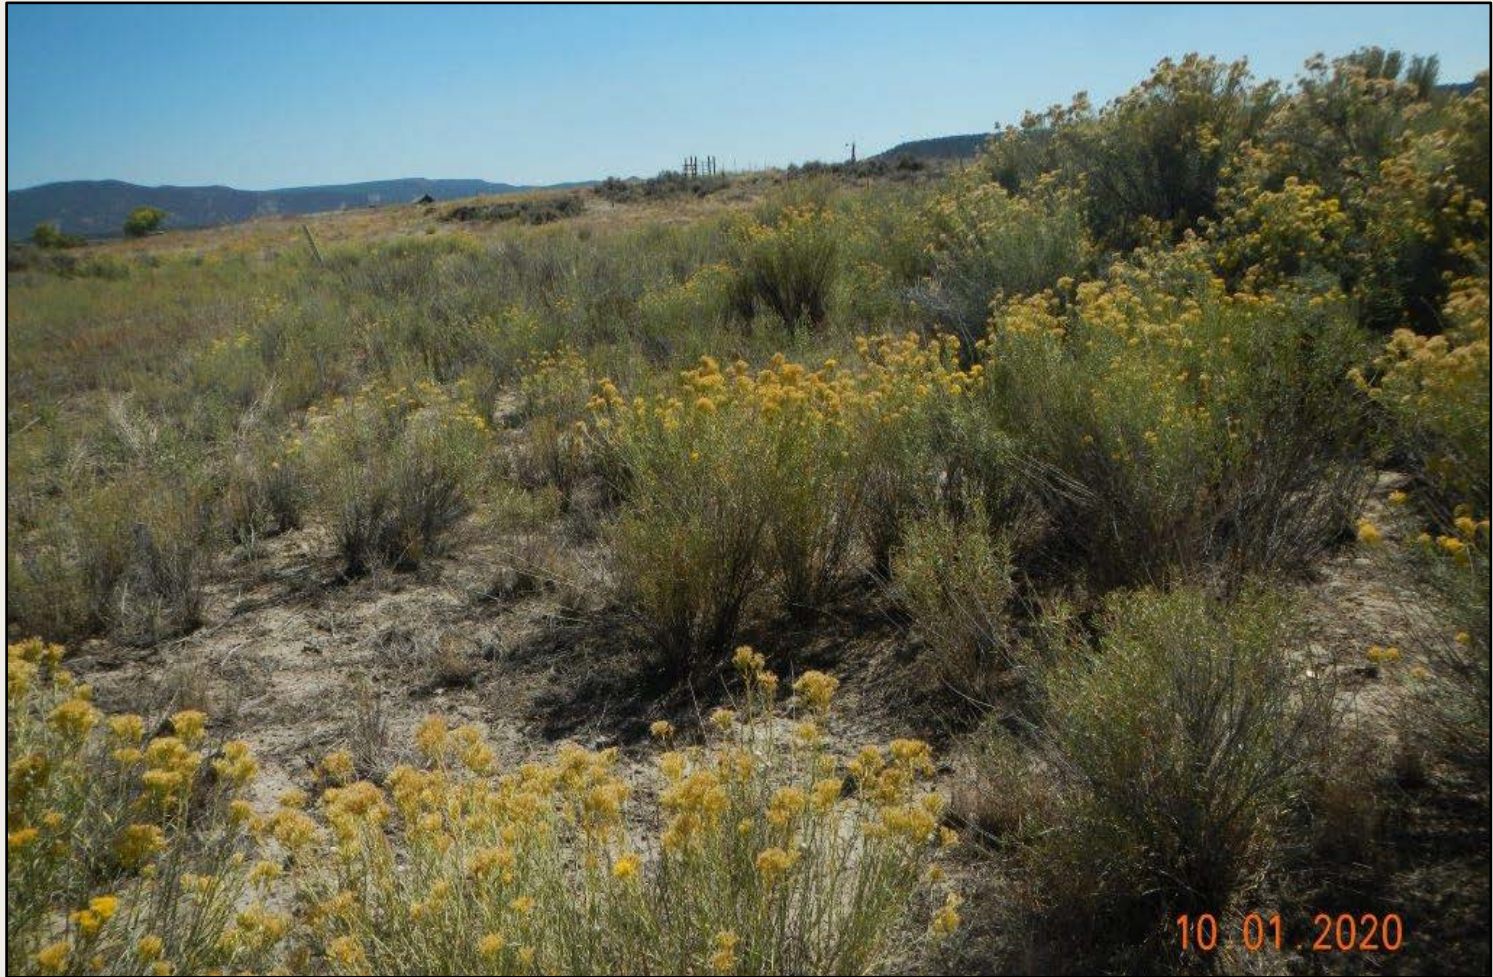
Photo 3. View of the eastern project area from the northeastern corner facing southward.

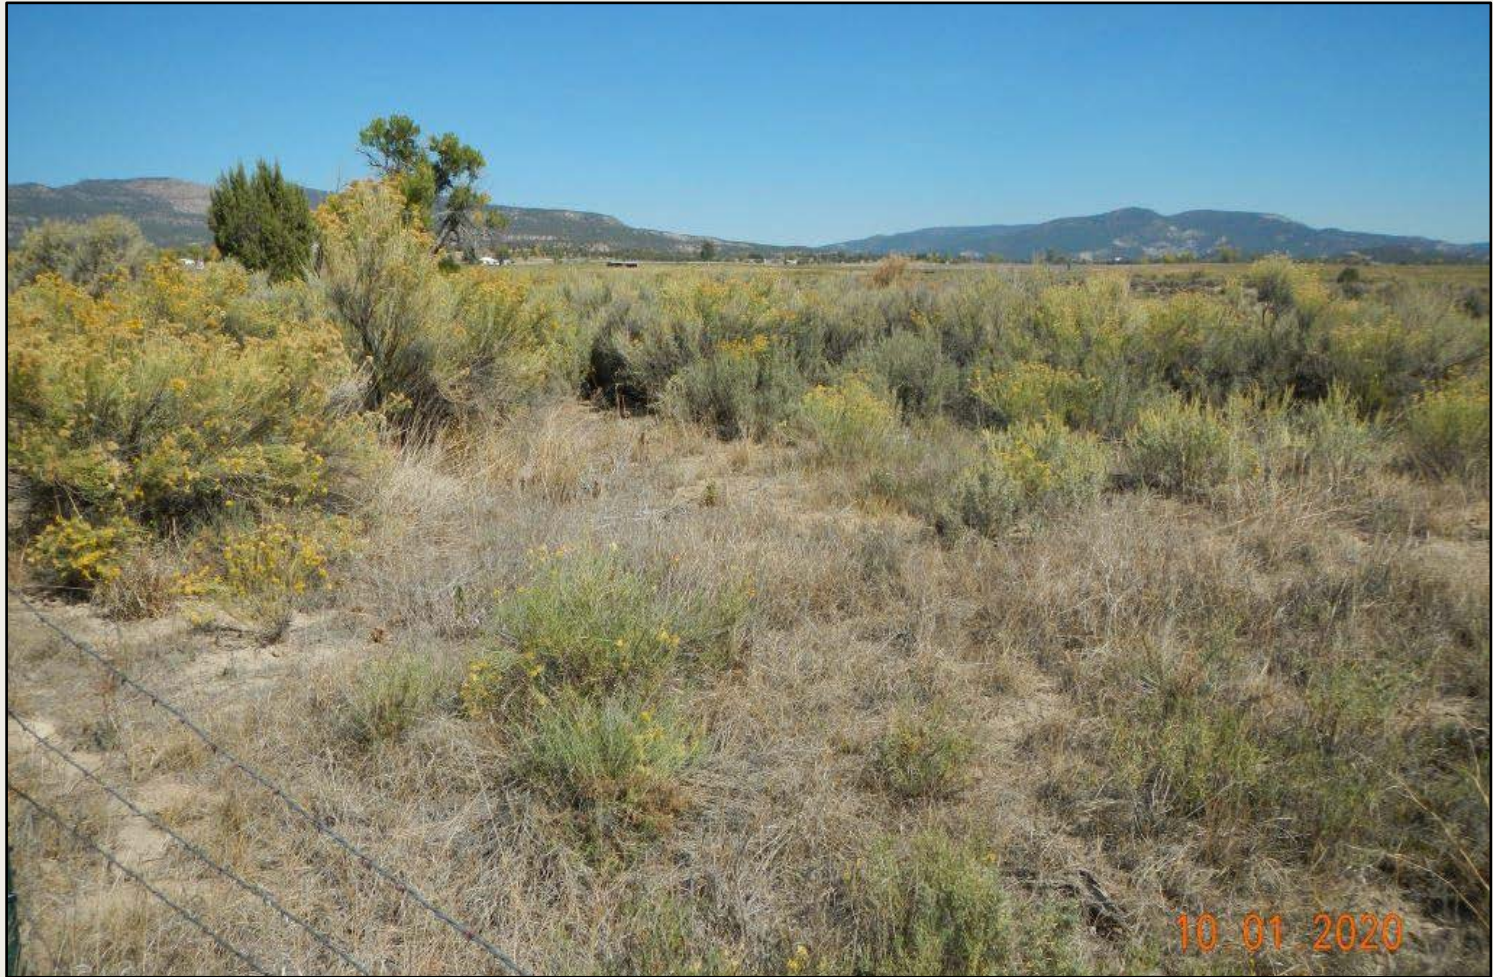
Photo 4. View of reference area vegetation comprised of dense rubber rabbitbrush with understory of grasses such as sand dropseed and western wheatgrass.

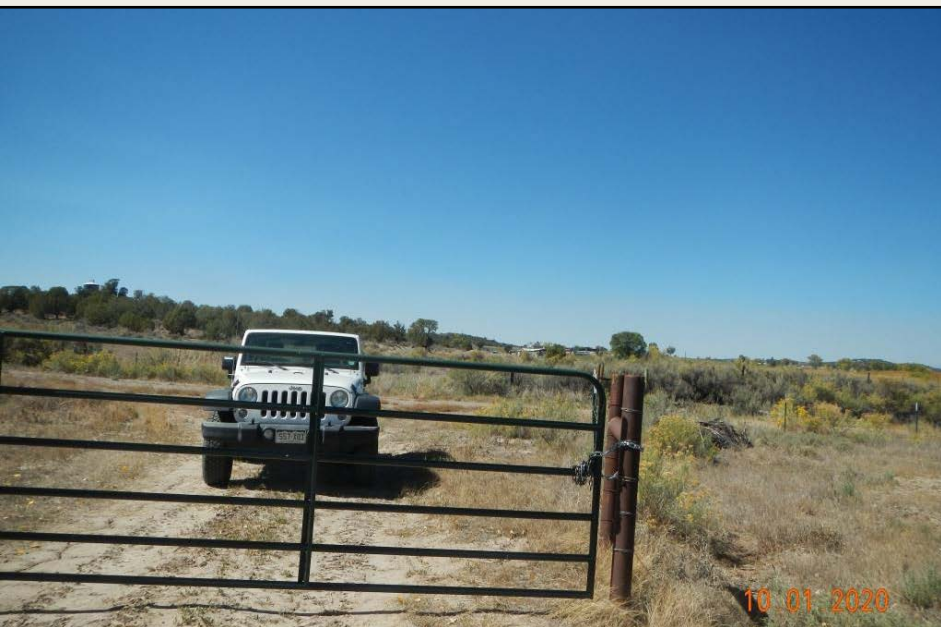
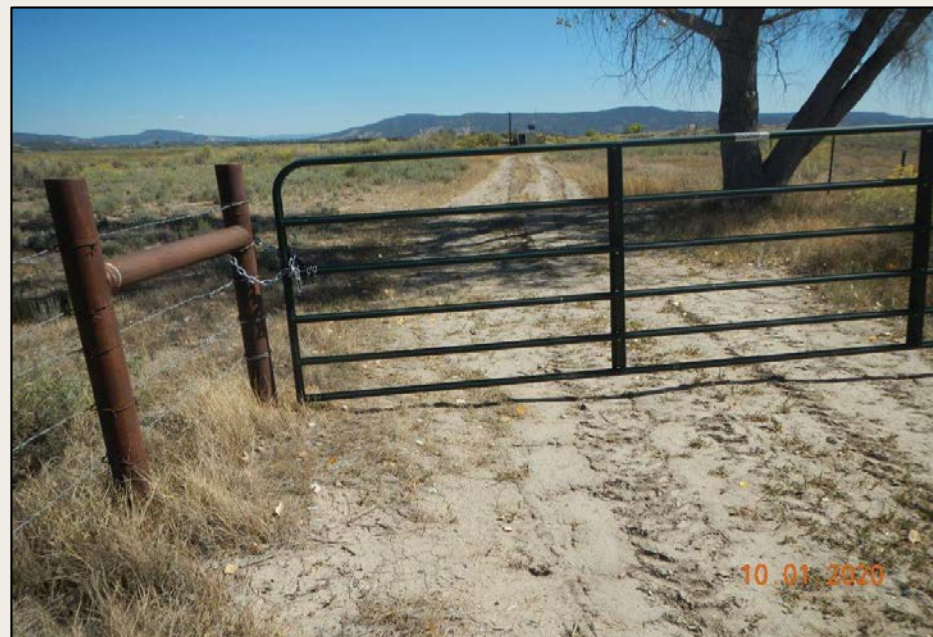
Photos 5/6. Closed gate coming in (left) and leaving (right). Vehicle outside of gate as inspector walked into site.
