Well Name: Pargin Mtn Unit 2 **API #** 05-007-06098
Document Number: 693902244
Corrective Action: Barbed wire and wood fencing debris within the eastern project area.
Remove debris.

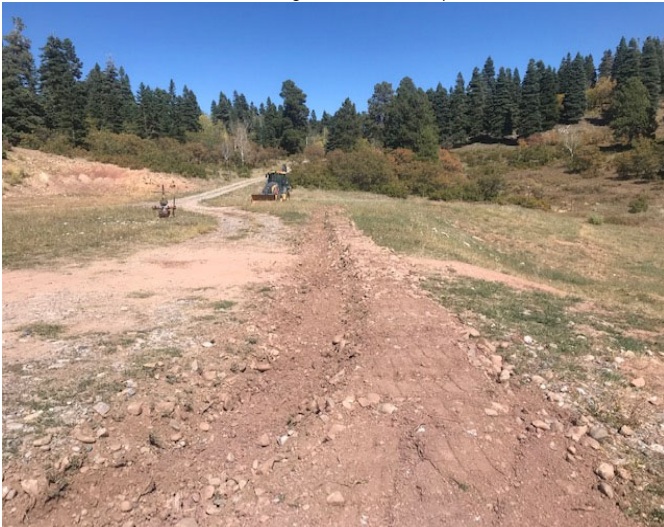
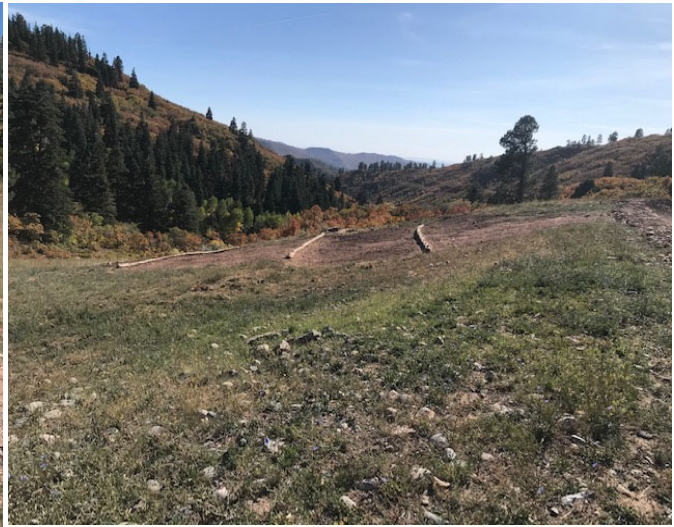
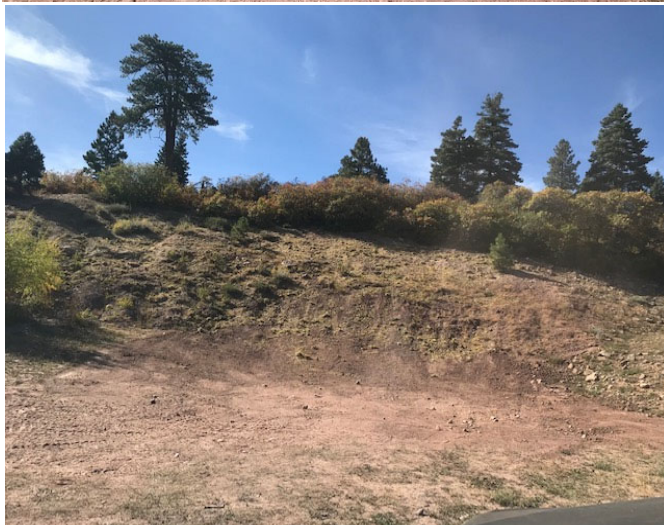
Wattles observed on cut-slope, and southwestern fill slope are largely out of alignment, full of sediment, and no longer functioning. While initial corrective action is addressed, wattles are not an adequate BMP in these areas.
Install long-term stormwater controls within the project area. Stormwater controls need to be selected, sized, installed, and maintained according to good engineering practices such as those described by CDOT in their erosion control manuals

Correction Action Due: 10/16/2020
Action Completed: 9/28/2020
Action Taken: Removed barbed wire and wood fencing debris within the eastern project area.

Removed nylon netting from wattles and disposed of them.
Dug ditch around the edge of the location to redirect runoff from the erosion damaged fill slope to a natural and flatted drainage area on the northern end of the project area.
Filled in and reseeded the area on the fill slope with erosion damage, and incorporated original terracing.
Raked out channeling and rills on the cut slope.
