Inspection Photos
Operator: Hilcorp Energy
API: 067-08171
Date: 10/7/2020

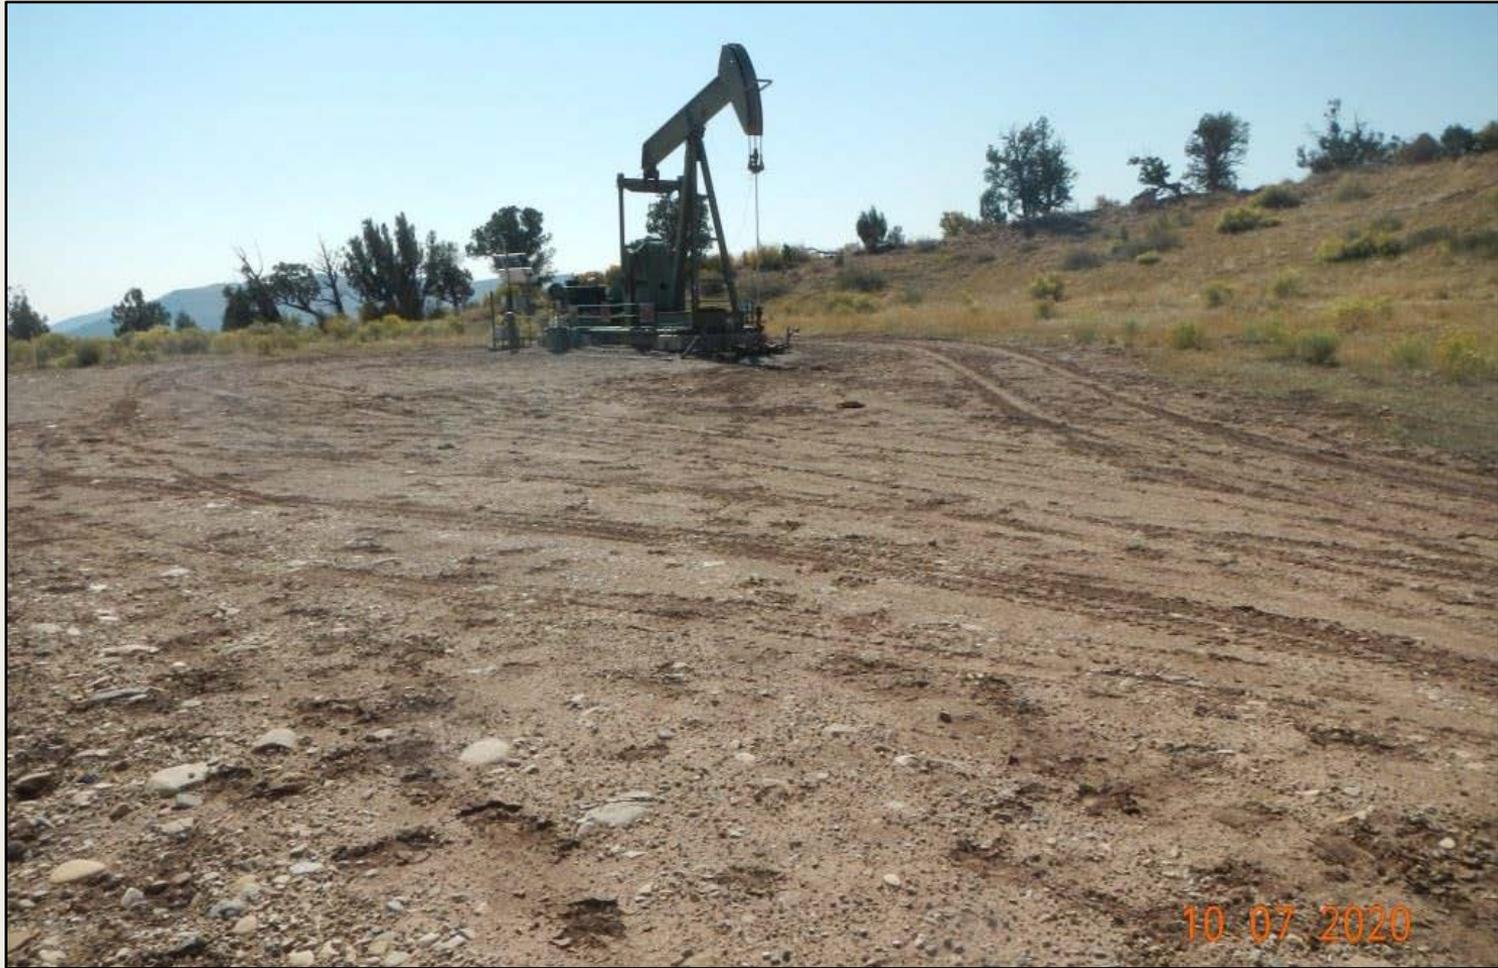
Photo 1. View of the project area from the northeastern corner facing center.

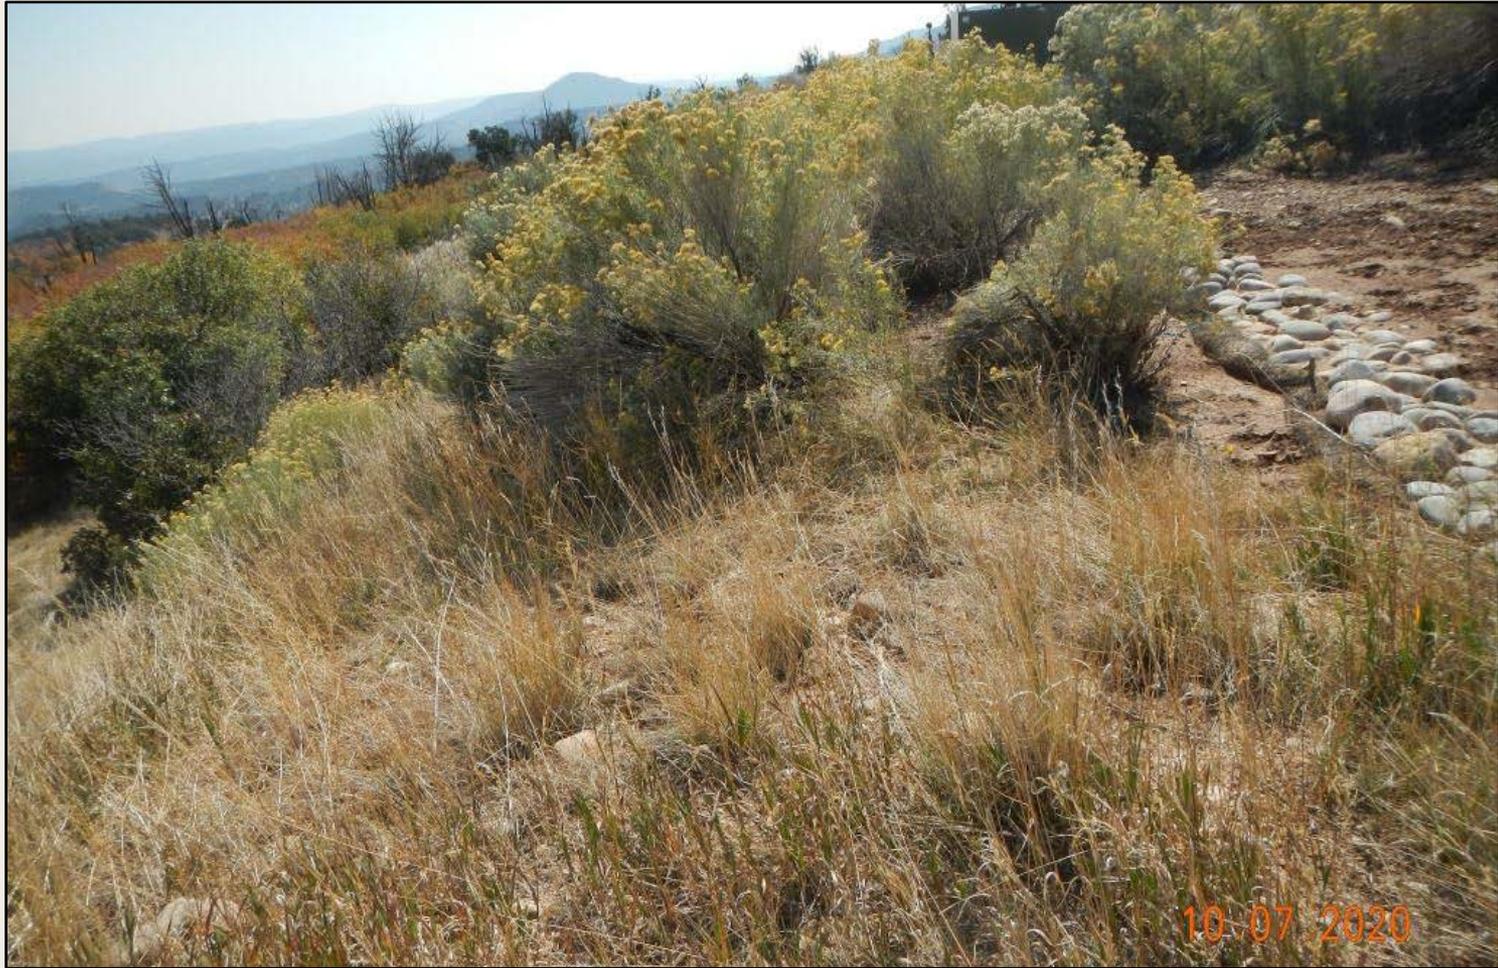
Photo 2. View of the eastern fill slope from the northeastern corner facing southward. Revegetation is progressing with smooth brome, western wheatgrass, and rubber rabbitbrush.

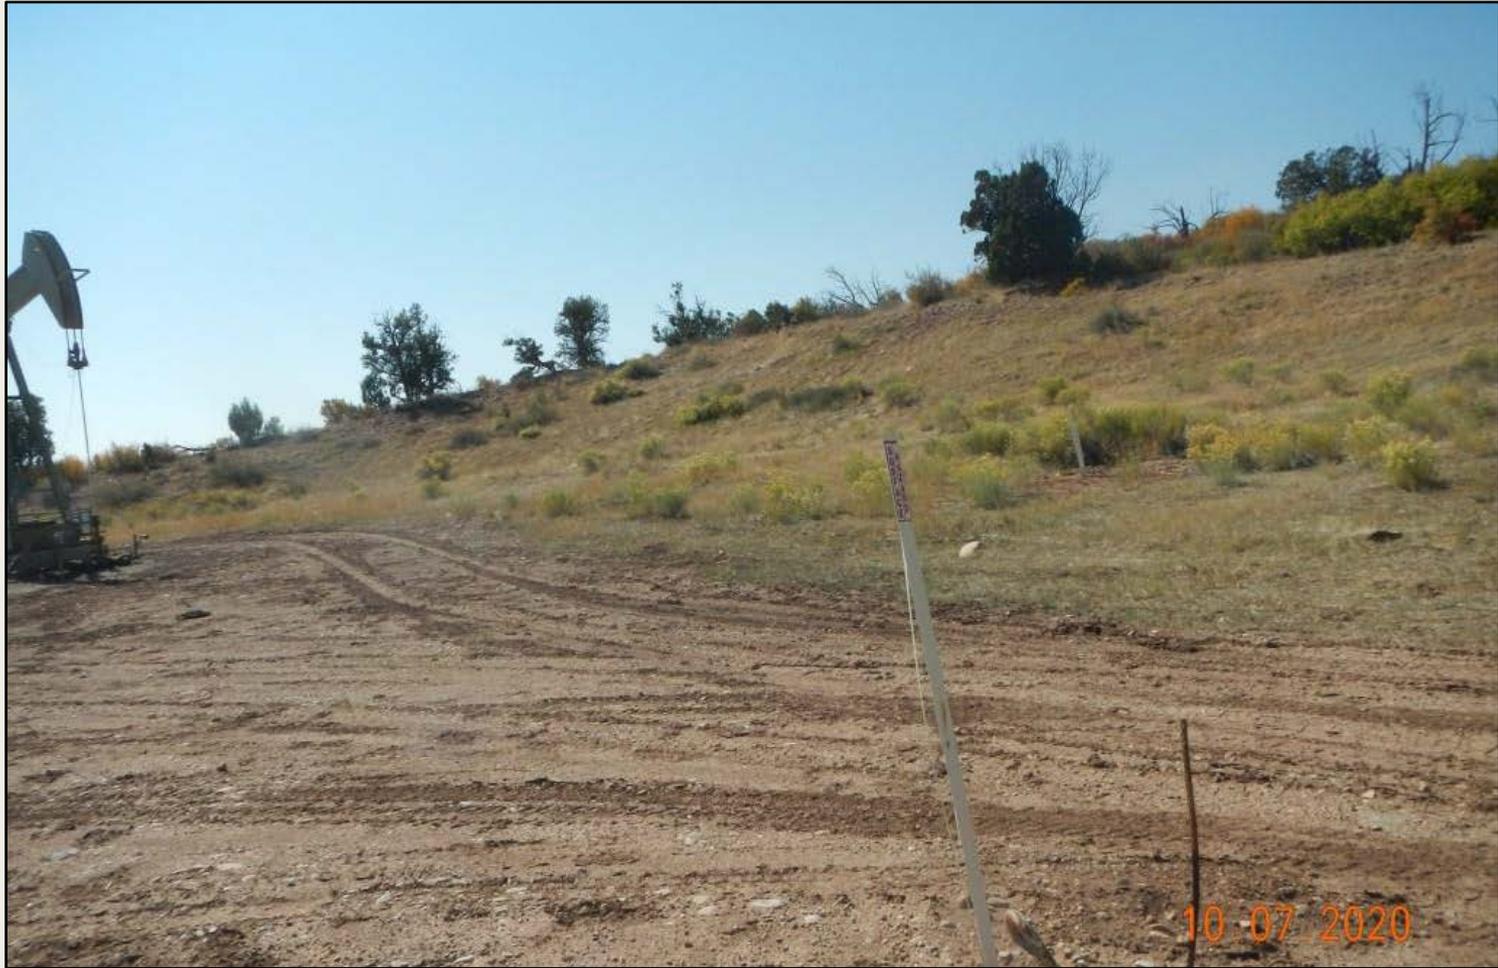
Photo 3. View of revegetation within the western and northwestern project area, facing southwestward.

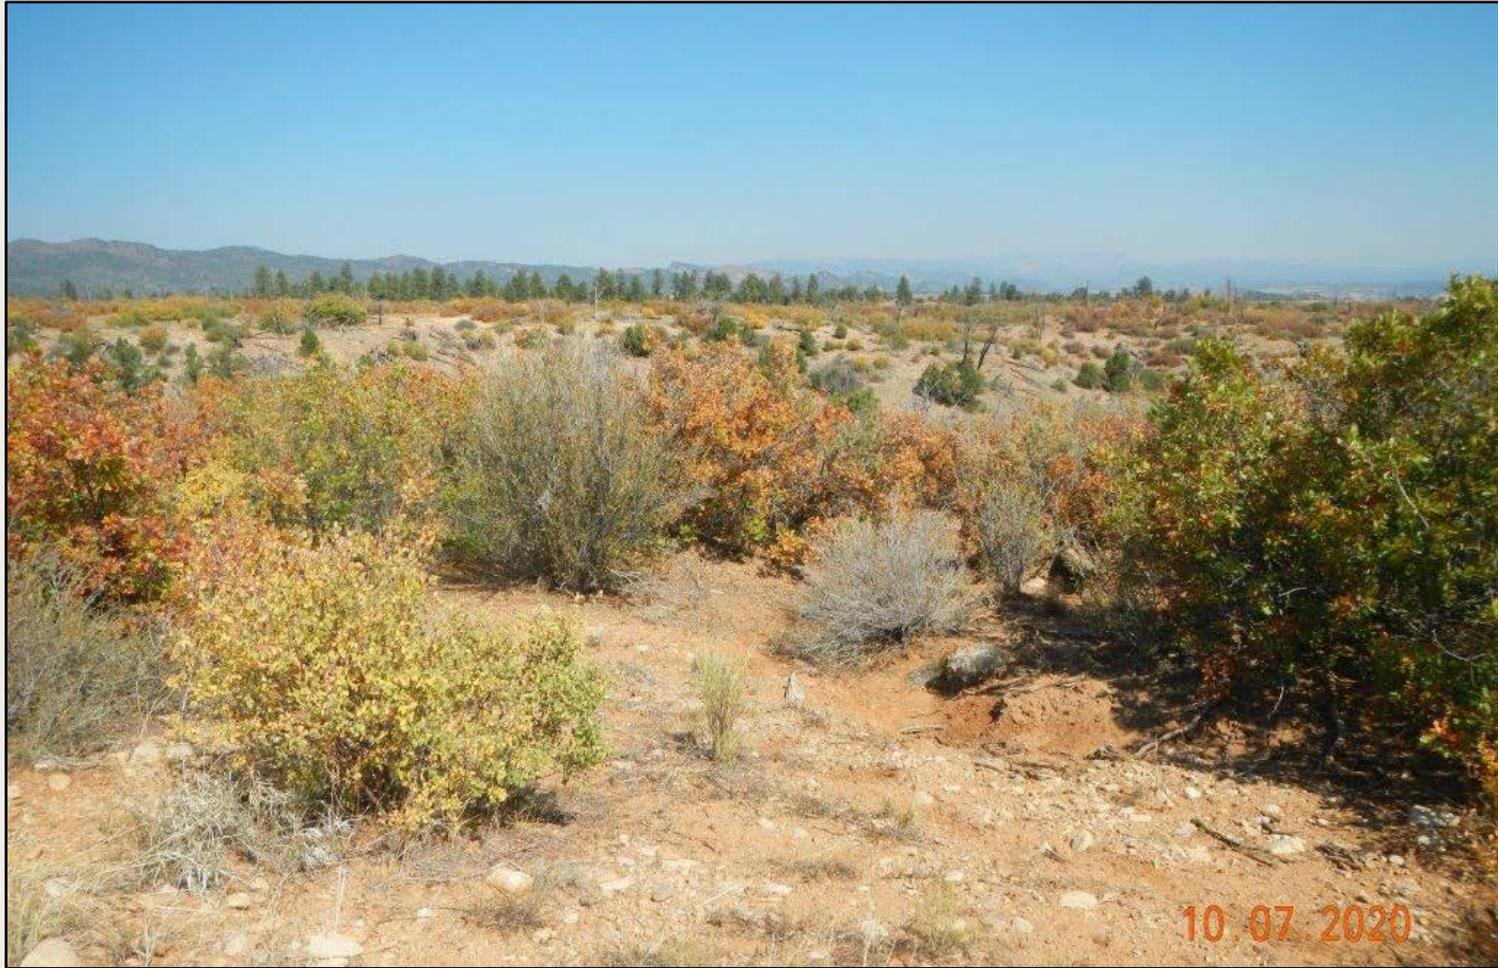
Photo 4. View of reference area vegetation comprised of gambel oak shrubland in a post-fire vegetative condition with other shrubs such as mountain mahogany, serviceberry as well as grasses and forbs such as squirreltail and Colorado rubberplant.
