**Inspection Photos**  
**Operator: Hilcorp Energy**  
**API: 067-08641**  
**Date: 10/7/2020**

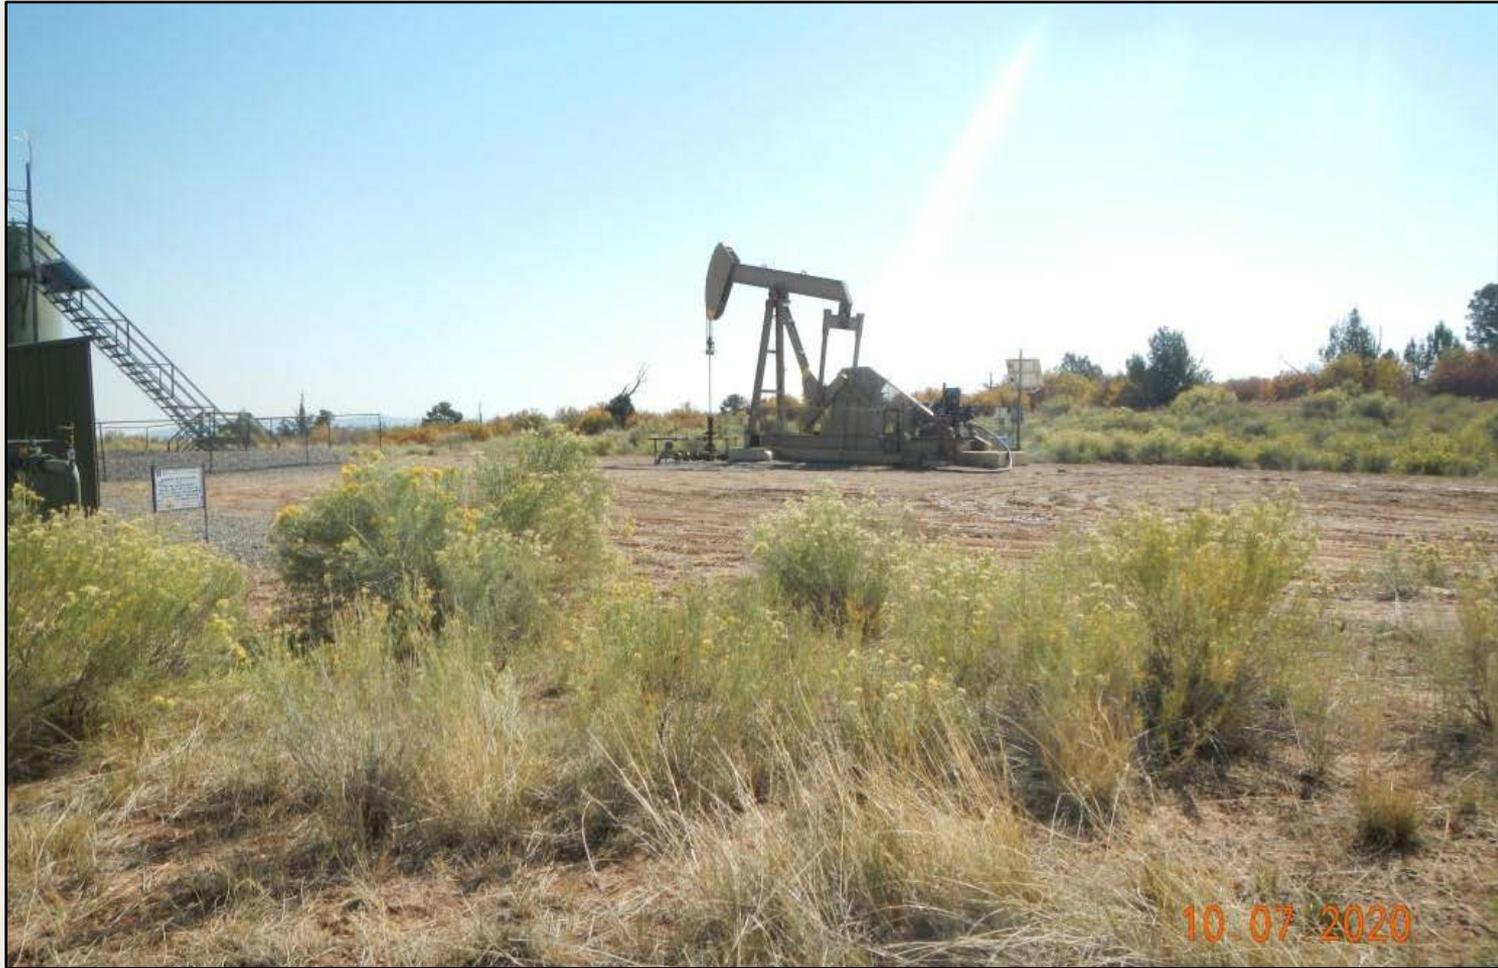
Photo 1. View of the project area from the northwestern corner facing center.

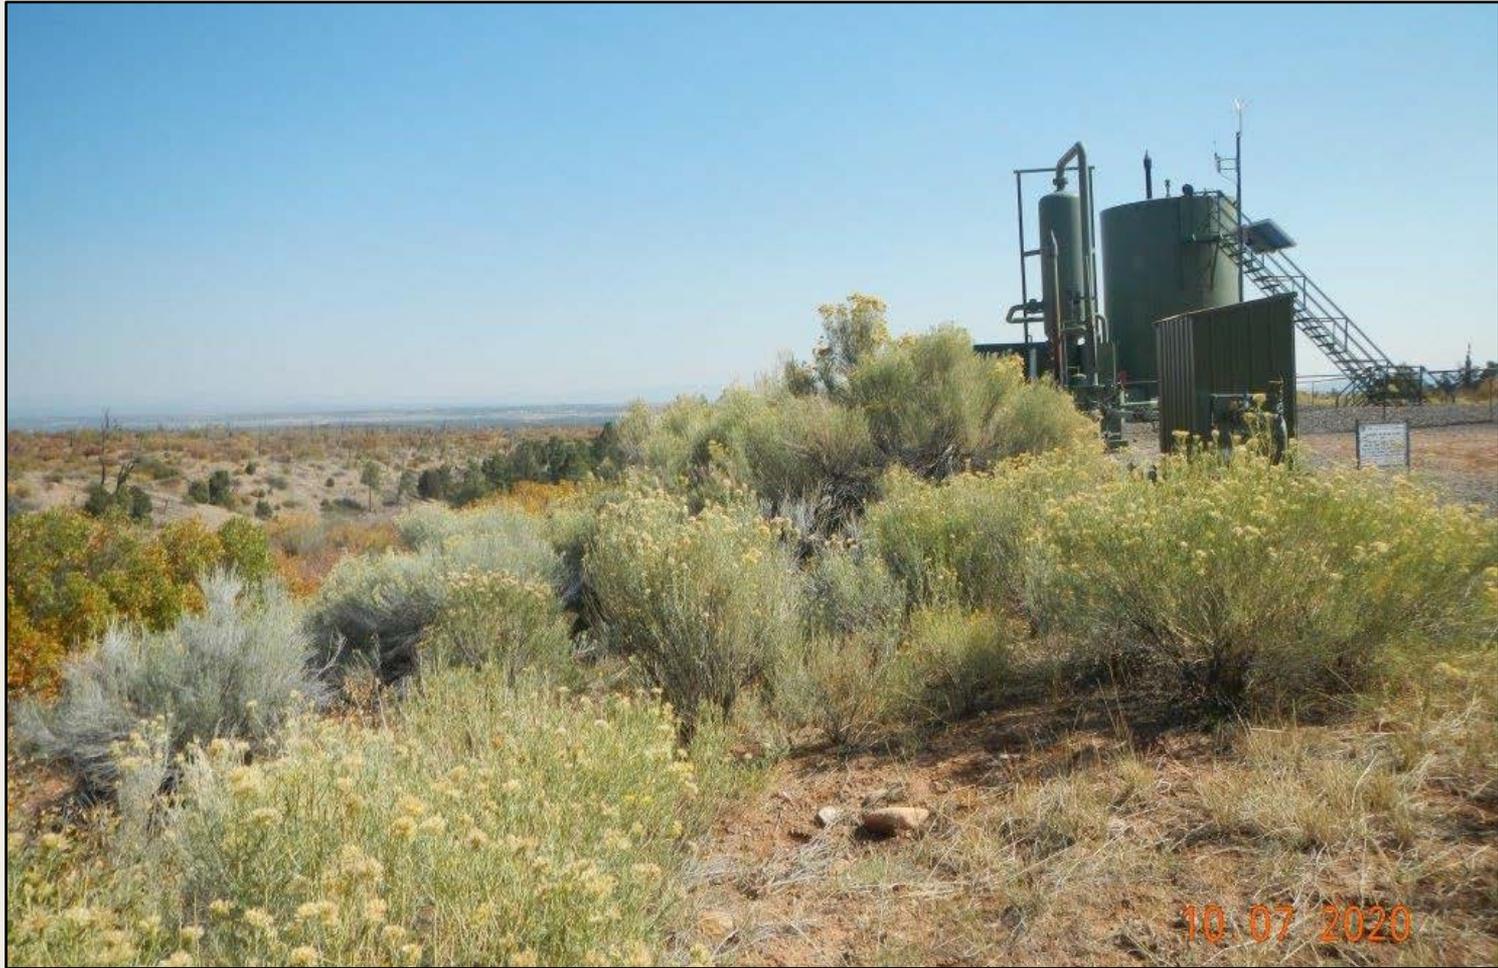
Photo 2. View of the northern fill slope from the northwestern corner facing eastward.

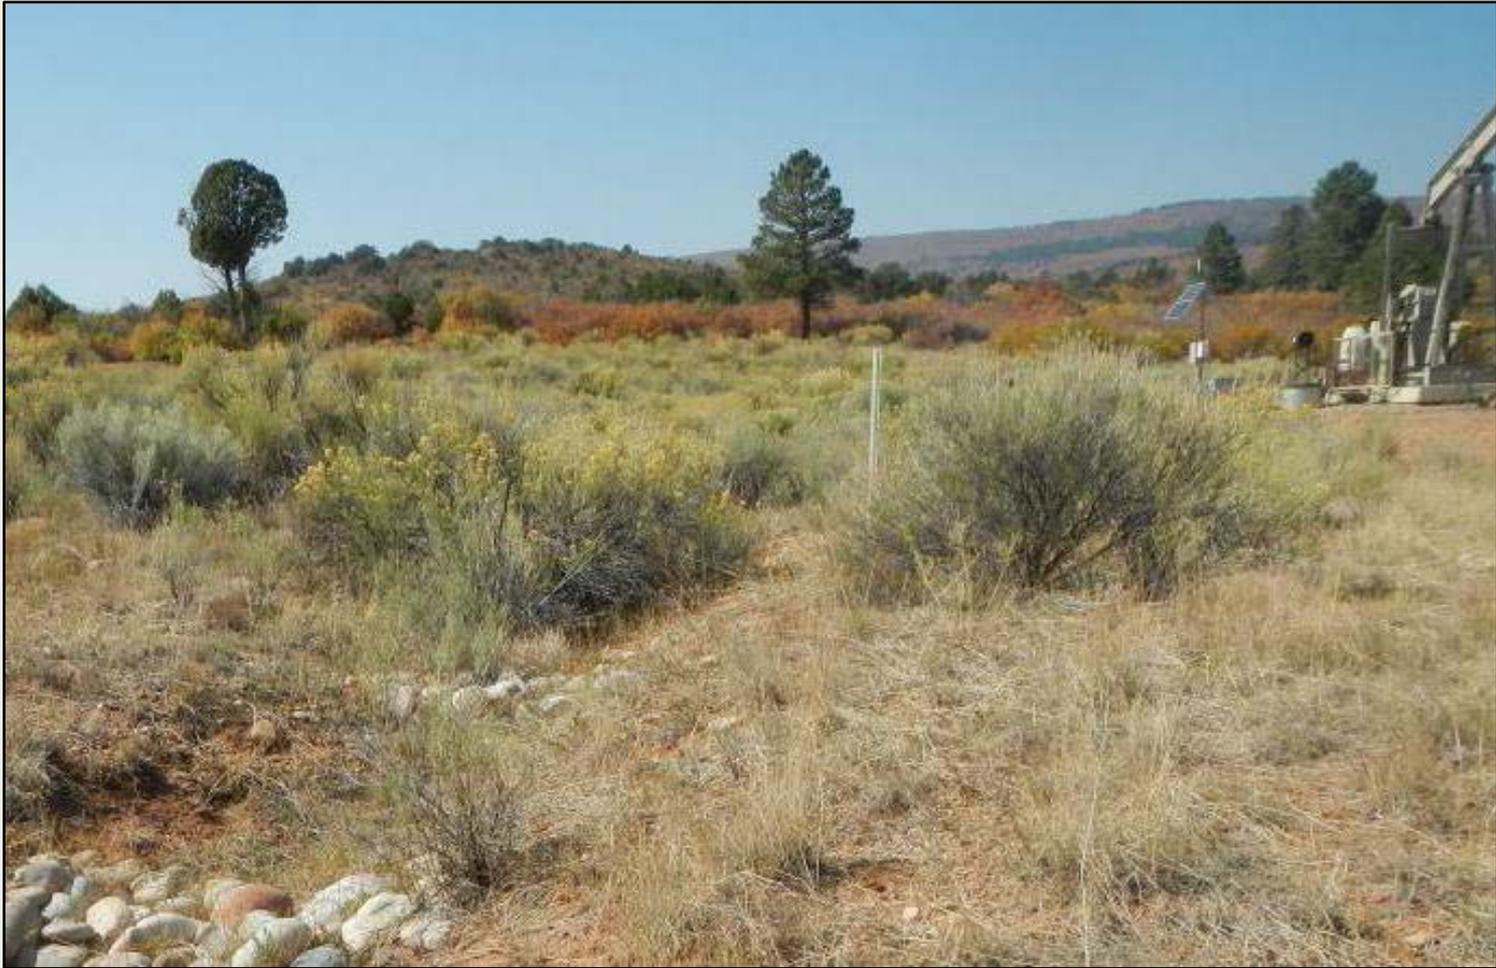
Photo 3. View of the southern project area from the southeaster corner facing westward.
