TEP
RMV 39-16
Location # 335788

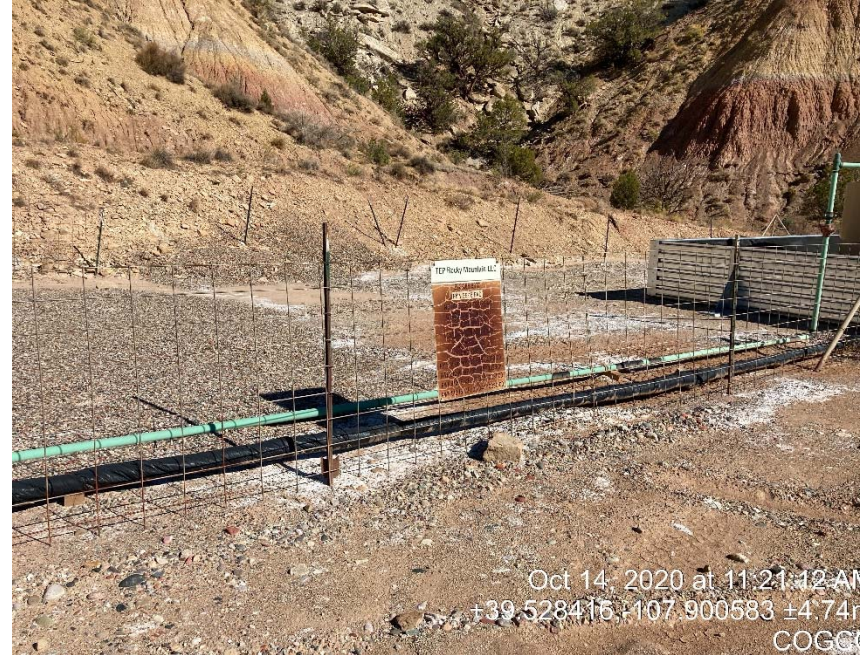
Signage is in need of repair

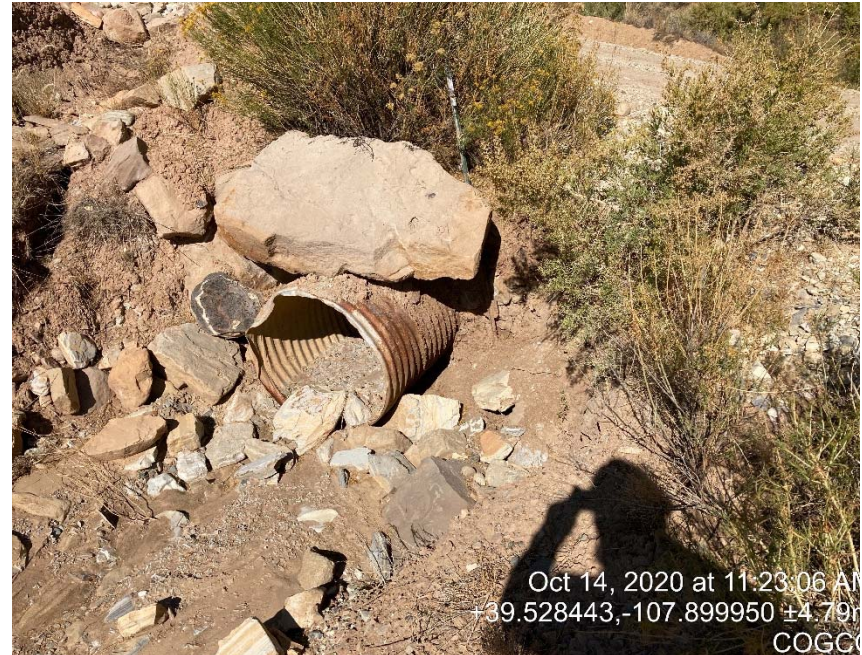
South side of road at entrance to location sediment coming through culvert.

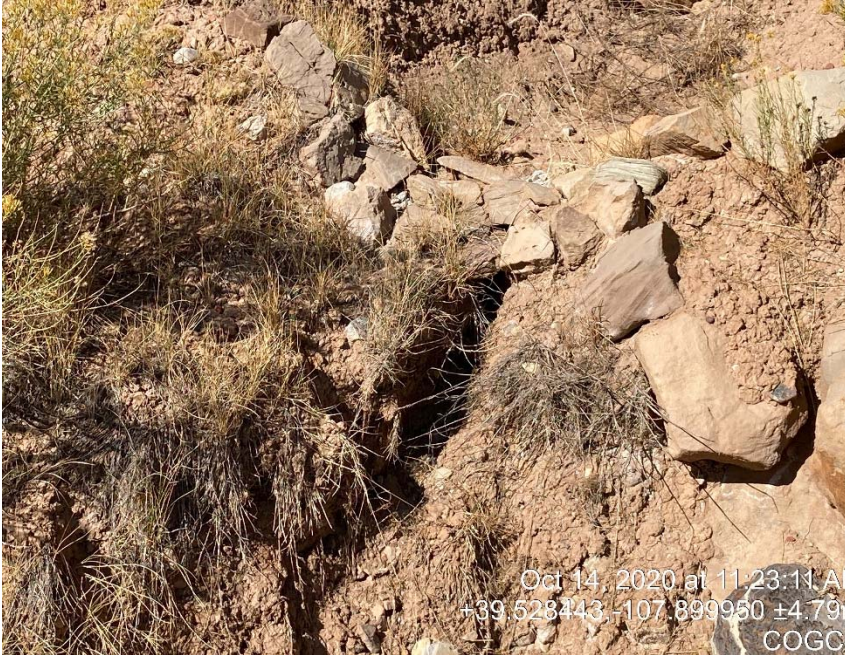
Erosion undercutting of BMP's

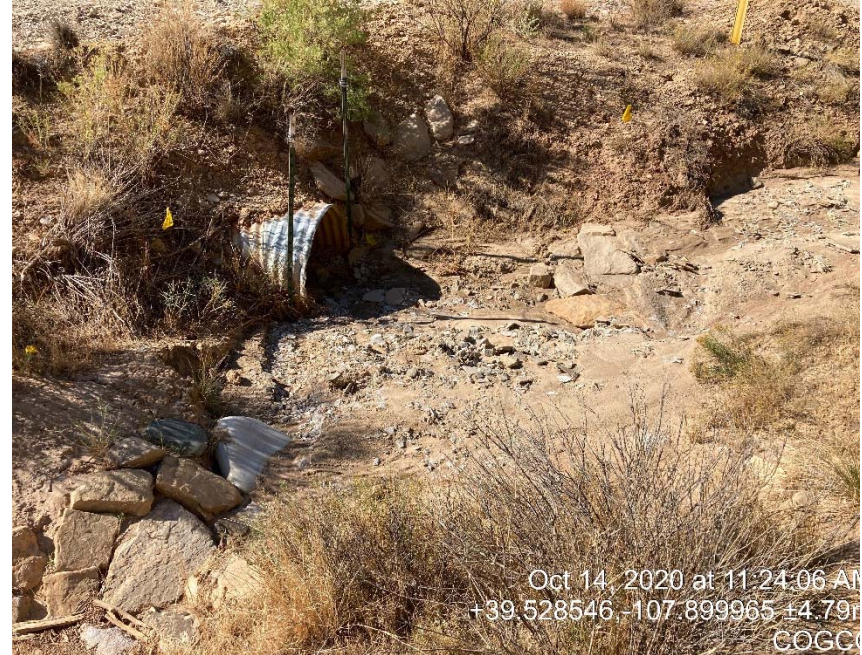
North side of road at entrance to location sediment going through culvert.

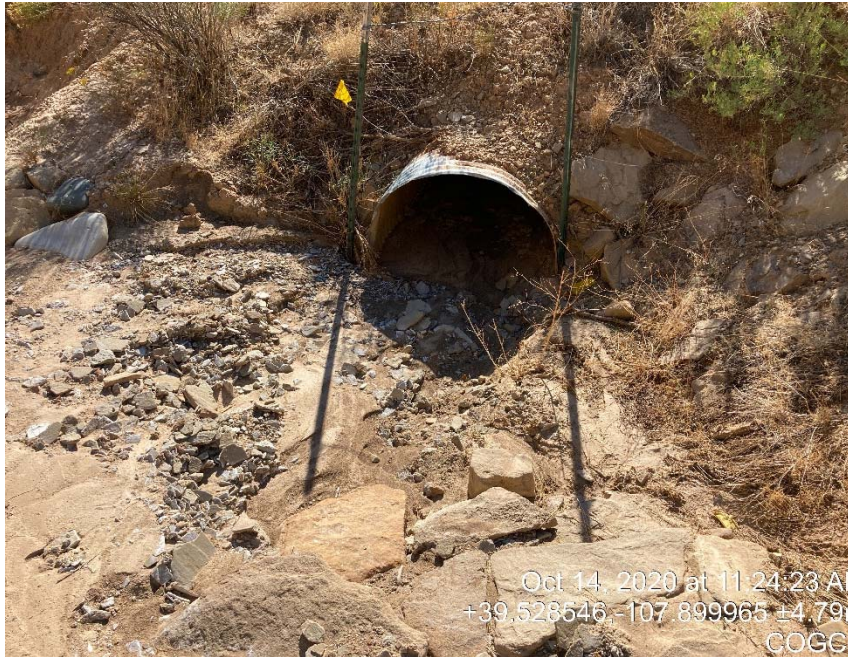
North side of road at entrance to location sediment going through culvert.

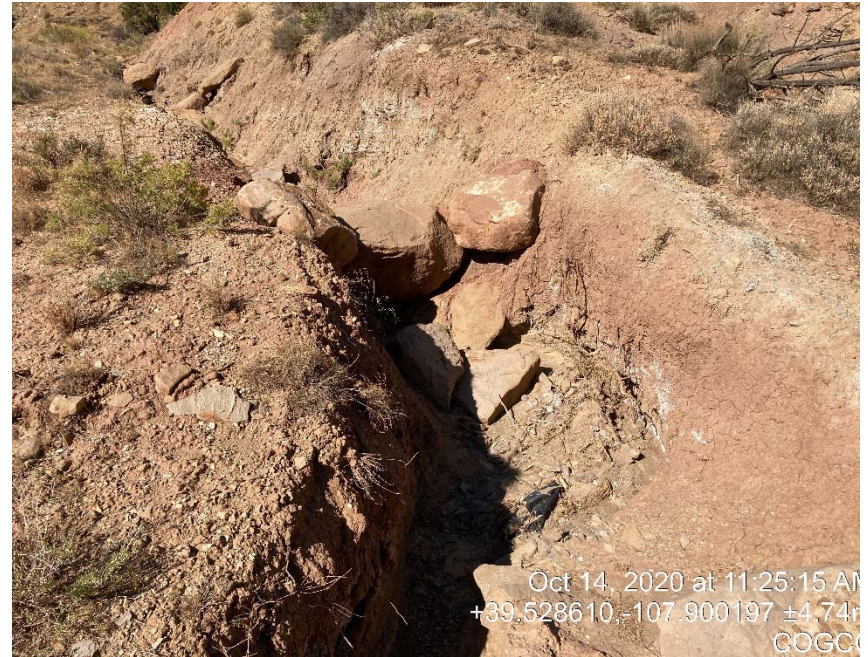
Erosion undercutting of BMP's

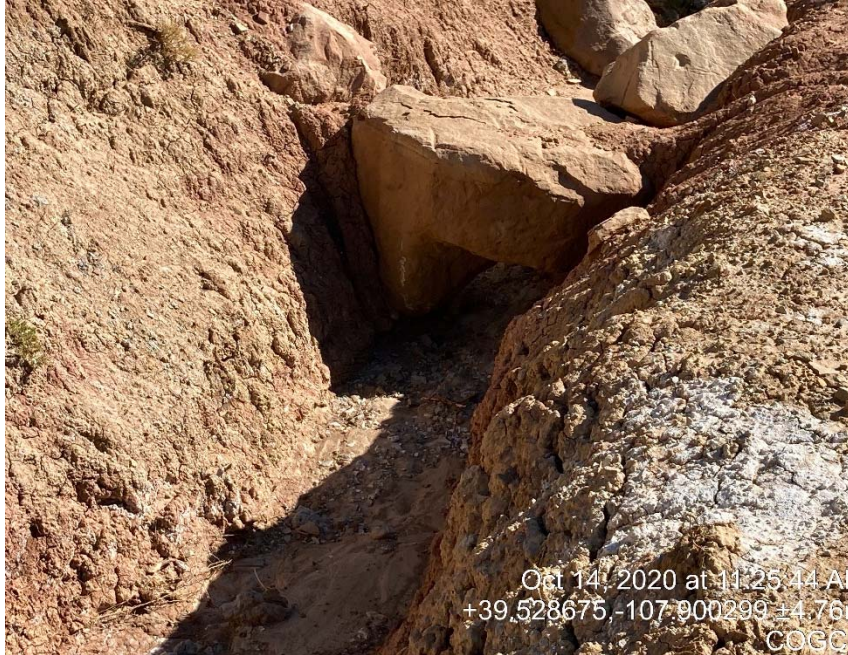
Erosion undercutting of BMP's

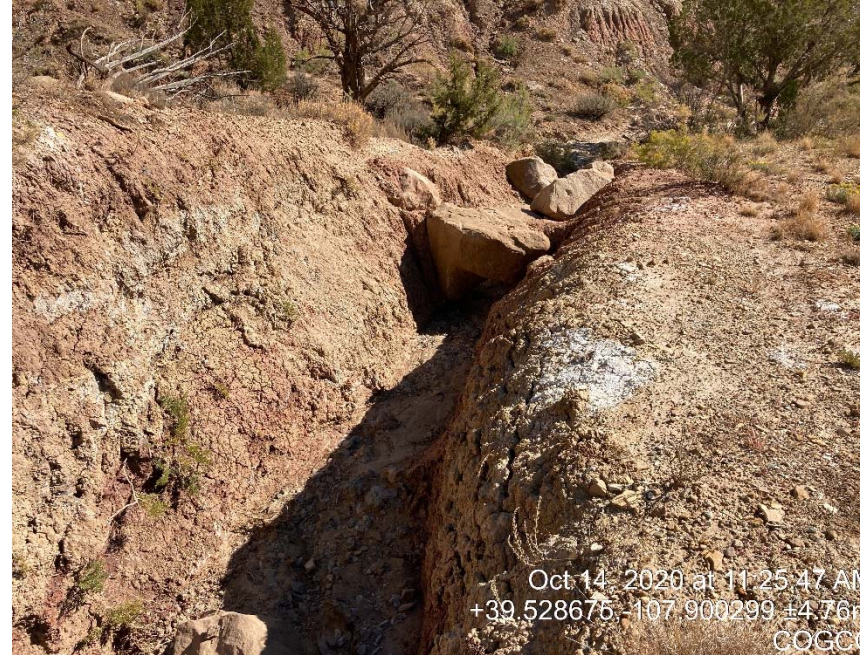
Erosion undercutting of BMP's

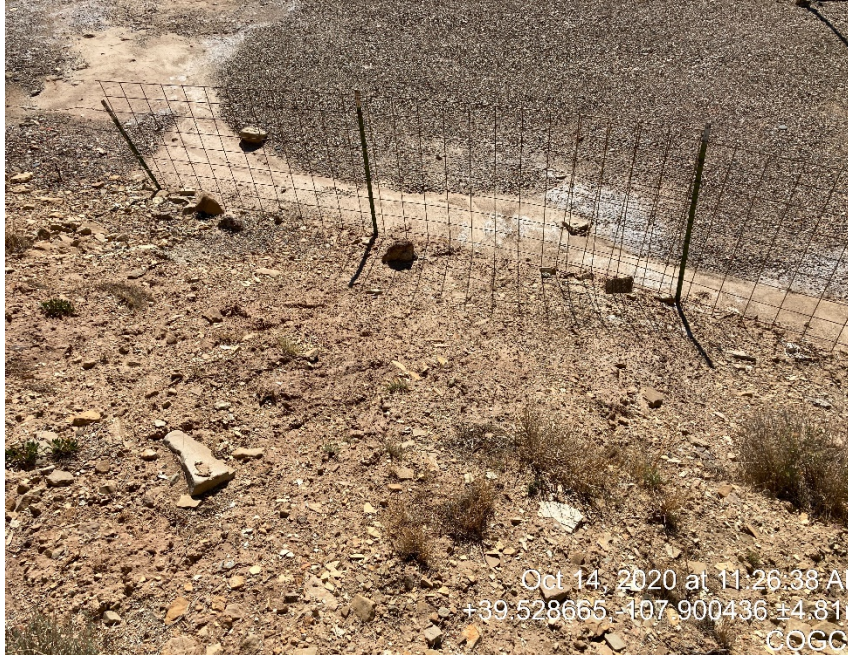
Sediment migration

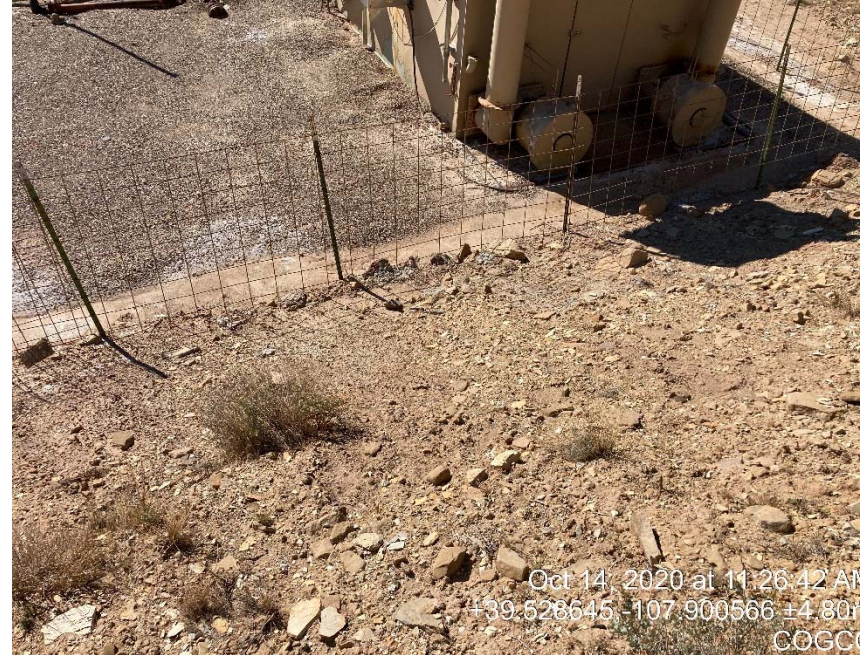
Sediment migration

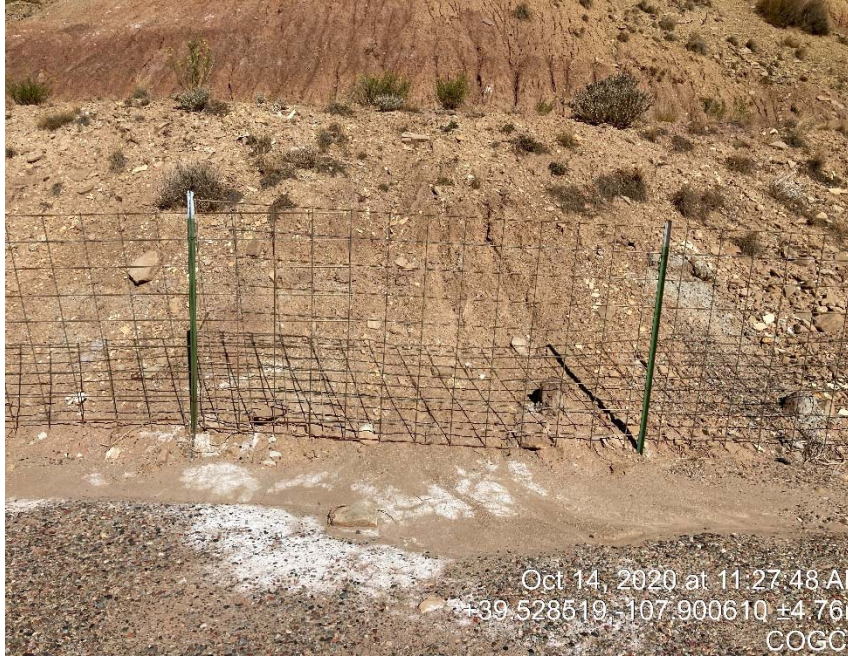
Riling and sediment migration

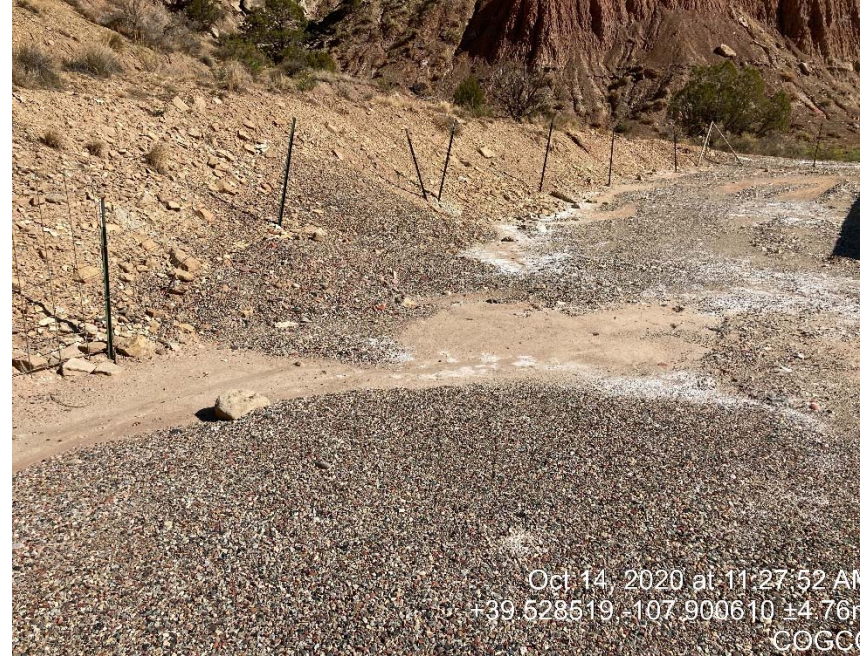
Sediment migration
