Inspection Photos
Operator: Catamount Energy
API: 067-05304
Date: 10/13/2020

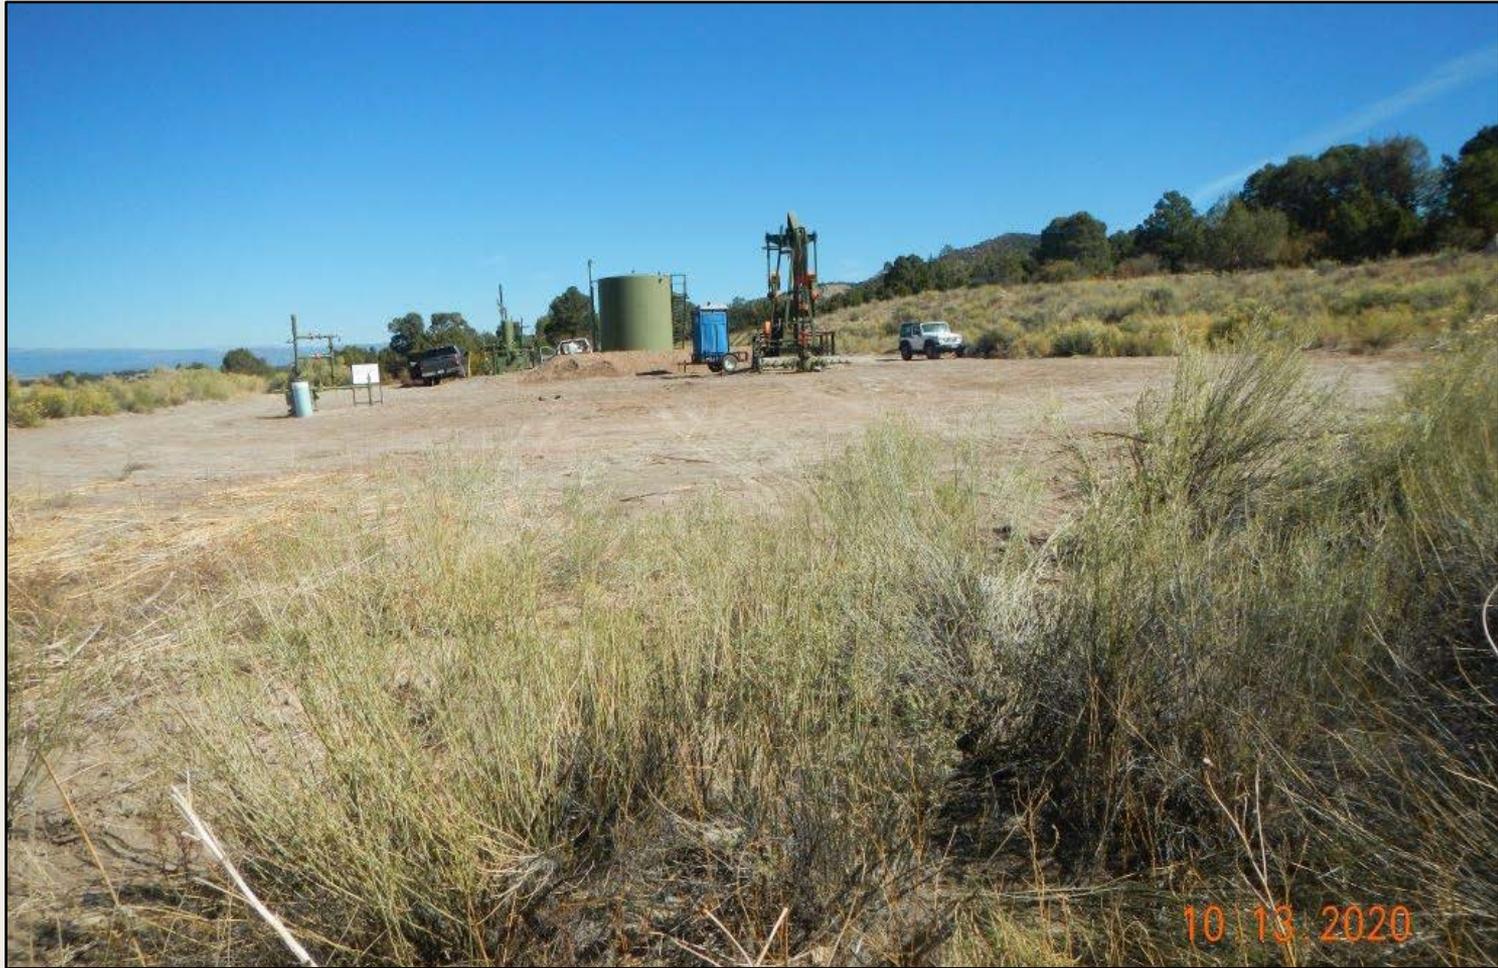
Photo 1. View of the project area from the northwestern corner facing center.

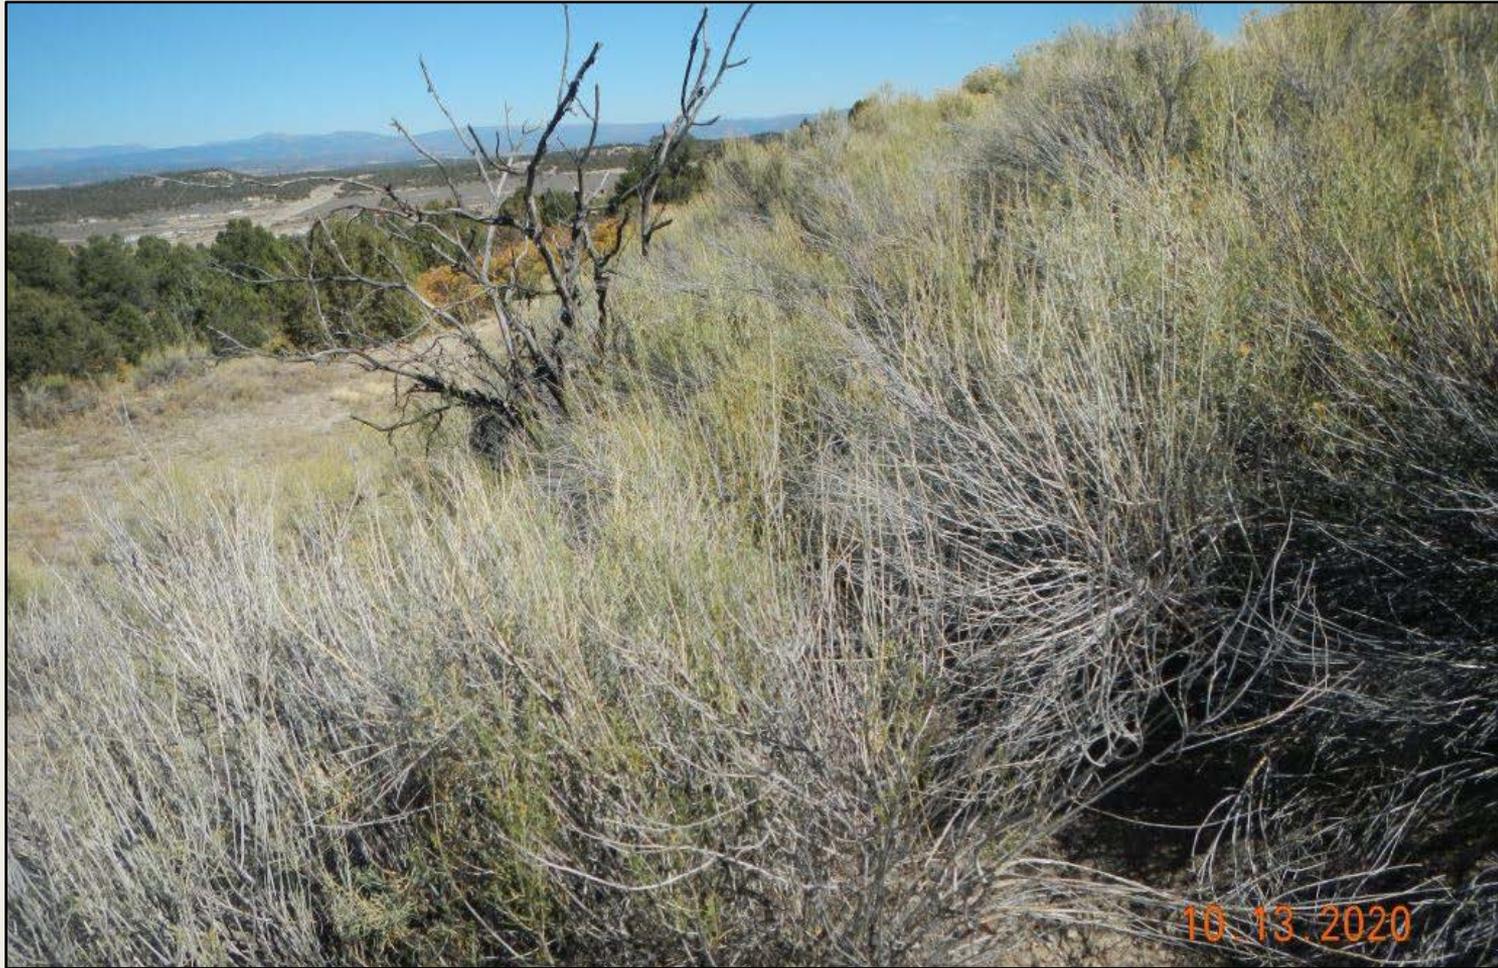
Photo 2. View of the northern fill slope from the northwestern corner facing eastward. Revegetation is progressing with smooth brome, western wheatgrass, and rubber rabbitbrush.

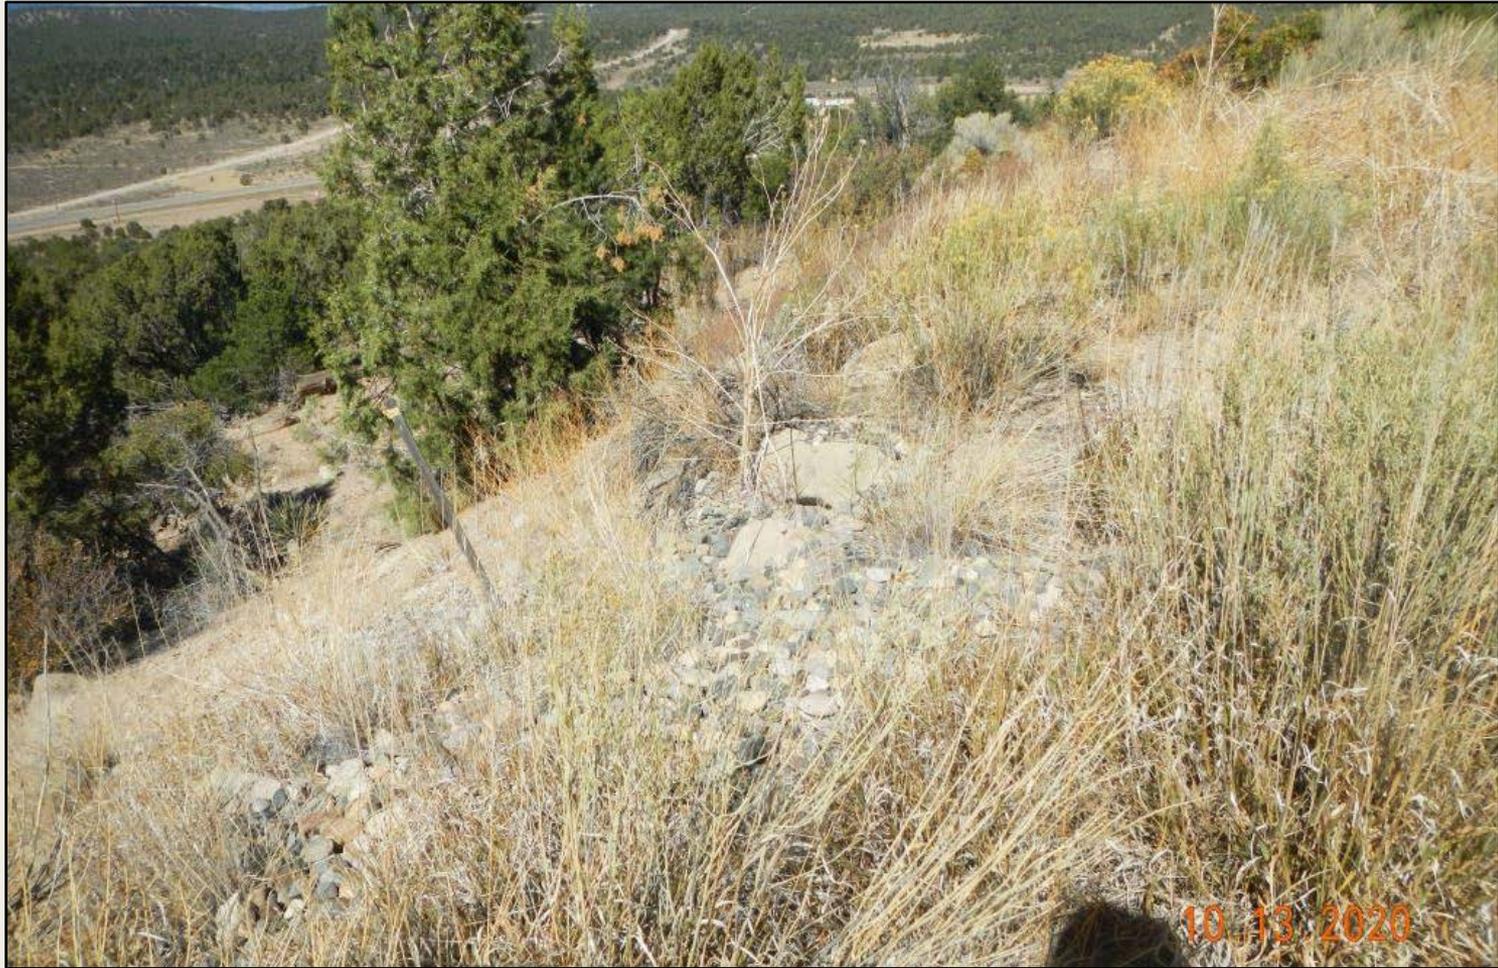
Photo 3. View of revegetation in the northwestern fill slope, that appears to be stabilized at this time.

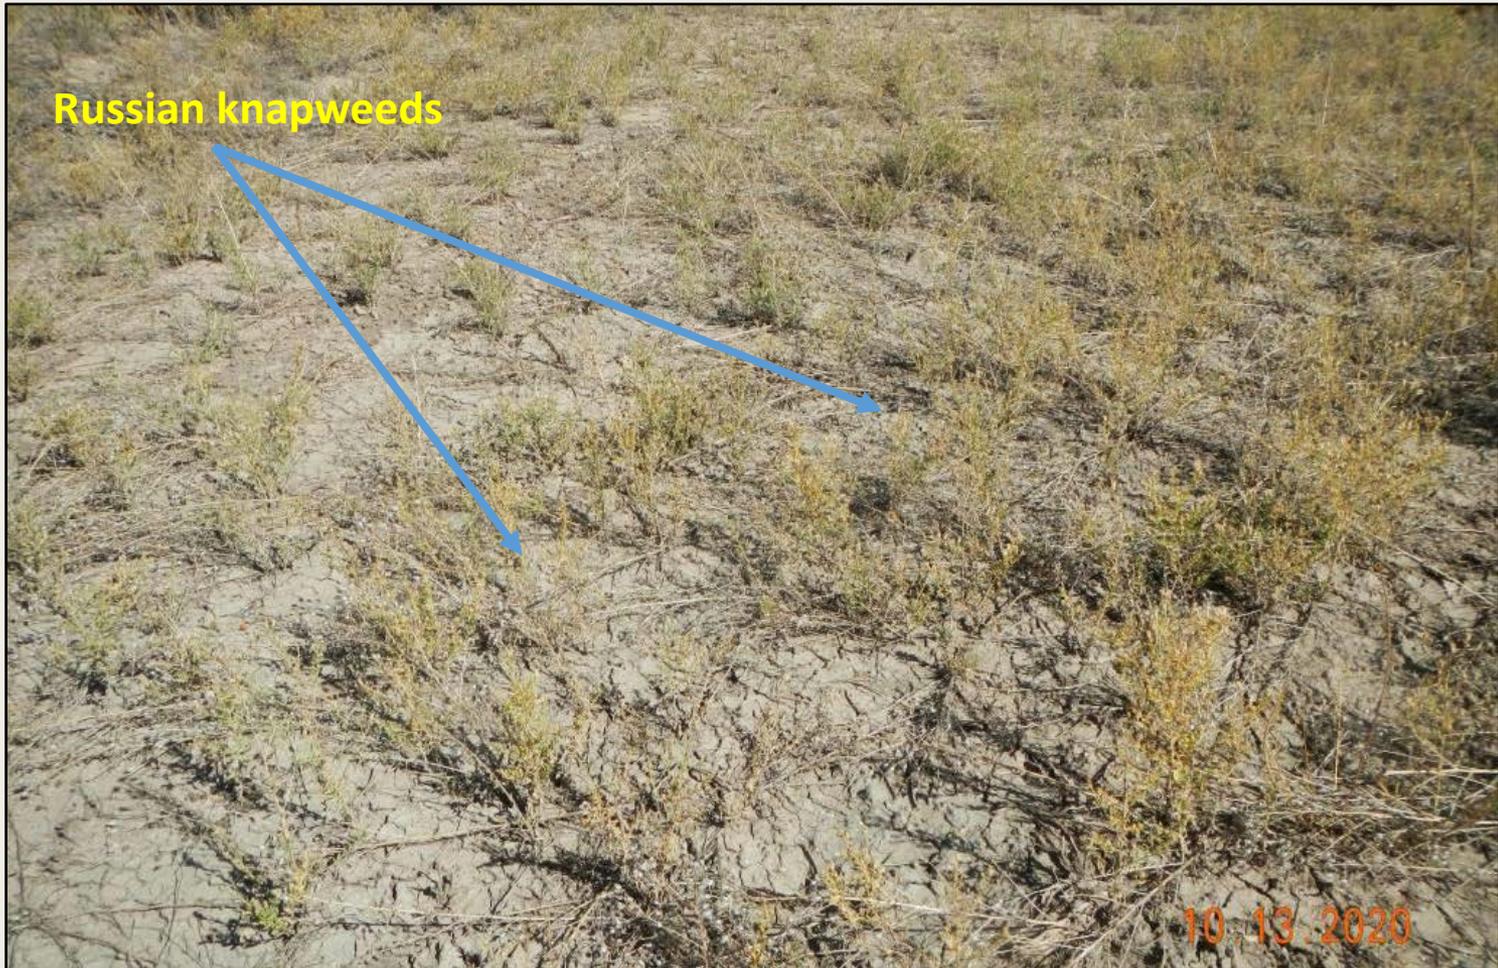
Photo 4. View of Russian knapweeds in the northern project area. Approximately 1000 individuals remain.

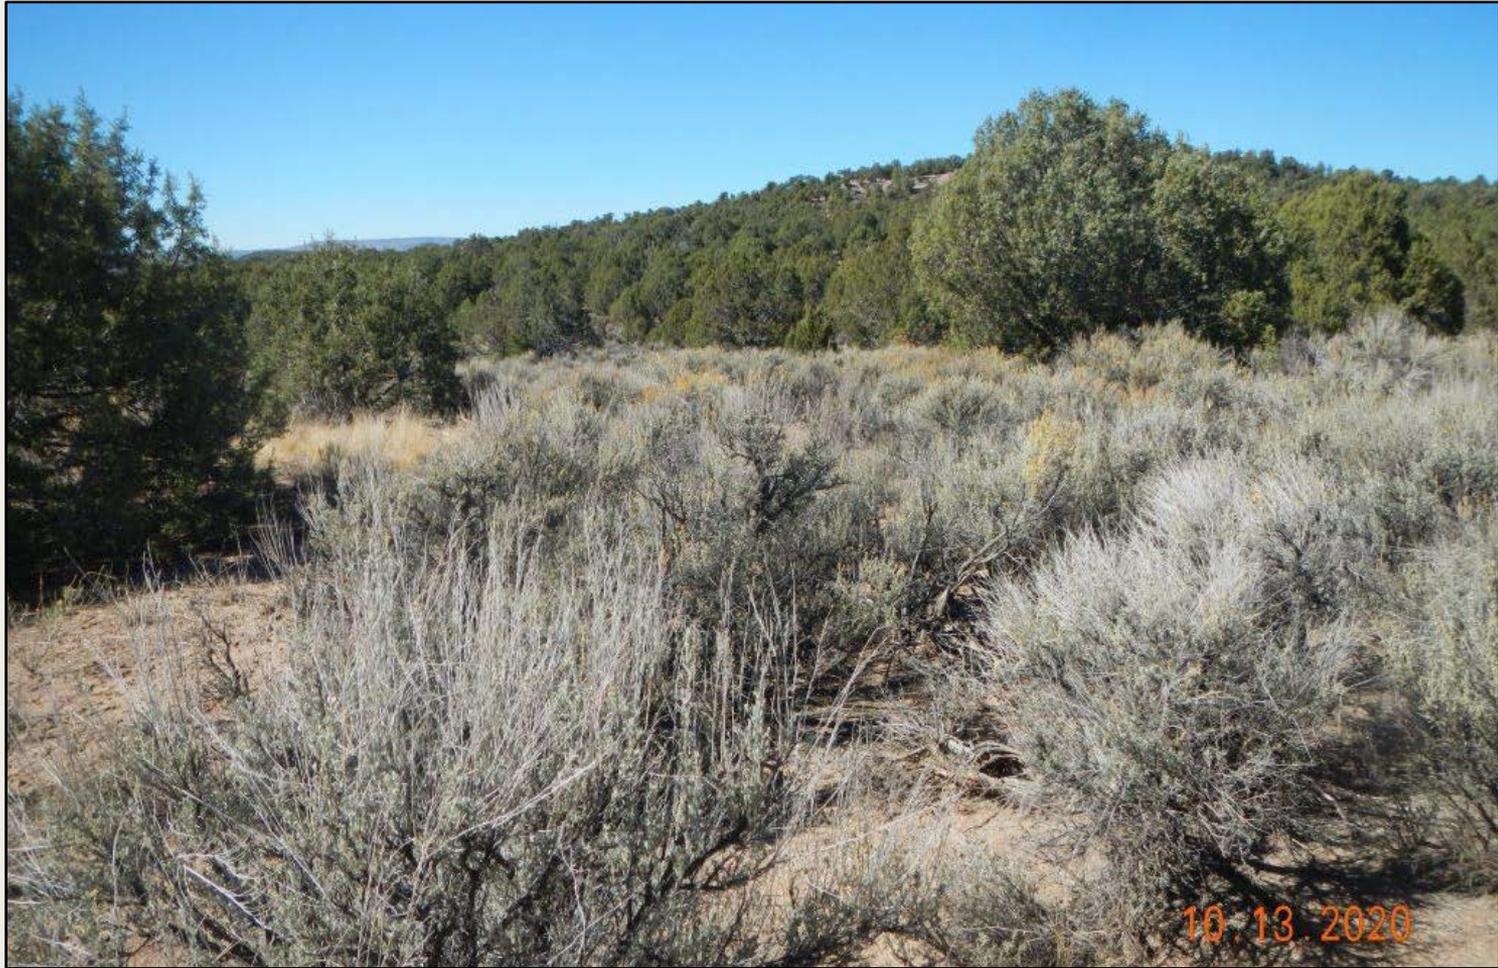
Photo 5. View of reference area vegetation comprised of pinyon and juniper woodland with and understory of sagebrush, squirreltail, Indian ricegrass, and mixed forbs.

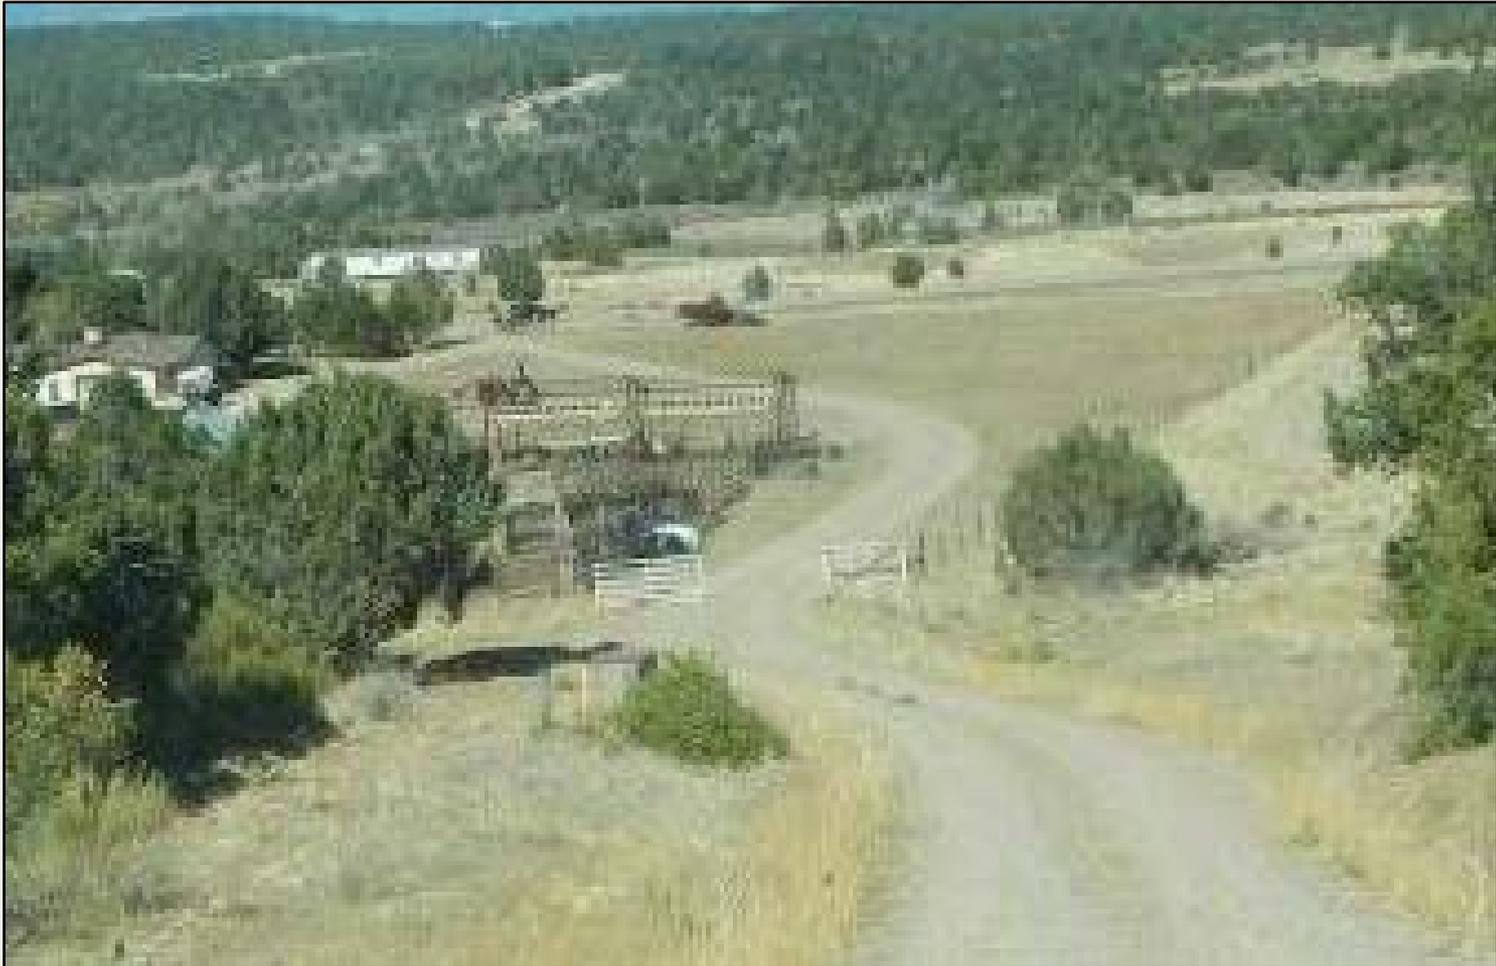
Photo 6. View of farm gates already open while entering and leaving location.
