Inspection Photos
Operator: Hilcorp Energy
API: 067-09340
Date: 10/15/2020

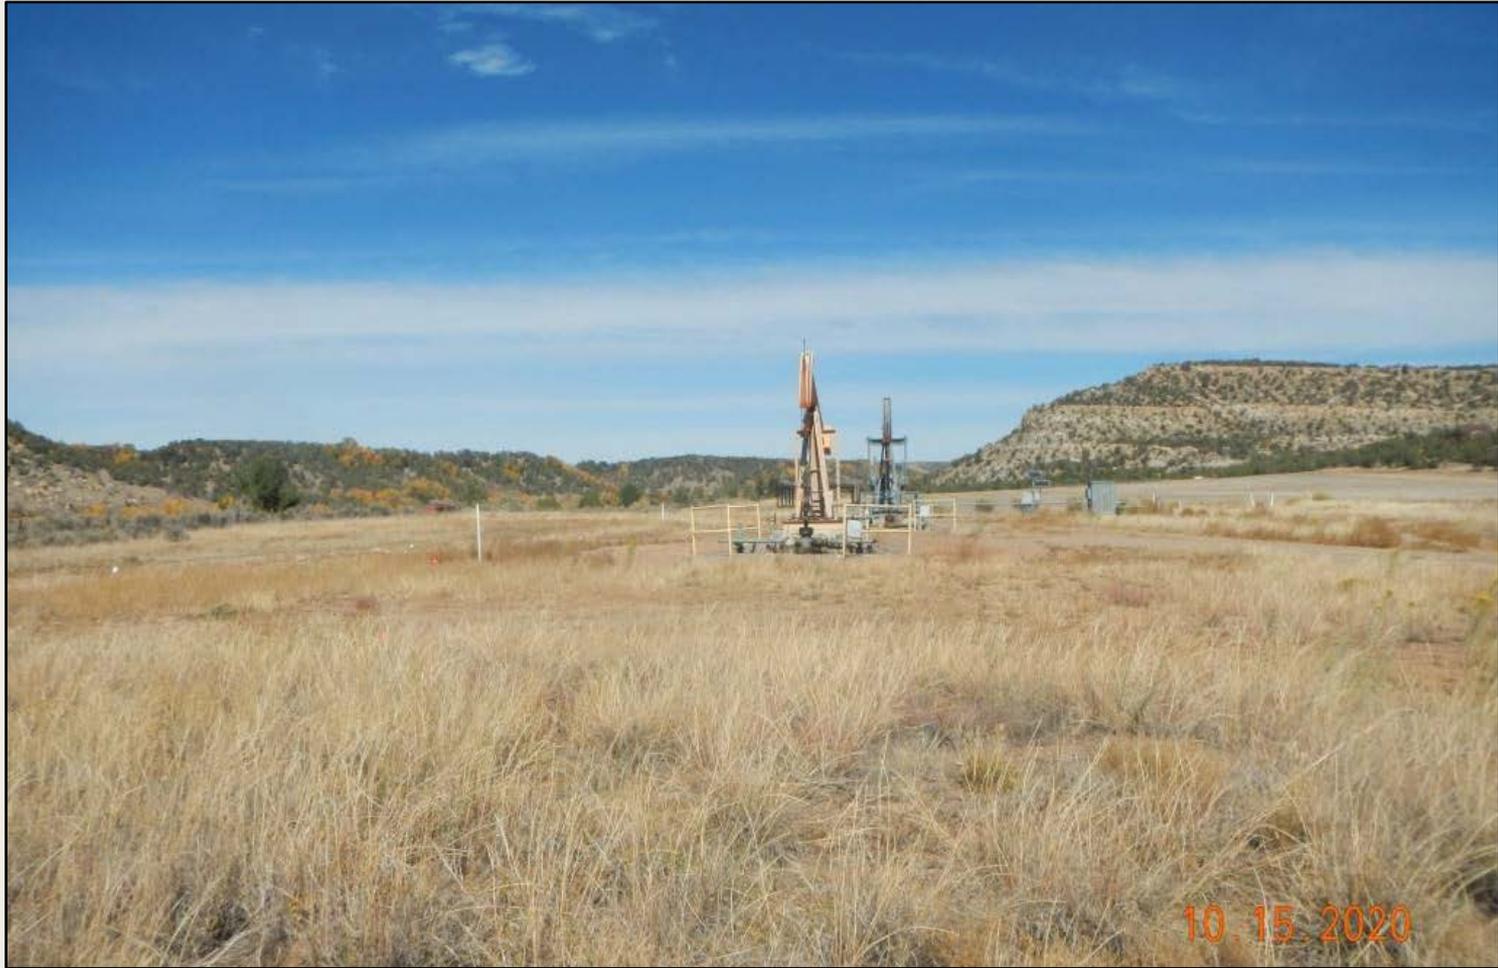
Photo 1. View of the project area from the southern edge facing center. Revegetation is progressing with sand dropseed and western wheatgrass.

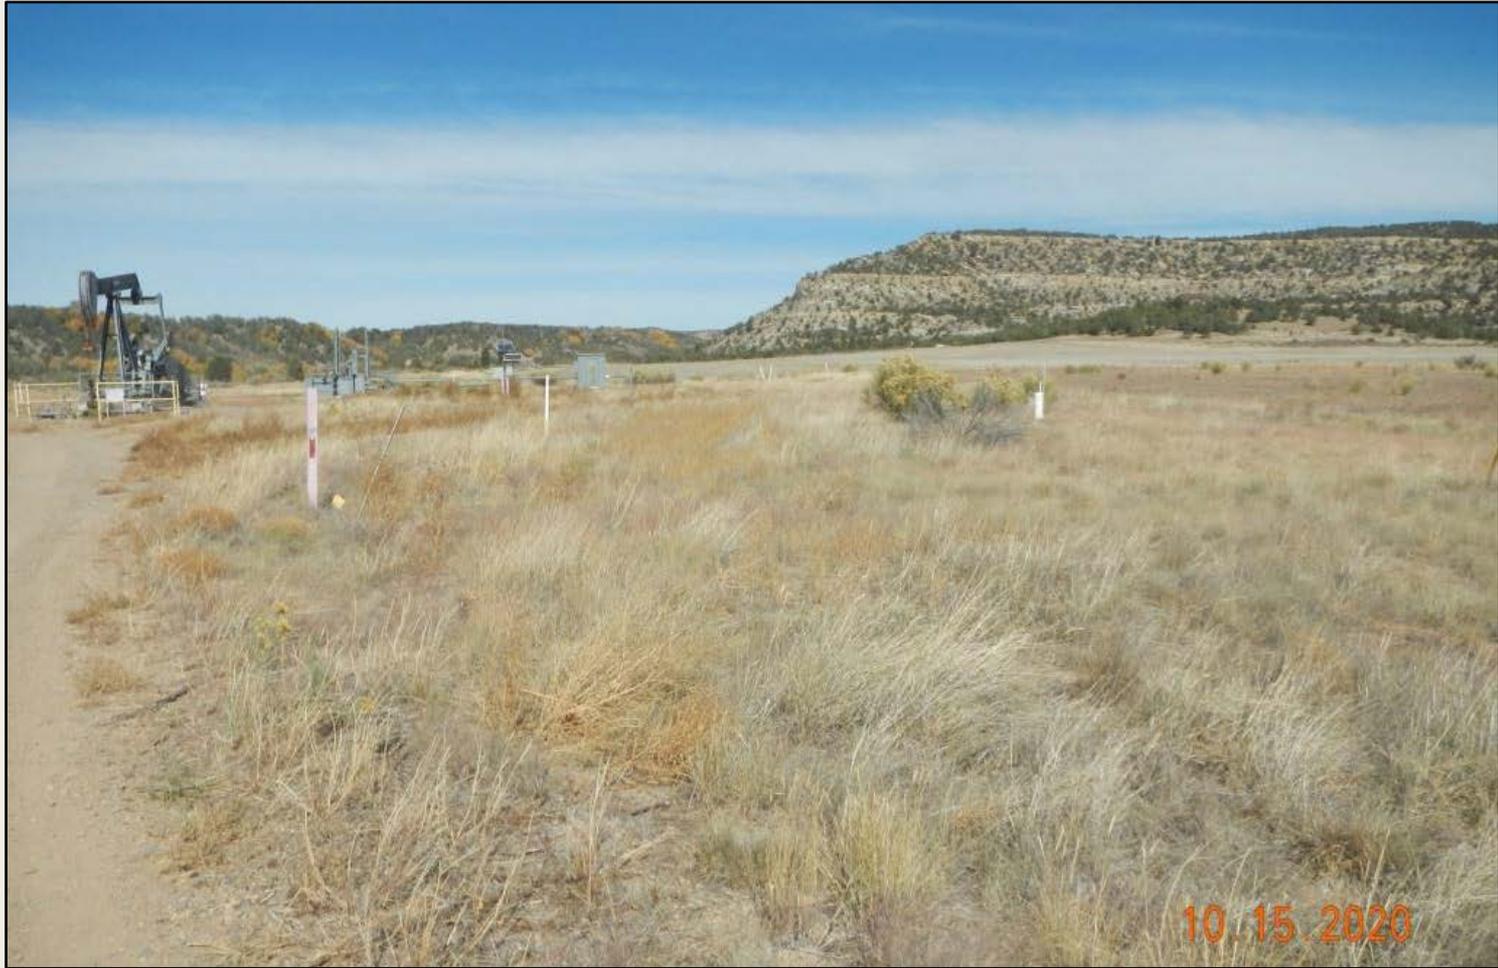
Photo 2. View of the eastern project area from the southeastern corner facing northward.

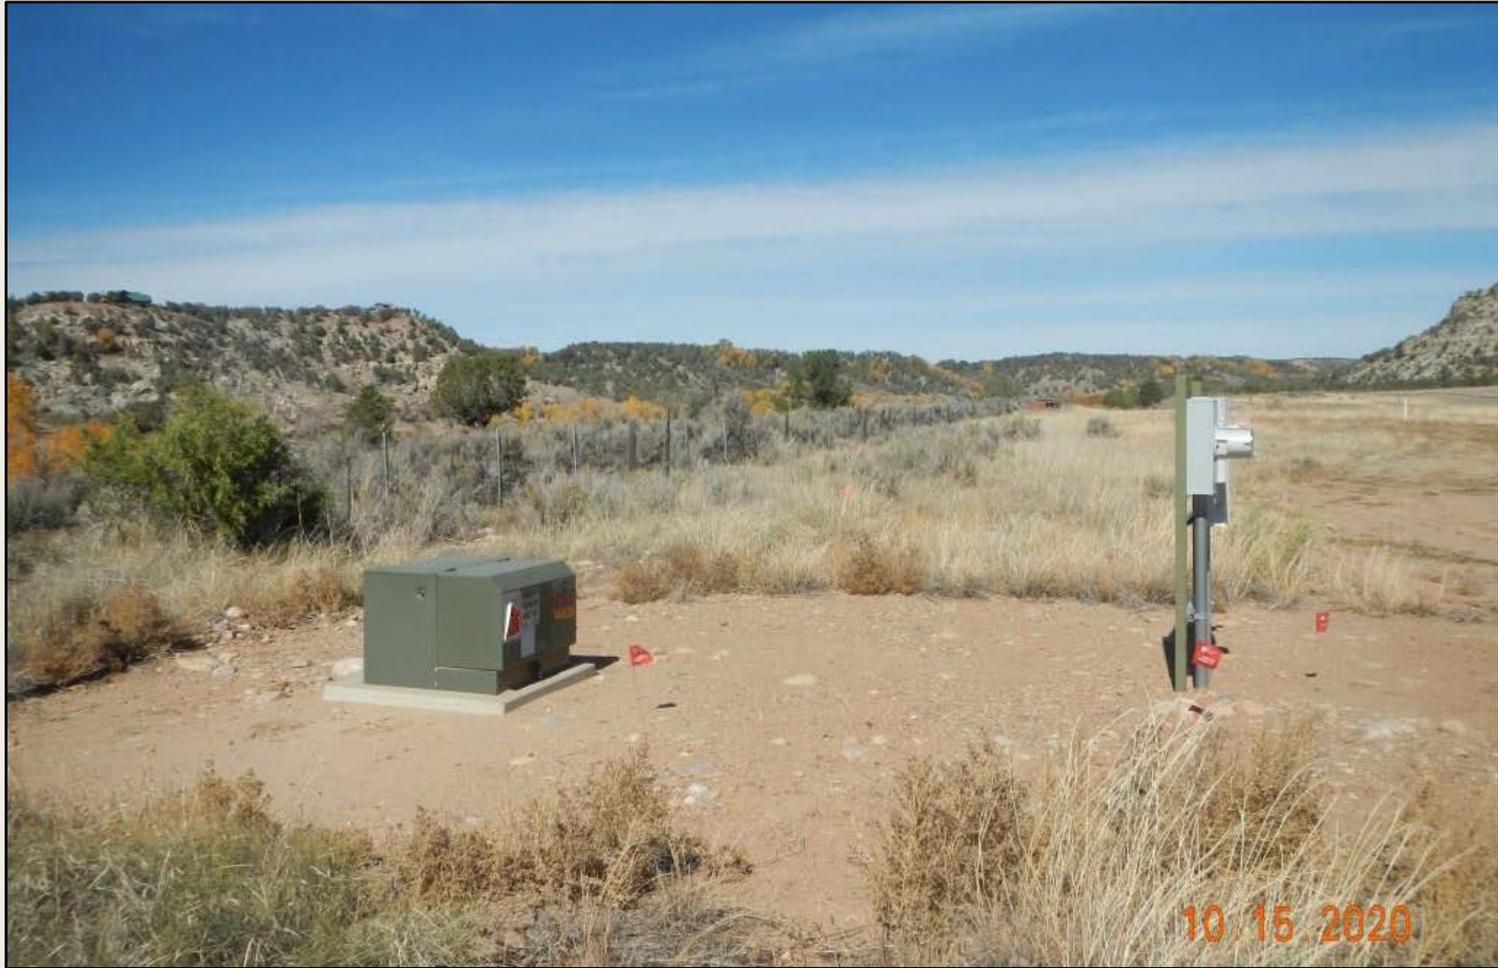
Photo 3. View of the western project area from the southwestern corner facing northward.

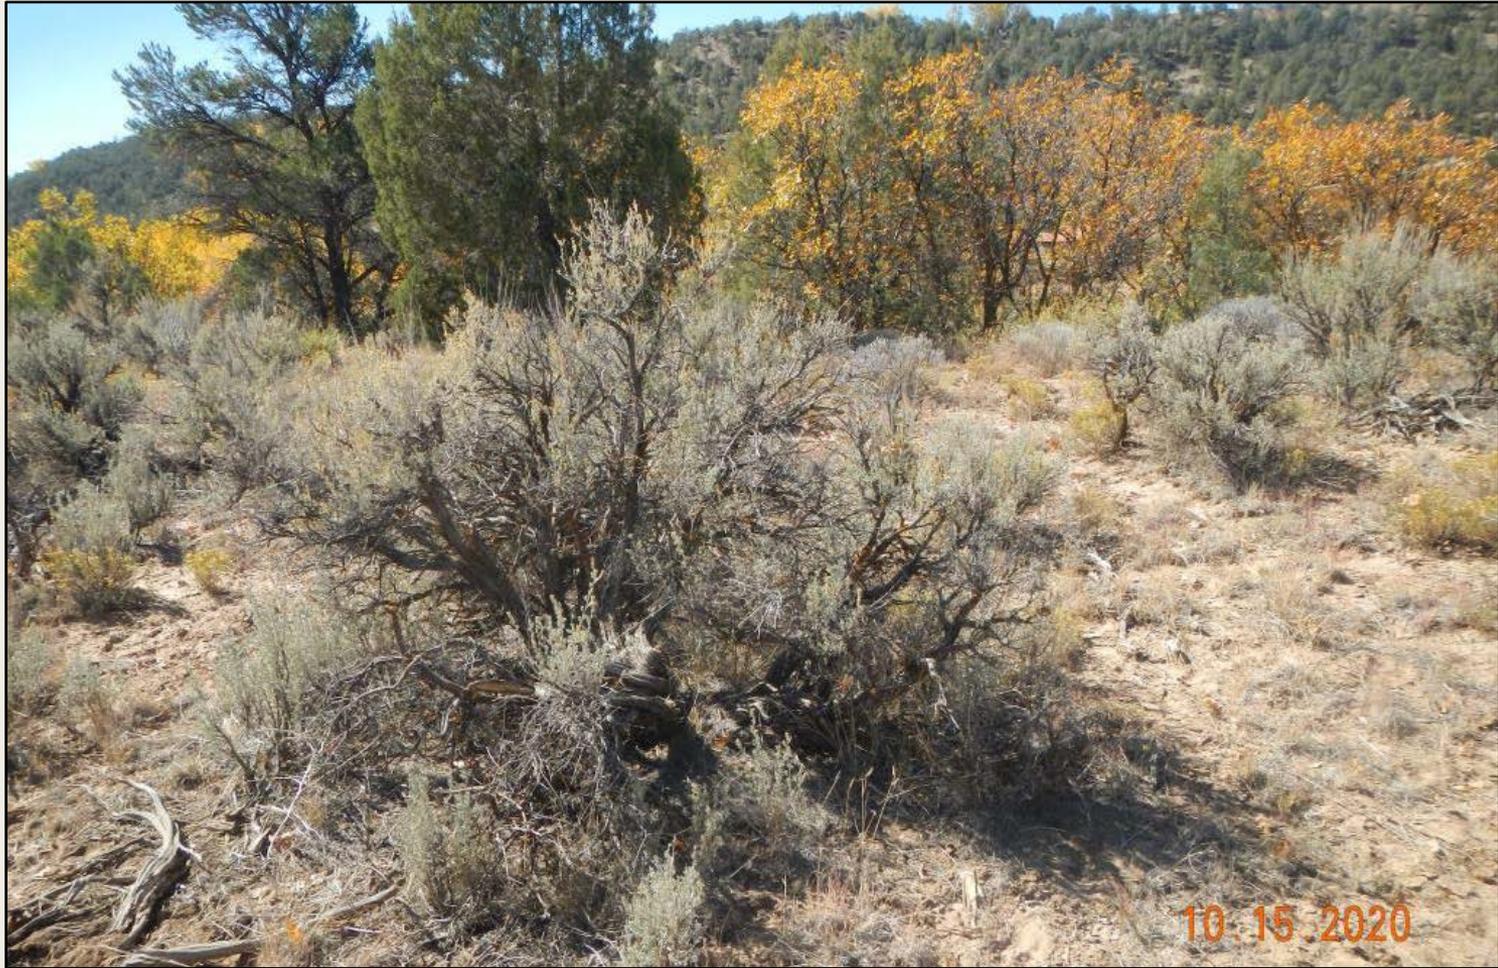
Photo 4. View of the reference area comprised of sagebrush shrubland and gambel oak shrubland mosaic with understory of grasses and forbs such as blue grama, sand dropseed, and snakeweed.

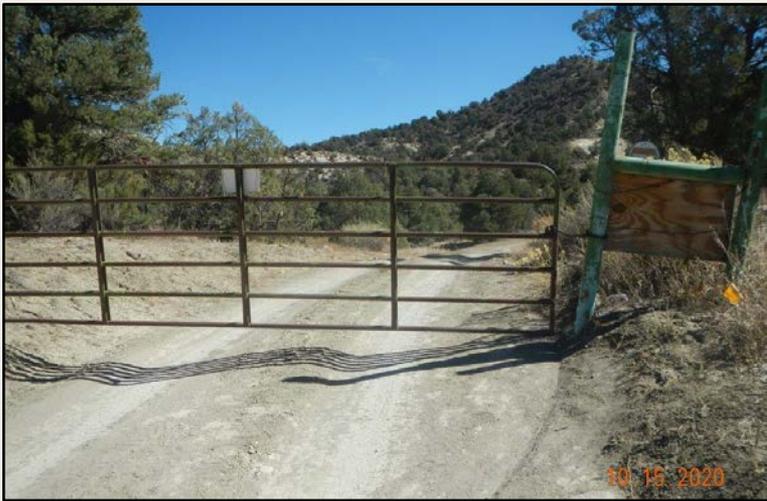
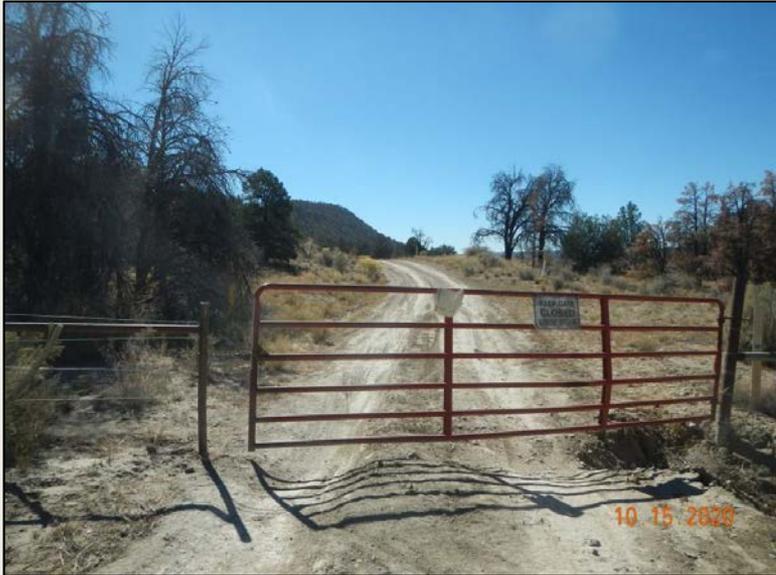
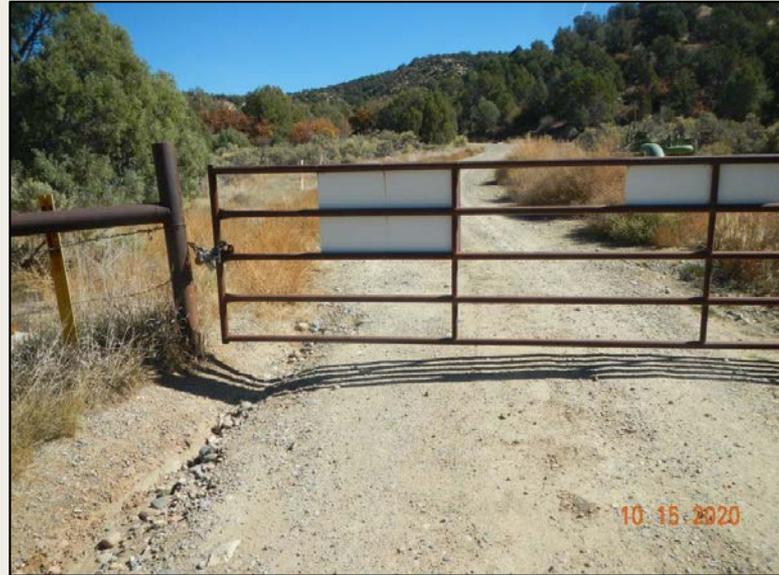
View of closed gates after crossing used to access location.
