Inspection Photos

Location Name: LARAMIE ENERGY LLC Homer Deep Unit /15-23 Pad

Location ID: 311760

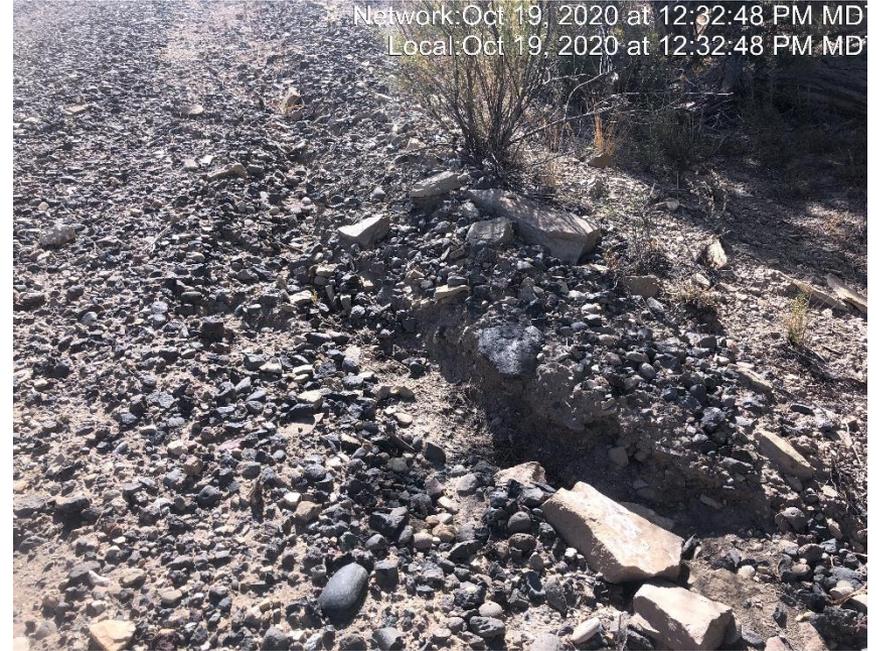
Photo #2047 Rill erosion

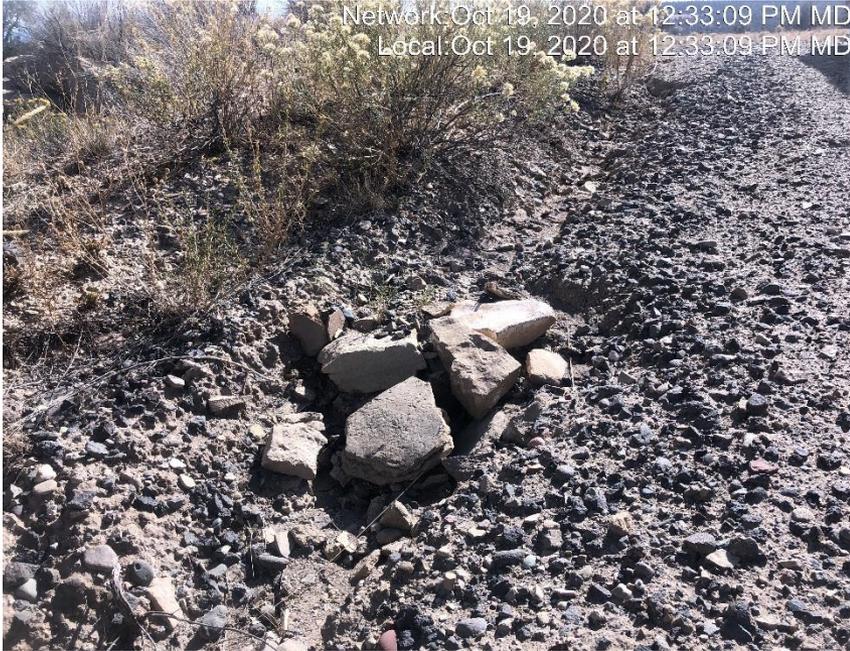
Photo #2048 Rill erosion around check dam.

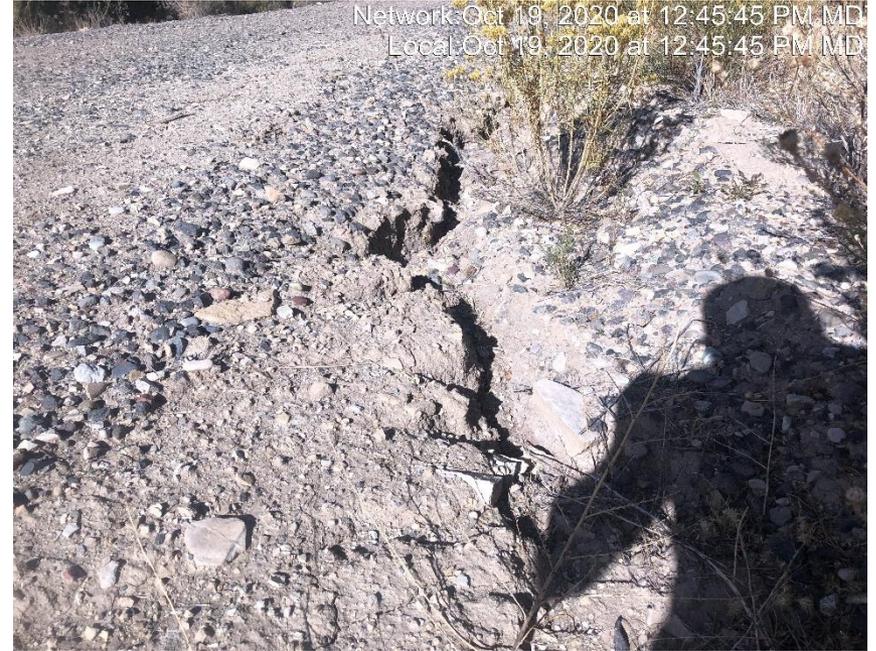
Photo #2049 Rill erosion

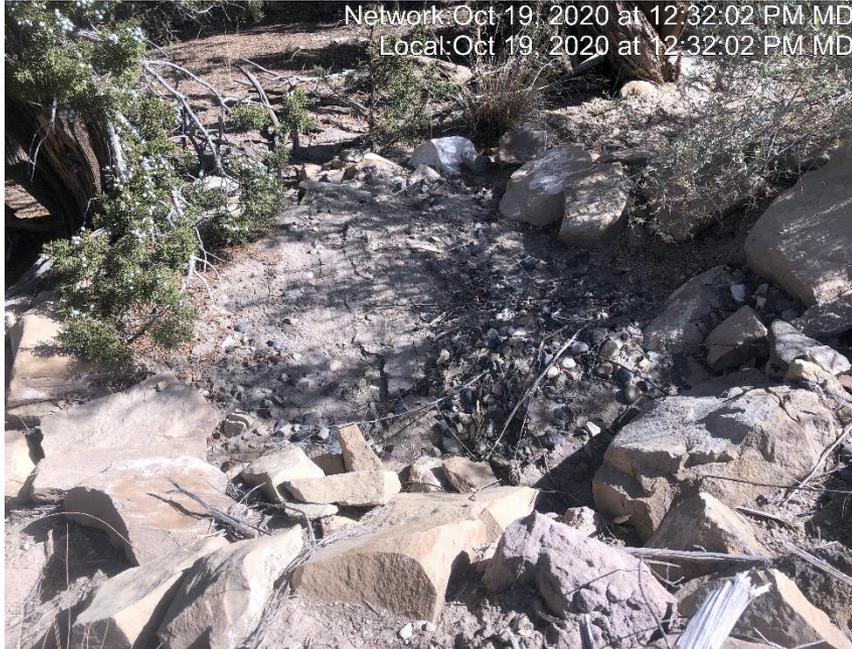
Photo #2046 Sediment trap is full.
