## Inspection Photos

Location Name: MARALEX RESOURCES INC SULFUR GULCH 9-98-22-69S98W /22NENW

Location ID: 312650

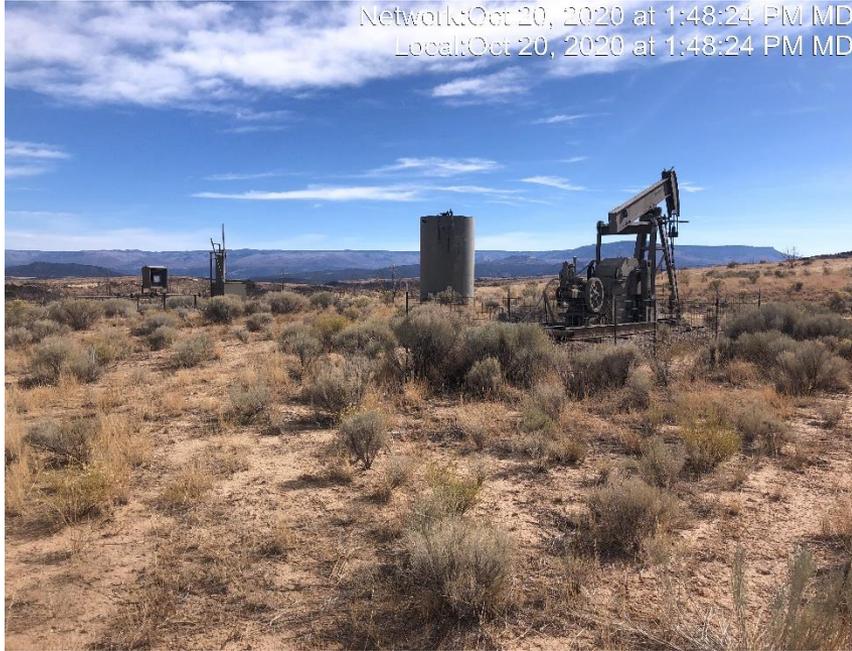
Photo #2061 from entrance to location.

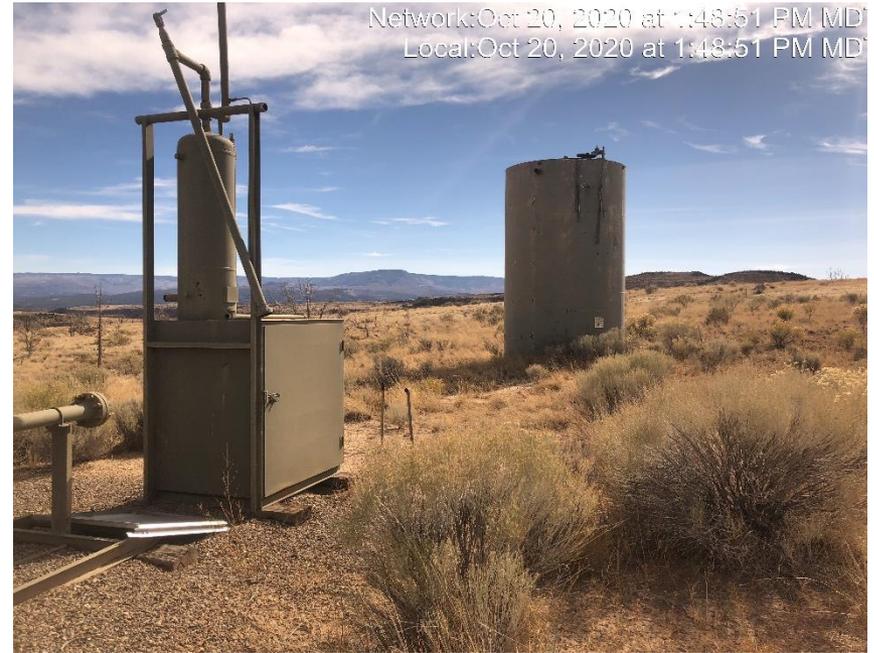
**Photo #2062 Unused equipment.**

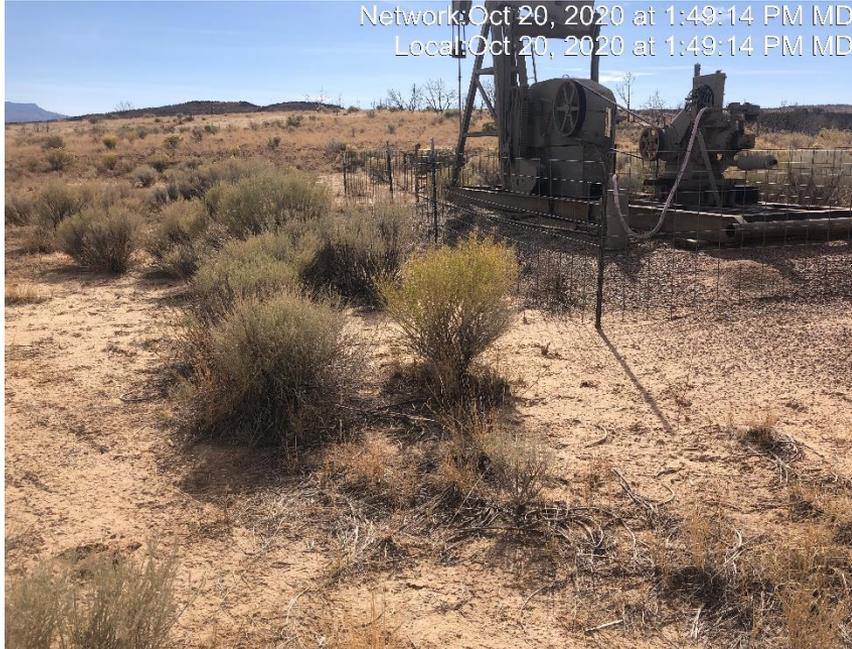
Photo #2063 Debris on location.
