Inspection Photos

API: 043-06221

Operator: AUSCO PETROLEUM INC

Inspection Date: 10/19/2020

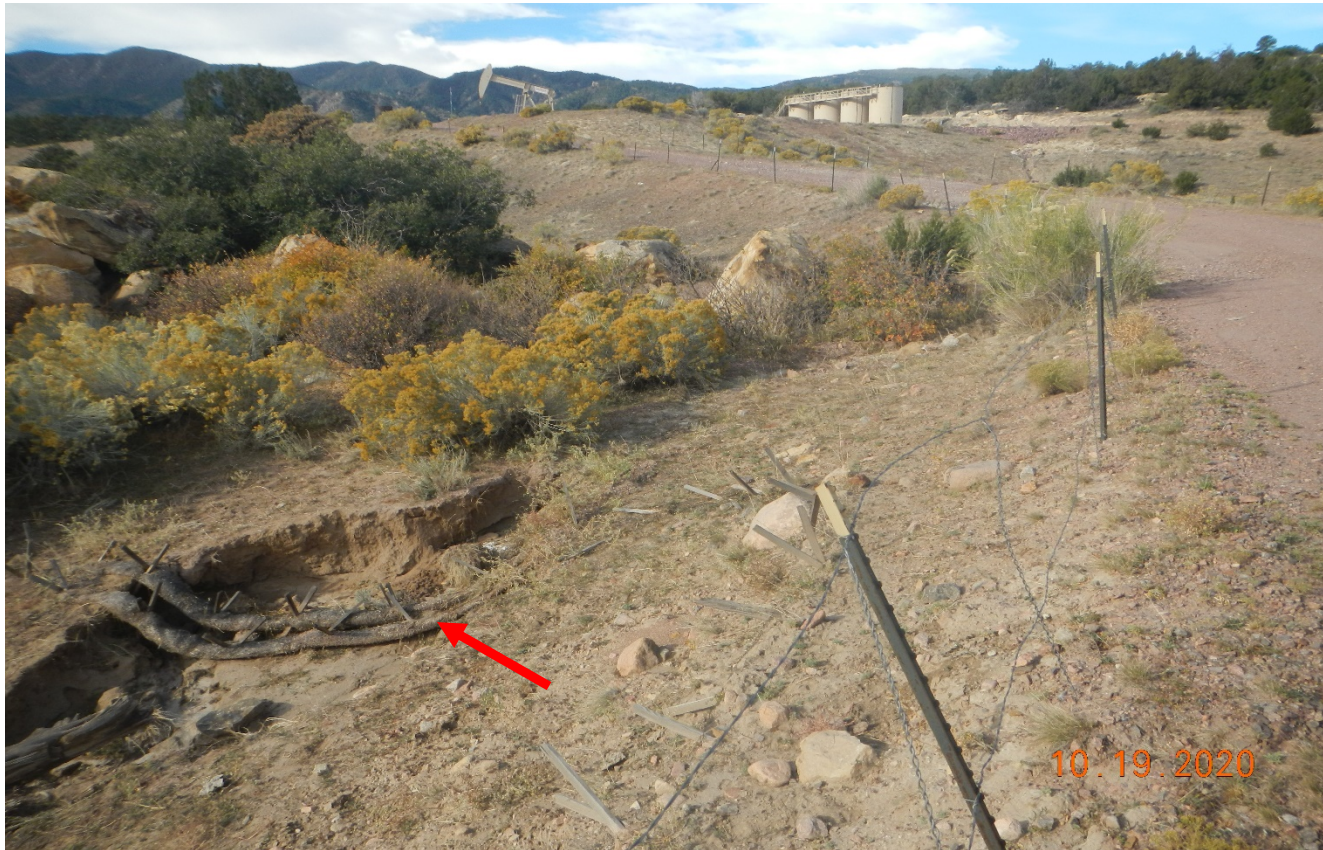
Photo 1. Facing southwest along the access road. Stormwater from the road is creating erosion in area shown at red arrow.. The wattles placed in this area are displaced and are not controlling erosion.

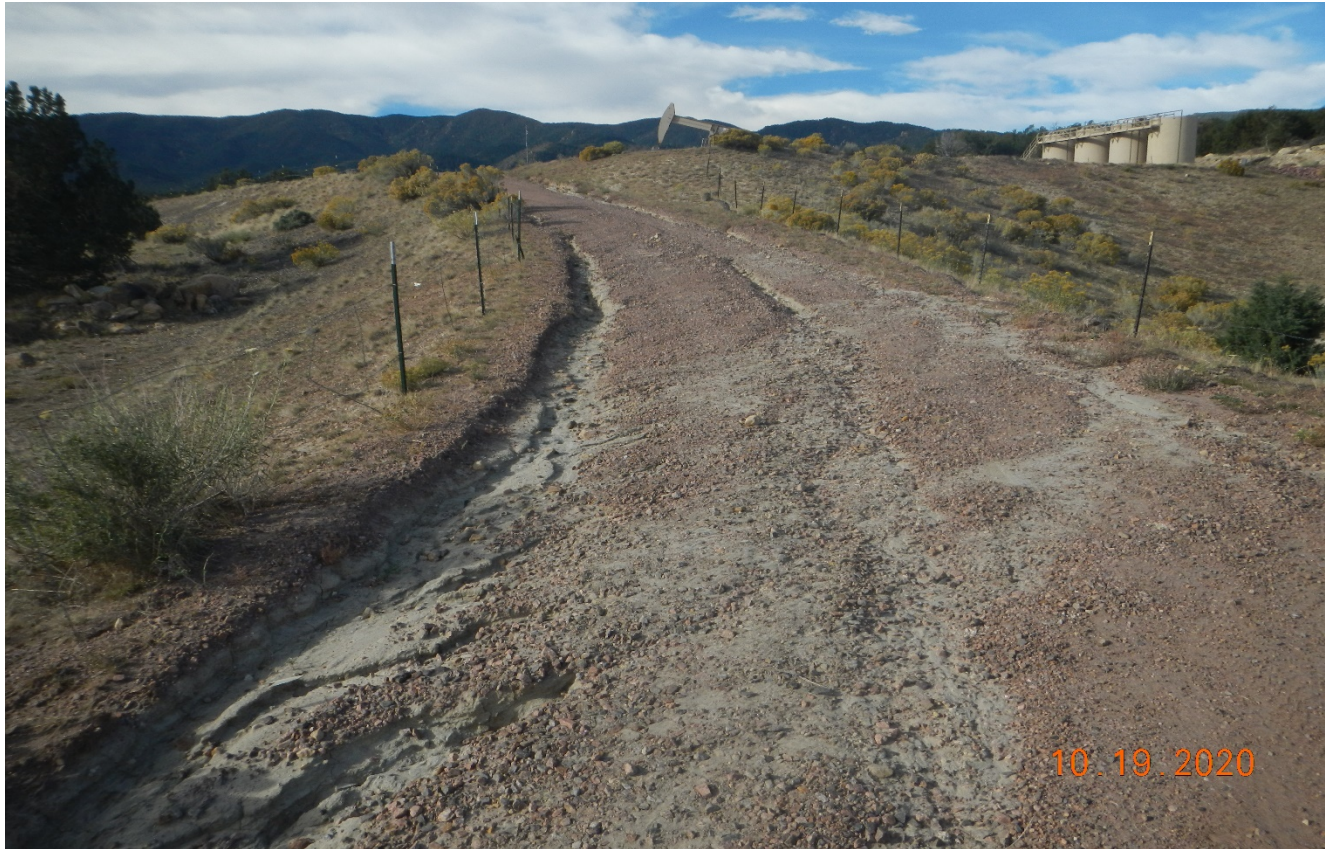
Photo 2. There is erosion along the access road. Stormwater is diverted down the road and into drainage area shown in previous photo. The erosion needs to be repaired and stormwater needs to be properly diverted.

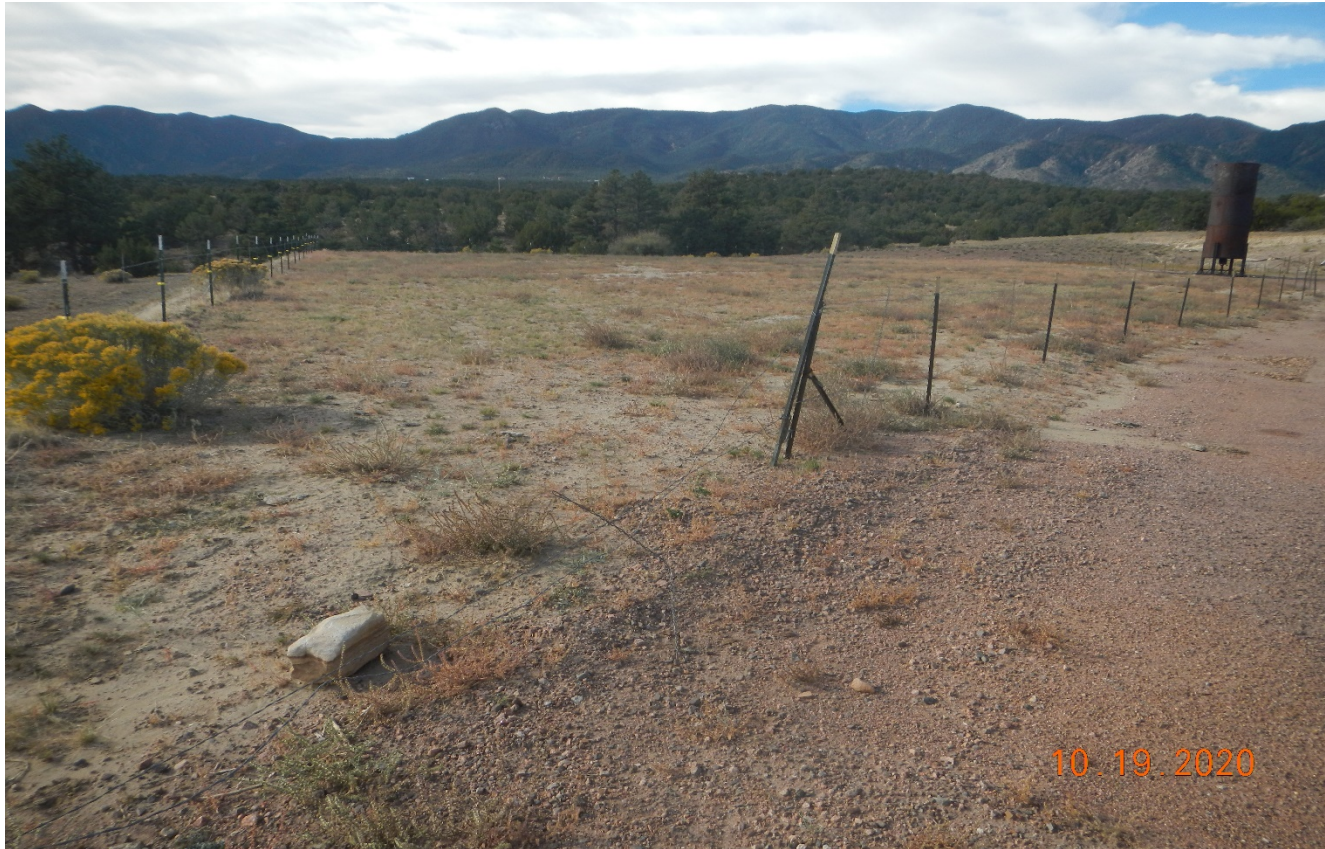
Photo 3. Facing south toward the location. The fence around the vegetated area is not maintained.

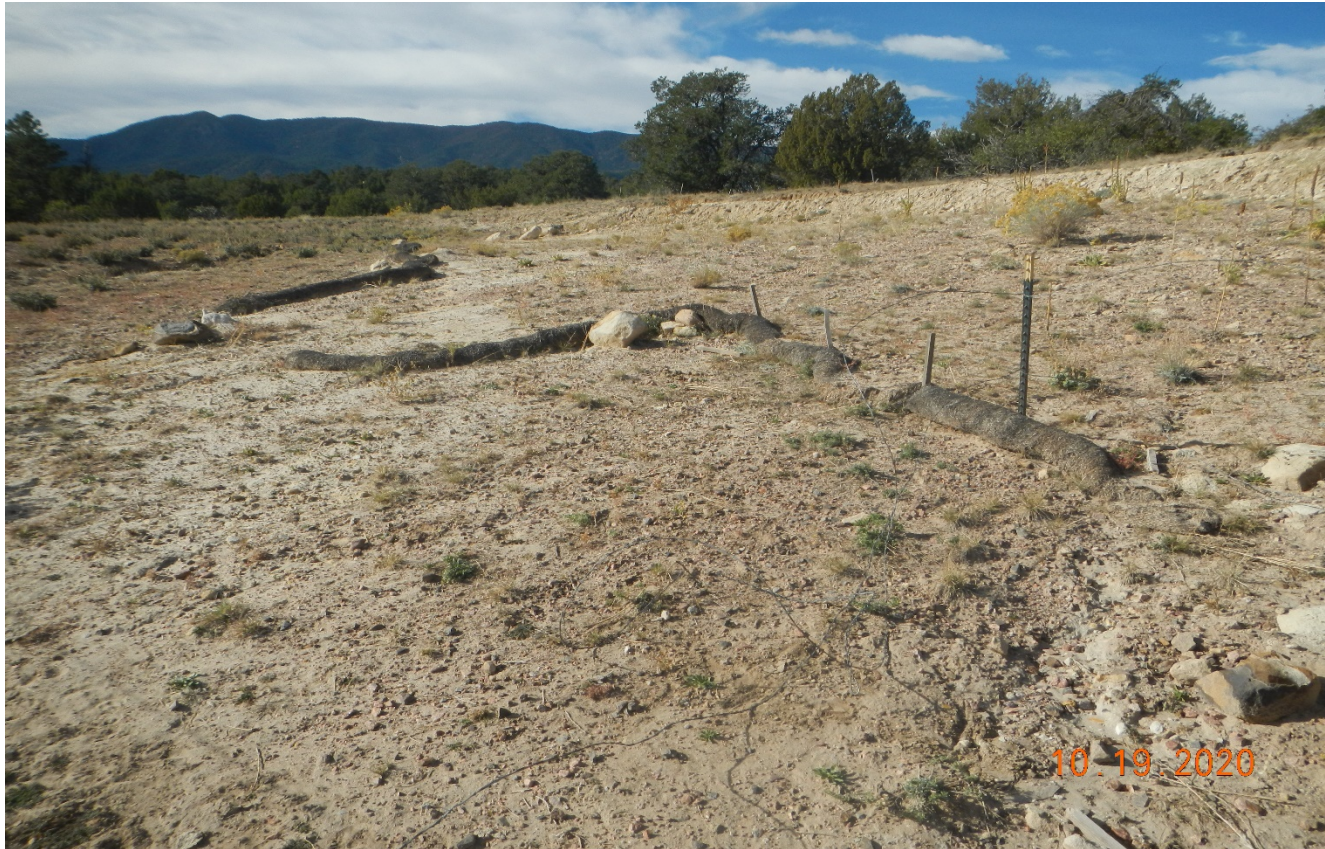
Photo 5. There are wattles displaced at the southwest side of the location. This was also observed in the previous inspection. Wattles need to be repired and maintained.

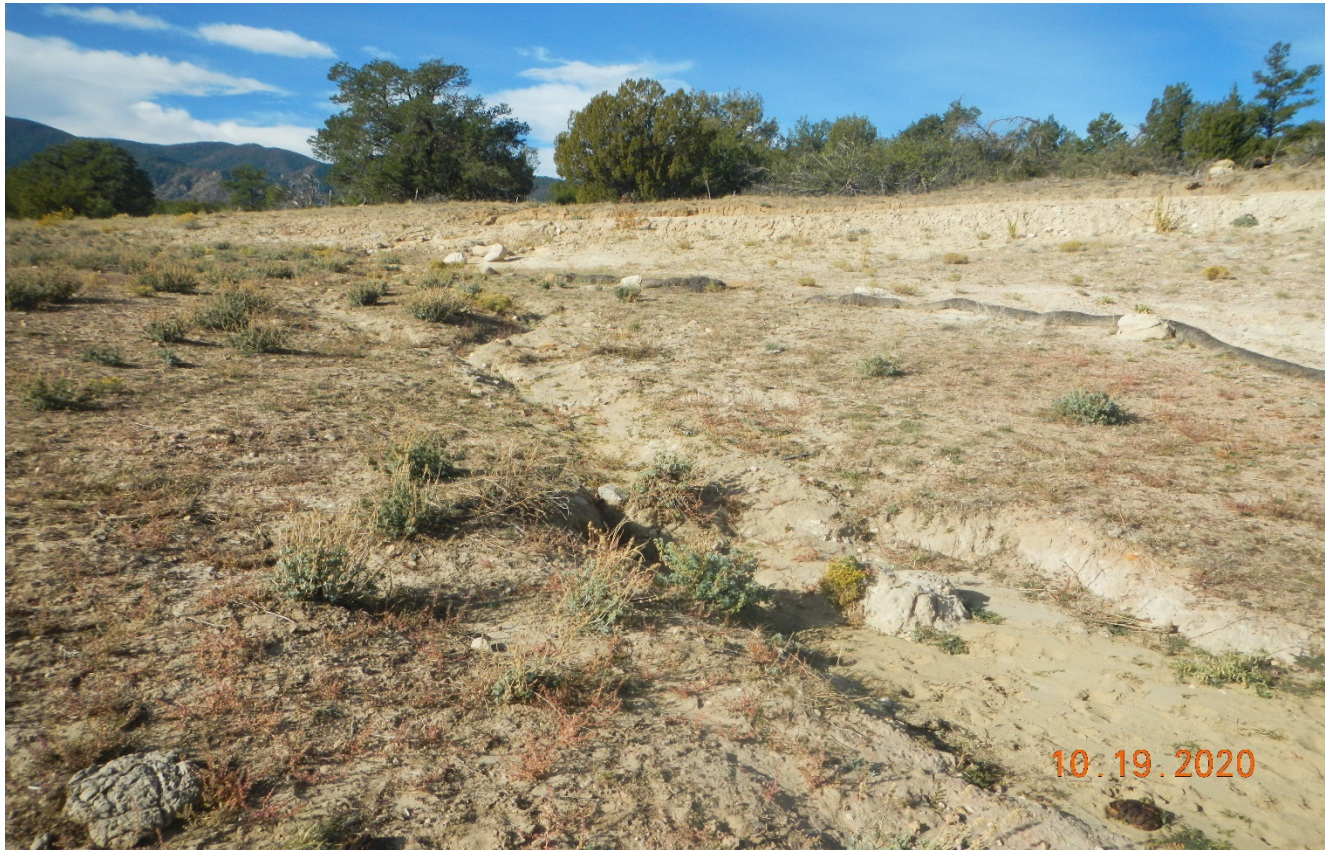
Photo 6. There is an erosion channel at the southwest side of the location. Stormwater is directed to this area from the top perimeter dictated. BMP's are needed in this area to prevent erosion.

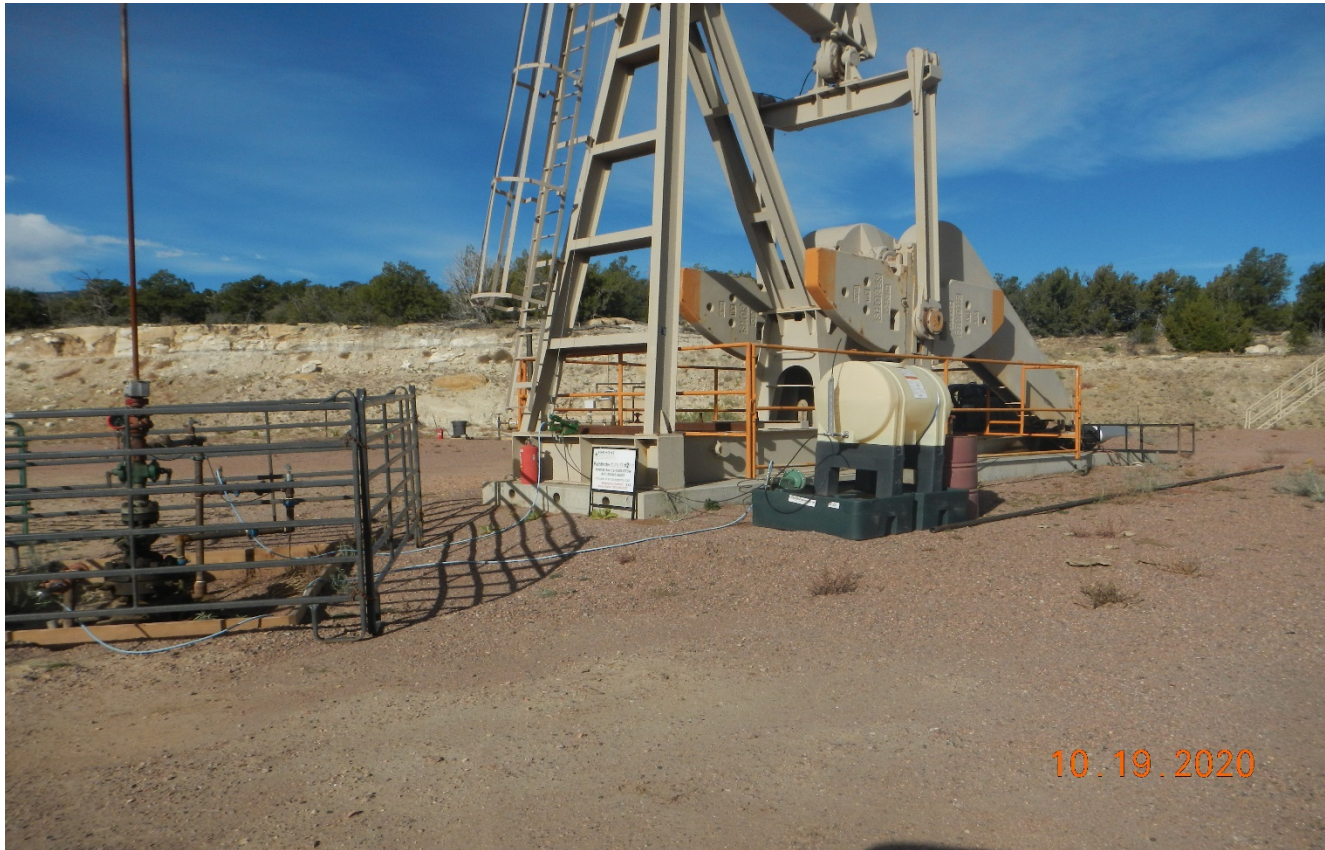
Photo 7. The well sign is posted at the pumpjack.

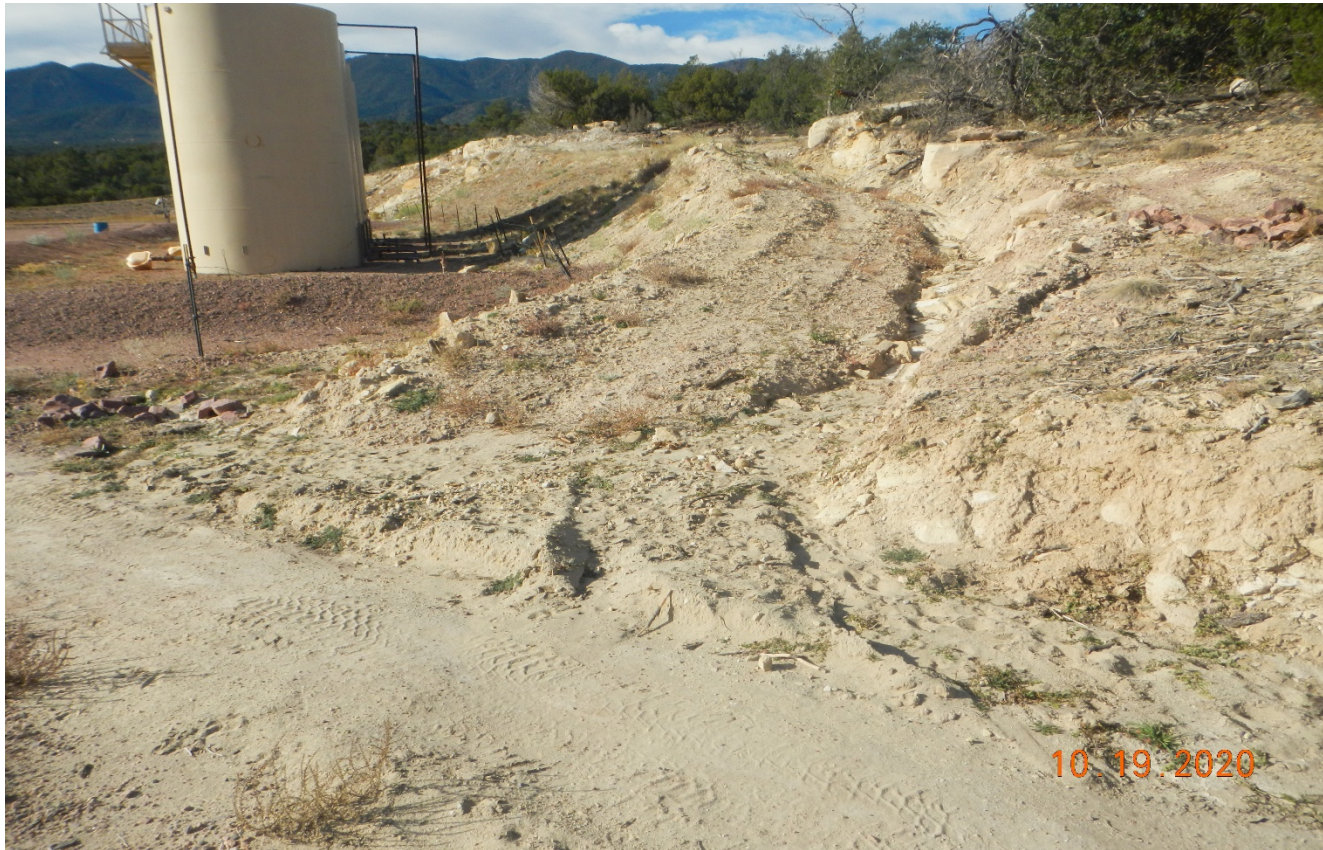
Photo 8. The top perimeter ditch is directing stormwater toward the road which has deposited sediment onto the road. BMP's are needed in this area.

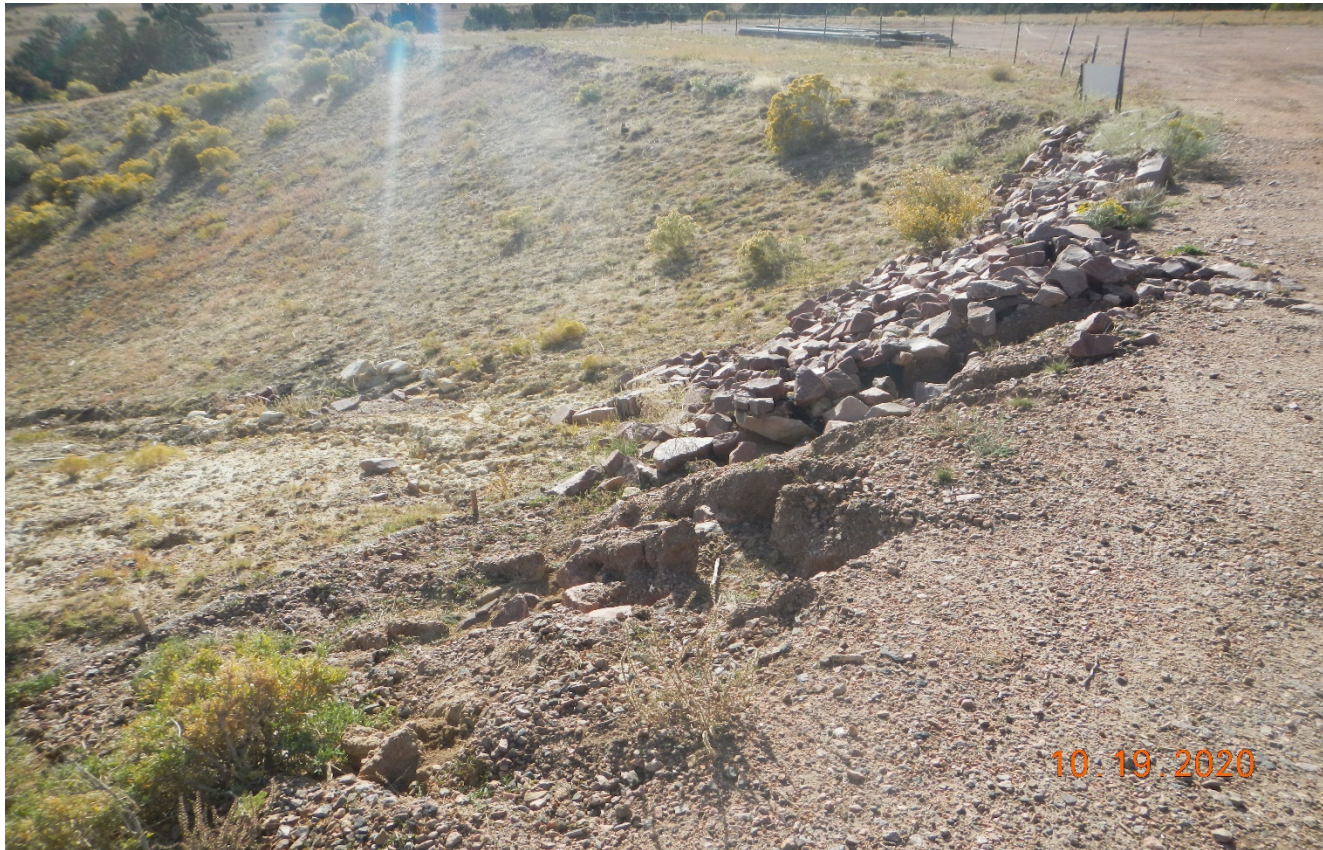
Photo 9. There is erosion occurring across the road at the north side of the location caused by stormwater directed from the top perimeter ditch shown in the previous photo.
