# Inspection Photos

API: 043-06219

Operator: AUSCO PETROLEUM INC

Inspection Date: 10/19/2020

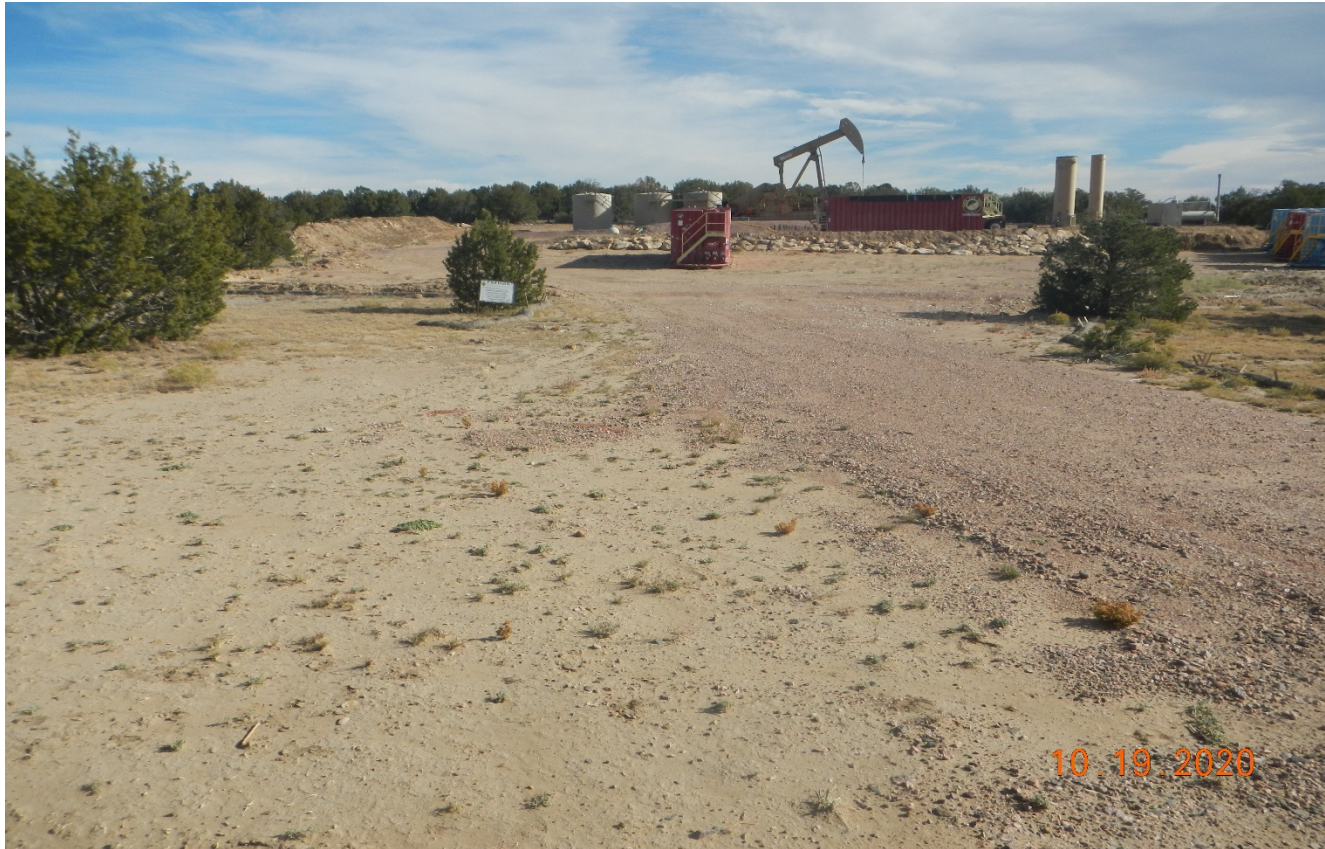
**Photo 1.** Facing northeast toward the location. The yellow tank has been removed however, other unused equipment has not been removed and interim reclamation has not been performed.

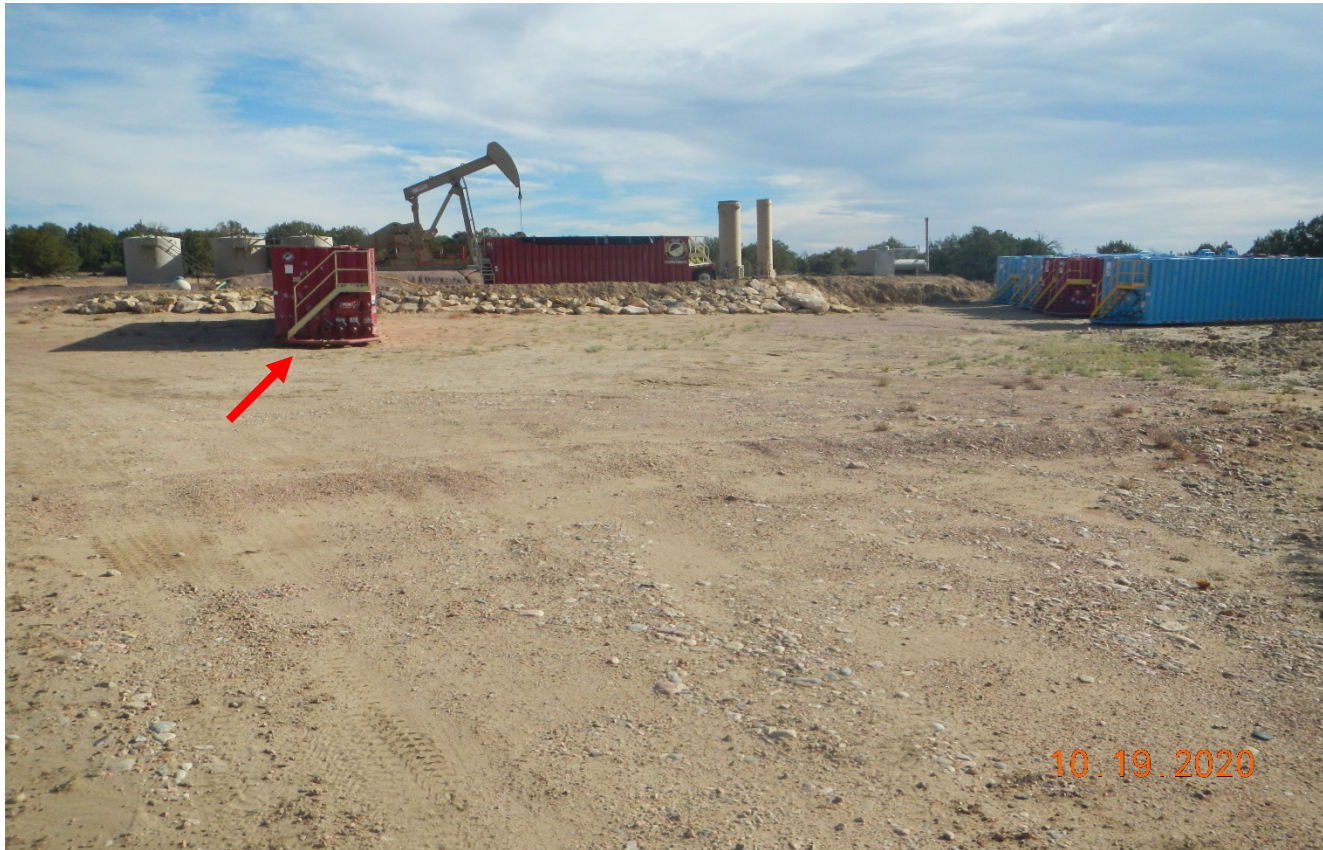
**Photo 2.** Facing northeast toward the location. This red tank shown by arrow has not been removed and this area has not been reclaimed. Previous corrective actions have not been performed.

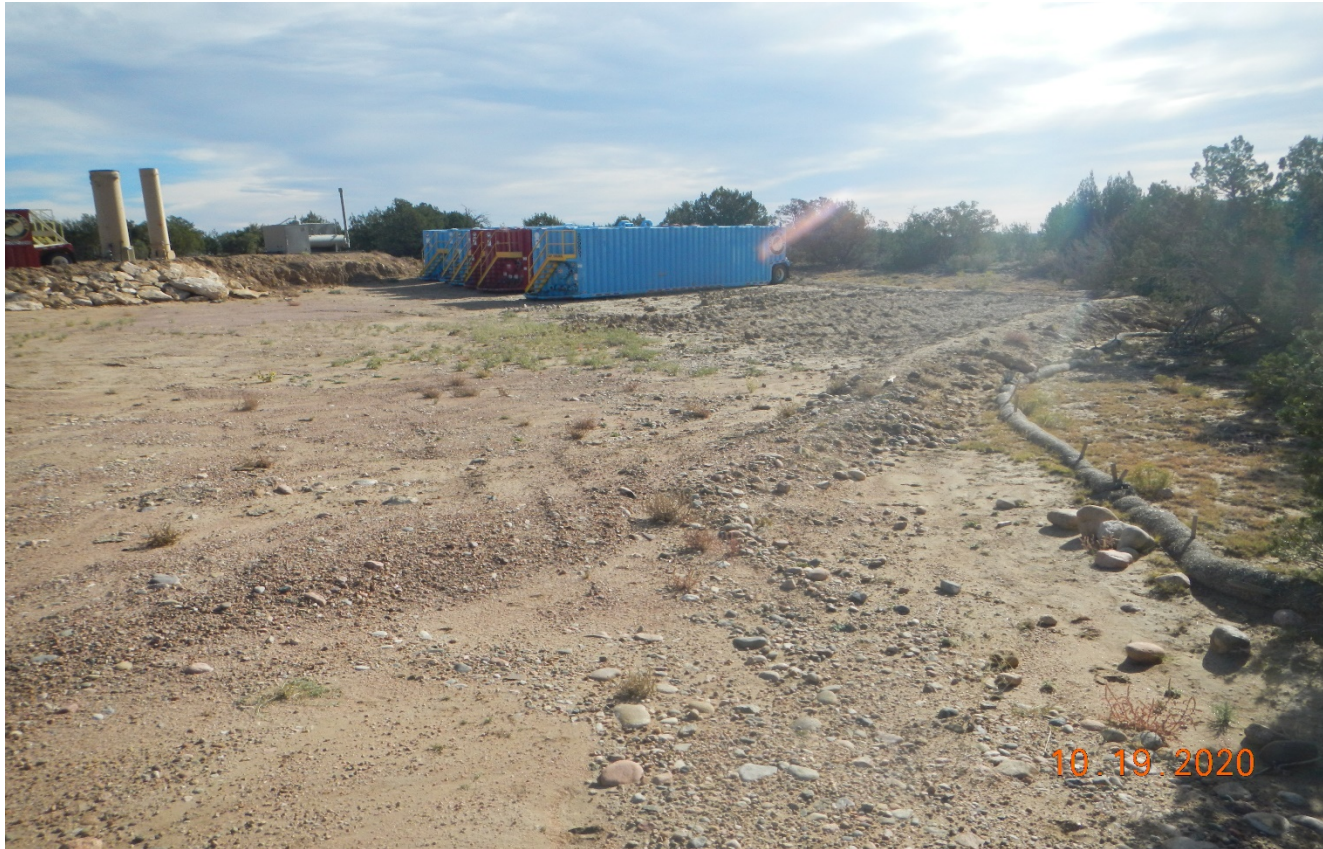
**Photo 3.** Facing east at the location. There is 5 frac tanks staged that remain. The tanks have not been removed since previous inspection. Previous corrective actions have not been performed.

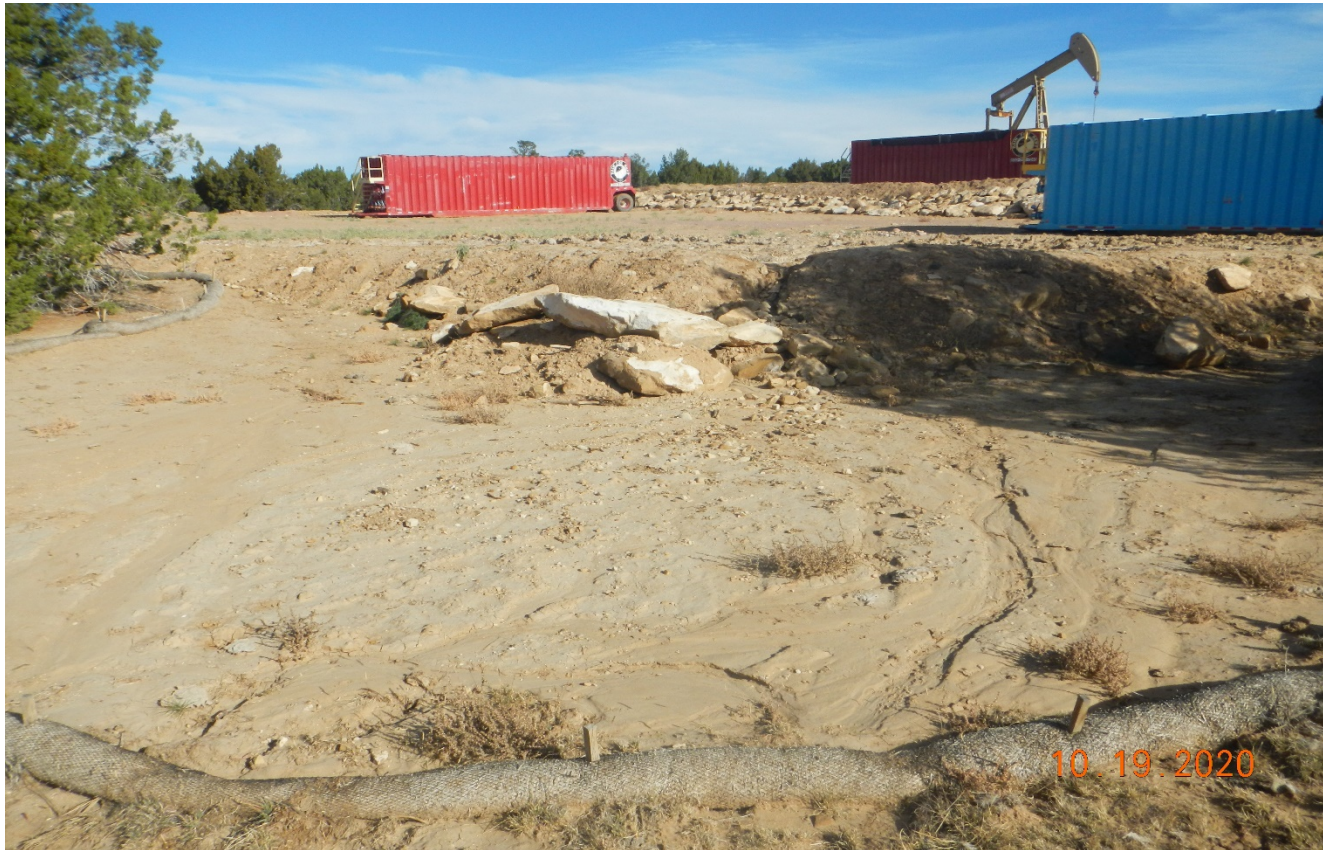
**Photo 4.** Facing north at the location. There is erosion occurring of the disturbed pad site which is filling in the perimeter wattles.

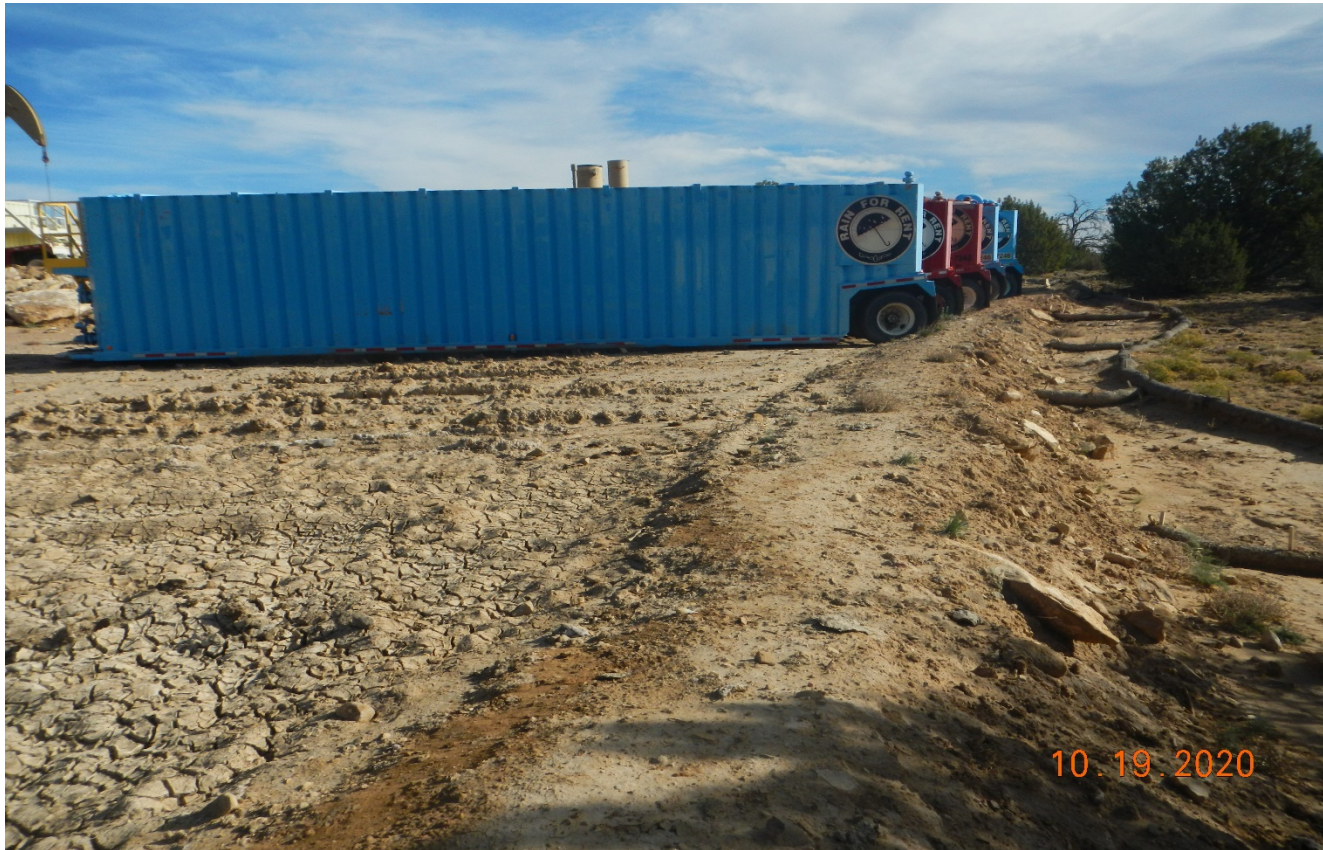
**Photo 5.** Facing northeast towards the frac-tanks stored at the location. It appears this area is pooling stormwater and is causing erosion shown in previous photo.

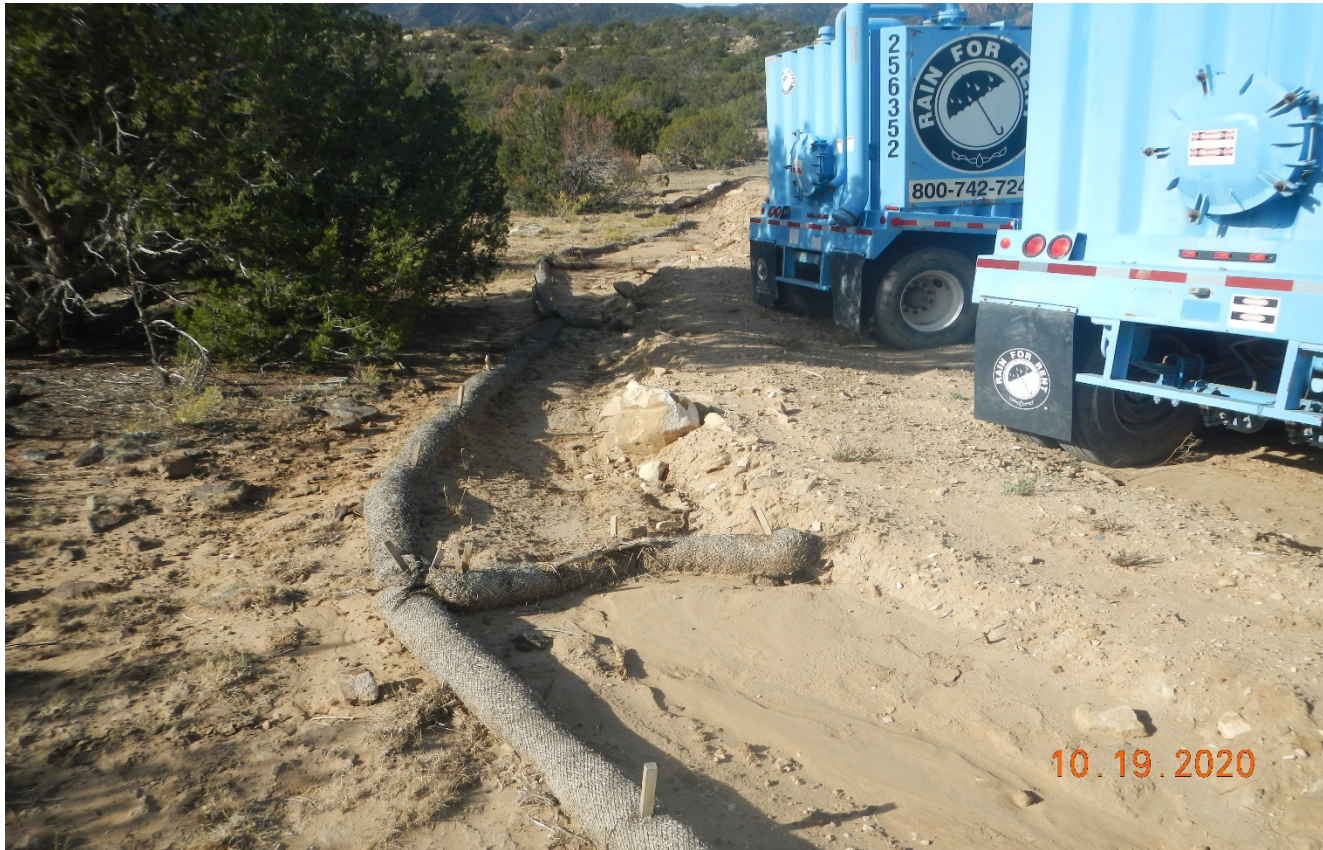
**Photo 6.** Facing southwest behind the frac tanks. The wattles have filled in with sediment.

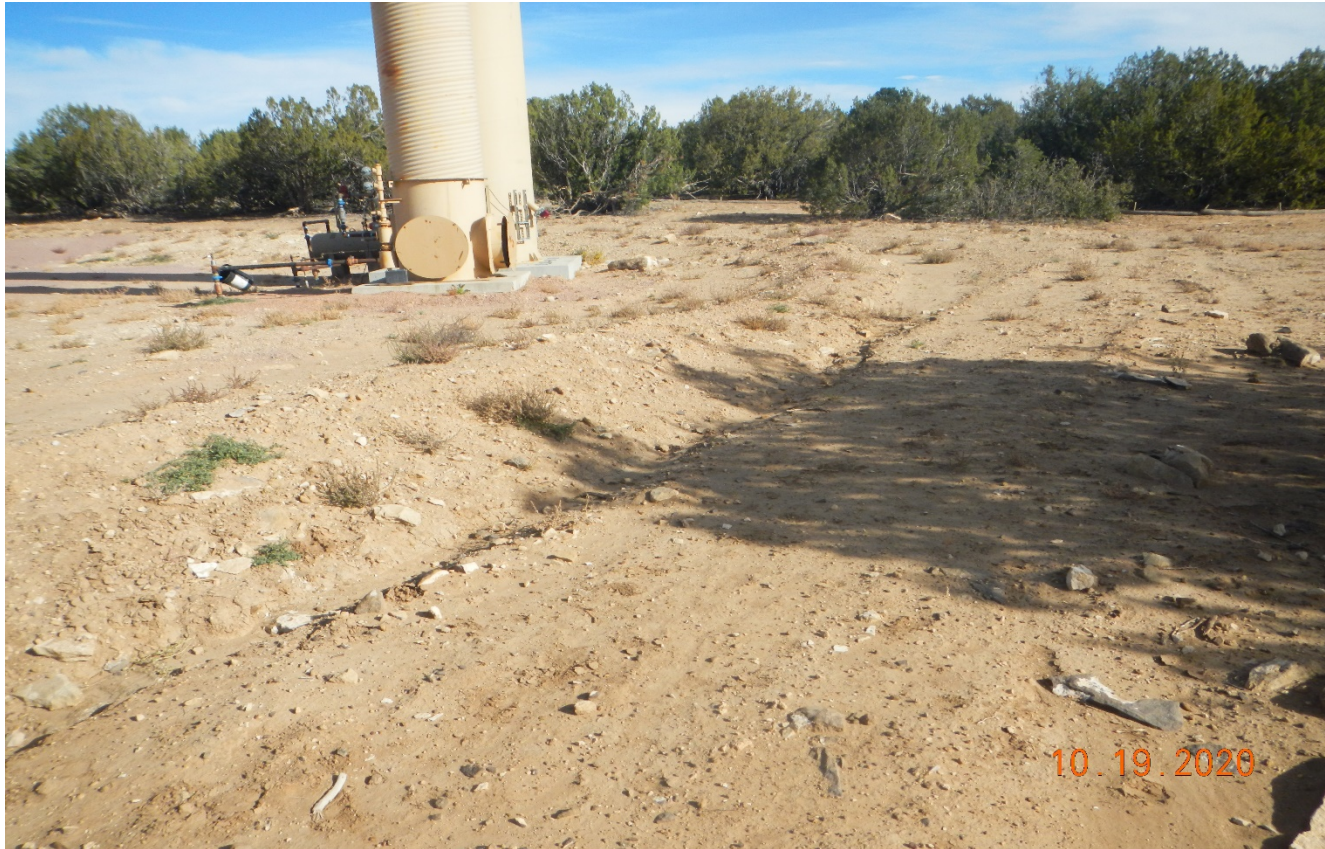
**Photo 7.** Facing north at the location. Disturbed areas around the location have not been reclaimed and stabilized.

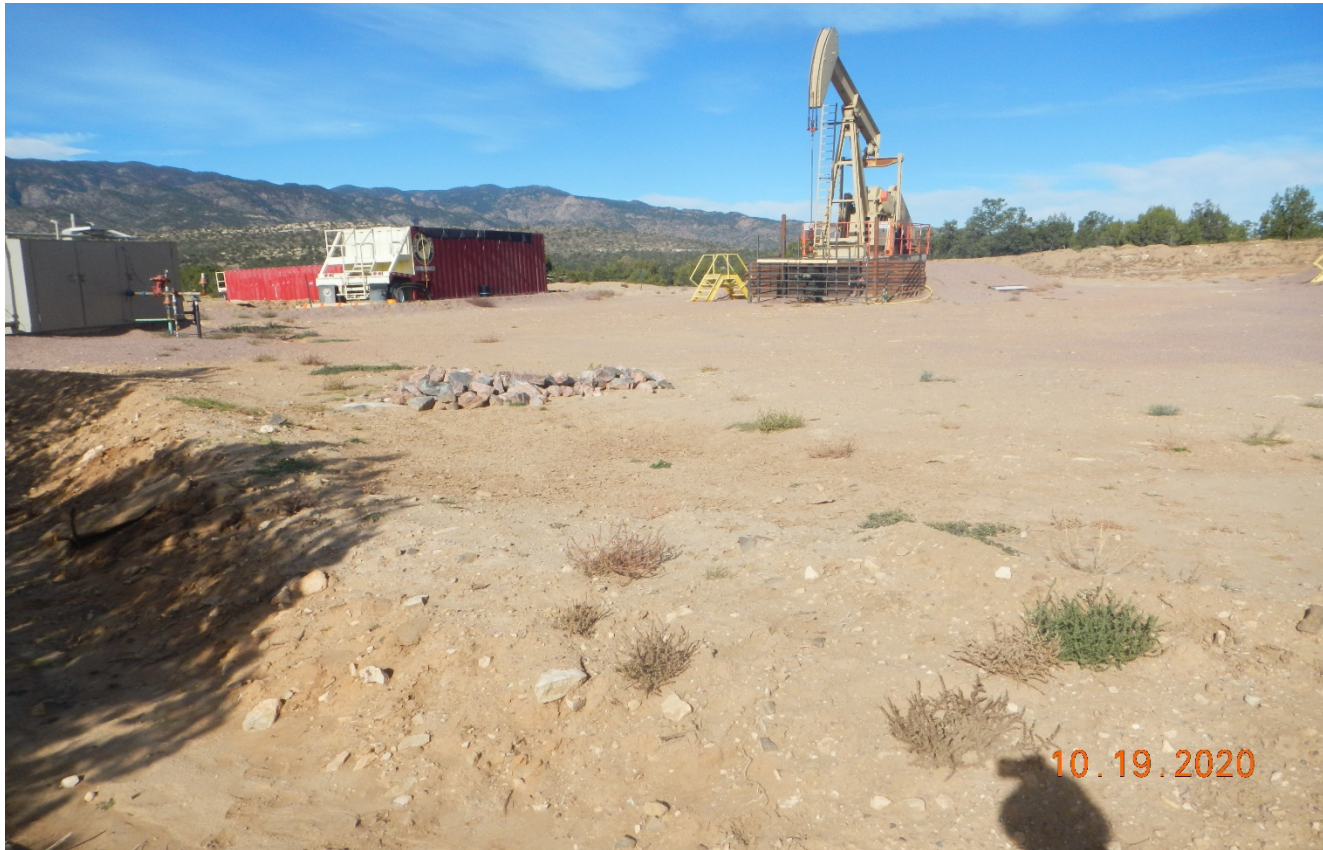
**Photo 8.** Facing southwest at the location and toward the production equipment.

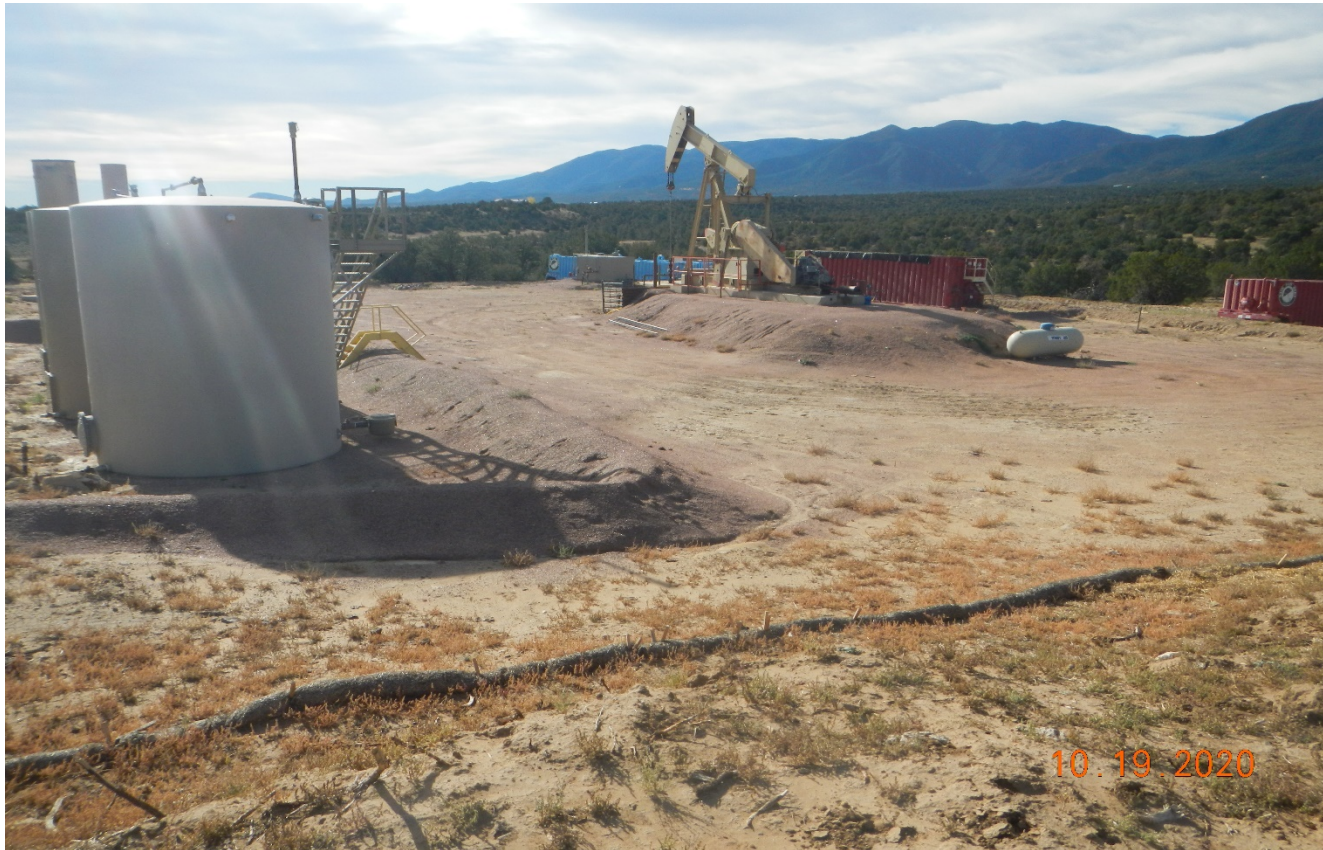
**Photo 9.** Facing southeast at the location and toward the production equipment.

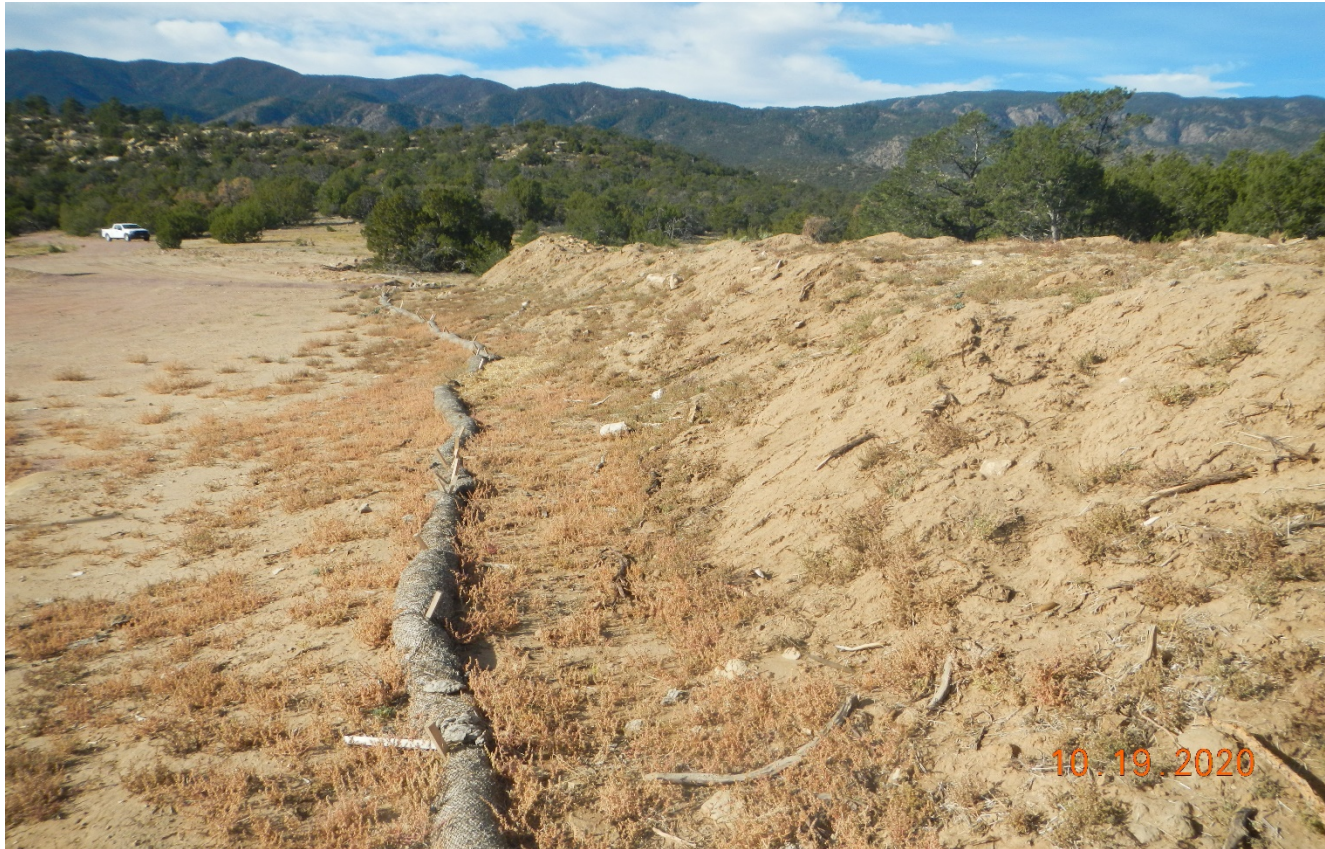
**Photo 10.** Facing southwest toward the topsoil pile which are not maintained and protected from degradation and weed infestation.

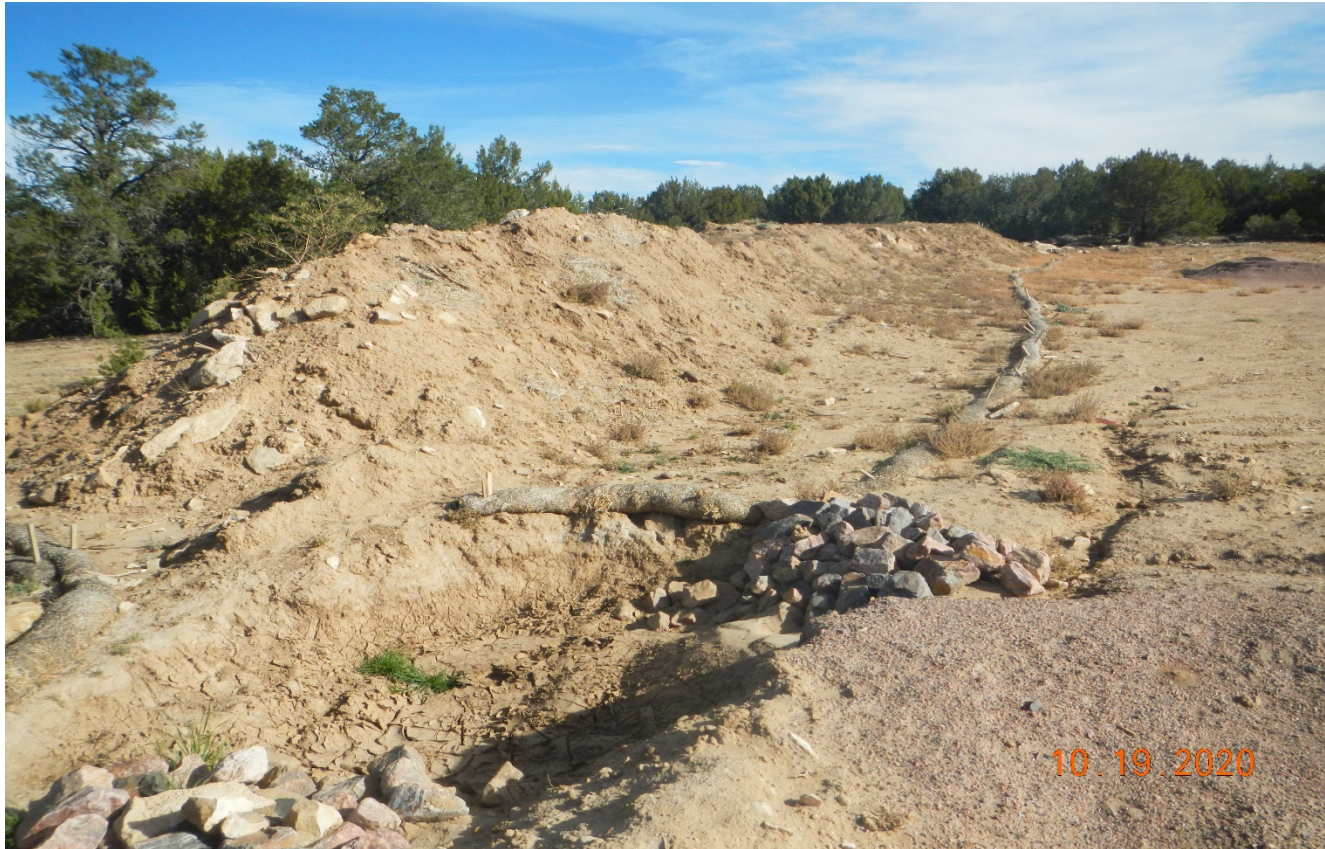
**Photo 11.** Facing toward the topsoil pile. The topsoil piles are not stabilized and protected. Topsoil piles have not been replaced for interim reclamation.

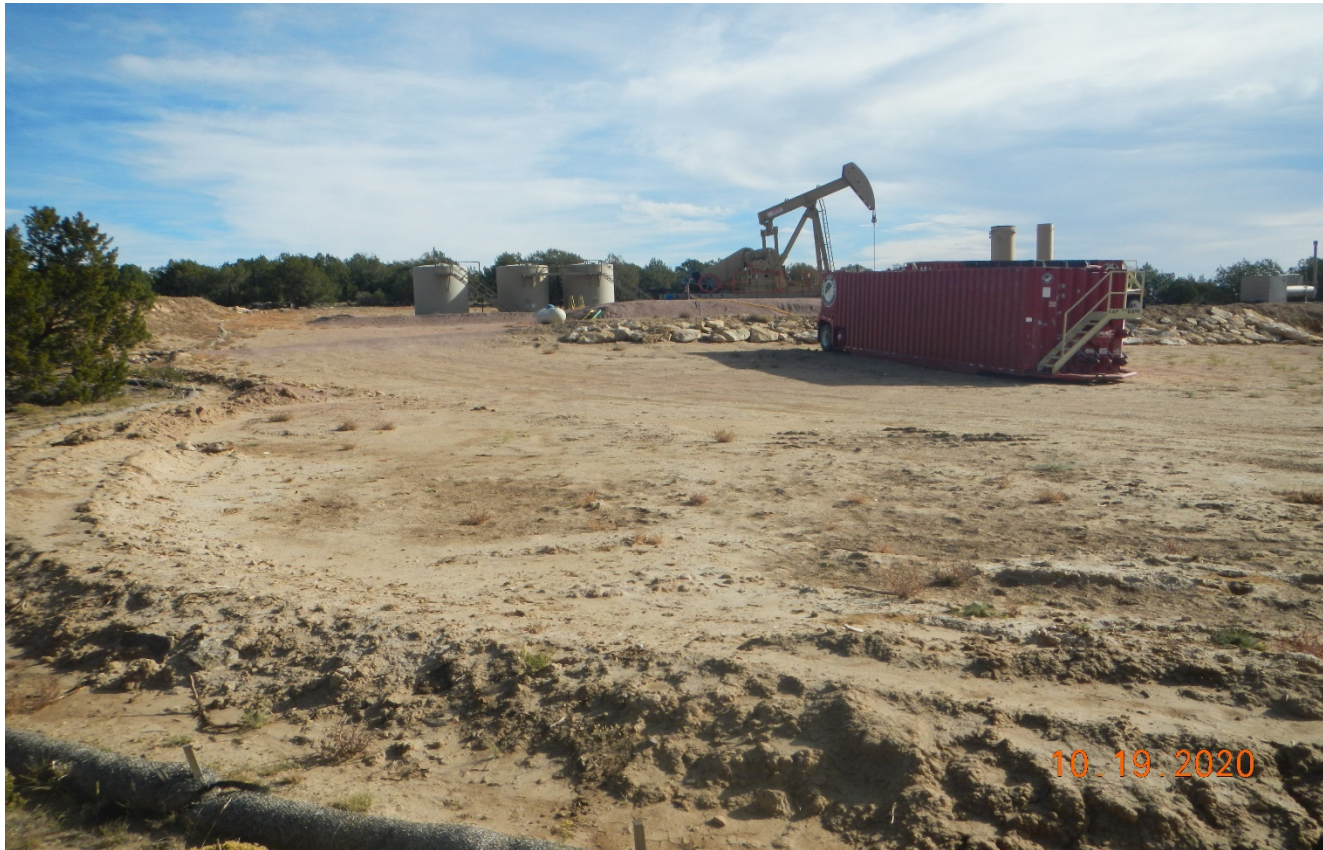
**Photo 12.** Facing northeast toward the location. The unused tanks need to be removed. This area needs to be recontoured and reclaimed. Previous corrective actions have not been performed.

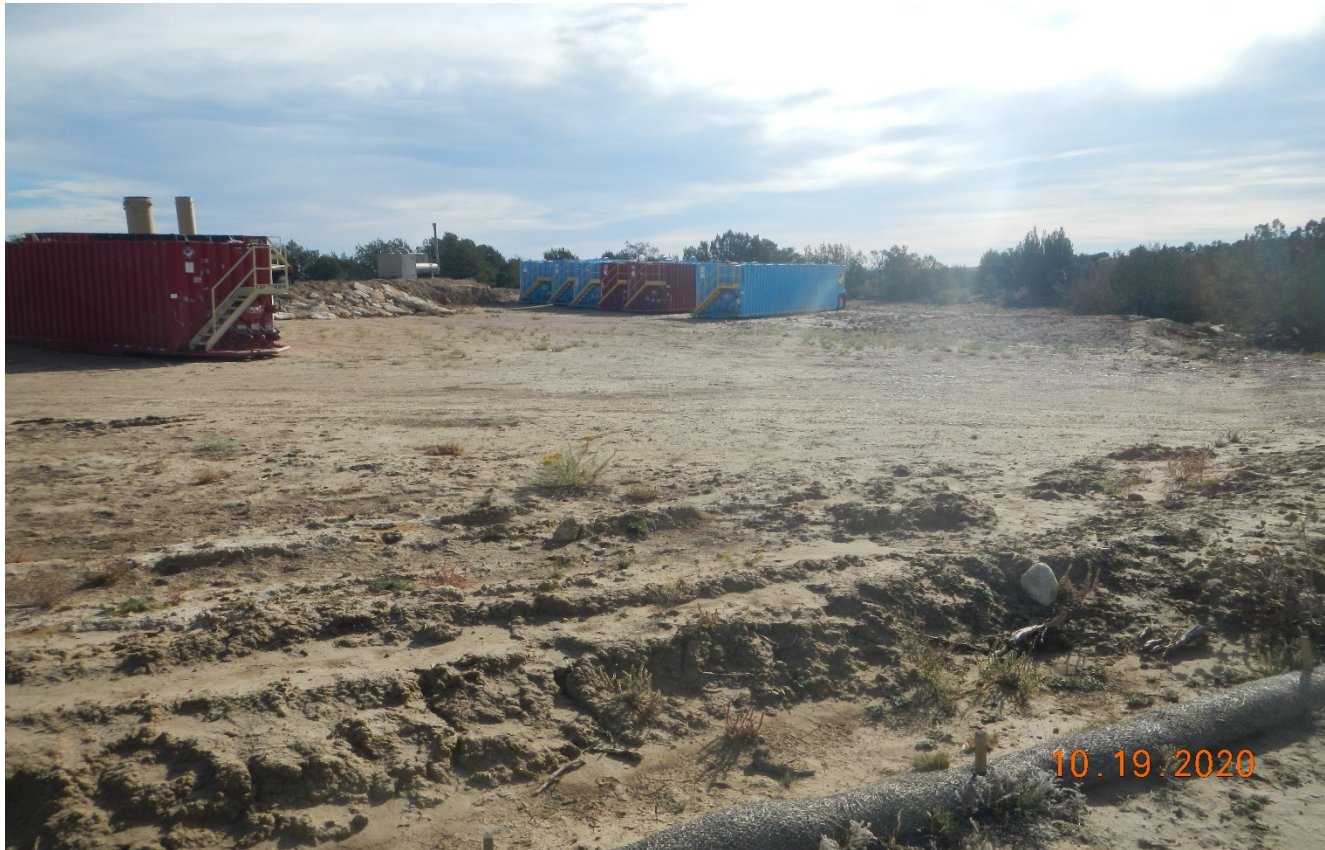
**Photo 13.** Facing east toward the location. The unused tanks need to be removed. This area needs to be recontoured and reclaimed. Previous corrective actions have not been performed.
